**UPDATED
RISK ANALYSIS & MANAGEMENT
FOR
PROPOSED ALTERATIONS & ADDITIONS
AT
61 DOLPHIN CRESCENT AVALON**

Jack Hodgson Consultants Pty Limited

CONSULTING CIVIL, GEOTECHNICAL AND STRUCTURAL ENGINEERS

MR 30609

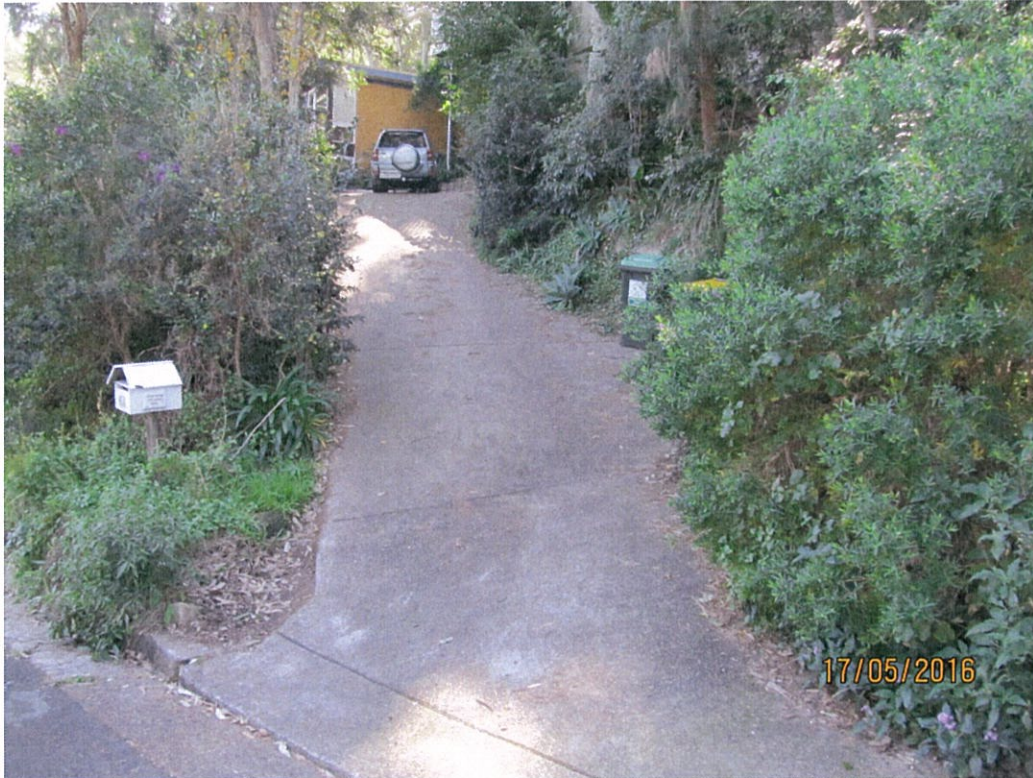
Photo 1

3.3 Vehicular access to the block is via a concrete driveway that rises from the southern corner of the property and terminates in a garage as part of the main residence (Photo 1). A densely vegetated garden containing small shrubs, trees and outcropping Narrabeen Group sandstones and shales rises from the road frontage and driveway toward the residence (Photo 1). A paved pathway extends along the southern corner of the residence. While considered stable in its current condition, the pathway displays evidence of settlement and movement (Photo 2). A set of masonry stairs provides access along the south-eastern side of the residence (Photo 3). A paved pathway extends along the north-eastern side of the residence (Photo 4). A stable masonry retaining wall extends along the northern side of the residence and supports the cut for a garden that rises to the northern boundary of the residence (Photos 4 & 5). A series of treated timber stairs rises from the northern corner of the residence and provides access to an average sized garden vegetated with small shrubs and trees (Photo 6). A set of concrete stairs provides access along the north-western side of the residence (Photo 7). While considered stable in its current condition, the stairs display evidence of cracking and movement.

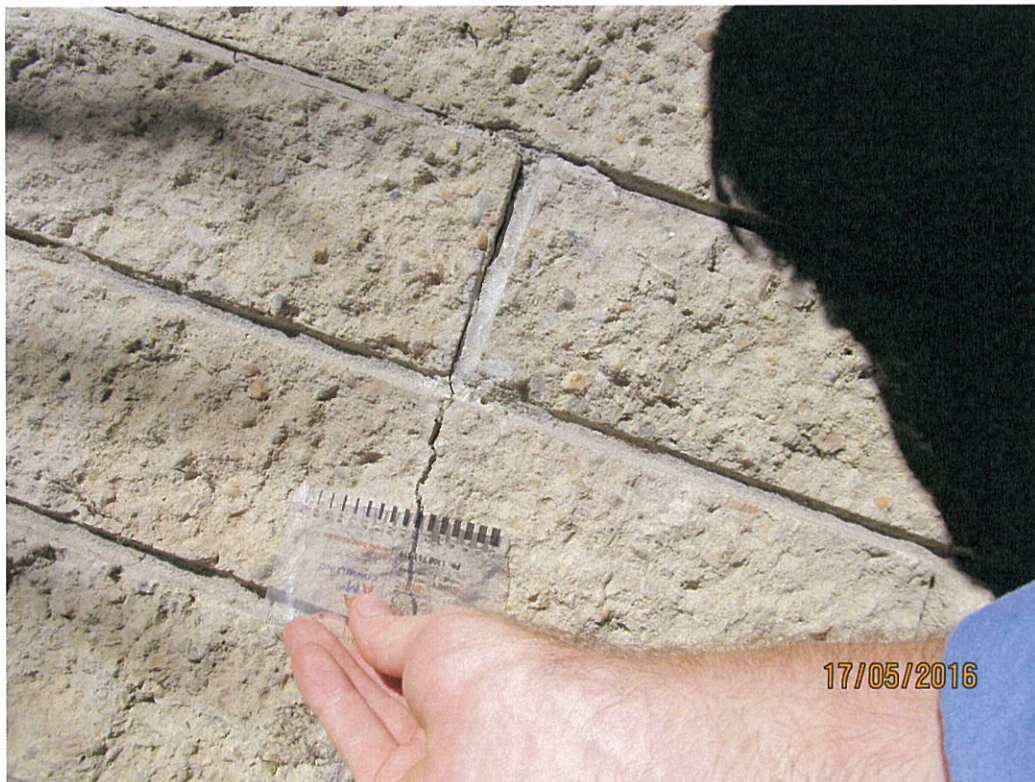
Photo 8

3.4 The existing, two storey, masonry house is in average condition for its age. It is supported by masonry walls and brick piers that display some signs of cracking or movement (Photo 8 & 9).

From the road frontage the slope of the land rises across the property at maximum average angles of 20 degrees. While considered stable in their current condition, evidence of minor cracking was evident within some of the masonry supporting walls of the residence and signs of settlement and movement could be seen in the stairs extending along the north-western side of the property and paved pathway situated near the southern corner of the residence. The likelihood of the slope failing is assessed as 'Unlikely' (10^{-4}). The consequences to property of such a failure are assessed as 'Minor' (5%). The risk to property is 'Low' (5×10^{-6}).
