62 Southern Cross Way, Allambie Heights

New DA.

PRELIMINARY GEOTECHNICAL ASSESSMENT:

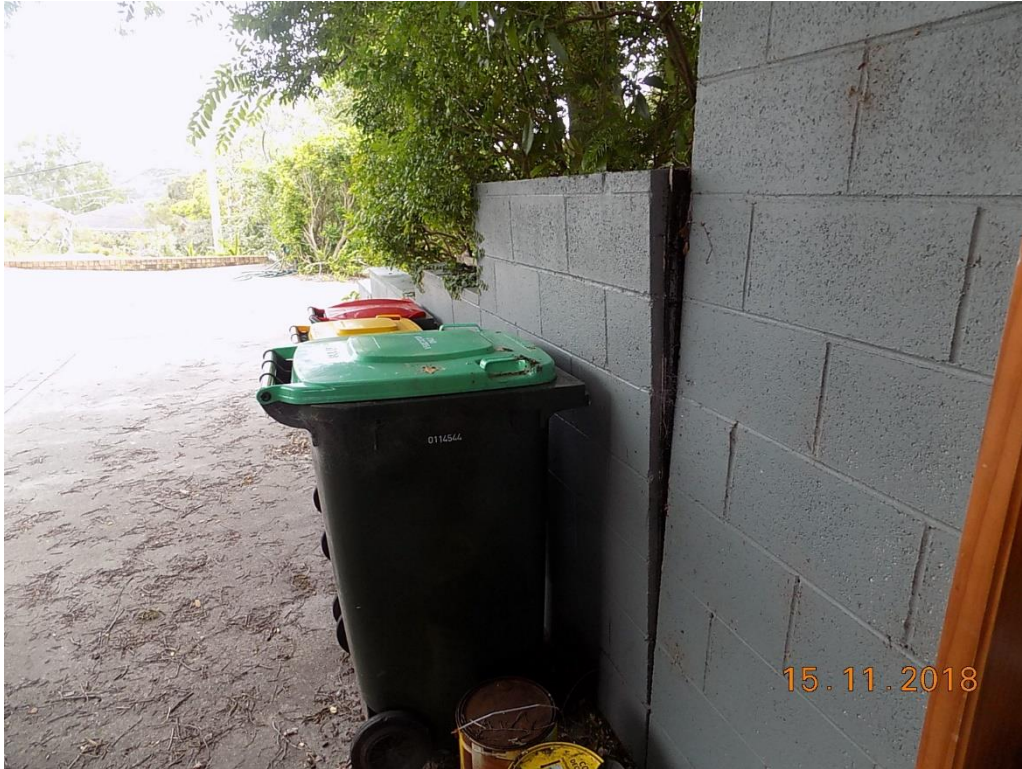
Photo 1

The concrete block retaining wall on the uphill side of the property is tilting downslope to ~4° (Photo 1). We recommend consideration be made to repairing/replacing the retaining wall during the proposed works to the carport. Alternatively, the retaining wall can be inspected by the owners on an annual basis or after heavy prolonged rainfall, whichever occurs first, keeping a photographic record of the inspections. We can carry out these inspections upon request. Should any new movement be observed, the retaining walls are to be remediated or rebuilt to current engineering standards.
