Re: Geotechnical Assessment

Project No: KFMGR-240309-Rv01

Address: 78 Mccarrs Creek Road, Church Point NSW 2105

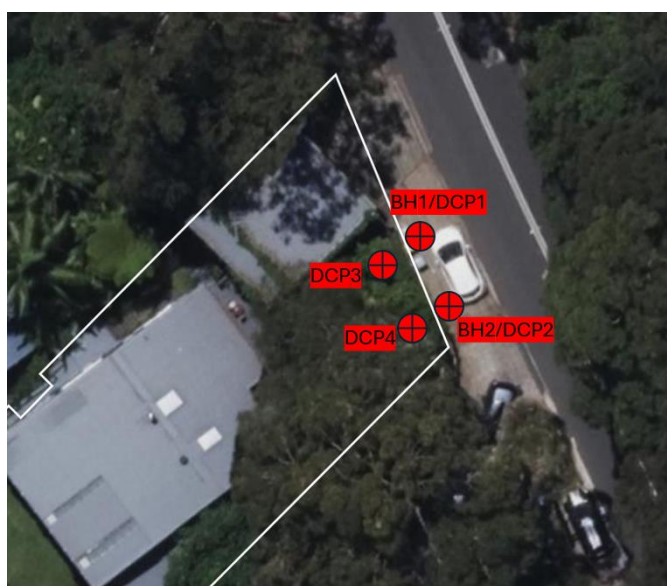
Figure 2. Borehole and DCP locations

A summary of the subsurface profile encountered in the borehole/DCPs is presented in Table 1 with the detailed log attached to this report.
