ARBORICULTURAL IMPACT STATEMENT

On: Tree Specimens at tree inspection at
123 Rickard Rd, Nth Narrabeen NSW
2101

For. Mr. & Mrs. Wright

On. 27/2/2021

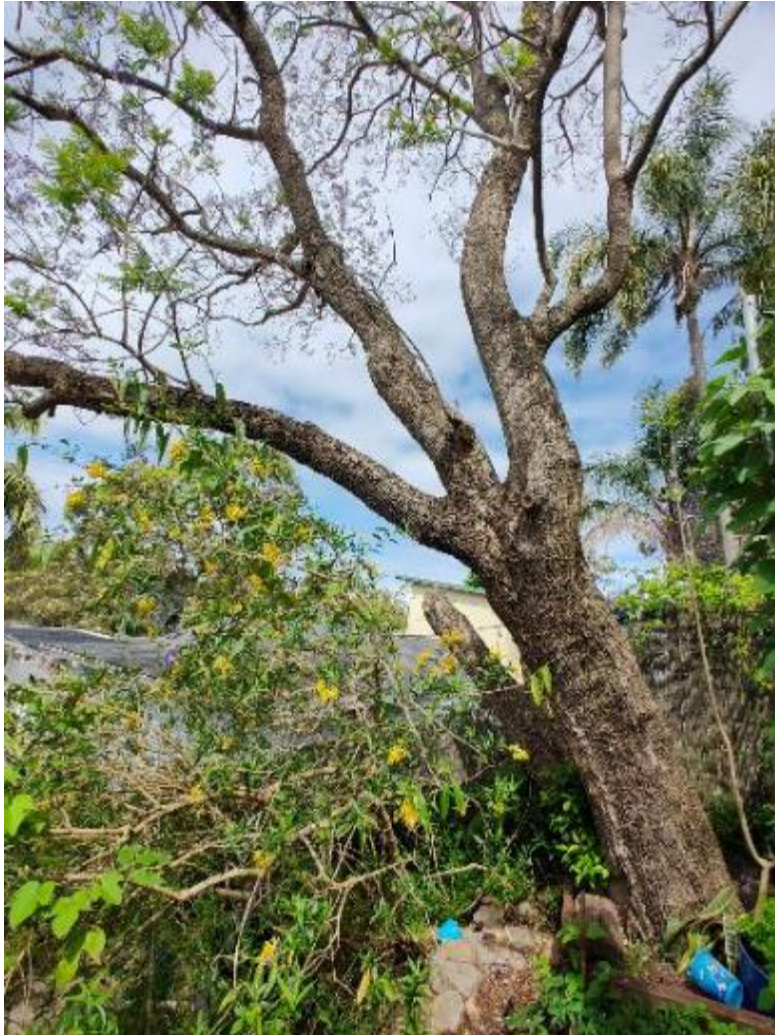
- 4.1 Tree T1 is a *Jacaranda mimosifolia* or simply 'Jacaranda' which is an exotic tree common to Brazil that had been planted in the rear yard to the South West of the existing dwelling (See Figs. 2, 3, 4, & 5). The tree has a significant defect in its formation where there are co dominant stems which adjoin in a 'V' shaped union at ground level (see Fig. 10). There is also strong bias in its crown to the East which overhangs the existing dwelling. Also noted is the presence of a *Ficus* sapling growing in the cleft formed by the stem junction of the *Jacaranda* stems.

Fig 2. Photo of T1 a *jacaranda mimosifolia*

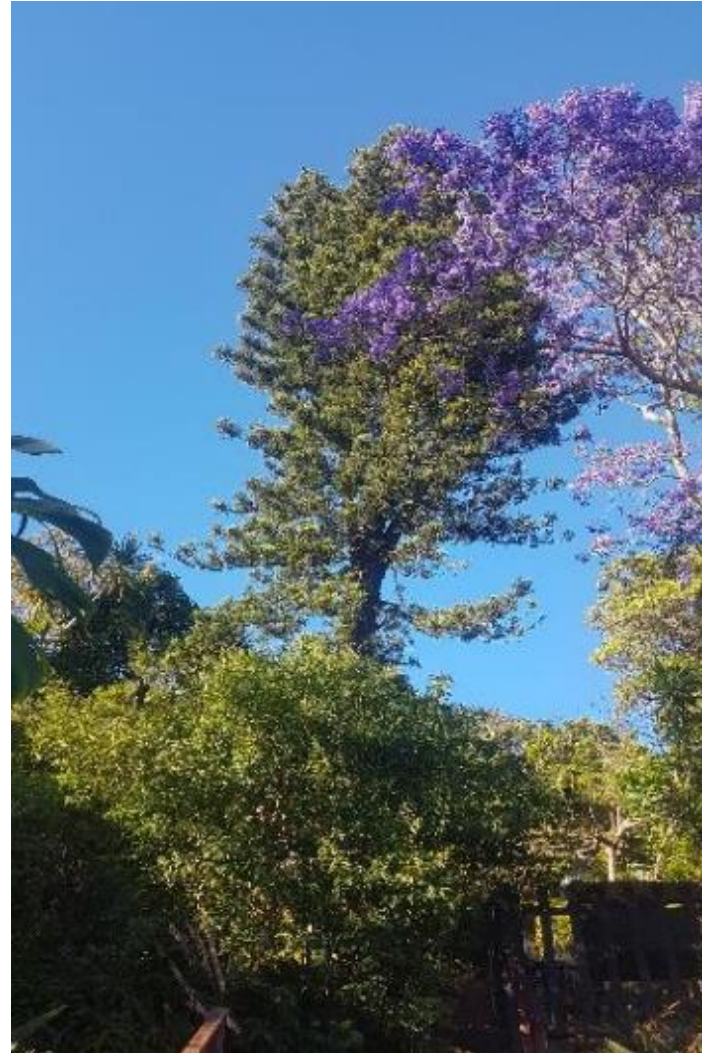
- 4.2 Tree T2 is an *Araucaria cunninghamii* or 'Hoop Pine' which is a native conifer that had been planted up slope near a small shed to the West of the existing dwelling (See Figs. 6 & 7). The tree has significant defects in the form of four multiple stems which adjoin in 'V' shaped stem junctions (See Figs. 3, 6 & 7).

Fig 3. Photo of tree T2 an *Araucaria cunninghamii*.

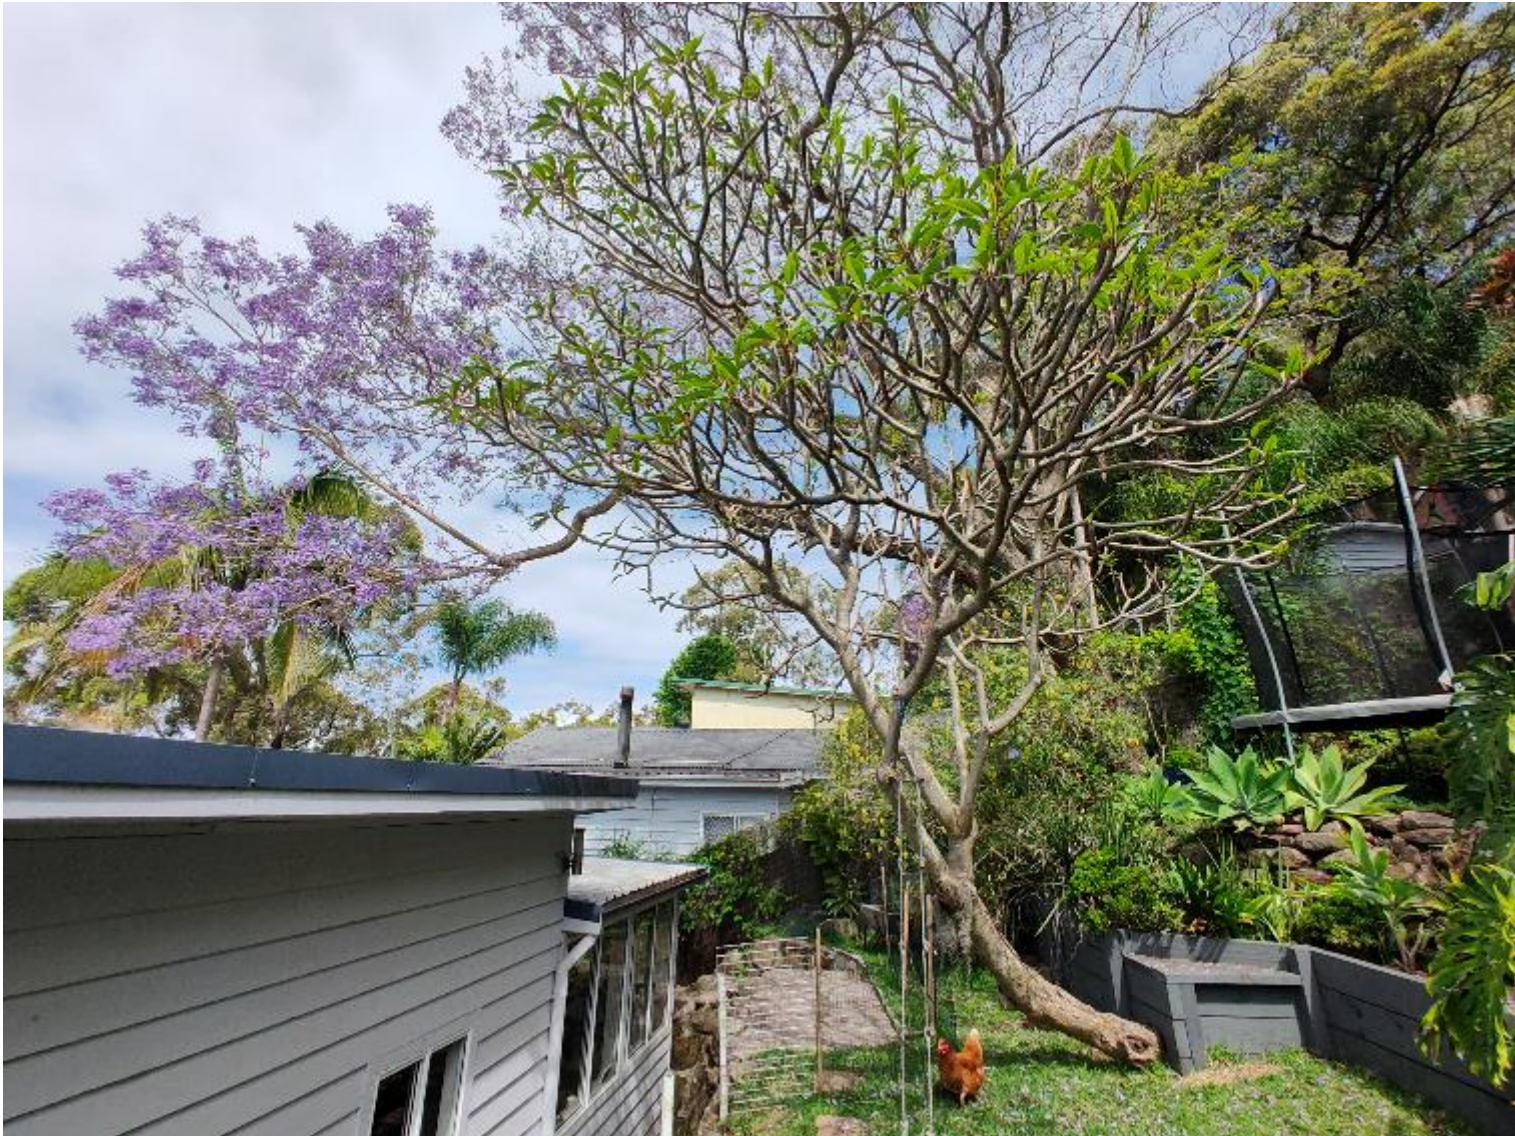
Fig4. Photo of of a *Plumeria* spp.

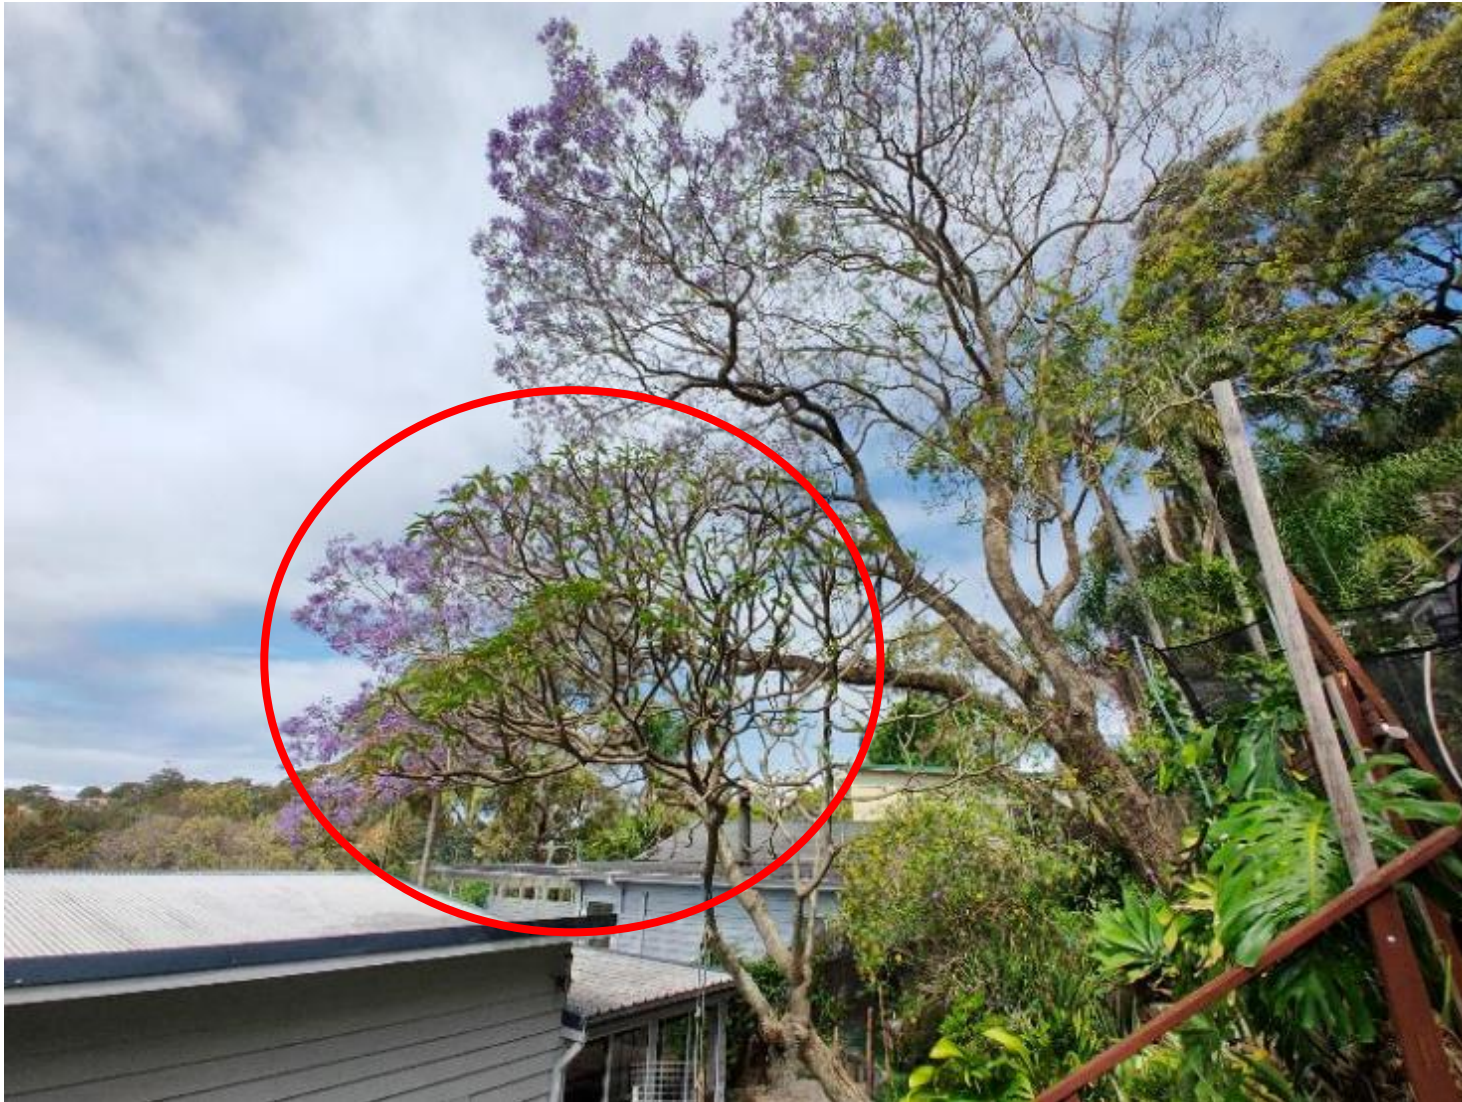
Fig 5. Photo of *Plumeria* and T1 the *Jacaranda* showing a strong bias in their main stems to the North East which overhang the existing dwelling.

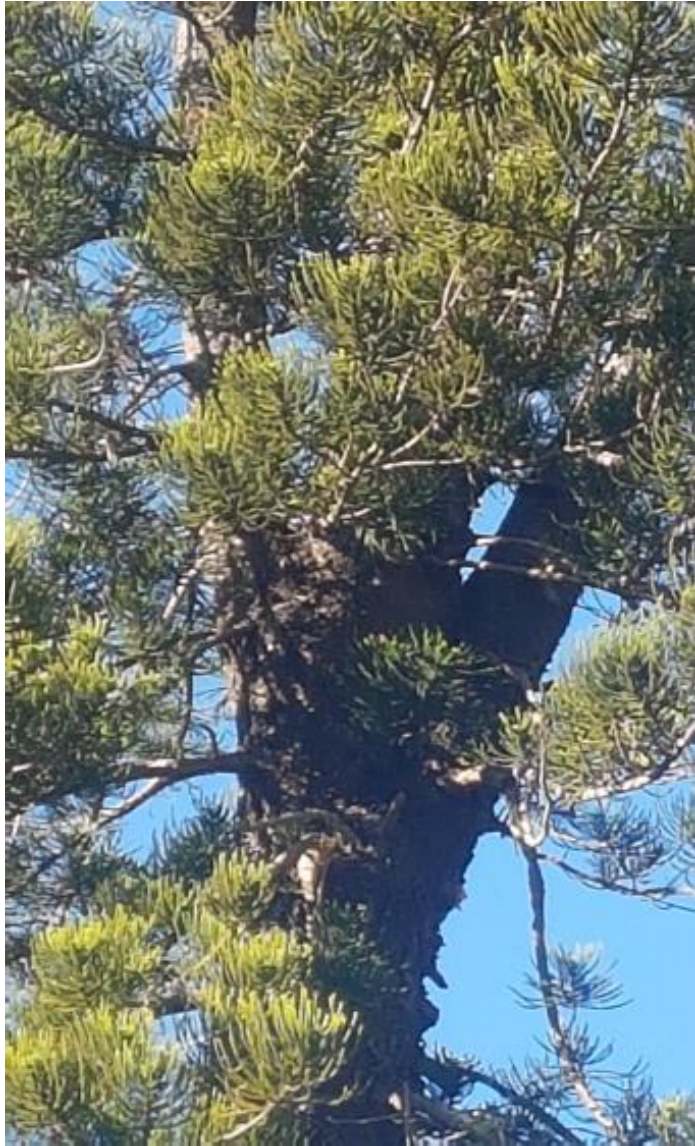
This tree won't be directly affected by the proposed development and is being considered for removal due to health and safety concerns in relation to a significant defect in its upper canopy (See Fig. 6) and the overall stability of the tree given that it is growing on a step slope and would have formed an asymmetric root plate (See Fig. 7).

5.3 Tree **T2** has a formative defect where the main stem has divided into 4 smaller stems which adjoin in 'V' shaped unions at the junction. As in the case of **T1** this is a significant defect which can lead to stem failure as the stems become heavier over time.

Fig. 6. Photo showing formative damage on T2

6.2 It is further recommended that **T2** be removed from the Site due to structural defects and a potential for personal injury and property damage from falling limbs and stems.

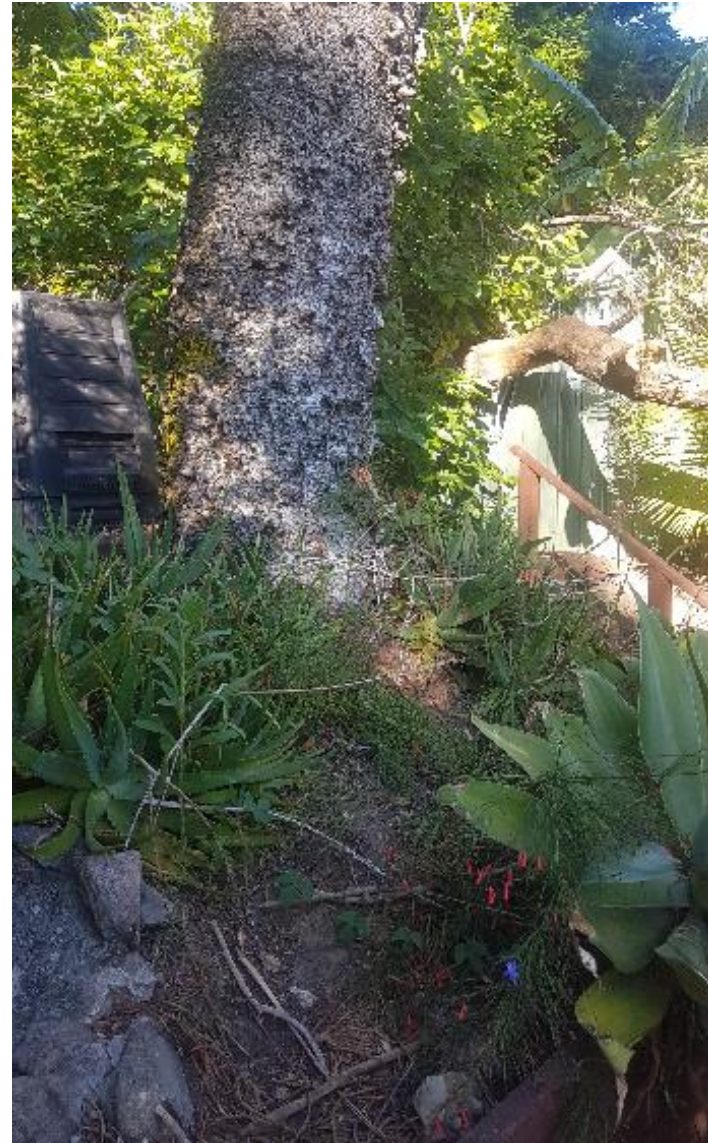
5.4 Further to this both of the subject trees have asymmetric rootplates where it is assumed that the bulk of the roots, in particular structural roots that are responsible for the stability of the tree, would be located up slope and be in tension counteracting for the lack of roots downslope.

Over time, and as the main stems of these trees become heavier, there is a potential for the main stems to fail and fall onto anything within their respective target areas. This includes neighbouring properties.

Fig. 7. Photo showing main stem of T2 growing on steep bank.

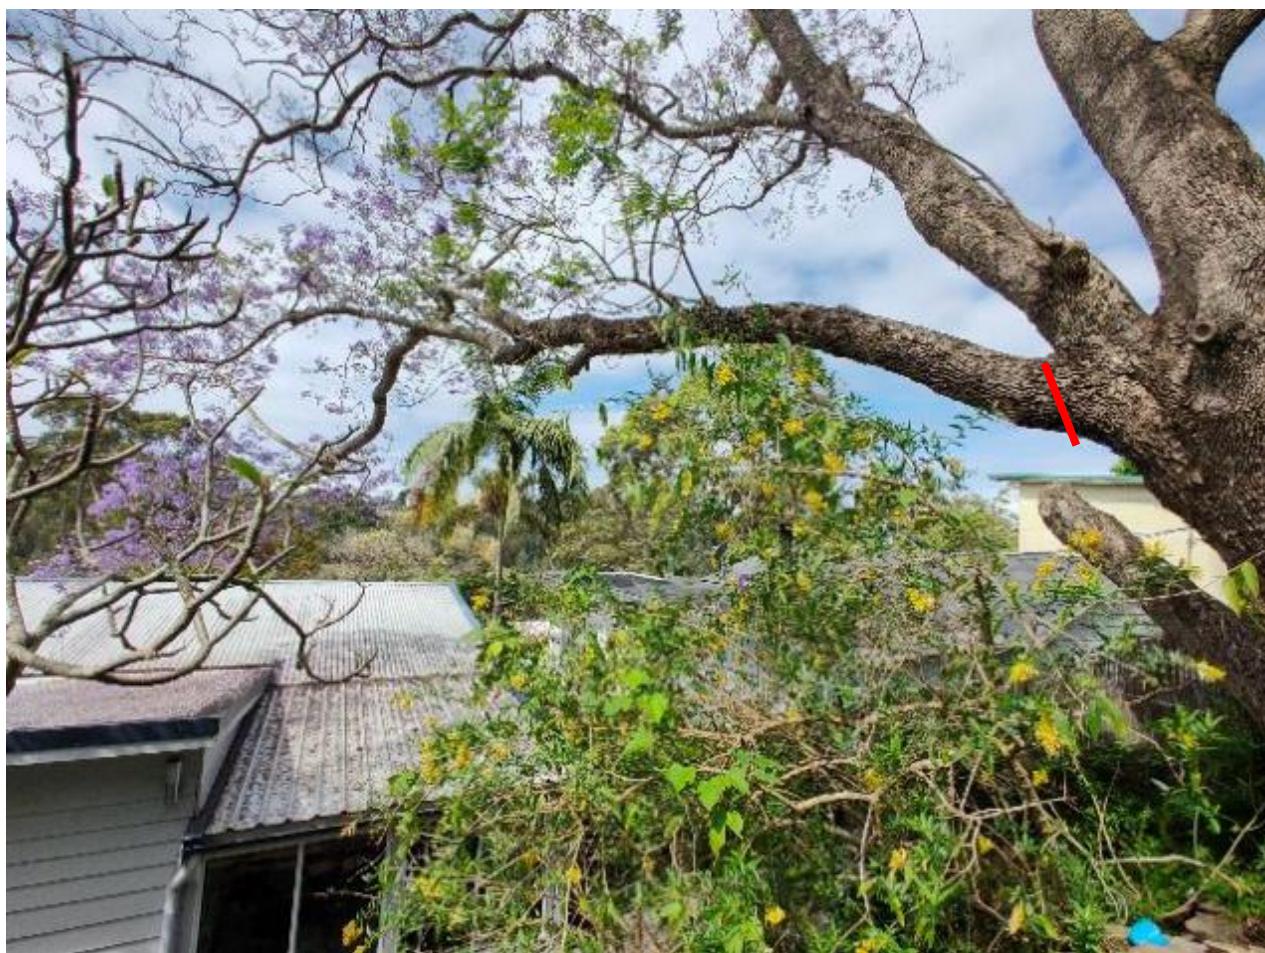
This specimen will be subjected to a Major Encroachment into its TPZ from the new upper floor which will necessitate the removal of one limb which overhangs the existing dwelling and forms a constraint for development to proceed as planned (See Appendix 2b & 2c).

Fig 8. Photo showing limbs from T1 overhanging the existing dwelling. t

Nonetheless Mr. Wright advises me that they wish to retain the *Jacaranda* which can be achieved by the removal of one limb on the Tree's North East (See Figs.8 & 9).

6.1 It is recommended that one **T1** retained with the removal of one limb as depicted in Figs 8 & 9.

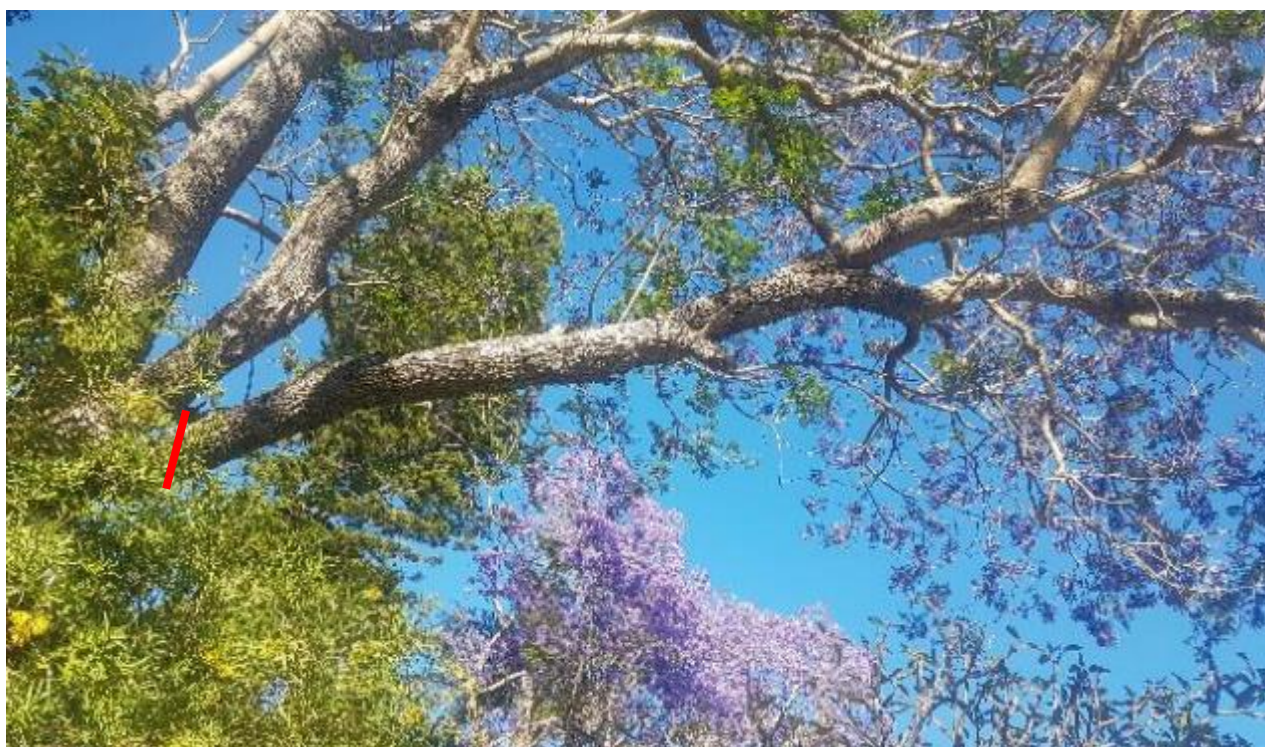
Fig. 9. Photo showing limb proposed for removal overhanging existing dwelling.

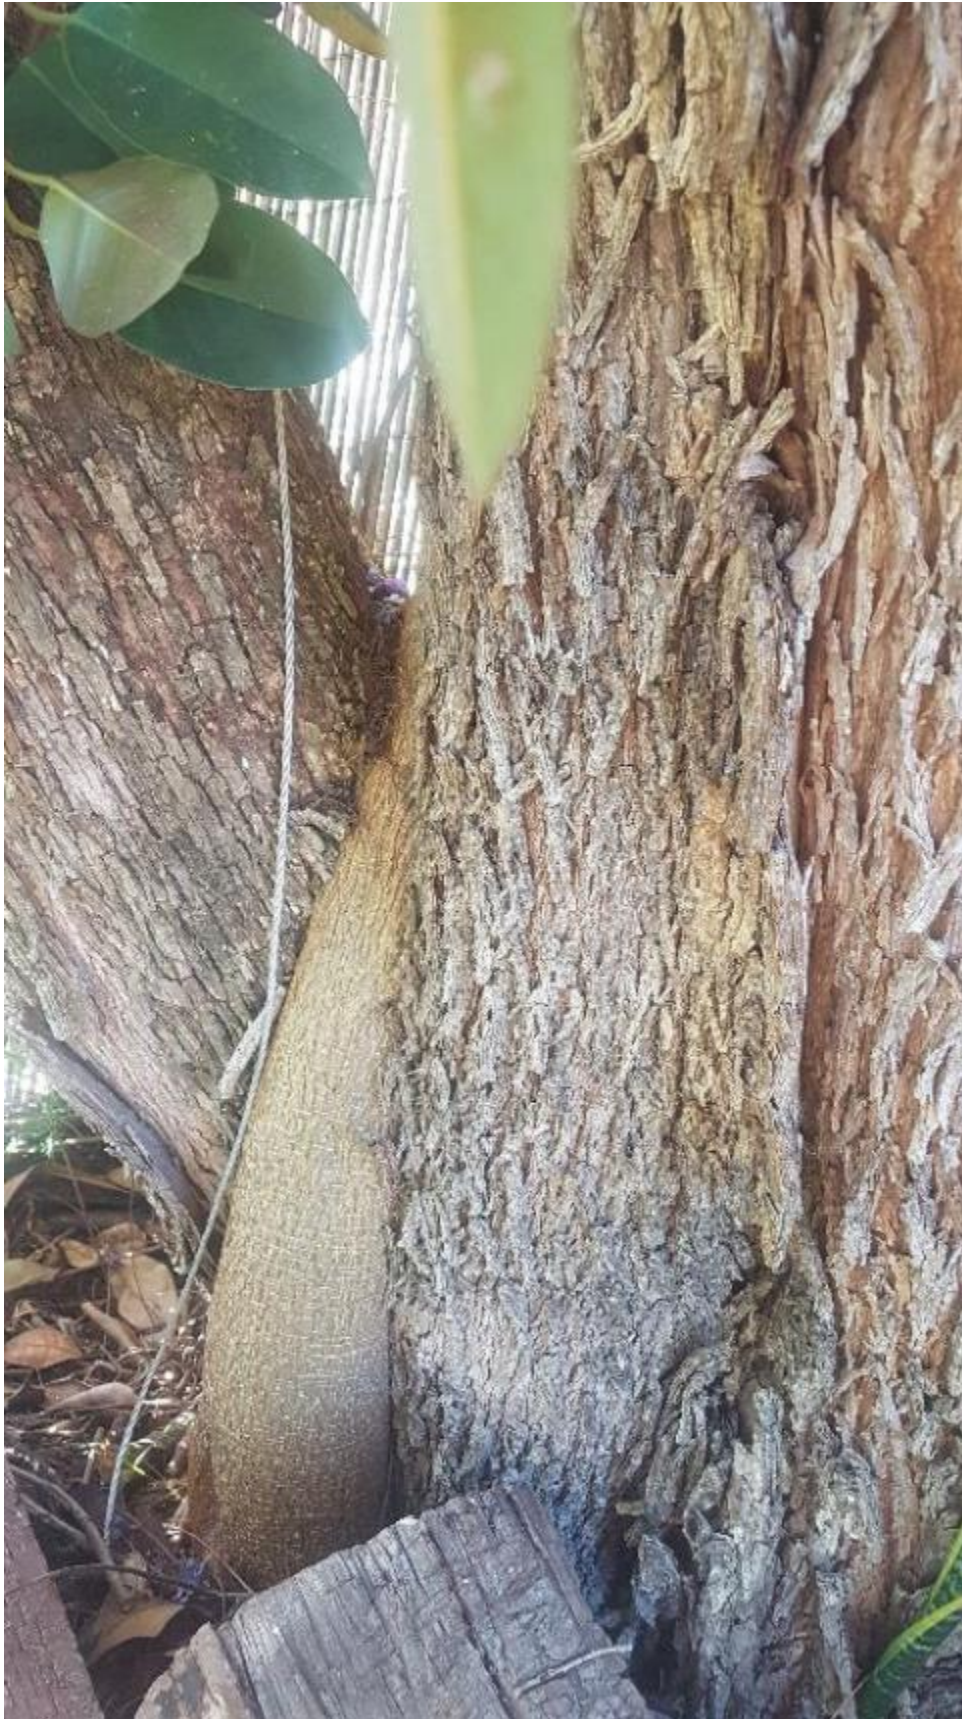
- 5.2 Tree T1 has co dominant stems at ground level which has a 'V' shaped stem junction with included bark in the union (See Fig. 10).

This is considered to be a defect in that the stems can move differentially and fail especially during high wind events and the included bark precludes the tree from forming a strong stem attachment (Matteck & Breloer 2006).

Exacerbating this situation there is a *Ficus* tree sapling growing in the cradle of the union which has the potential to expand and split the main stem of the *Jacaranda* (See Figure 10).

Fig. 10. Photo showing co dominant stems with 'V' shaped stem junction and a *Ficus* growing in the cradle of the junction.
