Naturally Trees

14 October 2021

TREE IMPACT STATEMENT - Tree 3: 40 Sunrise Road, Palm Beach NSW

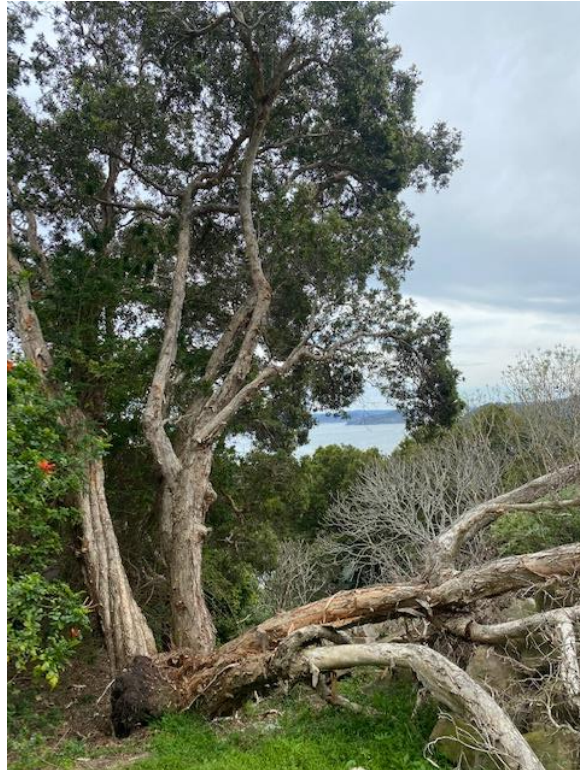
Following my site inspection, I can confirm that the subject tree, *Melaleuca quinquenervia* (Broad-leafed Paperbark), has had a major failure, with one of three main leaders failing at the base. The tree fell away from the neighbouring property but has left a large cavity at the base of the tree. Due to this failure, I believe that the structure of the tree has been severely compromised, and there is a much greater risk of the remaining leaders failing onto the neighbouring residence or the proposed construction works. It is my strong recommendation that this tree be removed and replaced.

Figure 1: Failure of main leader (trunk)

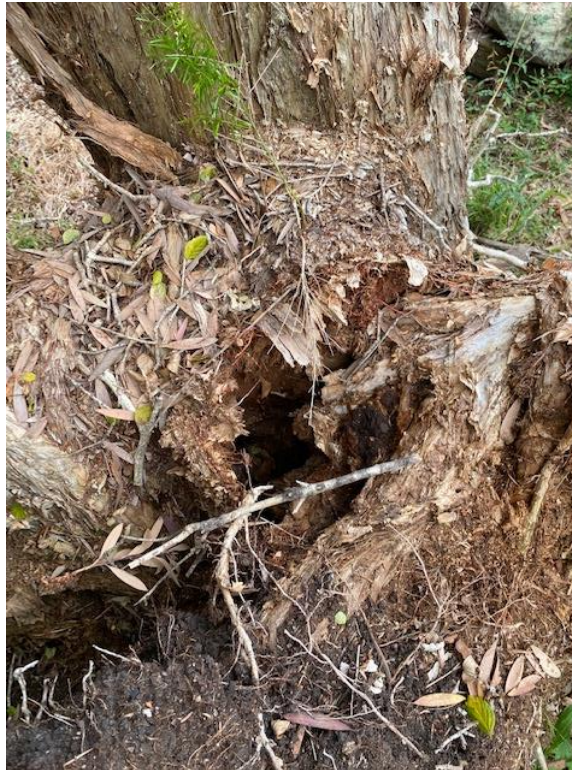
Figure 2: Cavity at base

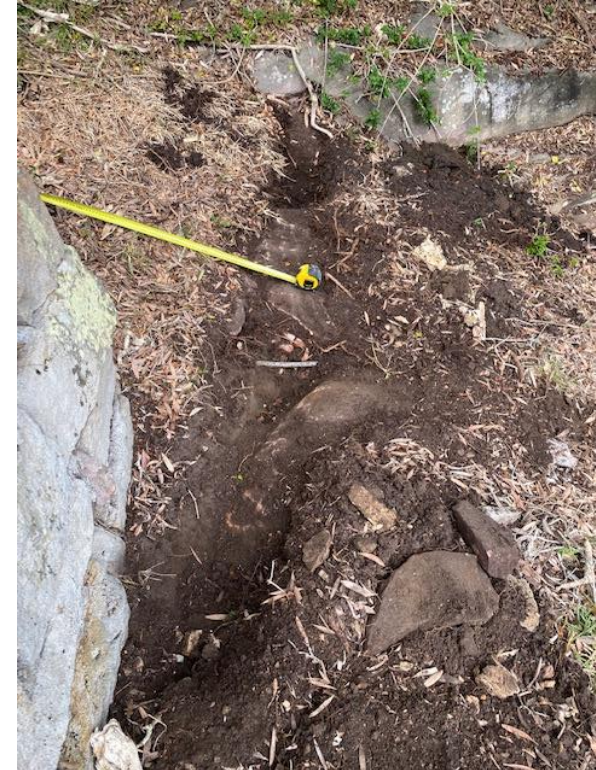
In addition, a root investigation trench was dug in line with the proposed works, and no significant roots were located. The area has extremely shallow soil, with bedrock just below the surface. The result of this investigation is that in the event of the tree being retained, it can be said that the proposed works will have little additional impact on its stability, condition or longevity into the future.

Figure 3: Root investigation trench
