Geotechnical Assessment

Project: Alterations & Additions
106 Rose Avenue, Wheeler Heights NSW

Prepared for:
Phoebe Buchanan, c/ Rapid Plans

Ref: AG 24574
20 January 2025

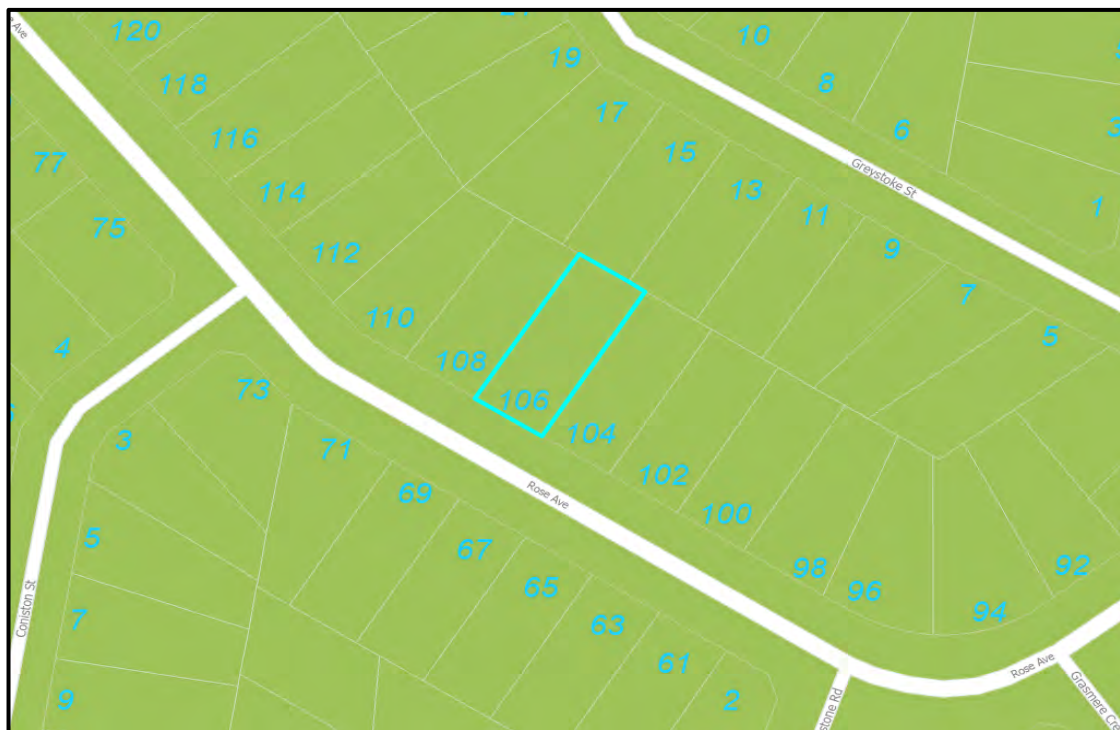
Image 2. Warringah Landslip Risk Map:
106 Rose Avenue, Wheeler Heights (© NBC Maps)

- No evidence of significant soil creep, tension cracks or landslip instability were identified across the site or on adjacent properties as viewed from the subject site at the time of our inspection.
- The property is classified as **Area D** with reference to Northern Beaches Council WLEP – Warringah Landslip Risk Map (**Image 2**).

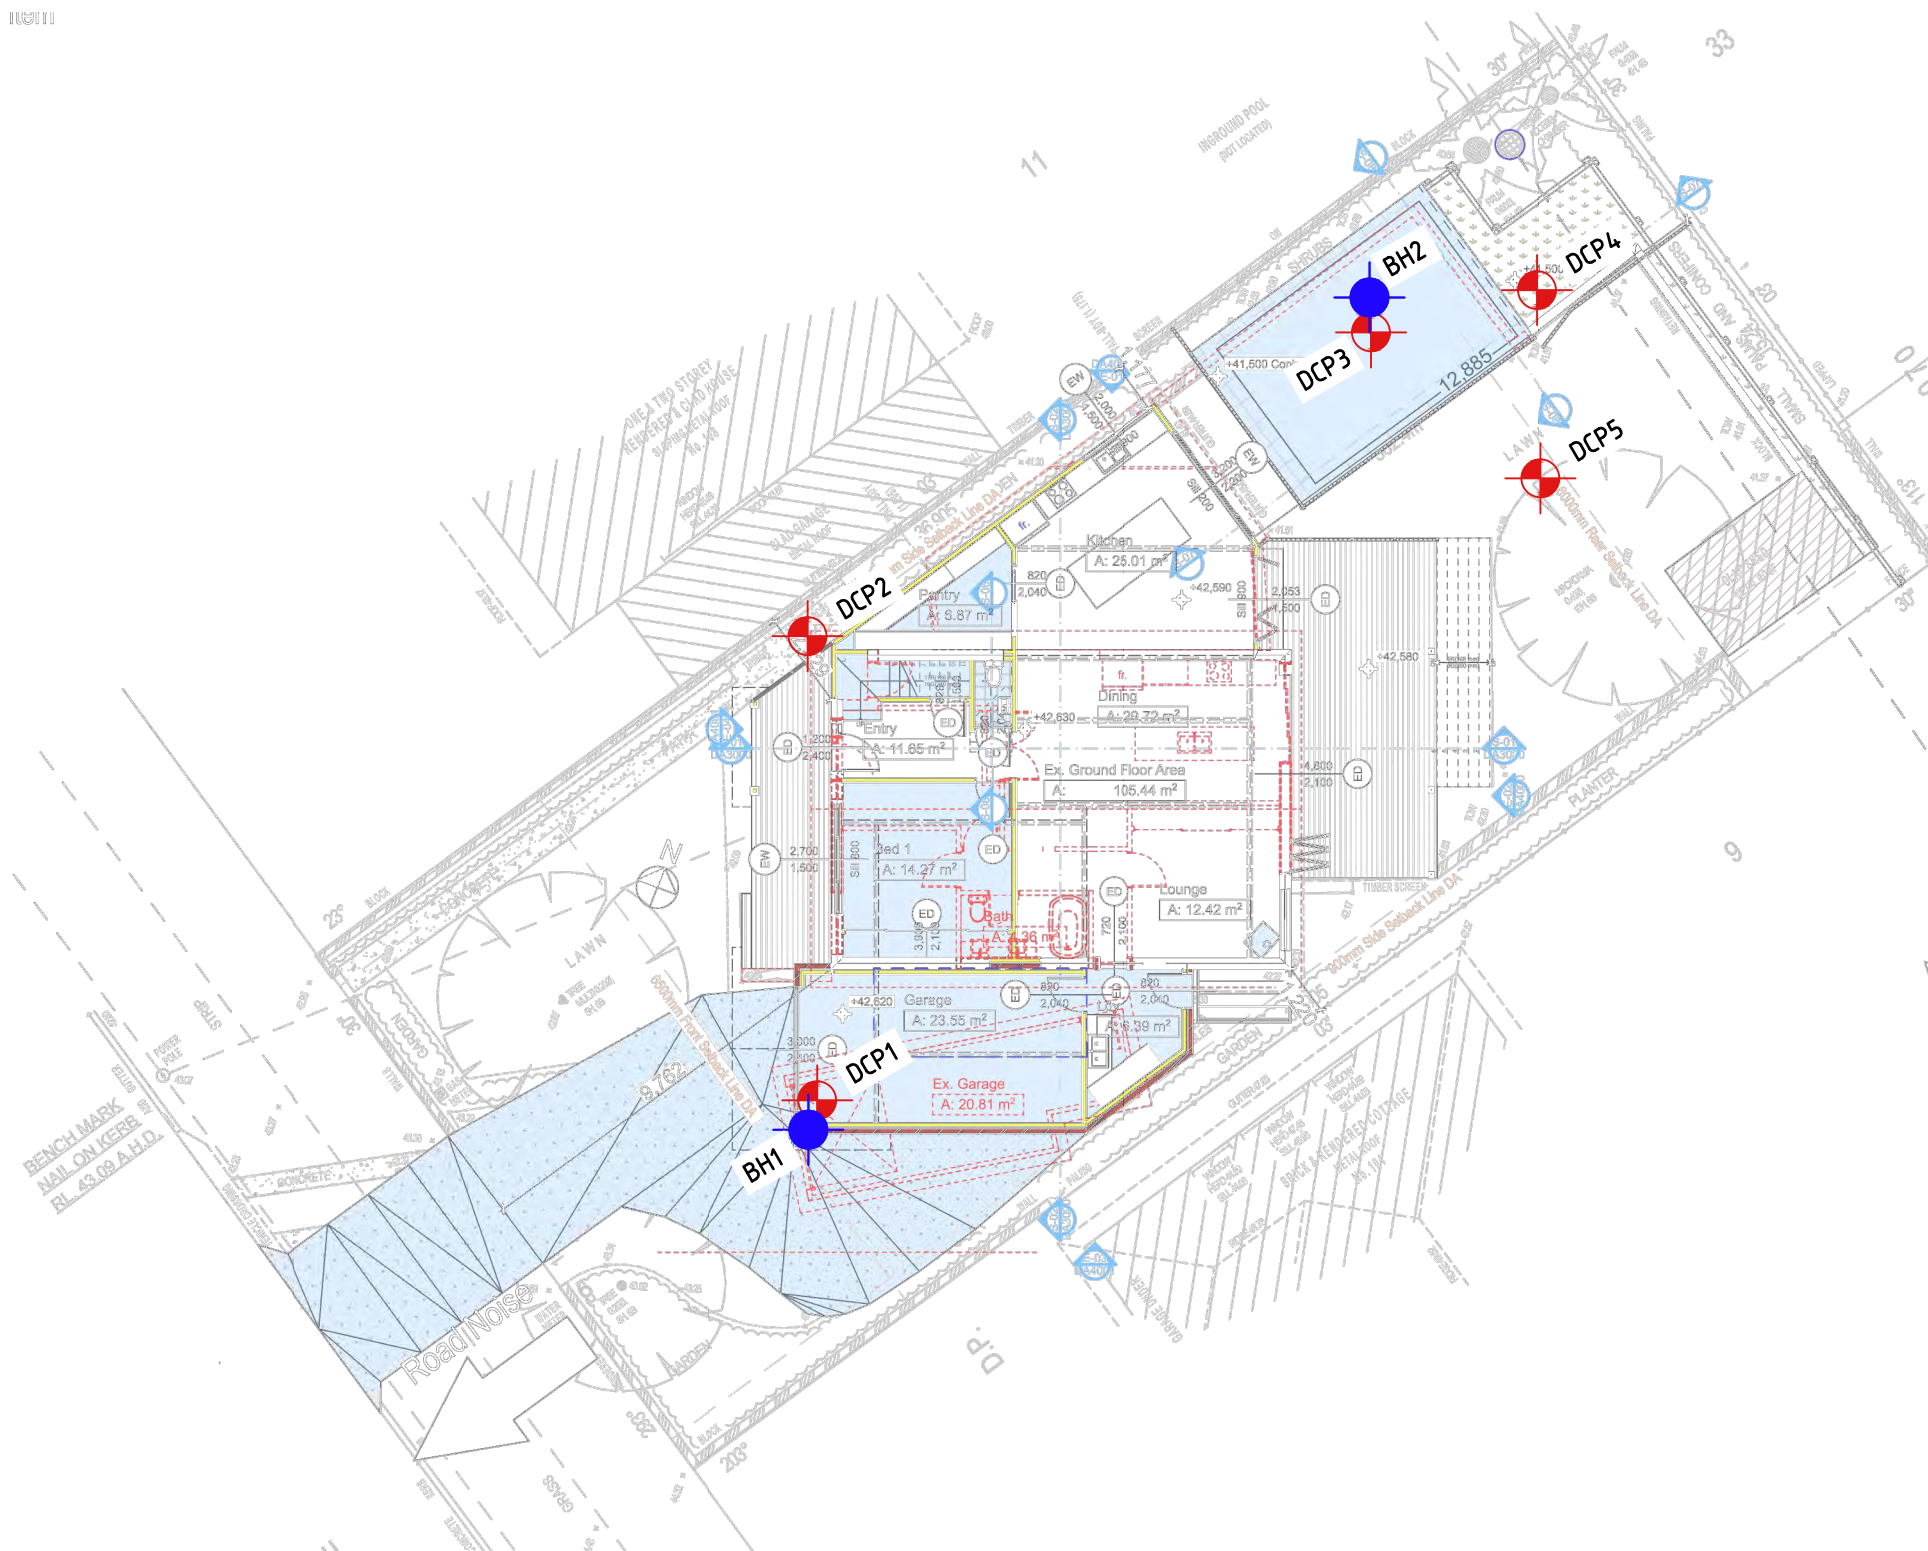
SITE PLAN/GROUND TEST LOCATIONS
SCALE NTS

Test	Summary
DCP 1	Refusal @ 1.4m Bouncing on bedrock. Brown sand on moist tip.
DCP 2	Refusal @ 1.5m Bouncing on bedrock. Brown sand on moist tip.
DCP 3	Refusal @ 0.7m Bouncing on possible buried surface in FILL. Dark brown sand on moist tip.
DCP 4	Refusal @ 0.6m Bouncing on possible buried surface in FILL. Dark brown sand on moist tip.
DCP 5	Refusal @ 1.4m Bouncing on bedrock. Brown sand on moist tip.

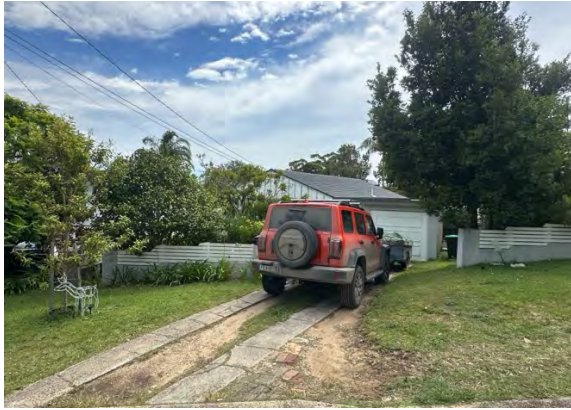
Photo 1: Site frontage, looking north.

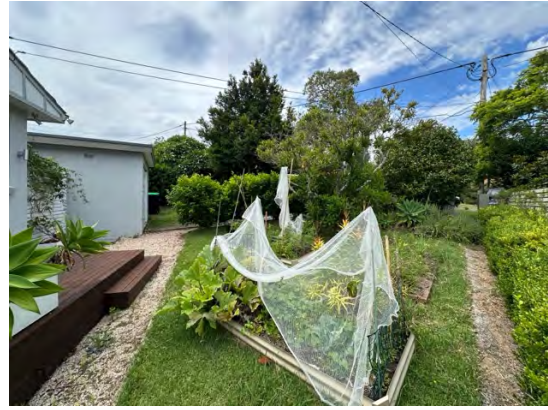
Photo 2: Western boundary of site, showing front yard conditions, looking south-east.

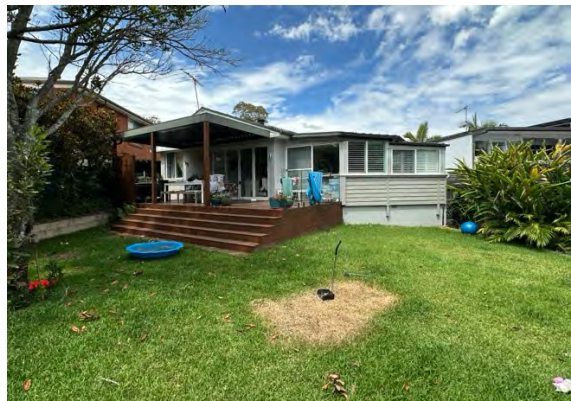
Photo 3: Northern boundary of site, looking south.

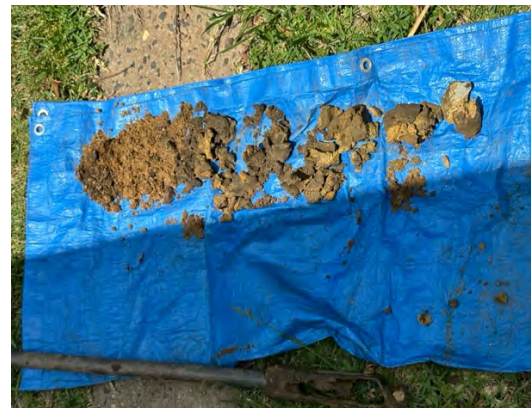
The soil profile consists of shallow uncontrolled fill and silty topsoil (O & A Horizons), silty sand (B Horizon) and weathered bedrock (C Horizon). Based on our observations and the results of testing on site, we would expect weathered sandstone bedrock to be found within 1.4 to 1.5 metres below current surface levels across the area of the proposed works and potentially deeper where filling has been carried out.

Photo 4: Subsurface soil profile of BH01.

Footings	<p>We recommend that all new footings are taken to and founded directly upon the underlying sandstone bedrock (Unit 3) using piers as required.</p> <p>The allowable bearing pressure for footings taken to competent weathered bedrock of at least low strength is 800kPa. Higher allowable bearing capacities may be achievable subject to inspection and certification of excavated footings by AscentGeo.</p> <p>Pier footings should be of sufficient diameter to enable effective base cleaning to be carried out during construction.</p> <p>To mitigate the risk of differential settlement, it is essential that all footings are founded on competent bedrock of similar consistency. This may require excavation through sandstone floaters or the relocation of planned footings.</p> <p>It is essential that the foundation materials of all footing excavations be inspected and approved before steel reinforcement and concrete is placed. This inspection should be scheduled while excavation plant and operators are still on site, and before steel reinforcement has been fixed or the concrete booked.</p>
