Report Title: Geotechnical Report 1742 Pittwater Road, Bayview

## **GEOTECHNICAL INVESTIGATION:**

### **New Pool and Boatshed at 1742 Pittwater Road, Bayview**

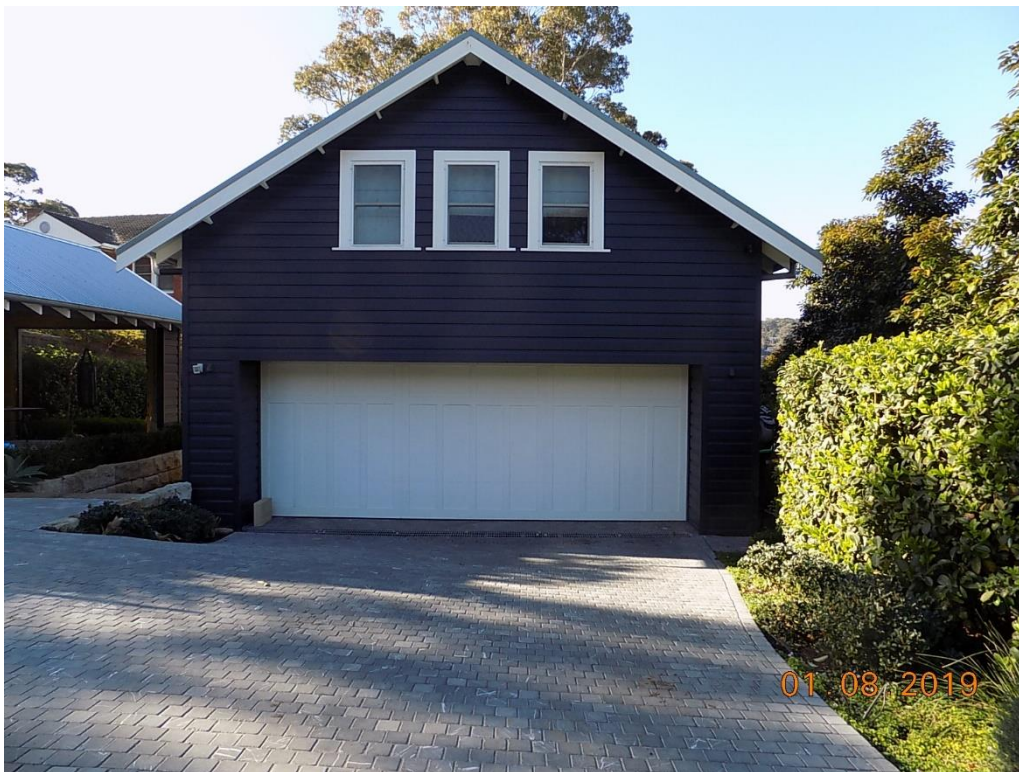
Photo 1

- 2.3** At the road frontage, a concrete driveway runs to a garage attached to the uphill side of the house and to a carport on the uphill side of the property (Photos 1 & 2). The part two-storey framed and clad house is recently constructed and in good condition (Photo 3). A gently sloping lawn extends off the downhill side of the house (Photo 4). At the NE end of the block, the bank that descends to the waterfront is landscaped with flagging walls and low rockeries (Photos 5 & 6). An old dilapidated pool and surrounding paving is located at the toe of the bank (Photo 7). The retaining walls and pool will be demolished as part of the proposed works. A stone and concrete

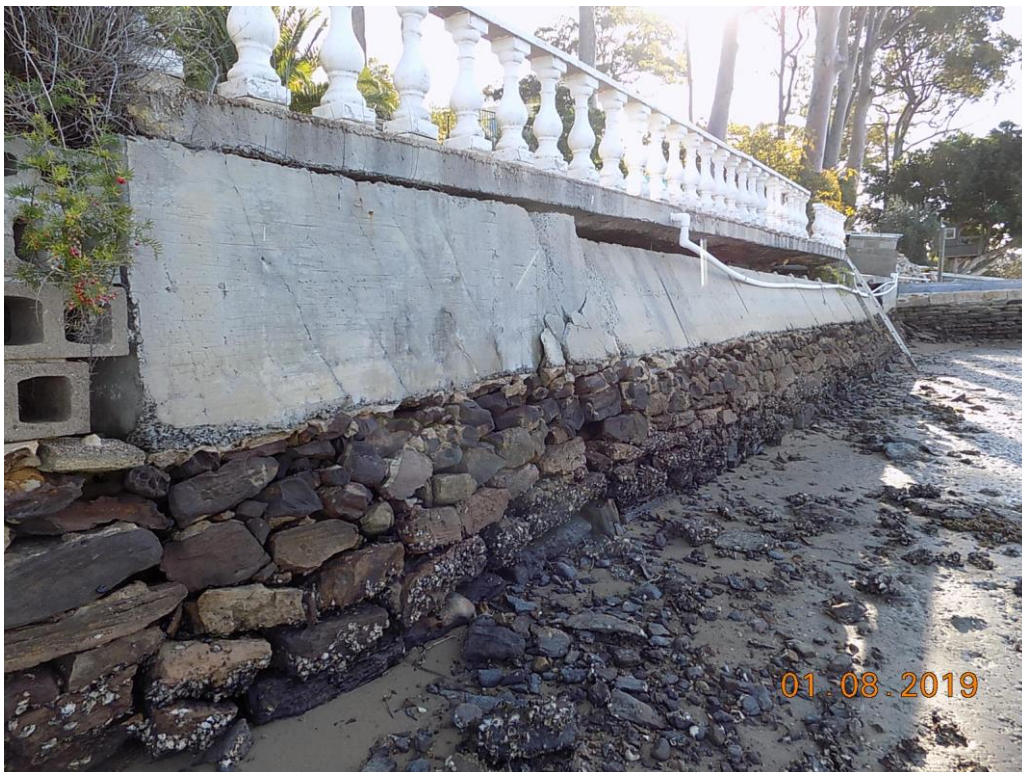
Photo 8

seawall runs along the downhill side of the pool in the vicinity of the mean high-water mark (Photo 8).

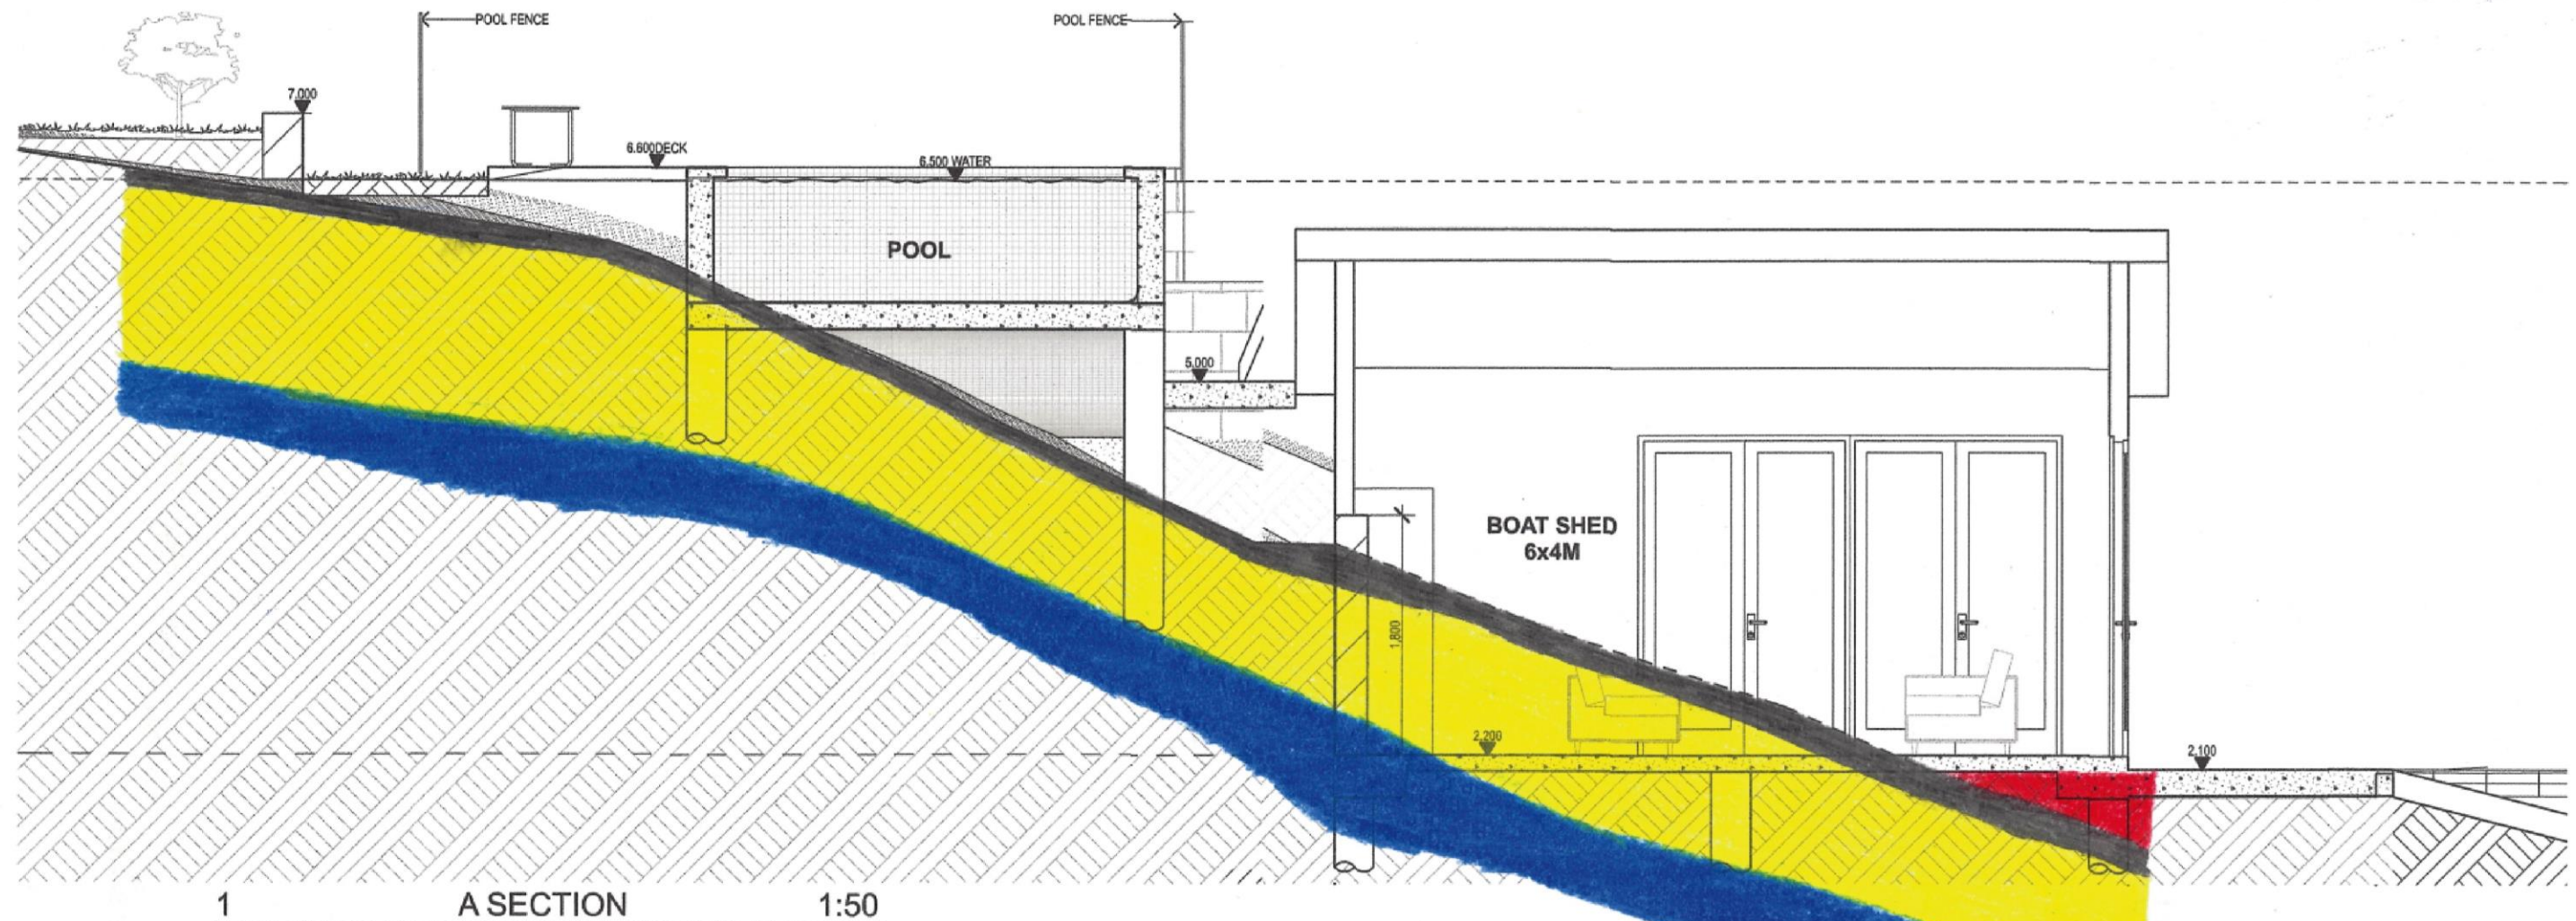
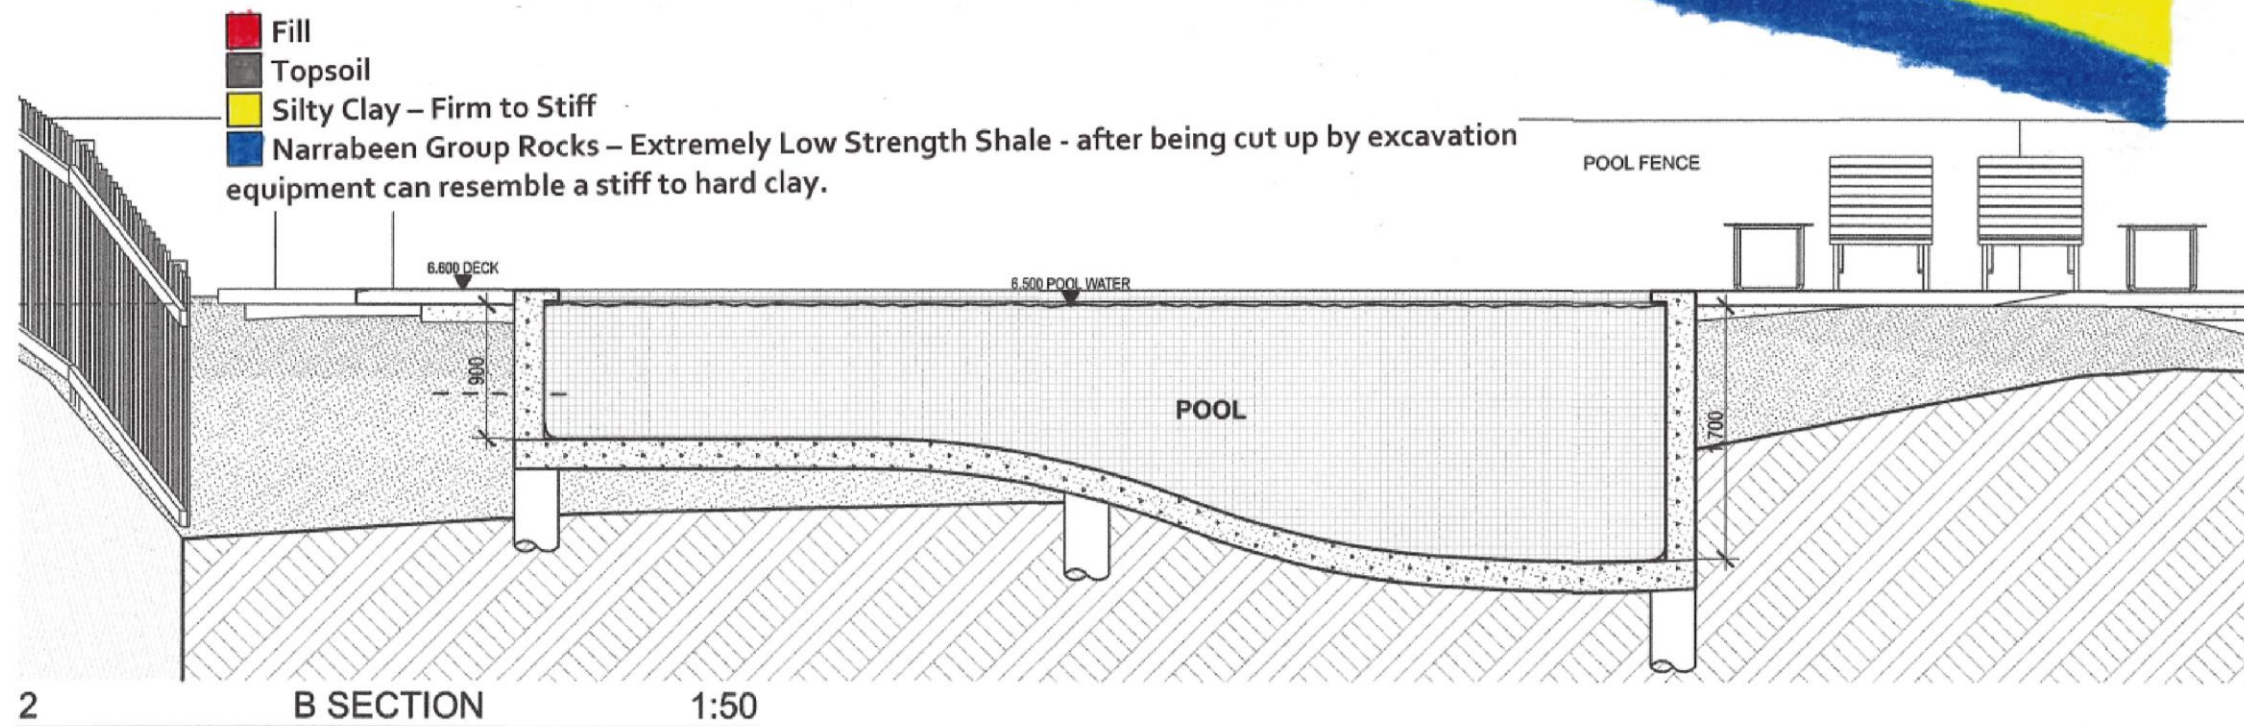
# TYPE SECTION – Diagrammatical Interpretation of expected Ground Materials

The slope materials are colluvial at the near surface and residual at depth. In the test locations, the ground materials consist of sandy clays and clays with rock fragments throughout the profile. The sandy clays and clays merge into the weathered zone of the underlying shale at depths expected to be in the range of 1.2m to 1.5m below the natural surface. The weathered zone is interpreted to be Extremely Low Strength Rock that becomes progressively stronger with depth. See Type Section attached for a diagrammatical representation of the expected ground materials.

The excavation for the proposed boatshed will be taken to depths of ~1.9m. It is expected to be through shallow topsoil, firm to stiff clay to ~1.2m before encountering Extremely Low Strength Shale. This material will appear as a grey to mottled maroon clay when cut up by excavation equipment. It is expected that the excavations can be carried out with an excavator and bucket.

The proposed boatshed can be supported on a concrete slab and piers taken to Extremely Low Strength Shale. This ground material is expected to be exposed across a portion of the base of the excavation. Where the slope drops away on the downhill side, this ground material is expected at depths of between ~1.2 to 1.5m below the current surface.

The proposed pool can be supported on piers taken to and embedded ~0.6m into Extremely Low Strength Shale. This ground material is expected at similar depths as above.
