TREE INSPECTION REPORT.

**Location: 79 Ashworth Avenue
Belrose NSW 2085**

TREEHAVEN ENVIRONSCAPES.
60 Kestrel Way Yarramundi NSW 2753
smcl2666@bigpond.net.au

For. Mr. Luca Mastroianni
On. 28/4/2025

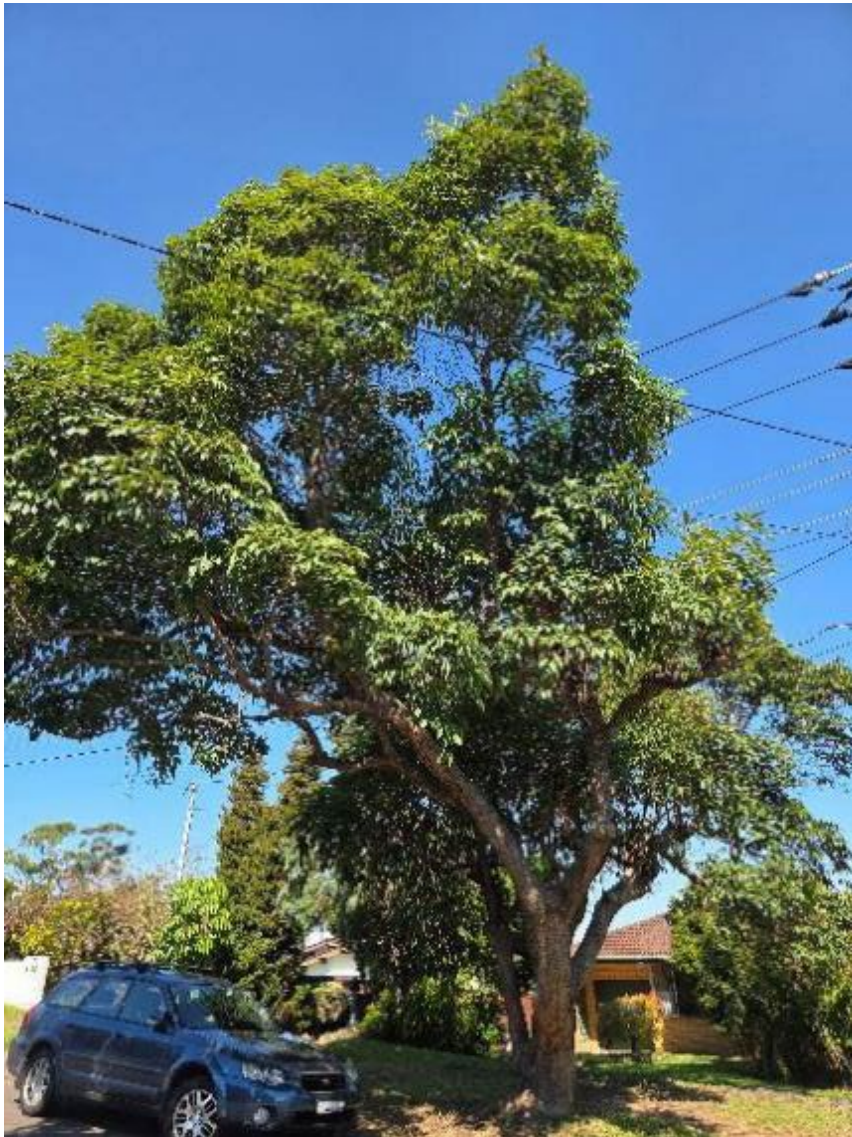
- 4.1** Tree **T1** is a *Lophostemon confertus* or 'Queensland Brushbox' which is a native species endemic to Northern NSW and Southern Queensland. The tree has been planted in the nature strip to the North of the Site (see Fig. 2).

The tree was in good health and vigour at the time of inspection and has been subjected to regular pruning to accommodate power lines.

Tree **T1** will be subjected to a Major Encroachment from the new driveways and footpath crossovers.

The location of the proposed Western driveway, footpath crossover and layback will subject the tree to a Major Encroachment of 11.5% which includes a portion of its SRZ (Appendices 2b & 2e). The location of the driveway is further constrained by the presence of a power pole located to the Southwest of the tree which leaves limited space for the proposed driveway works. It is estimated that an excavation of 200mm depth and removal of the existing kerb and gutter is required in order to establish a new driveway footpath crossover and layback.

Fig. 2. Photo of tree T1 a *Lophostemon confertus*

6.2 Given the constraints posed by Council's street tree **T1** it is considered to be a better outcome for the orderly development of the Site to remove this tree and replace it with an appropriate specimen in keeping with Council's Street Tree strategy.
Further to this it is recommended that the neighbour at 83 Ashworth Avenue be contacted in regard to the removal of tree **T19**, a *Ficus microcarpa* which is an exempt species that can grow into a large specimen with very invasive root system. The reason for its removal is that it can cause damage to both the dwellings at 83 Ashworth and the proposed dwelling at 79 Ashworth.

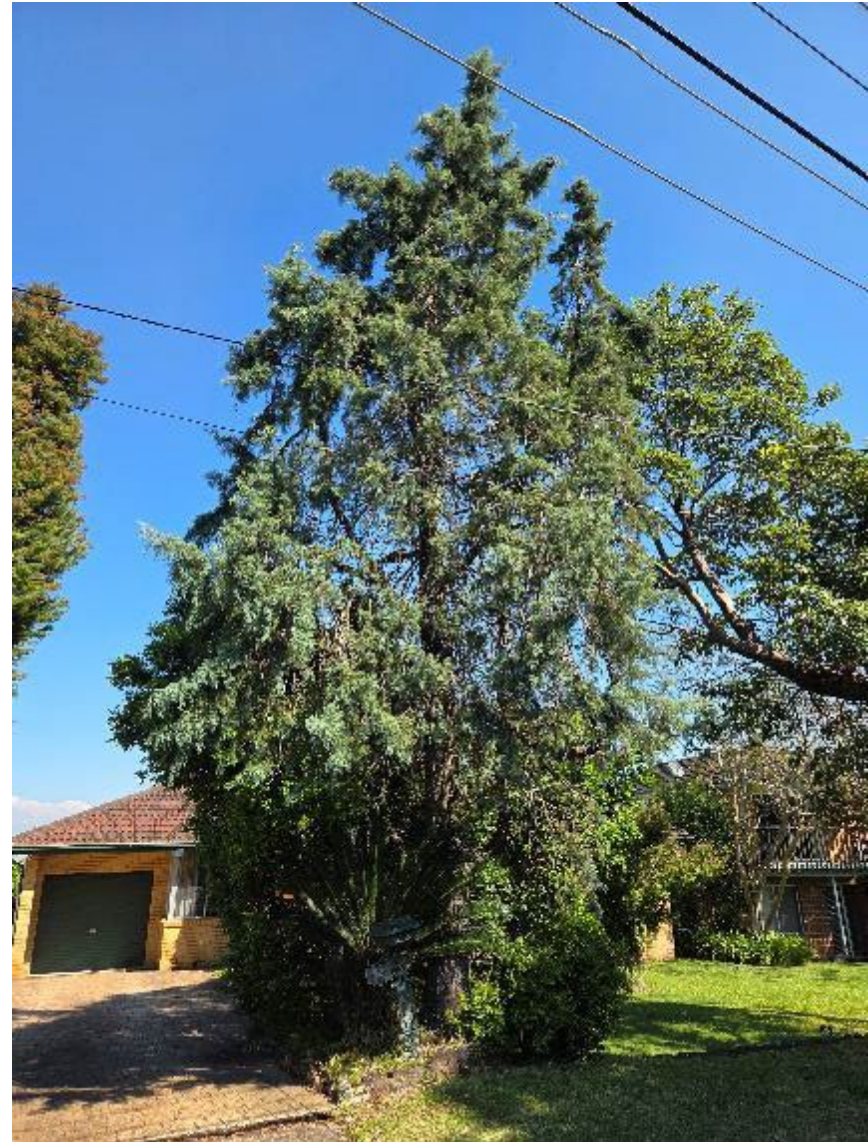
- 4.2** Tree **T2** is a *Cupressus lusitanica* or 'Mexican Pine' which is an exotic conifer endemic to Central America. The tree has been planted in the front yard in the Northern portion of the Site to the right hand side of the existing driveway (see Fig. 3).

The tree was in good health and vigour at the time of inspection. Further it is noted that *Cupressus* species are listed in NBC's list of undesirable species and are exempt from protection in the TVP controls.

Fig. 3. Photo of T2 a *Juniperus chinensis*

Tree **T2** is scheduled to be removed in the new landscaping plan for the Site and is proposed to be replaced with new vegetation (See Appendices 2b & 2c).

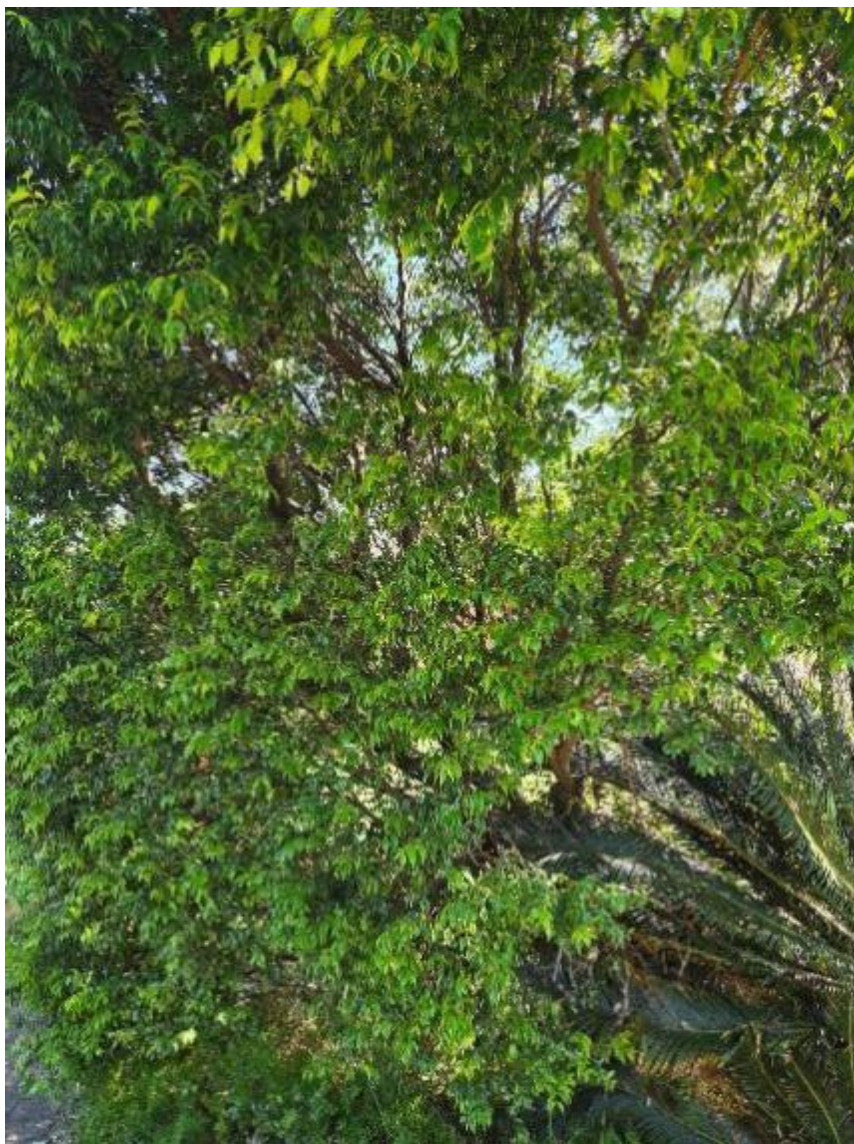
- 4.3** Tree **T3 & T6** are both *Syzygium leuhmannii* or 'Riberry' which is a native species which have both been planted in the Northern portion of the Site. The trees were in good health and condition at the time of my inspection and are less than 5m in height and exempt from protection under the TVP controls (See Figs. 4 & 6).

Fig. 4. Photo of tree T3 a *Syzygium* which is under 5m in height

Both of these specimens are proposed to be removed and replaced with new vegetation in the landscape plan for the Site (See Appendix 2b & 2c).

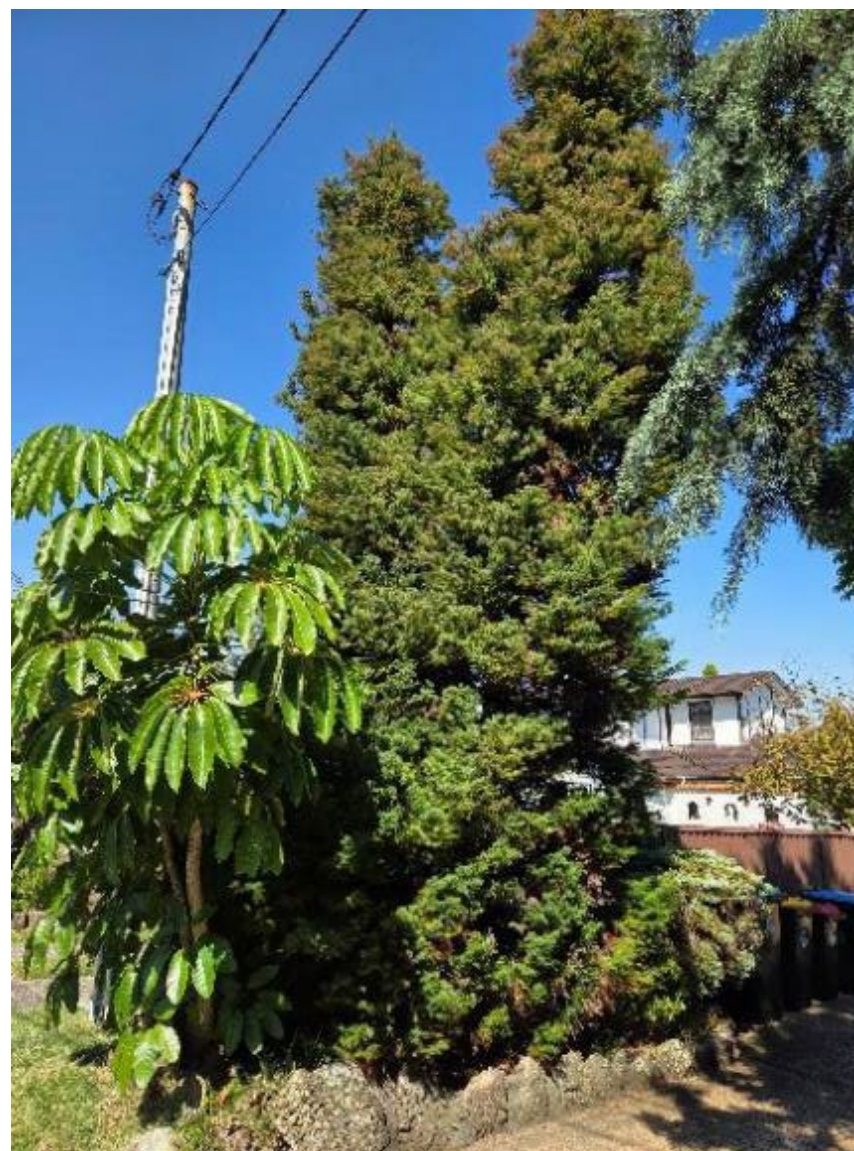
- 4.5** Trees **T5** is a *Cryptomeria japonica* or 'Japanese cedar' which is growing in the Northeast portion of the Site to the left of the existing driveway (See Fig. 5).

Fig. 5. Photo of tree T5 a *Cryptomeria japonica* with T4 a *Schefflera actinophylla* to the left of the frame.

This tree is scheduled to be removed and replaced in the new landscaping for the Site (See Appendix 2b & 2c).

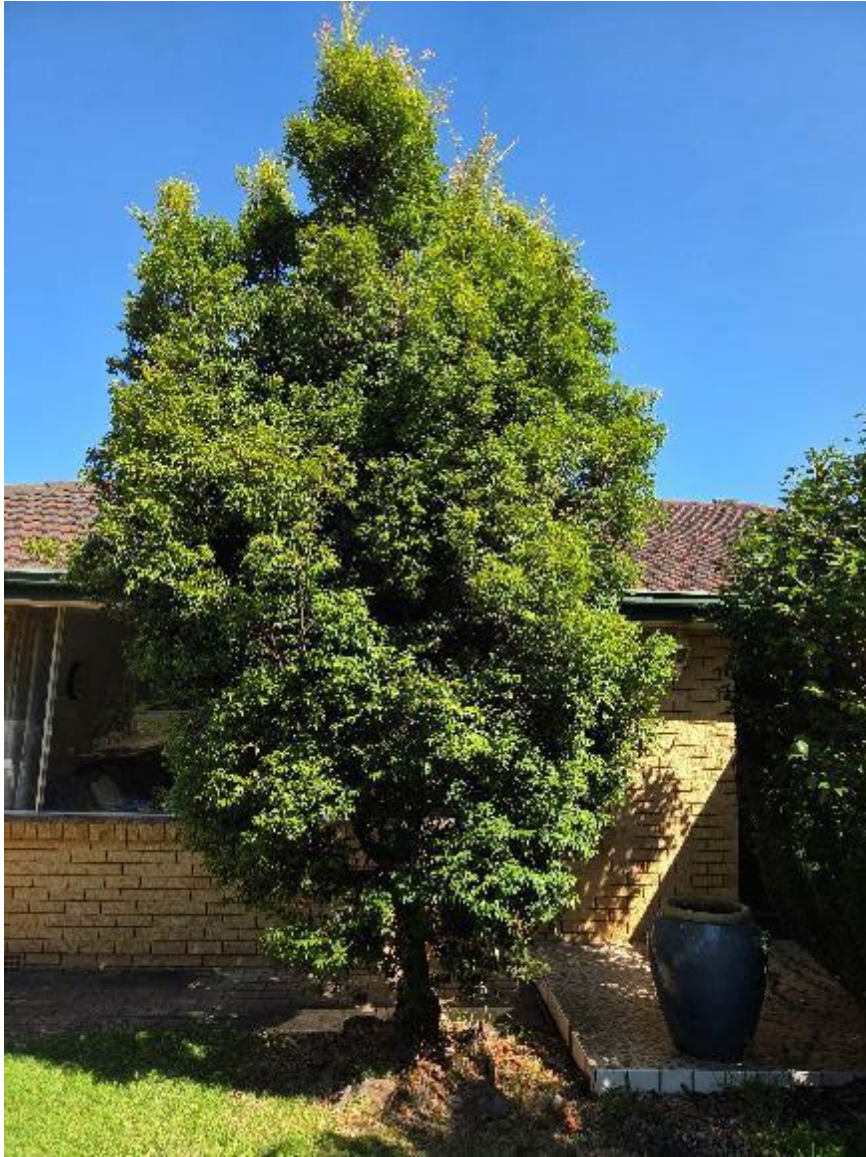
Fig. 6. Photo of tree T6 a *Syzygium* which is just under 5m in height

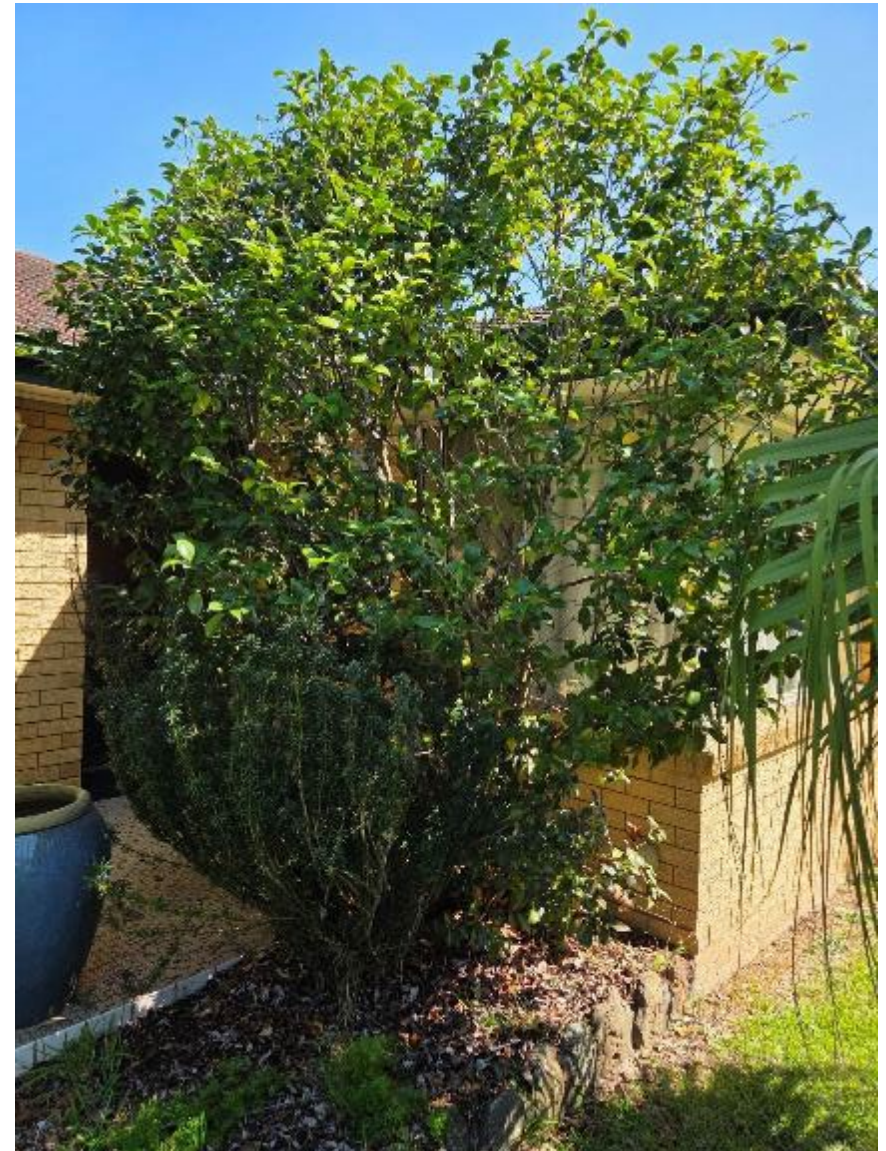
The trees were in good health and vigour at the time of inspection and has formed multiple stems to form a shrublike habit. Both specimens are less than 5m in height and therefore exempt from the TVP controls.

Fig. 7. Photo of tree T7 a *Camelia japonica* under 5m in height.

Both of these trees are scheduled for removal and replacement in the Architectural and Landscapes plans for the Site (See Appendix 2b & 2c).

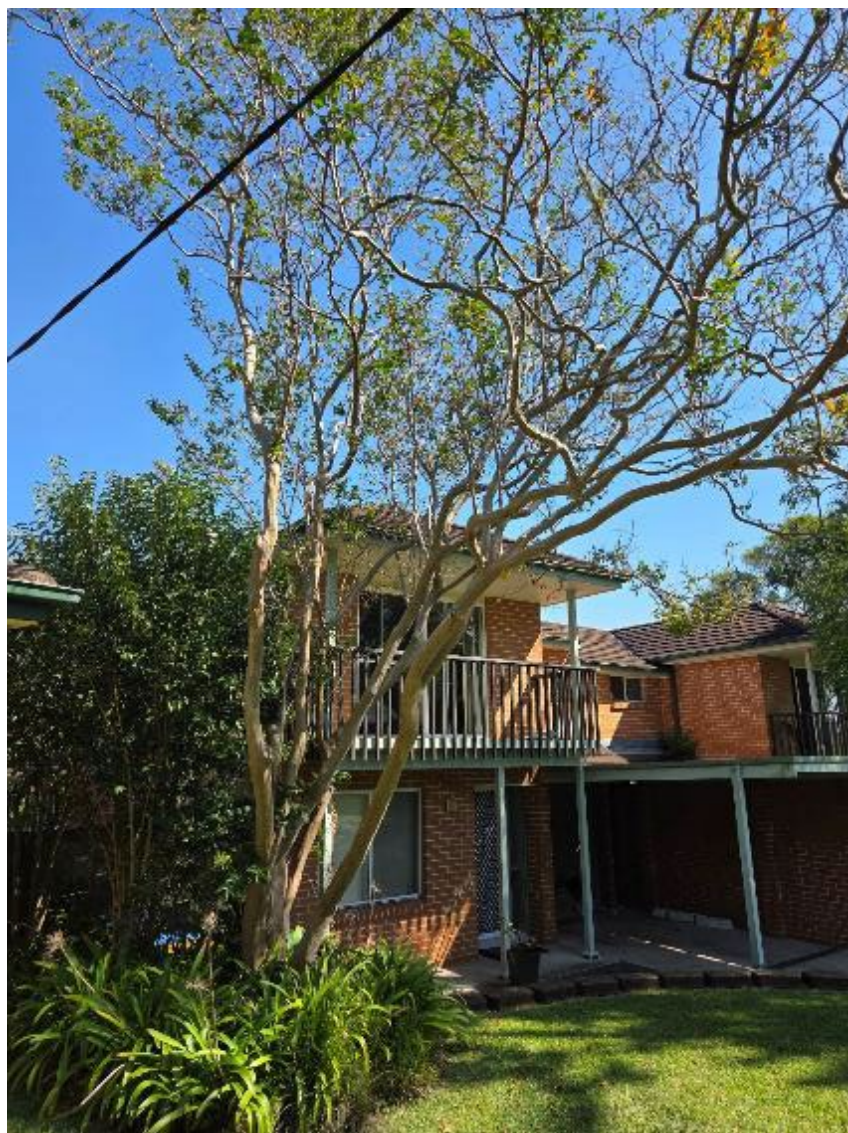
- 4.7** Tree **T9** is a *Lagerstroemia indica* or 'Crepe Myrtle' which is an exotic species from India. The has been planted in the neighbouring property to the West of the Site. The tree was in good health and condition at the time of my inspection (See Fig. 10). The tree has been planted in close proximity to the dwelling and will have formed an asymmetric rootplate as a result².

The tree will experience a Minor Encroachment from the proposed development of approx. 7% from the new driveway, stormwater pipes and a proposed Agricultural pipe within its TPZ (See Appendix 2b). The tree does not have a figure for an SRZ as it has an asymmetric rootplate.

Fig. 9. Photo of Tree T9 a *Lagerstroemia indica* in neighbour's land

5.2 Tree **T7**, the neighbour's *Lagerstroemia* will be subject to a Minor Encroachment of approx. 4% from the driveway and trenching for stormwater pipes (See Appendix 2f). It is recommended that any trenching for plumbing works be conducted using hand tools with the objective of avoiding or minimising damage to tree roots >30mm Ø and under the supervision of the Project Arborist (PA).

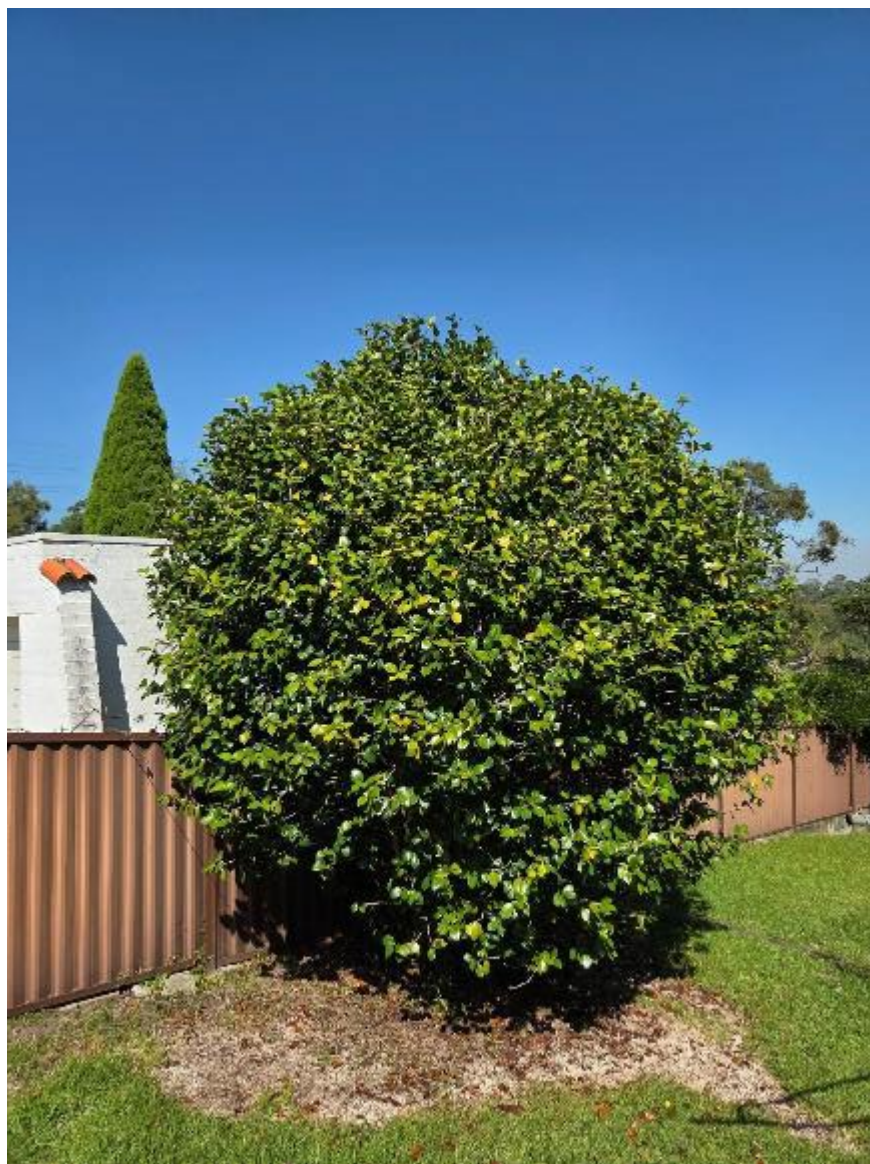
Fig. 11. Photo of T10 a *Camelia japonica* which is less than 5m in height.

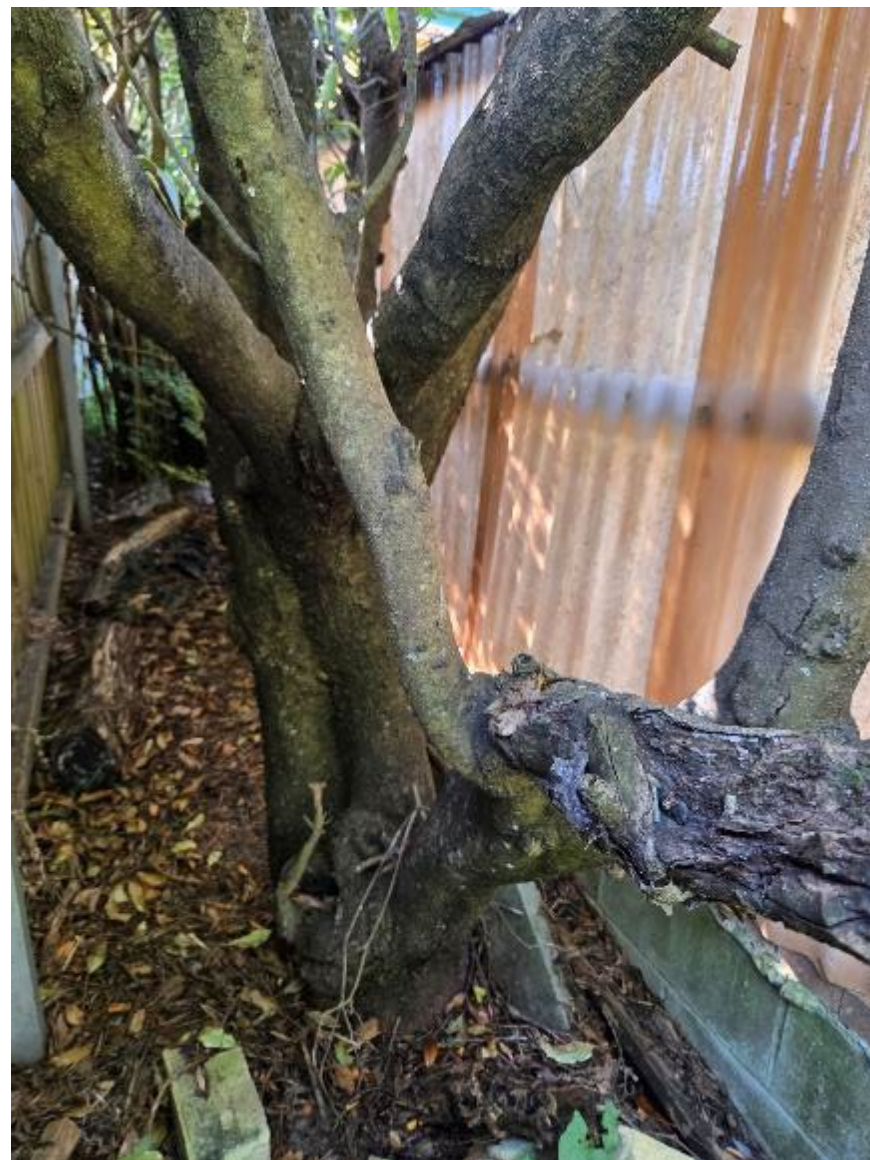
- 4.8** Tree **T11** is a *Pittosporum eugenioides* 'variegatum' or 'Variegated Pittosporum' which is a hybridised native species which is growing in the rear of the property to the West of the Site. The tree was in poor health and condition at the time of my inspection (See Figs. 12 & 13). The tree is under 5m in height and therefore exempt from the PTV.

Fig. 12. Photo of Tree T11 a *Pittosporum variegatum*.

This tree is scheduled to be removed and replaced in the new landscaping for the development (See Appendices 2b & 2c).

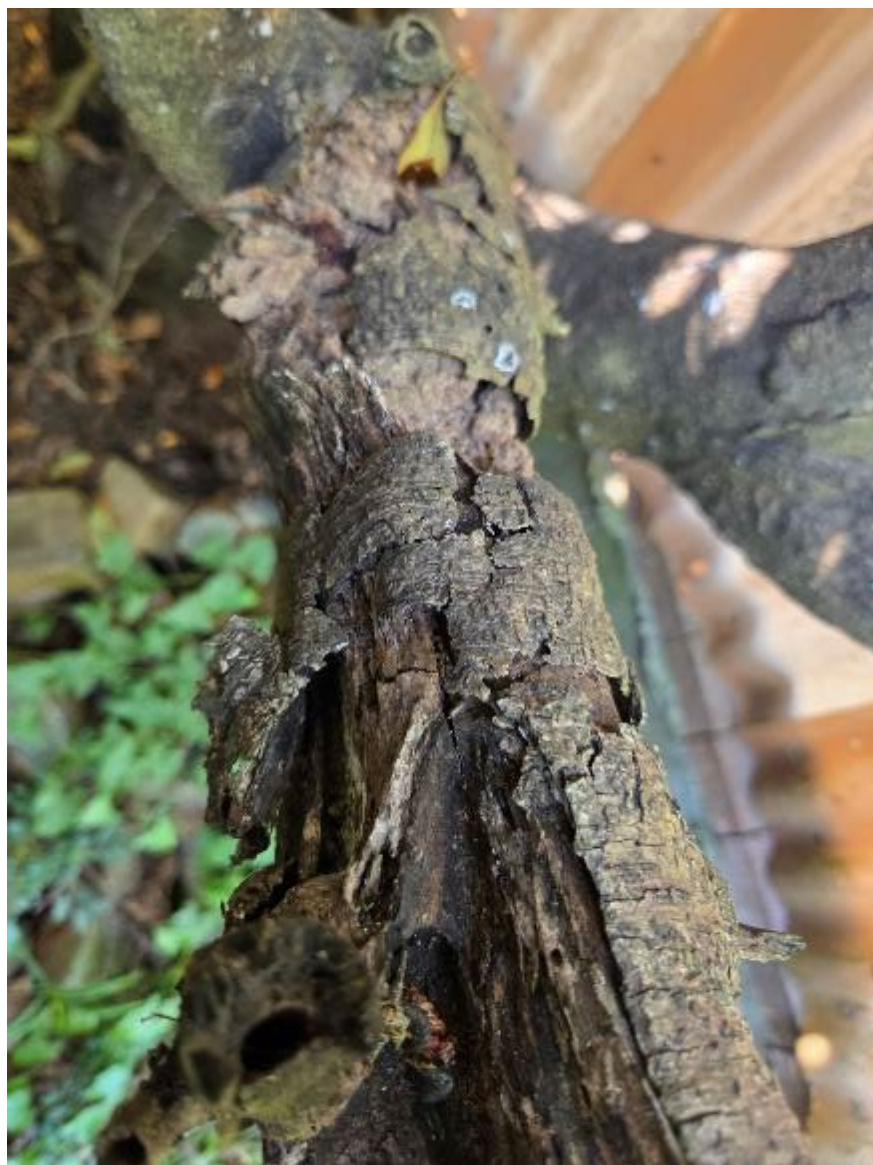
Fig. 13. Photo of borer damage on tree T11

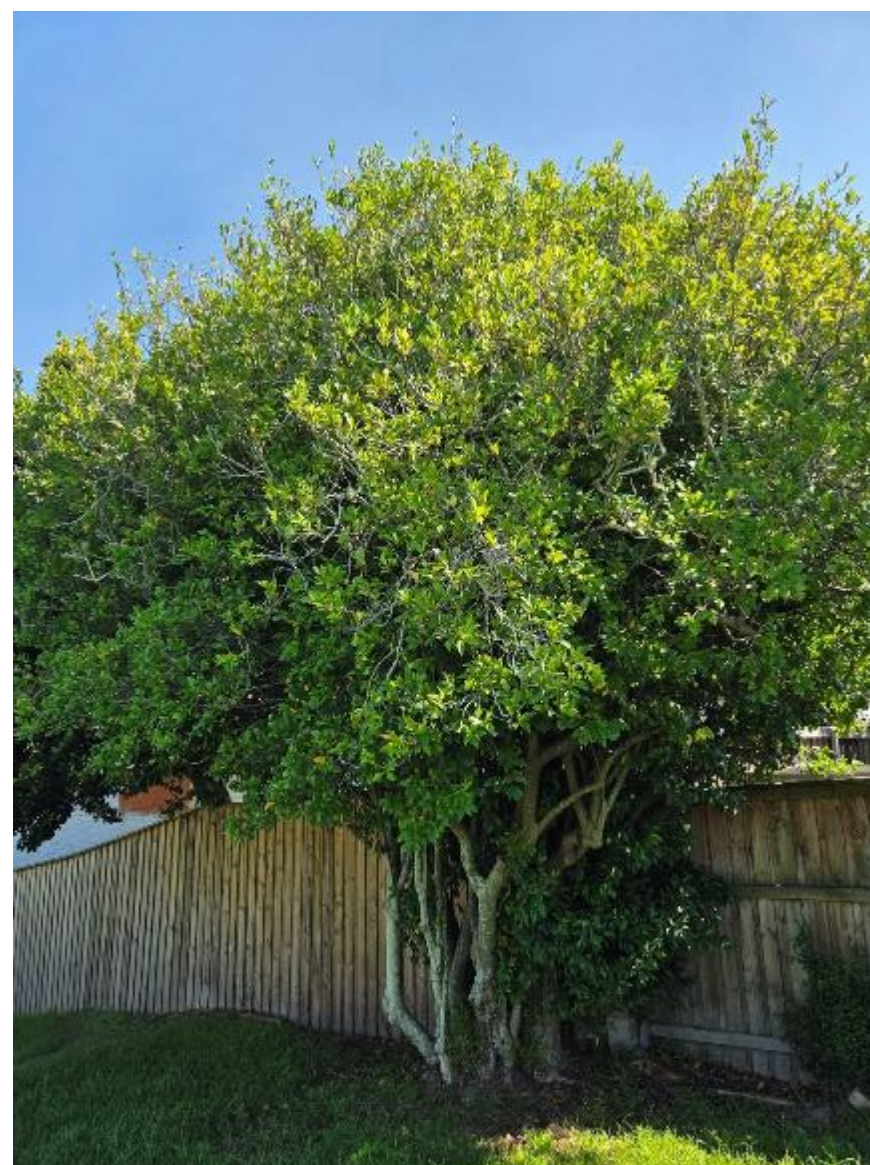
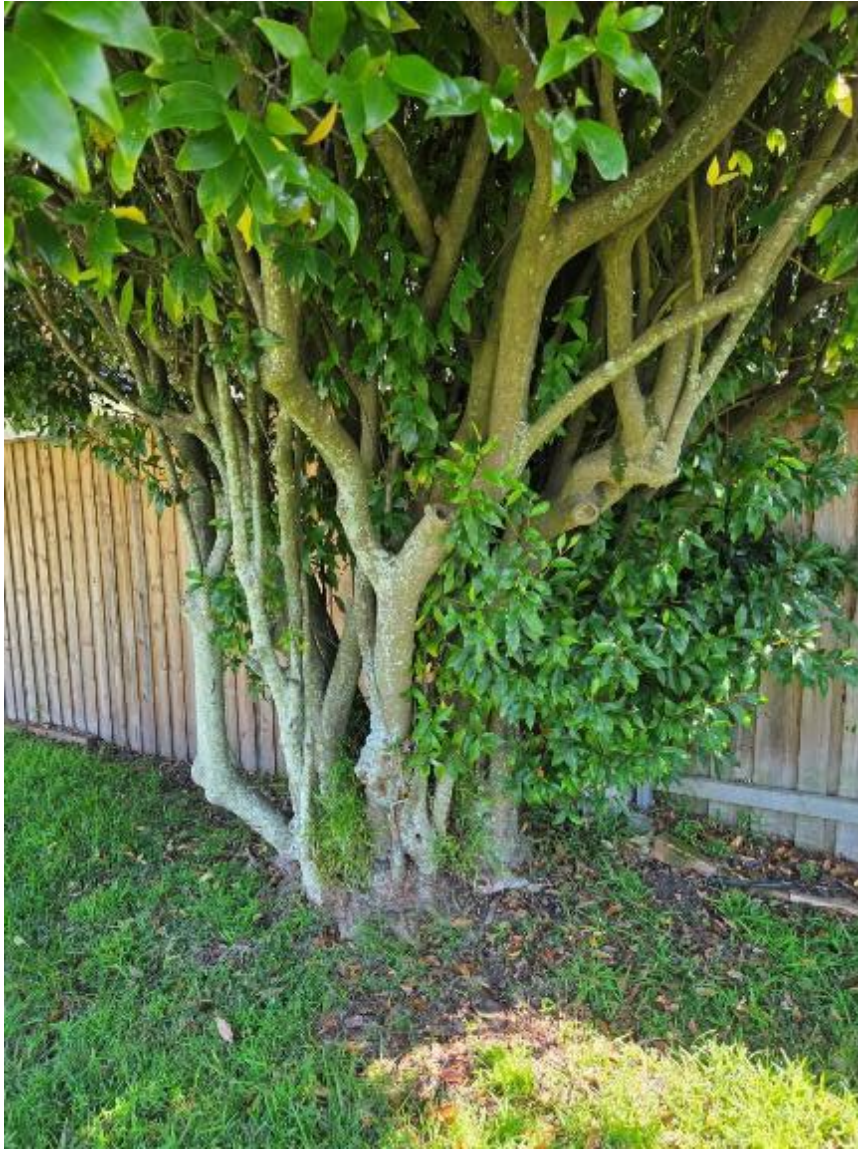
- 4.9** Tree **T12** is a *Magnolia figo* or 'Portwine Magnolia' which is an exotic species endemic to China (See Figs. 14 & 15). The tree has formed multiple stems and is located adjacent to the Western border in the rear yard of the Site. The specimen is less than 5m in height and exempt from the TVP controls.

This tree will be subjected to multiple encroachments from the building footprint of Unit 1 and stormwater and agricultural pipes (See Appendix 2b & 2c). Consequently it is proposed for removal.

Fig. 14. Photo of tree T12 a *Magnolia figo* less than 5m in height.

Fig. 15. Photo of T12 with multiple stems.

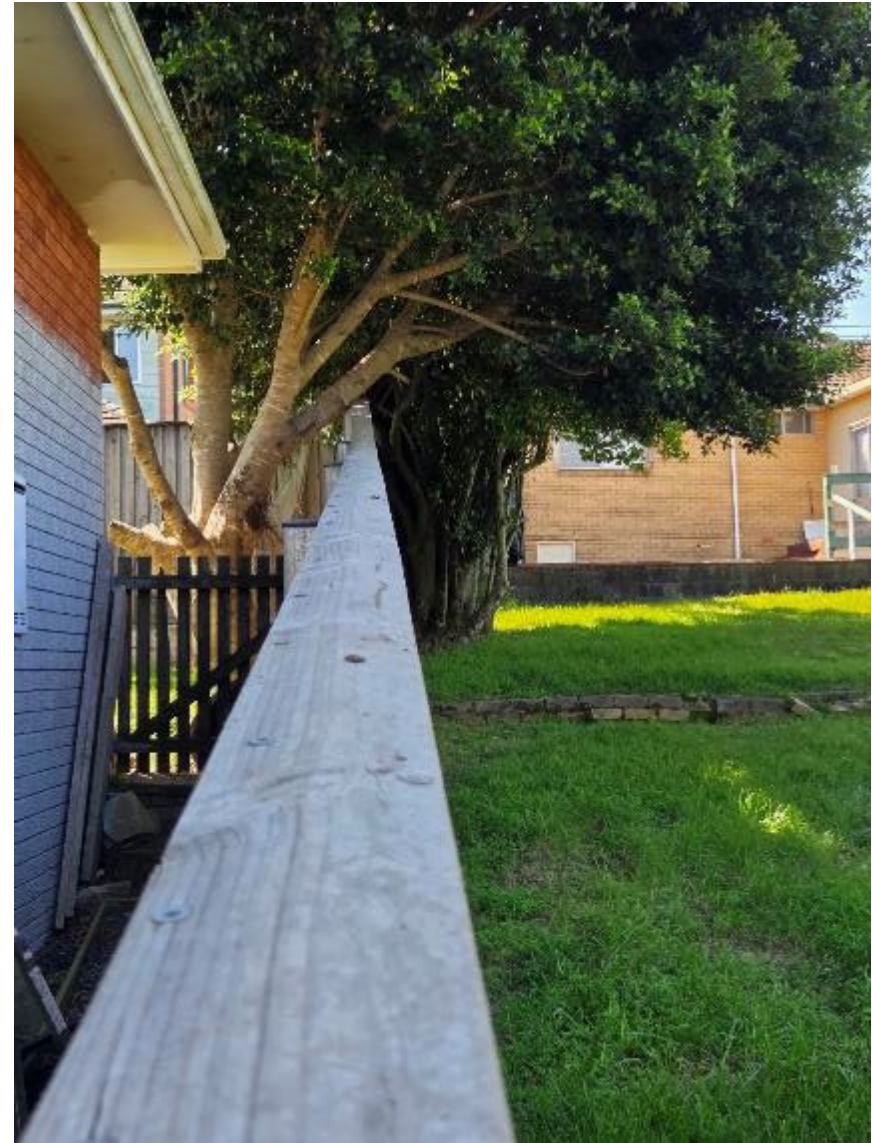
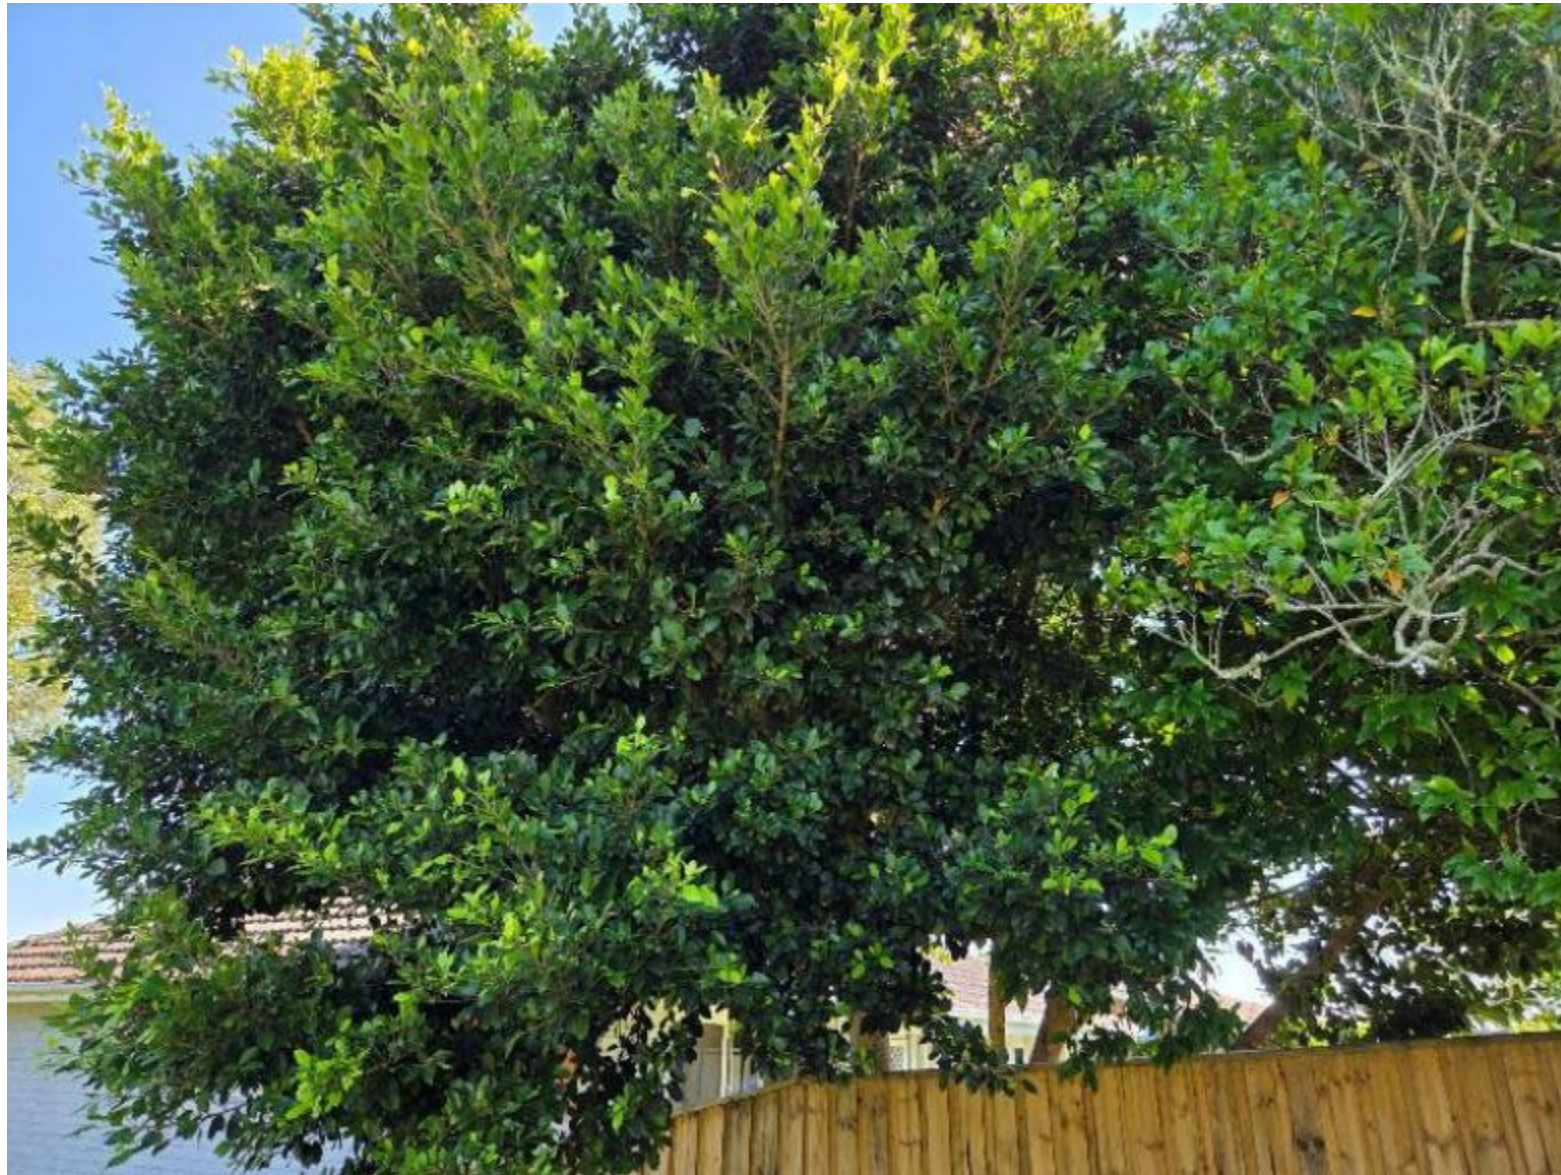
4.15 Tree **T19** is a *Ficus benjamina* or 'Weeping Fig' which is a native species endemic to Northern Australia and Southeast Asia. The tree is growing in the neighbouring property to the Southwest of the Site. The tree was in good health and condition at the time of my inspection (See Fig. 16). The genus is listed in NBC's list of undesirable species and therefore exempt from the PTV. This specimen has the potential to grow into a very large tree with a highly invasive root system.

This tree will be subjected to a Major Encroachment of 15% from the Onsite Stormwater Detention (OSD) tank and associated pipe work. (See Appendices 2b & 2c). Over time this specimen has the potential to become very large

Fig. 16. Photo of T19 a *Ficus benjamina* growing adjacent to the border.

Fig. 17. Photo of tree T19 a *Ficus benjamina*

5.3 Tree **T19** is an exempt species which will grow into a very large tree⁴ with a wide spreading and highly invasive root system. Consequently it is recommended to approach the neighbour regarding its removal as this tree would have an adverse impact on his property and services also. Alternatively, at this stage plans for the development indicate a 15% Encroachment into its TPZ (See Appendix 2g) which could be alleviated by design modifications to the OSD and plumbing work. It is recommended that any trenching for plumbing works be conducted using hand tools with the objective of avoiding or minimising damage to tree roots >30mm Ø and under the supervision of the Project Arborist (PA).

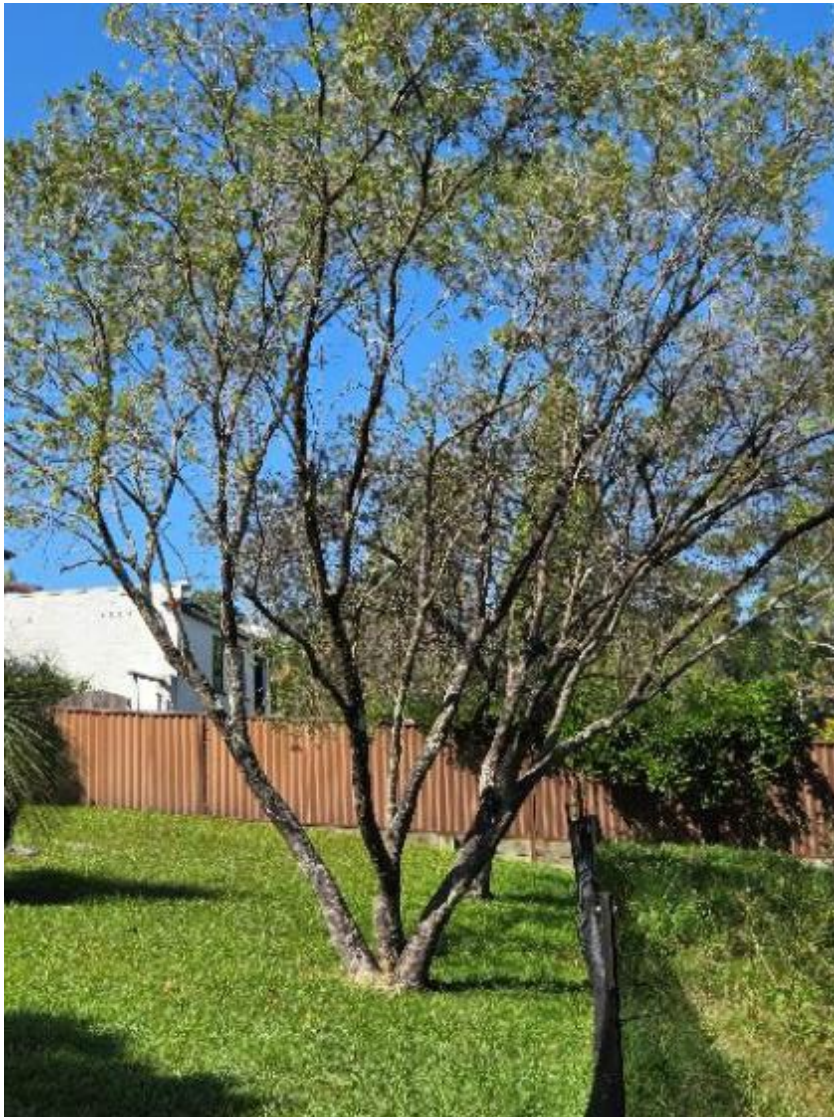
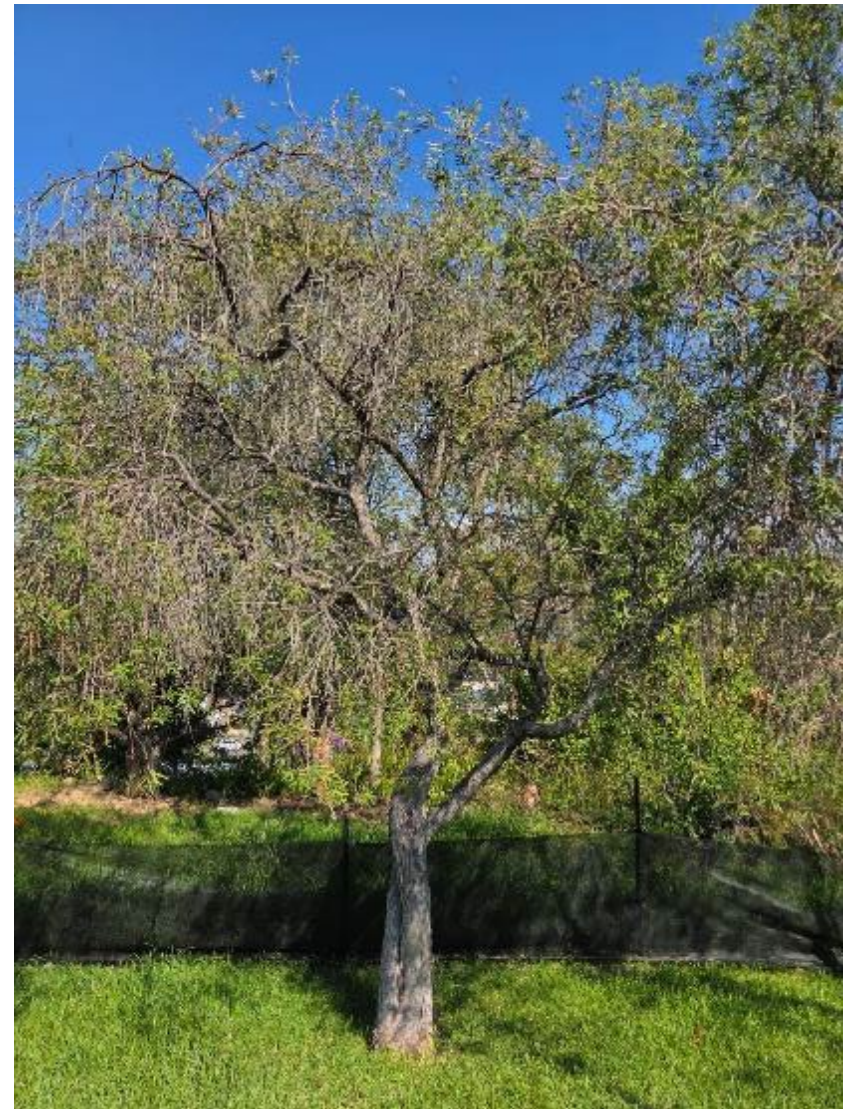
- 4.10** Trees **T13 & T14** are both *Callistemon viminalis* or 'Weeping Bottlebrush' which is a native species belonging to creeks and rivers in Northeastern NSW. Both of these trees are planted specimens and are located in the Southern portion of the Site. These trees were in good health and condition at the time of my inspection. They are less than 5m in height and exempt from the TVP controls.

Fig. 18. Photo of tree T13 a *Callistemon viminalis*

Fig. 19. Photo of tree T14 all *Callistemon viminalis*

Both of these specimens are scheduled for removal and replacement in the new landscaping for the development (See Appendices 2b and 2c).

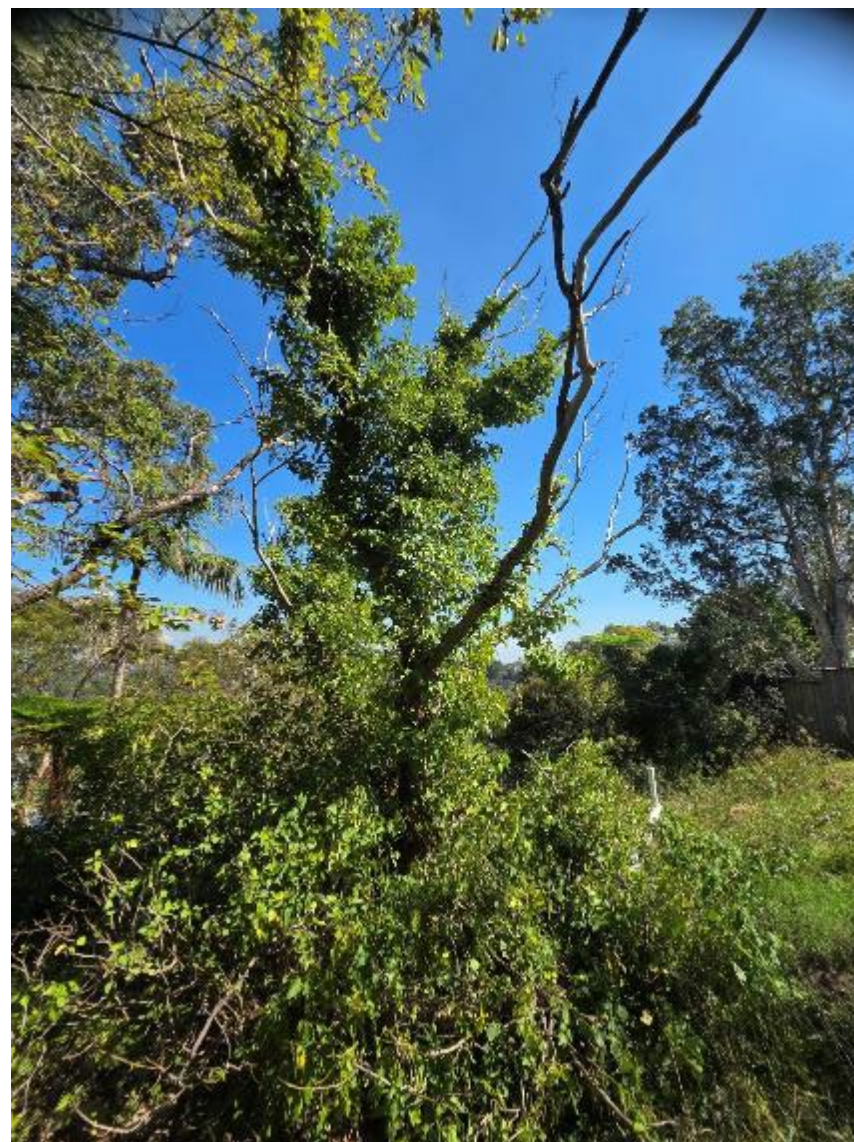
- 4.14** Tree **T18** is dead (See Fig. 25).

This tree located well outside the development site and unlikely to be damaged as a result of Site construction works (See Appendices 2b & 2c).

Fig. 25. Photo of a dead tree.

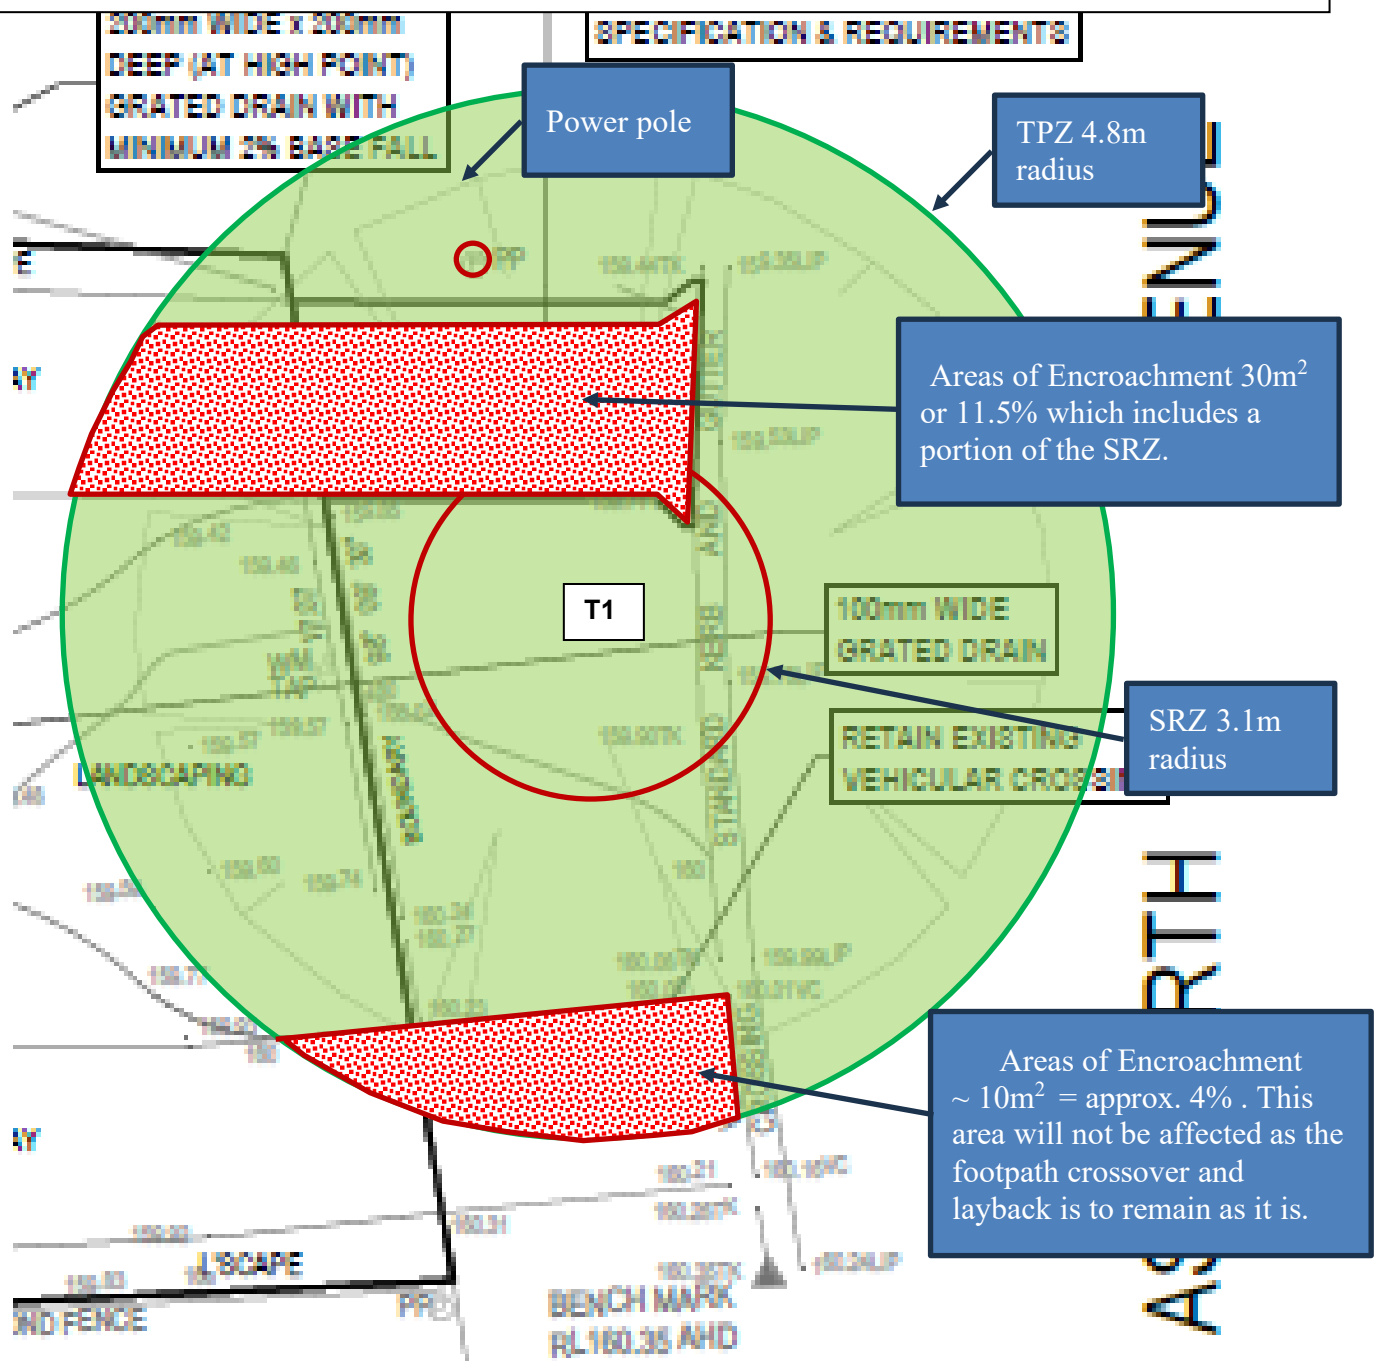
APPENDIX 2e. Excerpt from Stormwater Plan showing the location of encroachments from the new driveways within the TPZ and SRZ of T1 of 30m² & 10m² totalling 44m². However the Eastern driveway and layback are to remain intact and so this area is subtracted from the Encroachment calculation.

In order to minimise damage to the tree's root system one approach would be raise the driveway elevation so that existing ground levels are largely left intact. This would have the effect of arching the driveway over the roots and in doing so it is recommended that a subsurface layer in the form of a Structural Gade Soil³ be placed beneath the concrete to allow for gaseous exchange between the tree roots and the atmosphere. Alternatively it is proposed that this tree be removed and replaced with a small to medium sized tree such as a *Callistemon viminalis* (Weeping Bottlebrush) or a *Tristainiopsus laurina* (Water Gum) to be positioned mid way between the driveways.
