TREE INSPECTION REPORT.

**Location: 79 Ashworth Avenue
Belrose NSW 2085**

TREEHAVEN ENVIRONSCAPES.
60 Kestrel Way Yarramundi NSW 2753
smcl2666@bigpond.net.au

For. Mr. Luca Mastroianni
On. 28/4/2025

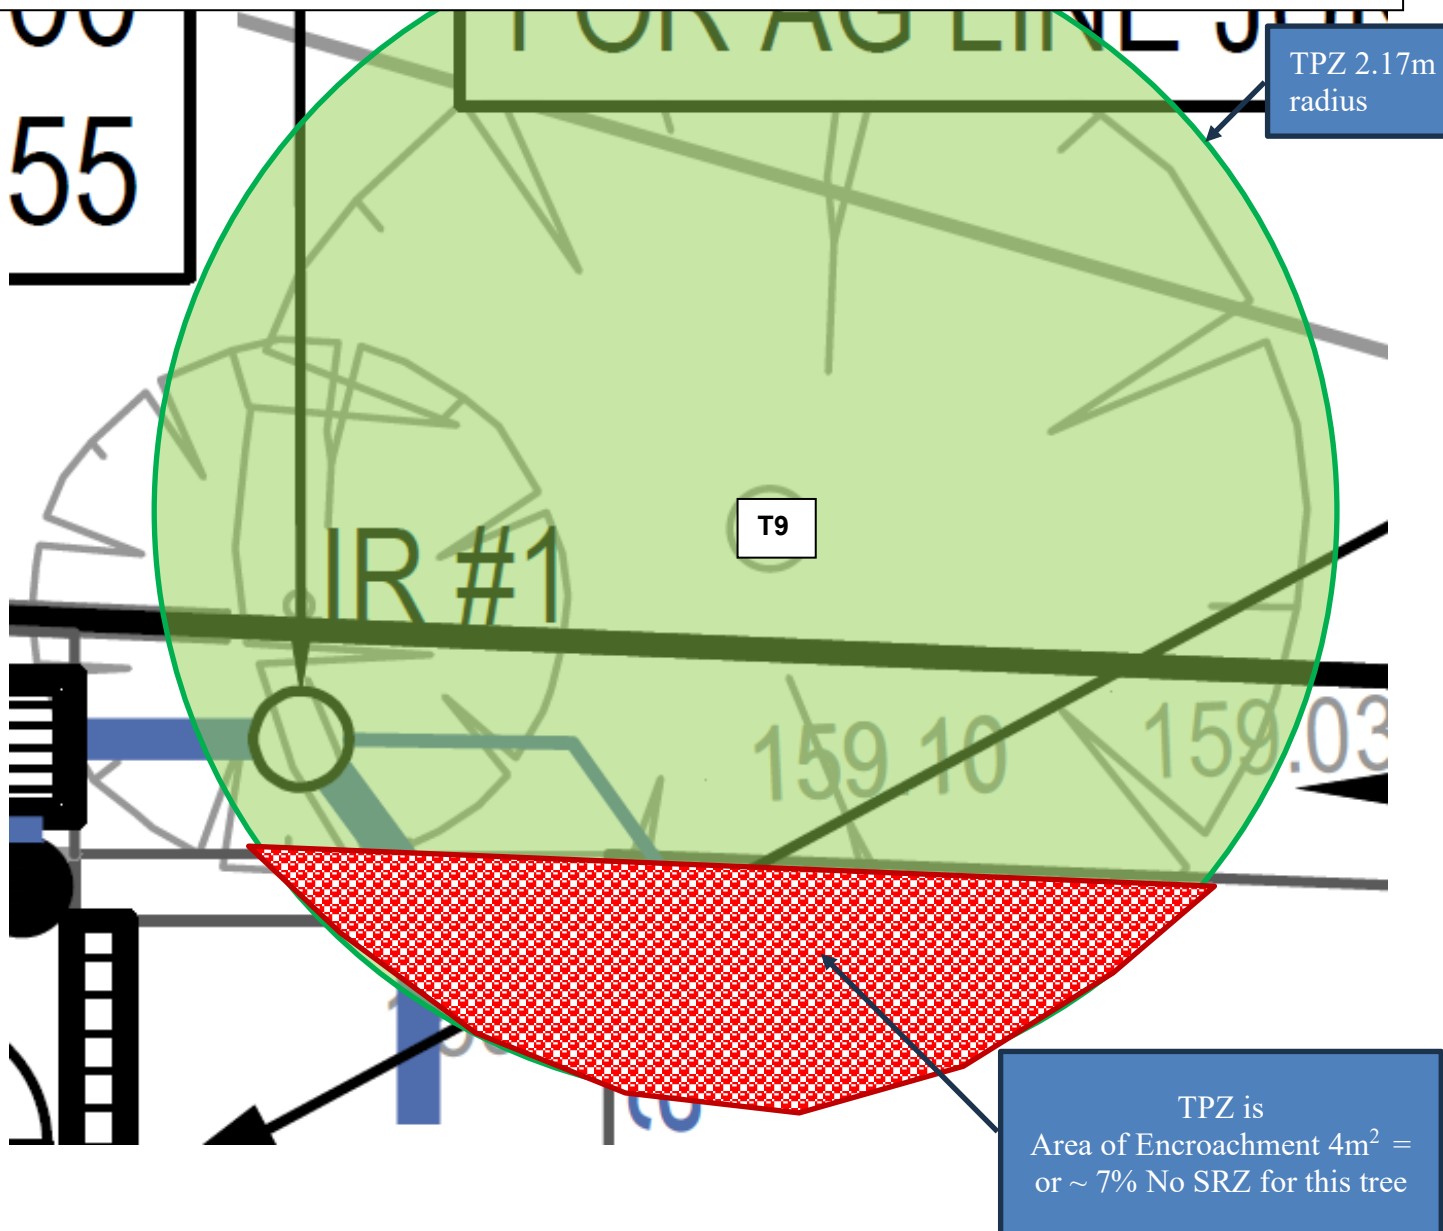
APPENDIX 2f. Excerpt from Stormwater Plan showing the location of a Minor Encroachment from the new driveway within the TPZ of T9 of 4m² which equates to 6.7%. also there are stormwater pipes and an agricultural Pipe which would make the Encroachment closer to 7%.

5.2 Tree **T7**, the neighbour's *Lagerstroemia* will be subject to a Minor Encroachment of approx. 4% from the driveway and trenching for stormwater pipes (See Appendix 2f). It is recommended that any trenching for plumbing works be conducted using hand tools with the objective of avoiding or minimising damage to tree roots >30mm Ø and under the supervision of the Project Arborist (PA).

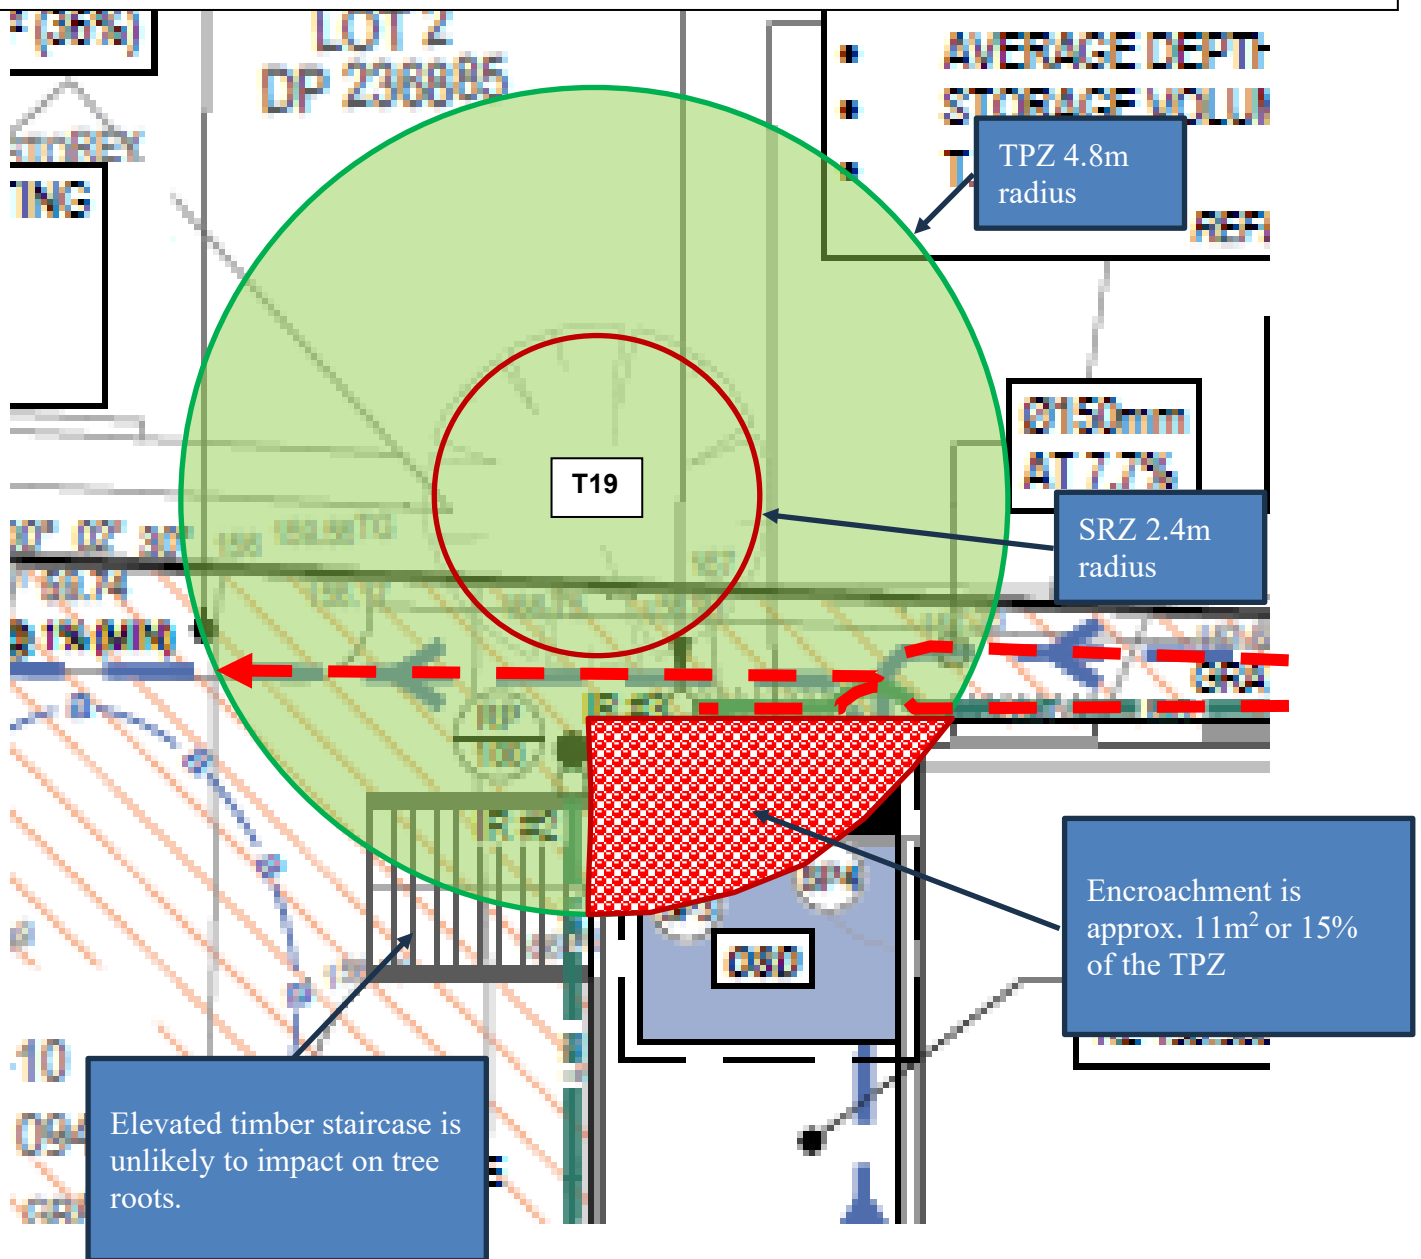
APPENDIX 2g. Excerpt from Stormwater Plan showing the location of a Major Encroachment from the new dwelling and OSD within the TPZ of T19 of approx. 24m² which equates to around 30%. Also there are stormwater pipes and an agricultural Pipe which would make the Encroachment closer to 33%.

5.3 Tree **T19** is an exempt species which will grow into a very large tree⁴ with a wide spreading and highly invasive root system. Consequently it is recommended to approach the neighbour regarding its removal as this tree would have an adverse impact on his property and services also. Alternatively, at this stage plans for the development indicate a 15% Encroachment into its TPZ (See Appendix 2g) which could be alleviated by design modifications to the OSD and plumbing work. It is recommended that any trenching for plumbing works be conducted using hand tools with the objective of avoiding or minimising damage to tree roots >30mm Ø and under the supervision of the Project Arborist (PA).

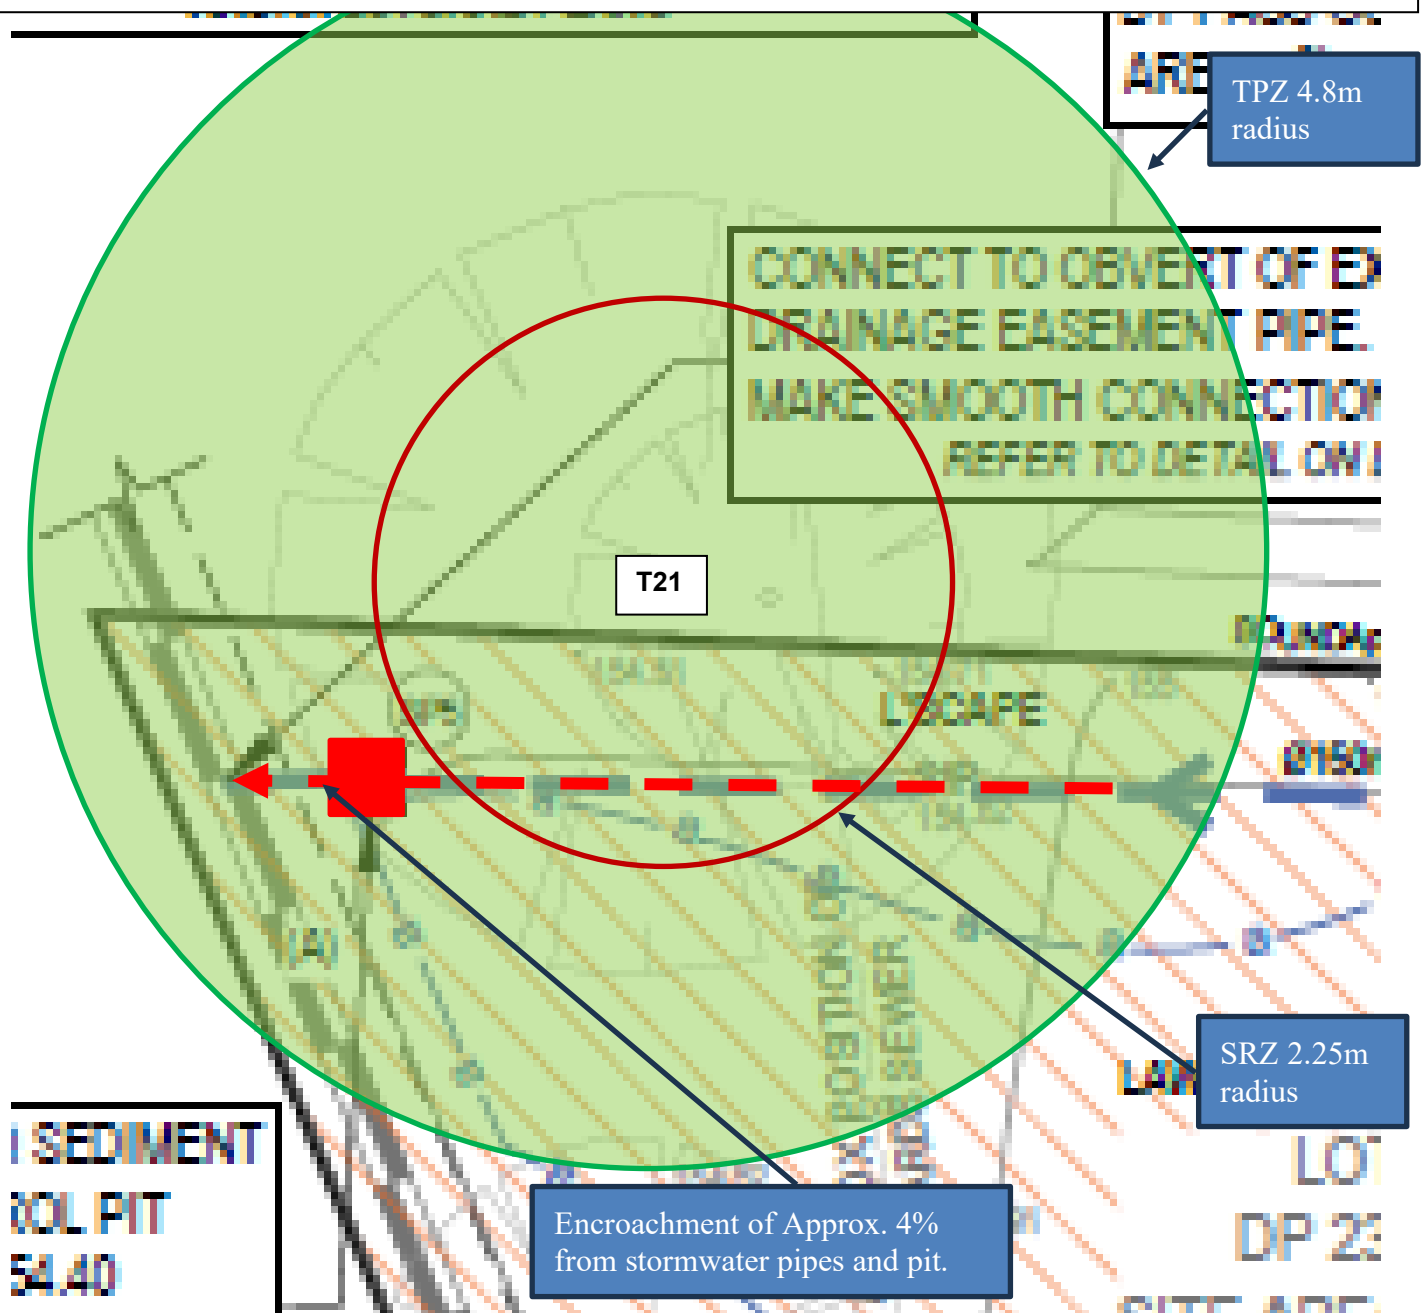
APPENDIX 2h. Excerpt from Stormwater Plan showing the location of a Minor Encroachment from the pipes, a pit and connection into the stormwater easement within the TPZ and SRZ of T21 of approx. 3m² which equates to around 4%.
