## **GEOTECHNICAL INVESTIGATION:**

Additions and Alterations at **546 Pittwater Road, North Manly**

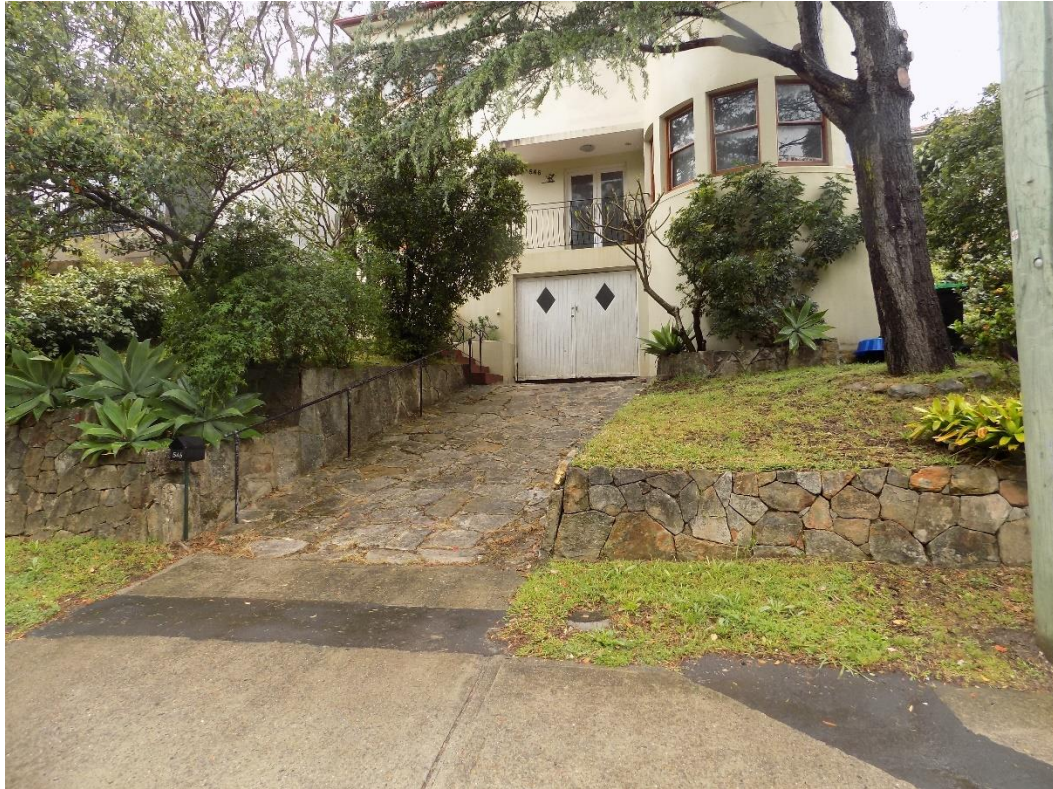
Photo 1

- 2.1** The site was inspected on the 13<sup>th</sup> October, 2021.
- 2.2** This residential property has dual access. It is on the high side of Pittwater Road and is also accessed by a Right of Carriageway (ROW) off of Hope Avenue. The property has a S aspect. The block runs SW – NE so there is a slight crossfall. It is located on the moderately graded lower reaches and toe of a hillslope. The slope rises across the property at an average angle of ~14°. The slope above the property continues at similar angles. The slope below eases to near level angles.
- 2.3** At the road frontage, a mortared sandstone driveway runs up the slope to a garage underneath the downhill side of the house (Photo 1). Between the road frontage and the house is a gently sloping lawn area. The ~1.0m high cut batter for the driveway is lined with sandstone flagging. The fill for the gently sloping lawn is

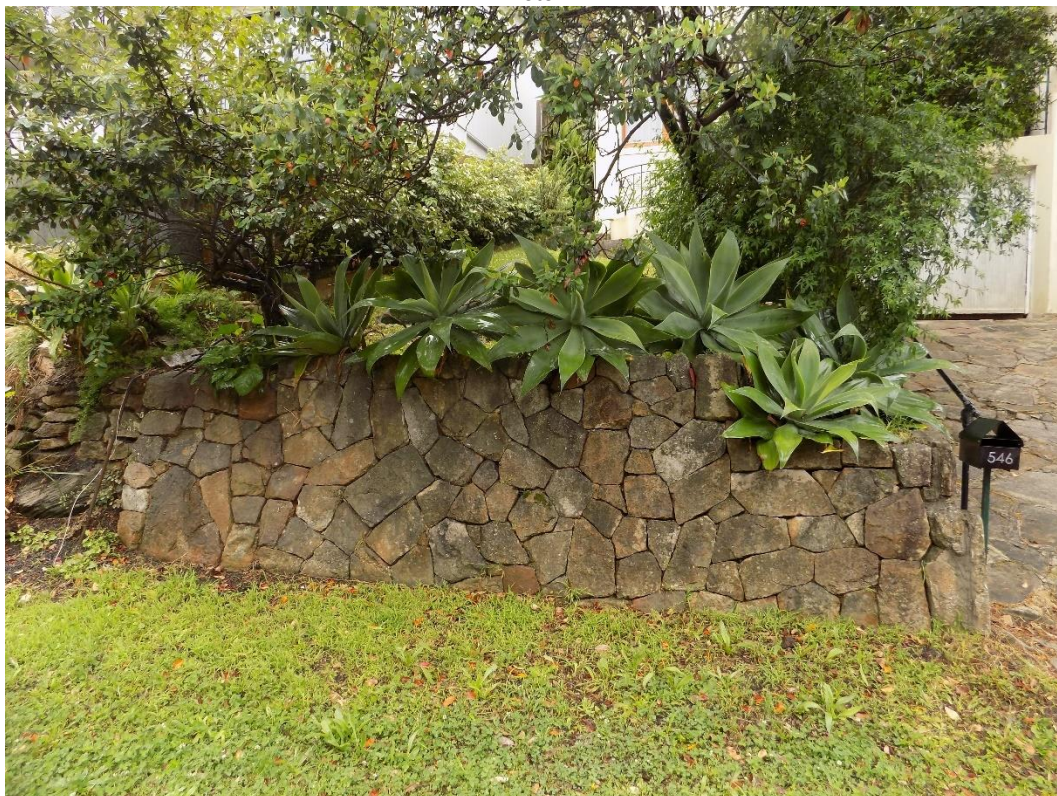
Photo 2

supported by a stable ~1.2m high stack rock retaining wall (Photo 2). The two-storey rendered brick house is supported on brick walls and brick piers (Photo 3). The brick walls show no significant signs of movement and the brick piers stand vertical. A ~2.0m cut to create a level platform for the house is supported by a stable mortared sandstone retaining wall (Photo 4). Competent Medium Strength Sandstone bedrock can be seen outcropping at the base of the wall. This wall is to be demolished as part of the proposed works. Immediately above the wall, outcropping sandstone bedrock steps up to a secondary dwelling on the uphill side of the property (Photo 5). Part of the sandstone outcrop was observed to be undercut slightly but is considered stable. The single-storey dwelling is supported on rendered brick walls and steel posts. The brick walls show no significant signs of movement and the steel posts stand vertical. A concrete driveway runs from the ROW to a carport underneath the secondary dwelling (Photo 6). A ~0.8m high stable concrete block retaining wall supports a fill for a level lawn area on the uphill side of the property (Photo 7).

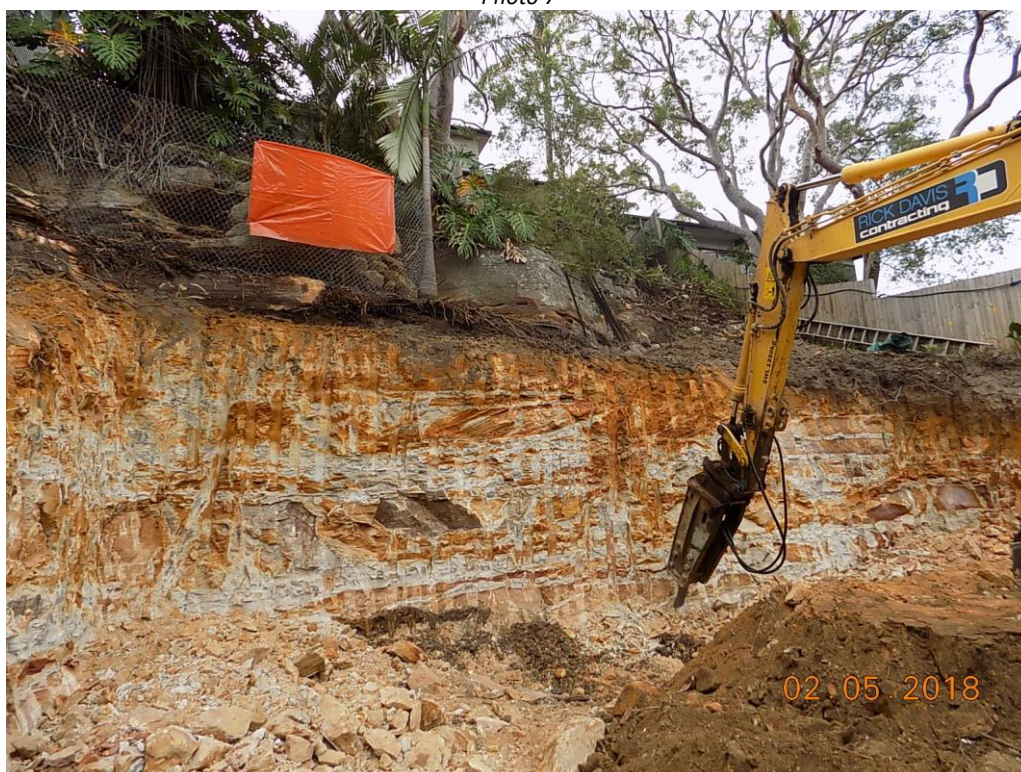
It is noted that prior works on the adjoining property to the NW identified that the Sandstone Bedrock in this area was of a lower strength than what was exposed at the surface (Photo 8).

Photo 8 (Excavation at adjoining property – 548 Pittwater Rd)
