**STABILITY REPORT  
FOR  
HOUSE & LAND  
AT  
60 BINBURRA AVENUE AVALON**

**MQ 29903**

23<sup>rd</sup> February, 2015

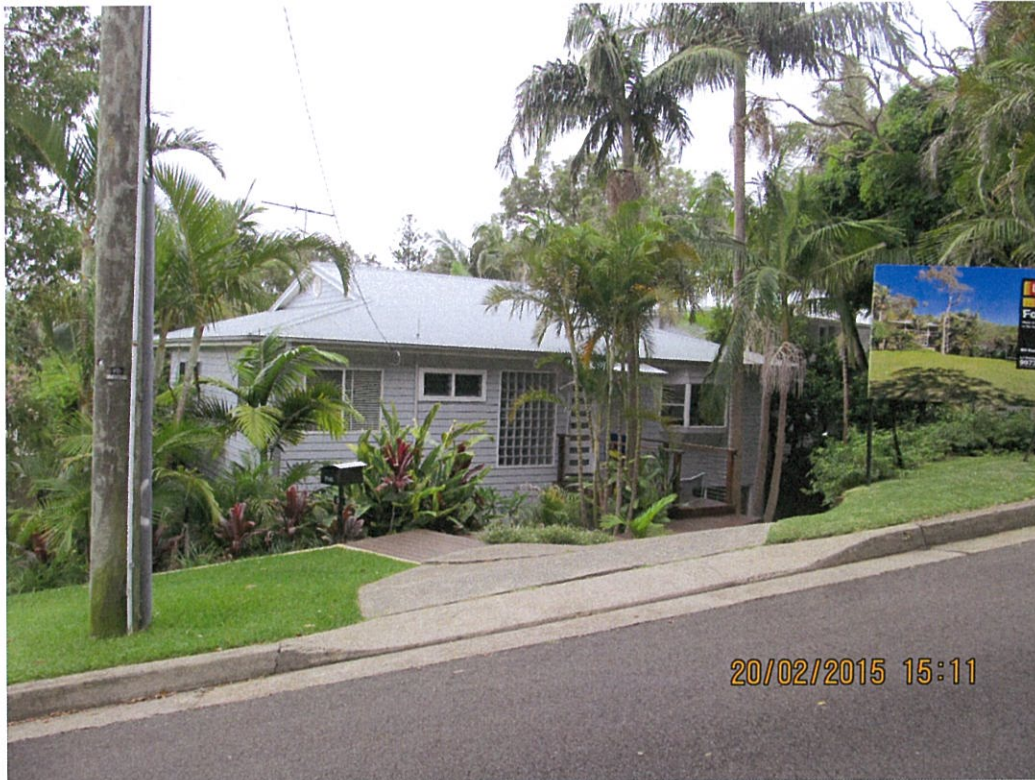
Photo 1

**1.3** From the road frontage a concrete drive cuts the slope and provides off street parking for the block (Photos 1 & 2). Some cracking and movement has occurred in the concrete driveway slab and cracks are evident running diagonally across the upper portion of the slab (Photos 3 & 4). These cracks are not interpreted to be recent features and are the result of causes undetermined, but the driveway slab is considered stable in its current condition. The road reserve is lawn covered and gently sloping to the north. The cut for the driveway and the slope above are supported by treated timber soldier pile walls that terrace the slope (Photos 2 & 5). While considered stable in their current condition some settlement and deflection was observed in the walls. A small paved area is situated toward the top of the terraces (Photo 6). This paving and its supporting ground have experienced settlement as a result of inadequate compaction of the underlying fill or the washing out of fine grained material from behind the timber wall (Photo 7). In ideal conditions treated timber walls of this kind can be expected to last 15-20 years. We would recommend the walls be monitored for signs of further movement. Should this be identified we would recommend the walls

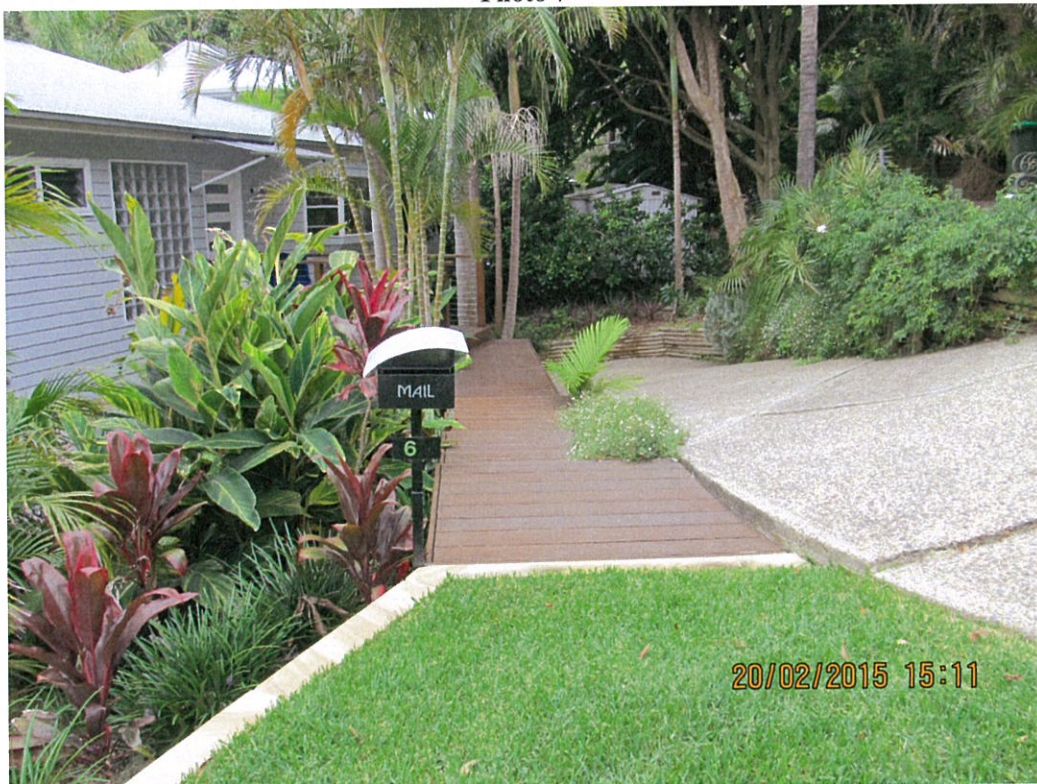
Photo 8

be replaces with similar, engineered treated timber soldier pile retaining walls. Pedestrian access to the house is via a timber pathway that extends along parallel to the driveway before spanning to the first floor of residence (Photos 8 & 9). The cut for the house is supported by stable treated timber soldier pile walls (Photo 9). Access around the house is possible along concrete corridors that extend along the eastern and western boundaries (Photos 10 & 11). A large timber deck extends from the northern side of the ground floor beyond which lies a small paved patio (Photo 12). A large, near level, lawn covered yard extends to the northern boundary of the block (Photo 13). Portions of the yard, particularly the northern end and south-western corner, are populated with small to medium shrubs and trees. No evidence of significant slope instability was identified at the time of our inspection.
