## **GEOTECHNICAL INVESTIGATION:**

### **Alterations and Additions at 4 Curra Close, Frenchs Forest**

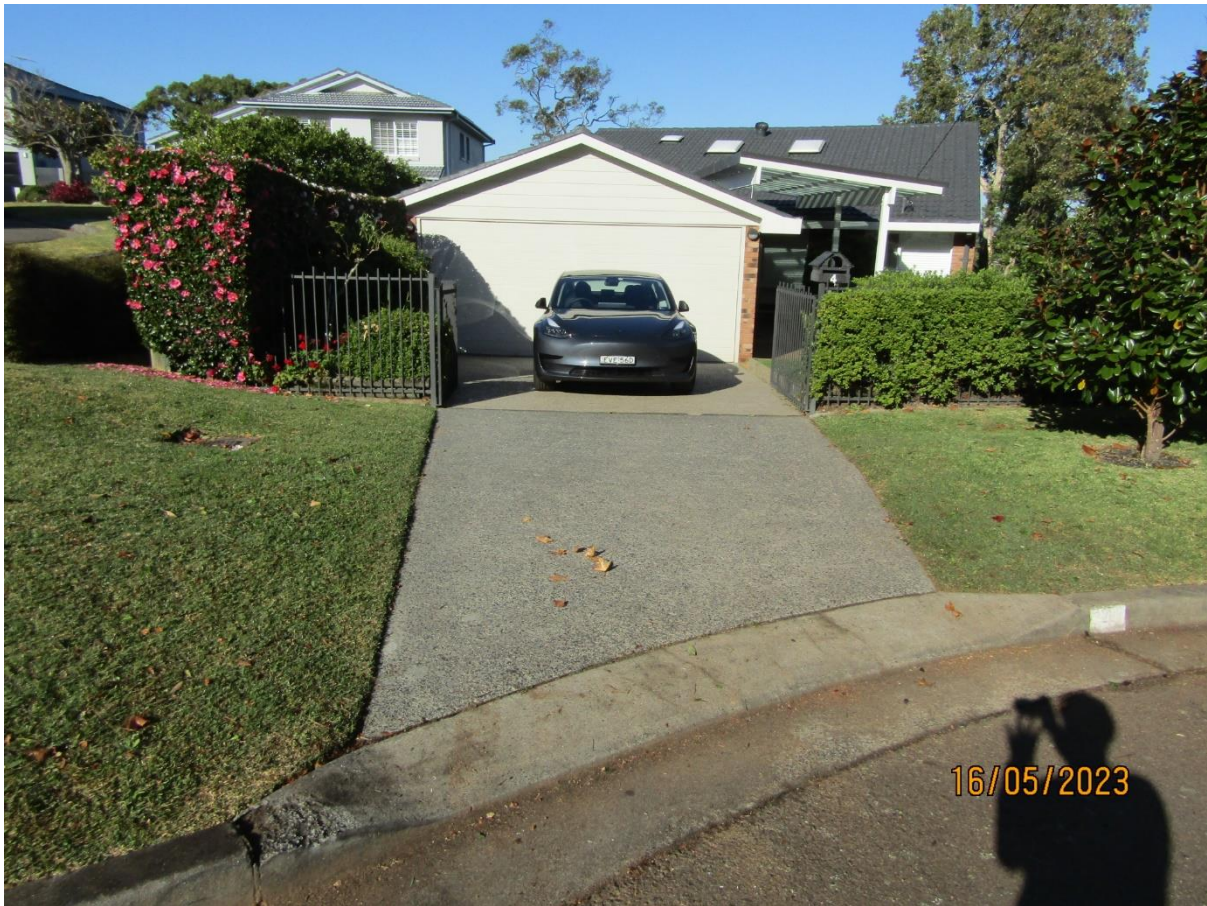
Photo 1

- 2.3** At the road frontage, a concrete driveway runs to a garage attached to the uphill side of the house (Photo 1). Between the road frontage and the house is a gently sloping lawn surrounded by garden beds. The part two-storey brick house is supported on brick walls and brick piers. No significant signs of movement were observed in the supporting brick walls. One of the supporting brick piers was observed to be tilting downslope at an angle of  $\sim 3^\circ$  (Photo 2). See **Section 13** for advice regarding this tilting pier. Competent Medium Strength Sandstone outcrops and steps down the slope to the E of the house. Most of the outcropping rocks display no significant geological defects. The lower portion of the outcropping rock was observed to be slightly

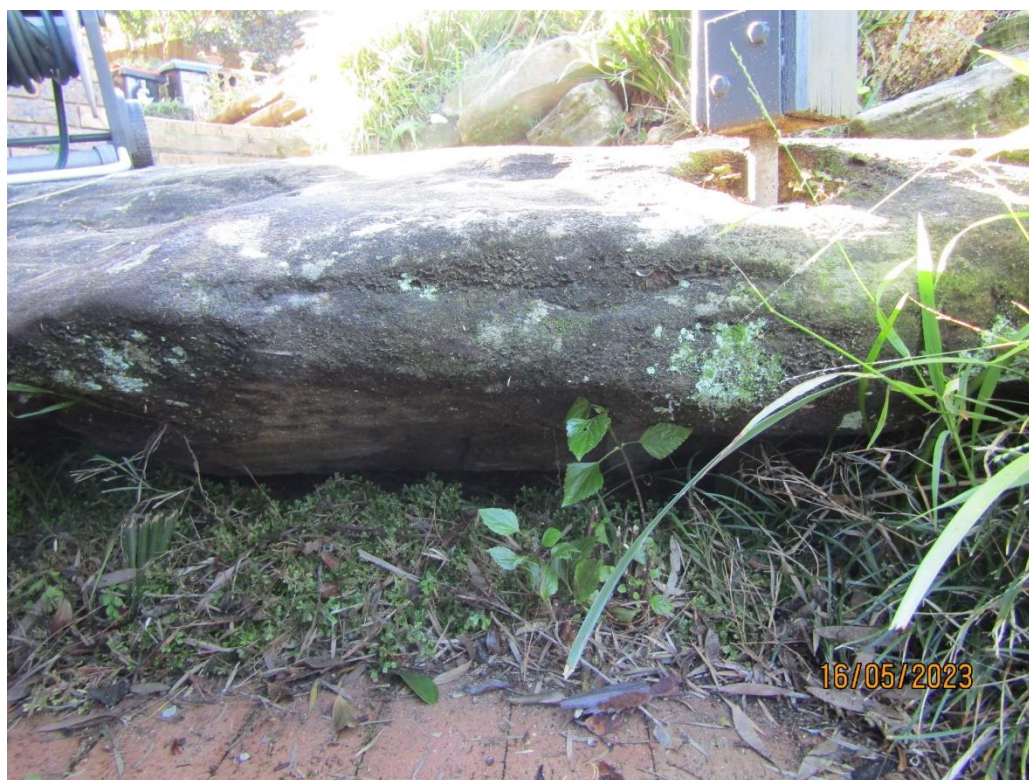
Photo 3

undercut (Photo 3). See **Section 12** for advice regarding the proposed deck foundations in this location. A fill extends off the downhill side of the house. The fill is supported by stepped timber retaining walls reaching ~1.4m high. These walls were observed to be tilting downslope at a maximum of ~5° (Photo 4). See **Section 13** for advice regarding these tilting retaining walls. A lawn-covered fill extends off the downhill side of these walls. This fill is supported by a concrete block retaining wall. This wall has a thick covering of vegetation and could not be easily assessed. A steep, densely-vegetated slope falls from the base of this wall to and beyond the lower common boundary (Photo 5). Due to dense covering of vegetation, only isolated sections of the rock was visible. As such this section of the slope could not be assessed for stability at the time of the inspection. We recommend the vegetation be cleared so it can be adequately assessed.

The new two-story deck is to be supported on piers taken to the underlying Medium Strength Sandstone. This material is expected at variable depths of between 0.3 to 1.5m below the current surface where it is not exposed. No portions of the deck are to be supported on any undercut portions of the exposed rock outcrop (See Photo 3). Where footings are over an exposed sloping rock surface, they may be supported off level pads cut into the rock. Assume a maximum allowable bearing pressure of 1000kPa for footings supported off Medium Strength Sandstone.

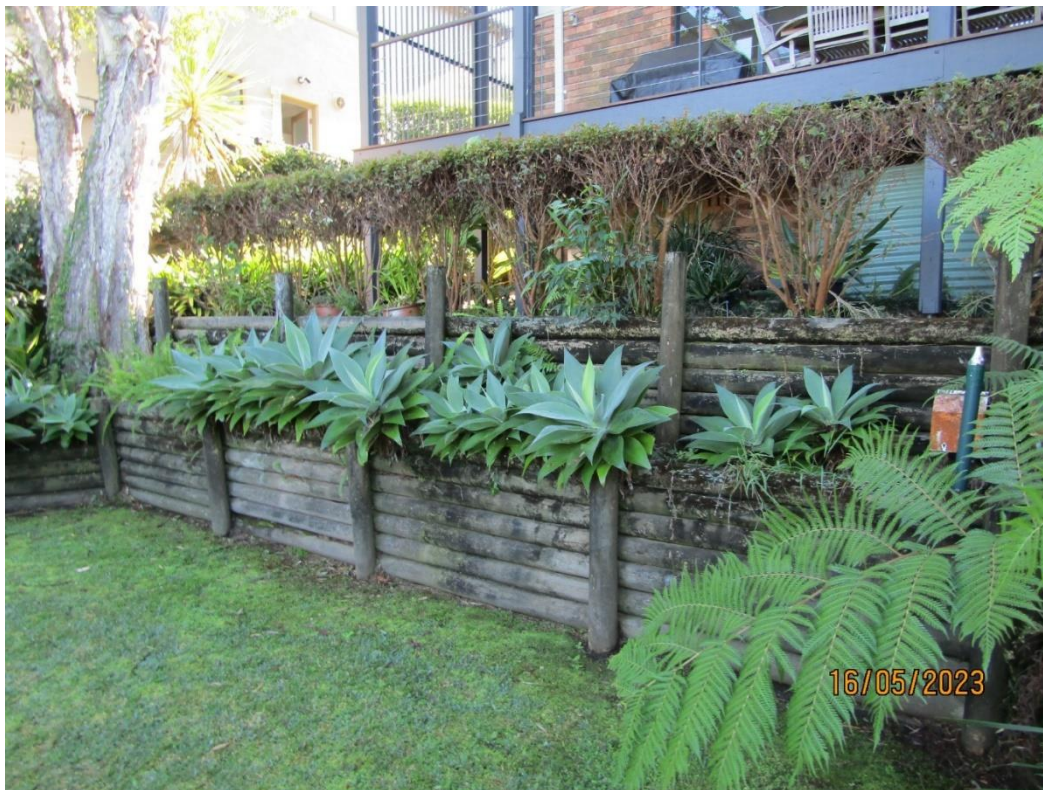
Photo 4

No geotechnical hazards were observed above or beside the property. The gentle to steep graded land surface that falls across the property and continues below is a potential hazard (**Hazard One**). Collapse of the tilting timber stepped retaining walls on the downhill side of the property are a potential hazard (**Hazard Two**).

The stepped timber retaining walls on the downhill side of the property are tilting downslope to  $\sim 5^\circ$  (Photo 4). We recommend consideration be made to repairing/replacing the retaining walls during the proposed works. Alternatively, the retaining walls can be inspected by the owners on an annual basis or after heavy prolonged rainfall, whichever occurs first, keeping a photographic record of the inspections. We can carry out these inspections upon request. Should any new movement be observed, the retaining walls are to be remediated or rebuilt to current engineering standards.

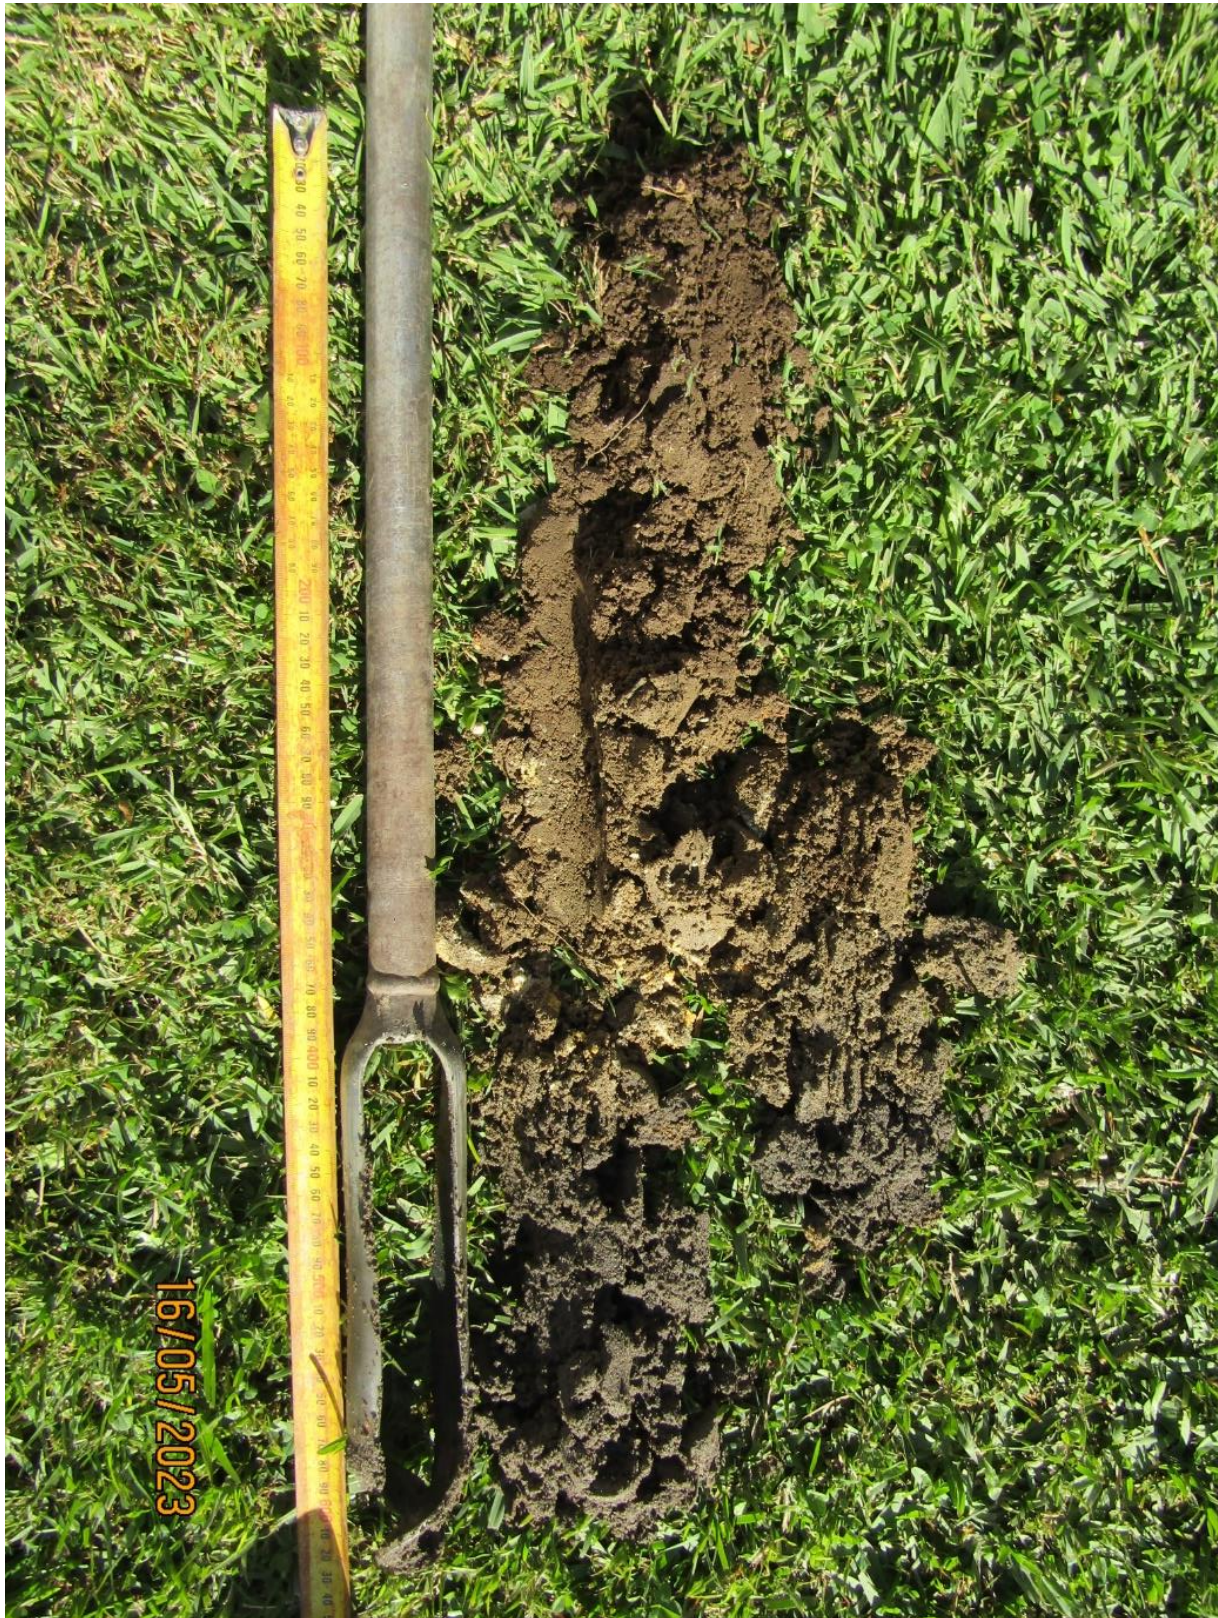
## AUGER HOLE 1 (~RL150.7) – AH1 (Photo 6)

Depth (m)	Material Encountered
0.0 to 0.4	<b>TOPSOIL</b> , sandy soil, dark brown, medium dense to dense, dry, fine to coarse grained from trace clay.
0.4 to 0.6	<b>SAND</b> , dark grey, damp, dense, coarse grained.

Refusal @ 0.6m grinding on rock. No water table encountered.

Photo 6: AH1 – Downhole is from top to bottom
