Report Title: Geotechnical Report <b>29 Wandeen Road, Clareville</b>
Report Date: <b>15/10/24</b>
Author: <b>BEN WHITE</b>
Author's Company/Organisation: <b>WHITE GEOTECHNICAL GROUP PTY LTD</b>

## **GEOTECHNICAL INVESTIGATION:**

### **Alterations and Additions at 29 Wandeen Road, Clareville**

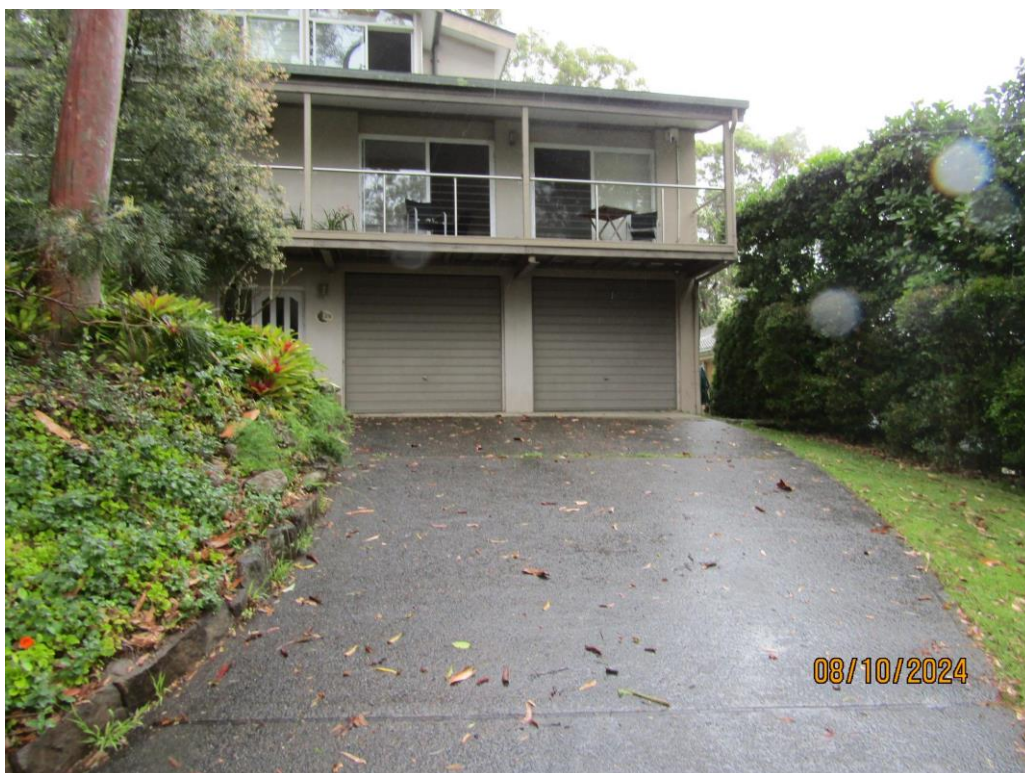
Photo 1

- 2.1** The site was inspected on the 8<sup>th</sup> October, 2024 and previously on the 3<sup>rd</sup> of March, 2020.
- 2.2** This residential property is on the high side of the road and encompasses the crest and moderate to steeply graded flanks a hillslope. The natural slope rises from Wandeen Road at an angle of ~16° before reaching the crest of the hillslope. The slope falls at the S side of the crest at an angle of ~22° towards the S property boundary. The slopes below the N and S boundaries of the property increase in grade.
- 2.3** At the road frontage, a concrete driveway runs up to the slope to a double garage on the ground floor of the house (Photo 1). Low stable stack rock, keystone,

and timber retaining walls support a cut and fill for the driveway and landscaping (Photos 1 & 2). The part three storey rendered masonry house with garage is supported on brick walls, concrete block walls, brick piers, and a concrete slab (Photos 1 & 3). The supporting walls show no significant signs of movement and the supporting piers stand vertical (Photo 4). A cut up to ~1.5m high in the foundation space of the house has exposed Very Low to Low Strength Rock (Photos 5 & 6). The cut batter is unsupported but appears to be currently stable.

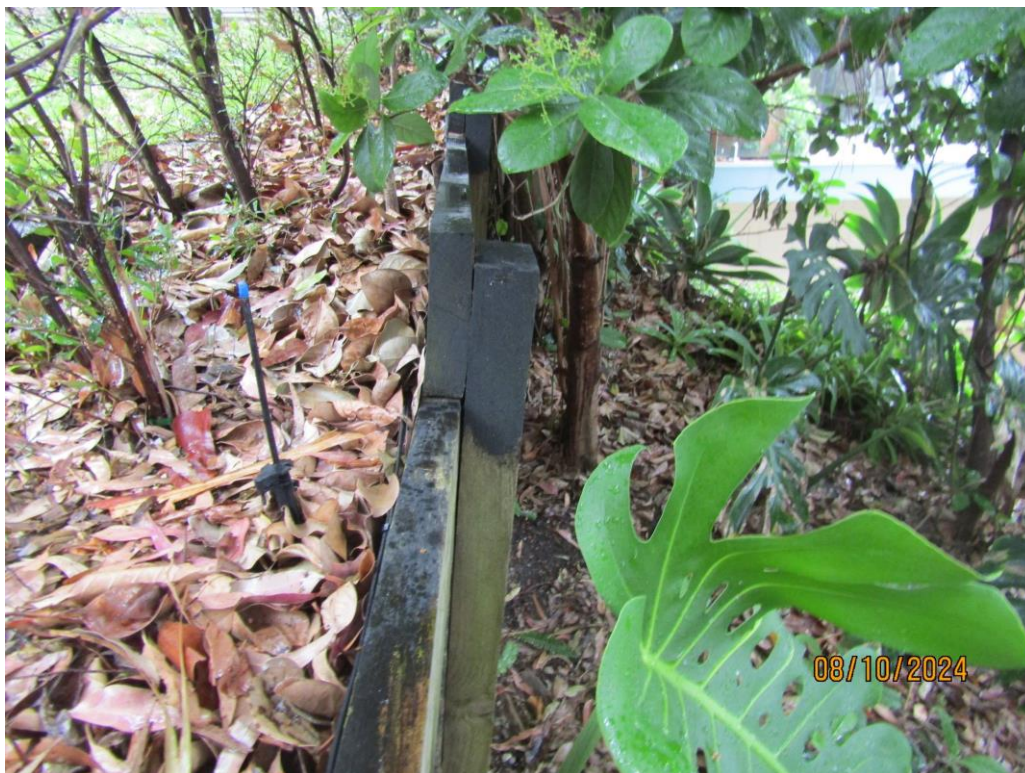
Photo 7

Timber retaining walls up to ~1.2m high along the W common boundary support fills for lawn and gardens (Photos 7 & 8). These walls are tilting downslope slightly. A timber retaining wall up to ~1.6m high along the E common boundary supports fill on the E neighbouring property (Photos 9 & 10). The wall is tilting at up to 15° from vertical (Photo 11). See '**Section 16 Remedial Works / Ongoing maintenance**'. A cut and fill provides a near level lawn which extends from the S side of the house (Photos 3 & 12). A stable masonry retaining wall up to ~1.4m high supports the cut (Photo 13). The lawn drops away to the S where the fill batter merges into the natural slope. A cut that is estimated to be between ~1.0m to ~2.0m high has been made in the slope along the downhill property boundary (Photo 14). The cut is mostly obscured by vegetation but some clay is exposed along the E side of the cut. Construction works are currently ongoing on the downhill neighbouring property in this location and it is expected a retaining wall will be constructed to support the cut as part of these works.

The owners of the property have informed us the tilting retaining walls (Photos 7 to 11) will be replaced. This work will not be part of the proposed development. The tilting wall along the E common boundary (Photos 9 to 11) should be replaced as soon as possible, or within 2 years from the date of this report.

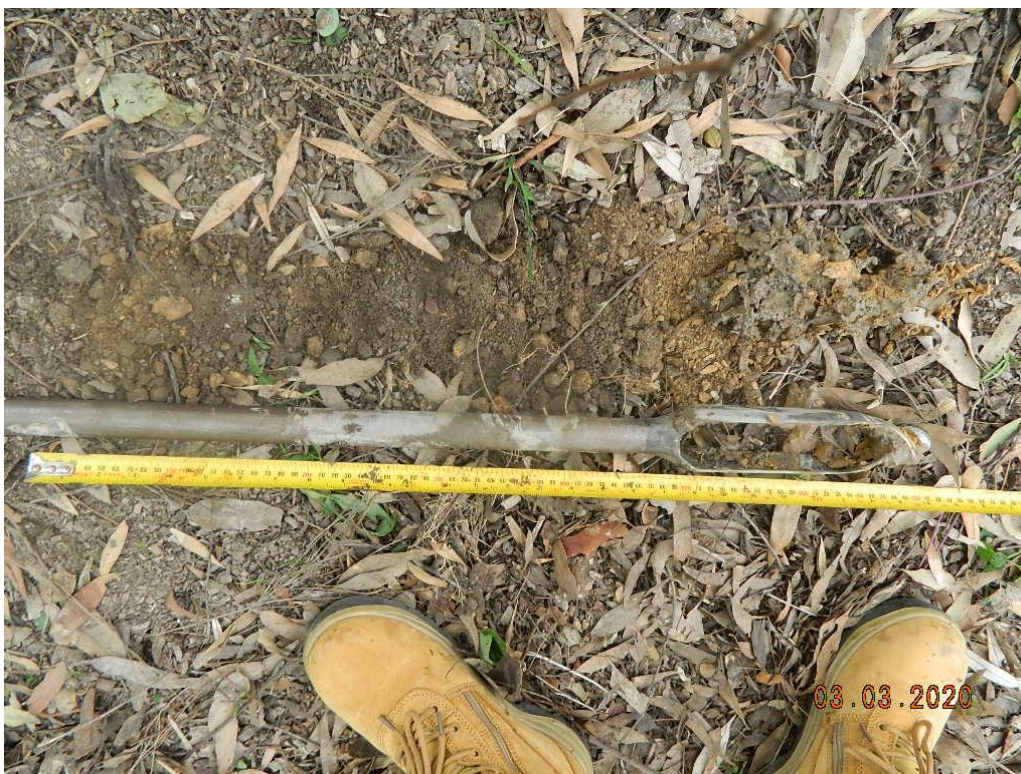
##### **AUGER HOLE 1 (~RL58.4) – AH1 (Photo 15)**

<b>Depth (m)</b>	<b>Material Encountered</b>
0.0 to 0.5	<b>CLAYEY SOIL</b> , brown and orange, dry, fine to medium grained.
0.5 to 0.7	<b>CLAY</b> , orange, firm to stiff, dry.

End of Hole @ 0.7m in firm to stiff clay. No water table encountered.

Photo 15: AH1 – Downhole is from left to right.
