## **PRELIMINARY GEOTECHNICAL ASSESSMENT:**

### **102 Grace Avenue, Forestville**

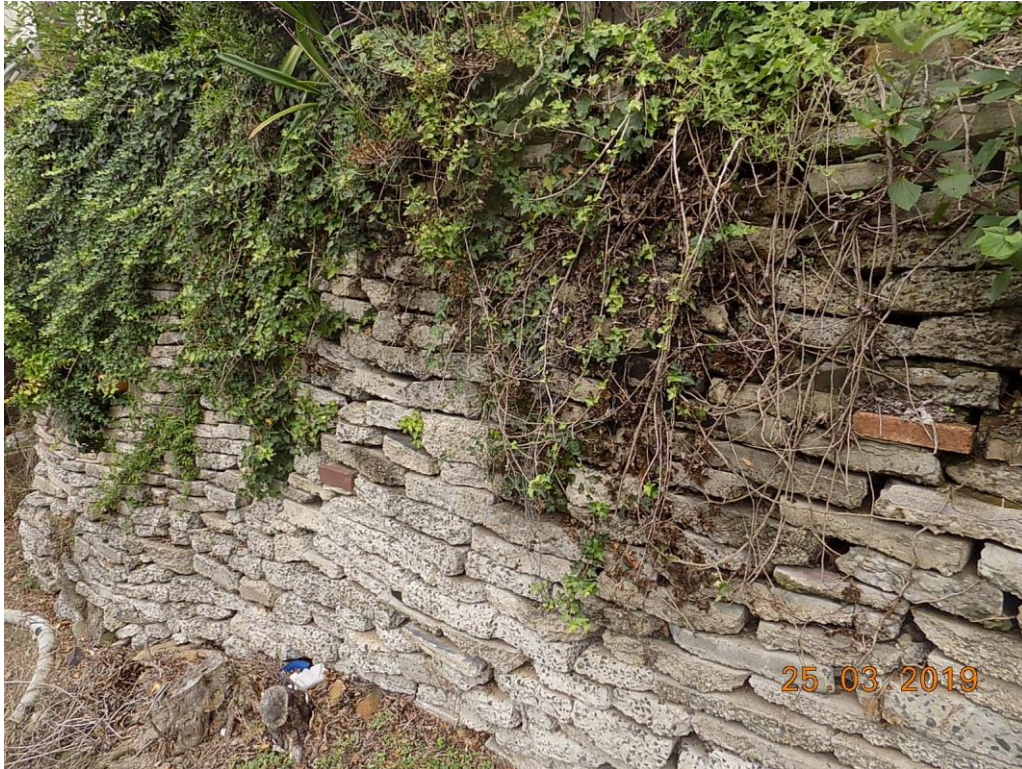
Photo 1

The natural slope falls from the road frontage at gentle angles to a rock face at approximately the midpoint of the property. The slope then continues at gentle angles to the lower common boundary. At the road frontage, a concrete driveway runs to a brick garage attached to the NE side of the house. Between the road frontage and the house is a gently sloping lawn-covered fill. The fill is supported by a stable rendered masonry retaining wall ~1.0m high that lines the SW common boundary. The single-storey brick house is supported on brick walls and brick piers. Some minor cracking was observed on the S corner of the house but we do not attribute this crack to ground movement. The supporting walls display no other significant signs of movement. The supporting brick piers stand vertical. Another gently sloping lawn-covered fill falls from the downhill side of the house. The fill is supported by a ~4.0m high makeshift concrete gravity wall (Photo 1). It is constructed of broken up slabs of concrete paving. It is not an 'engineered' retaining wall but the concrete components show no signs of detrimental movement and the wall is constructed with a slight tilt back into the slope. Additionally, no ground movement was observed in the lawn area above the wall. The wall is

currently considered stable but see **Section 5.0** for ongoing maintenance advice. Competent Medium Strength Sandstone bedrock outcrops beside the wall and steps down twice to a gently sloping lawn area below. The upper step is undercut ~1.0m (Photo 2). The undercut rock has a relatively thick cantilever arm in relation to its overhang length and does not show any cracking through the supporting cantilever arm as viewed from above or below. As such, we consider it to be currently stable. The lawn area below continues to the lower common boundary. The area surrounding the house is mostly paved or lawn covered. No signs of movement associated with slope instability were observed on the grounds. The adjoining neighbouring properties were observed to be in good order as seen from the road and the subject property.

To be prudent, we recommend the retaining wall (Photo 1) be inspected by the owners on a biannual basis or after heavy prolonged rainfall, whichever occurs first, keeping a photographic record of the inspections. We can carry out these inspections upon request. Should any new movement be observed, the geotechnical consultant is to be engaged to assess the movement and provide remedial advice if necessary.
