REPORT ON GEOTECHNICAL INVESTIGATION

PROPOSED RESIDENTIAL DEVELOPMENT

91 FLORIDA ROAD PALM BEACH

PROJECT: TGE22046

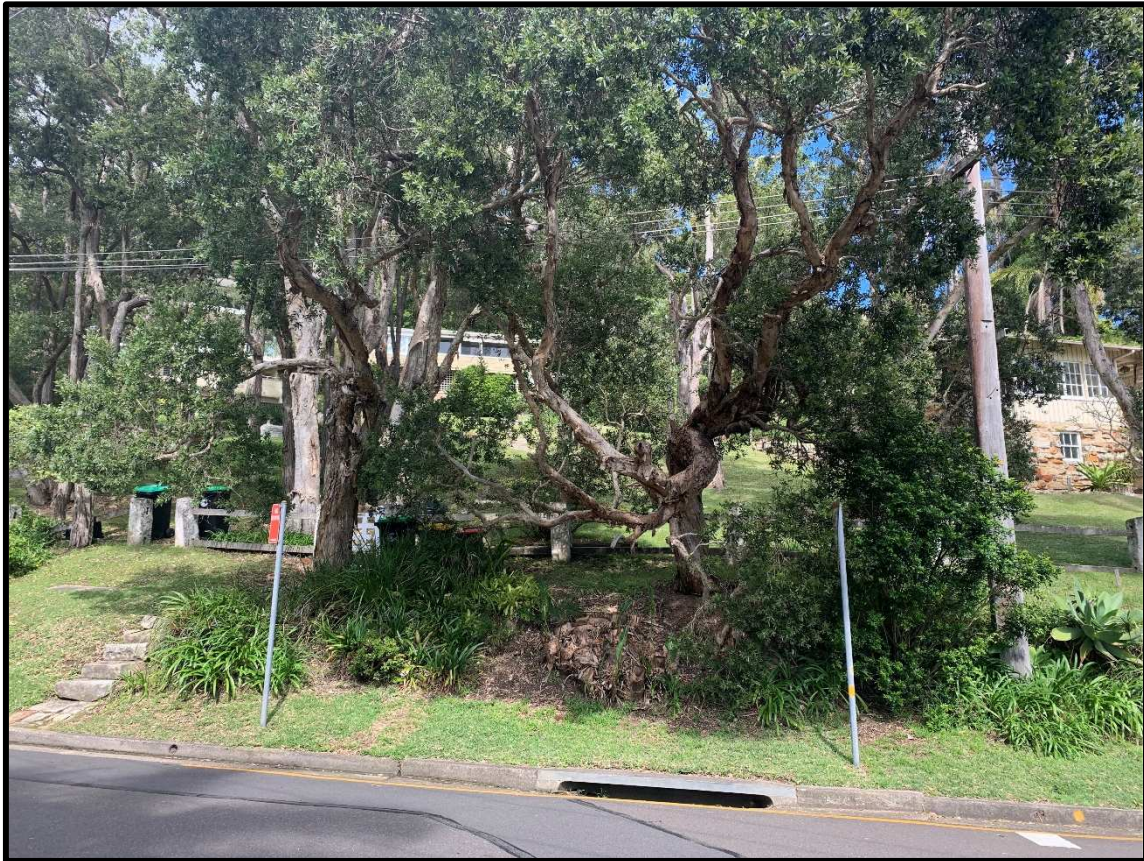
Photo 1 – View of site from Florida Road, looking west.

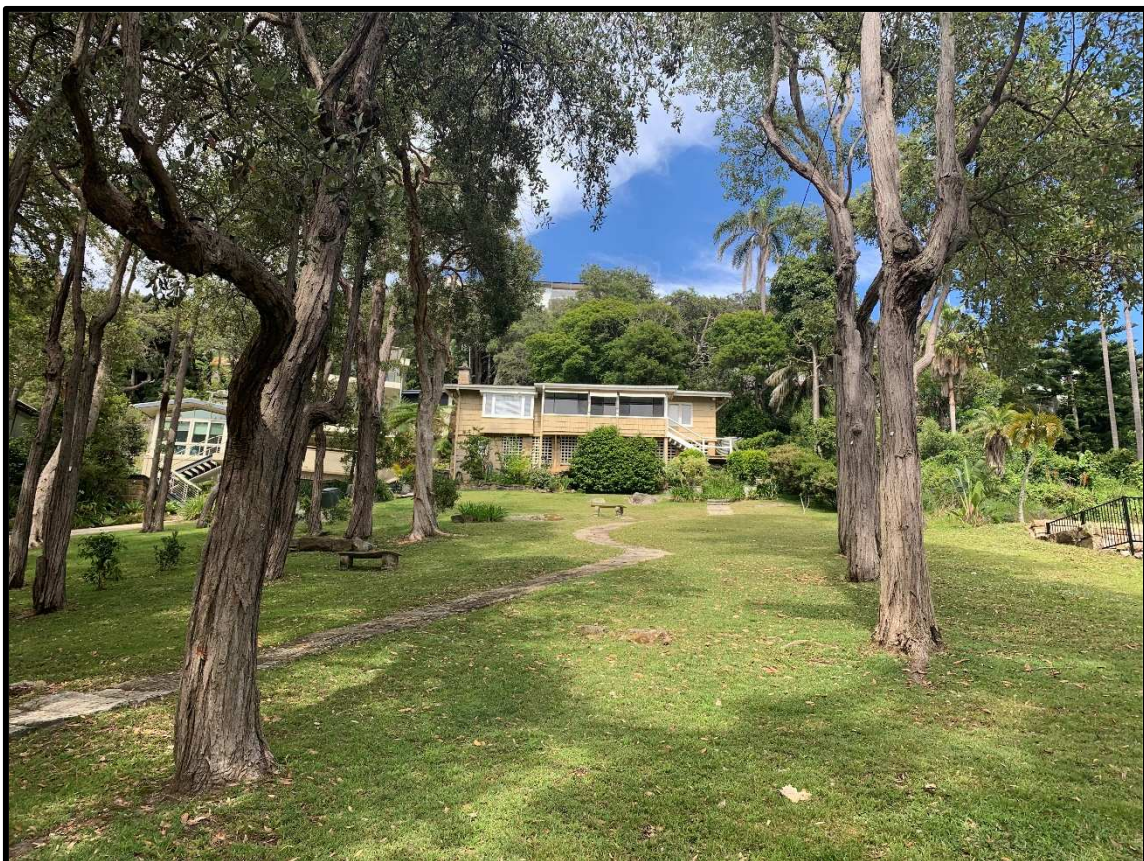
Photo 2 – View of eastern section of site, looking east.

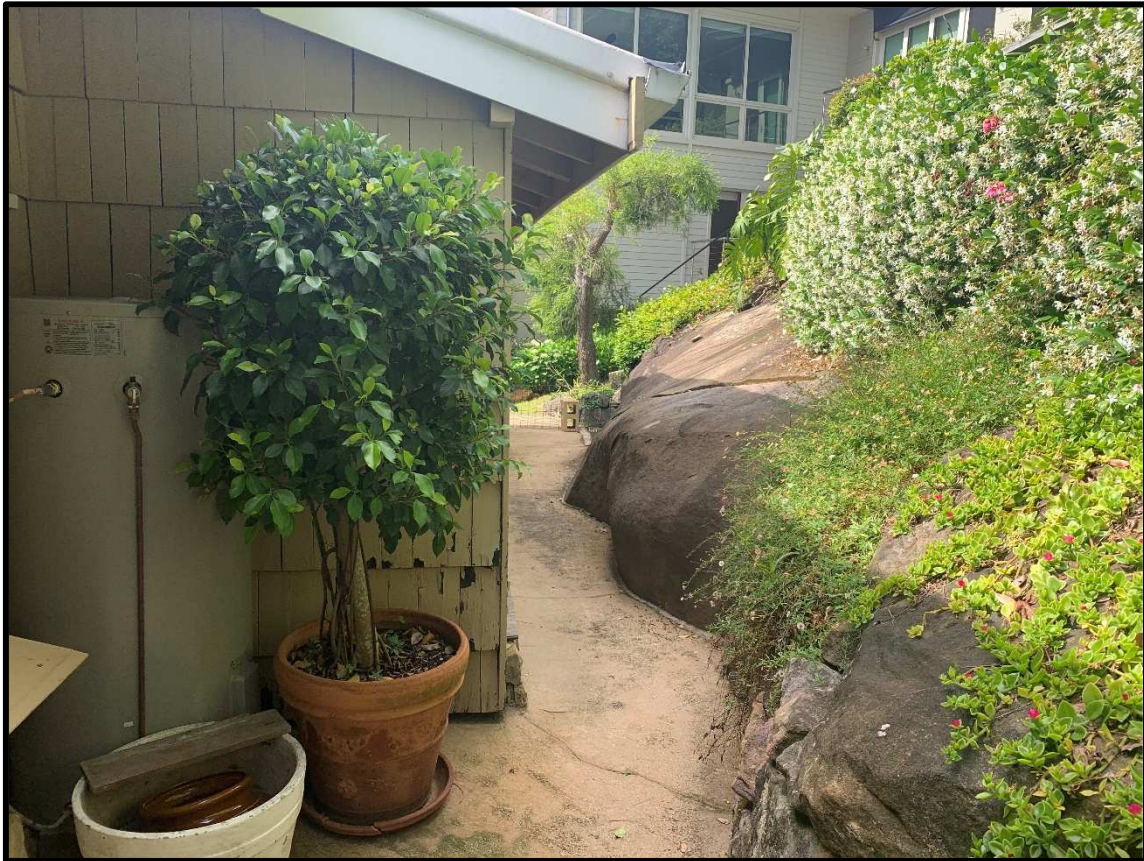
Photo 3 – View of large sandstone outcrop at rear of residence, looking south.

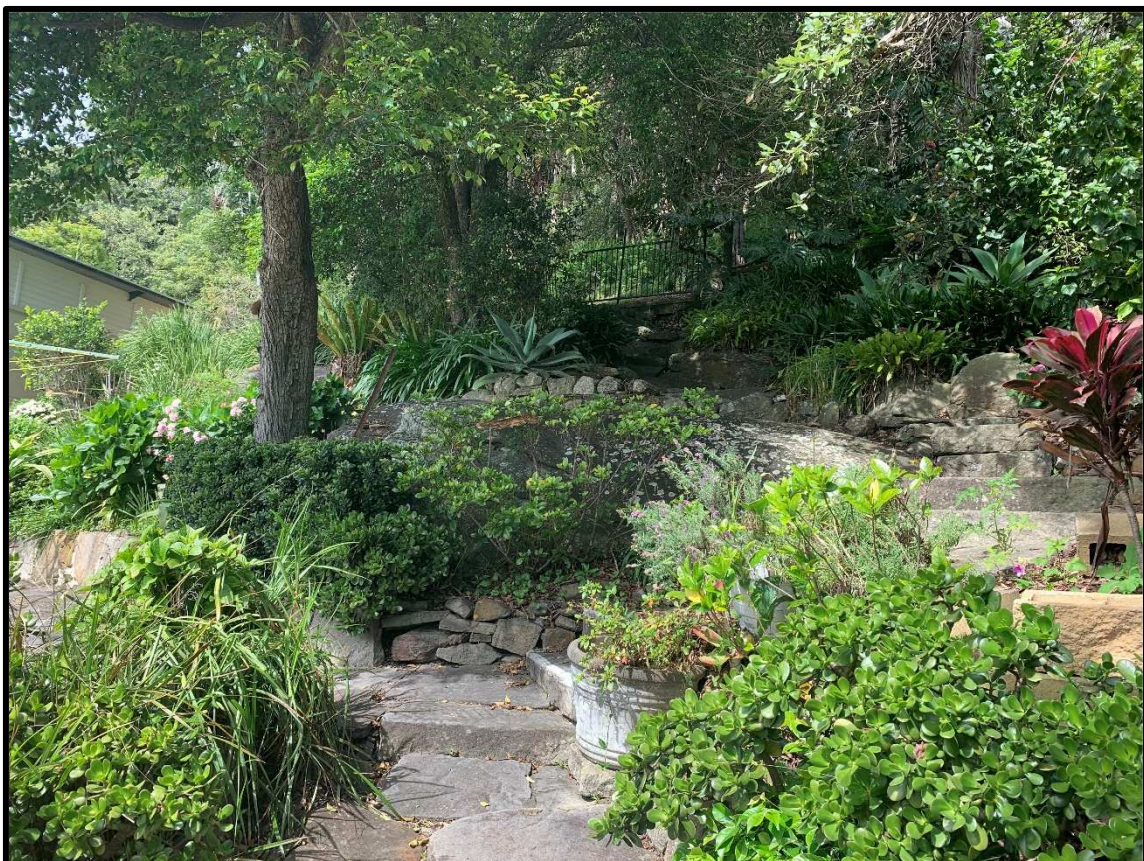
Photo 4 – View of terraced gardens in the western section of the site, looking south west.

Hazard	Likelihood	Consequence	Risk Level	Comments
Failure of existing retained terraced garden beds across western area of site upslope of residence.	Rare	Minor to insignificant	Very Low	Walls are generally less than 0.6 m and show no signs of movement.
Failure of existing embankment across front boundary of site.	Unlikely	Insignificant	Very Low	Embankment is not excessively steep and less than 1.5 m in height and is well vegetated.
Global slope failure across western section of site.	Rare	Major	Low	Shallow bedrock profile drainage to be incorporated into the proposed development.

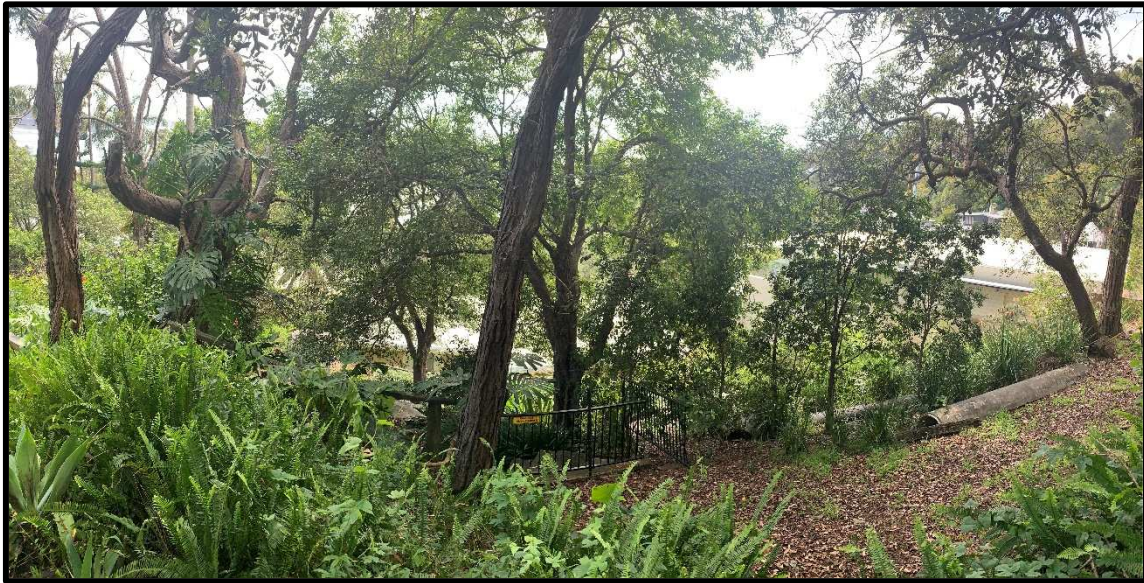
Photo 5 – View of site from rear boundary, looking east.

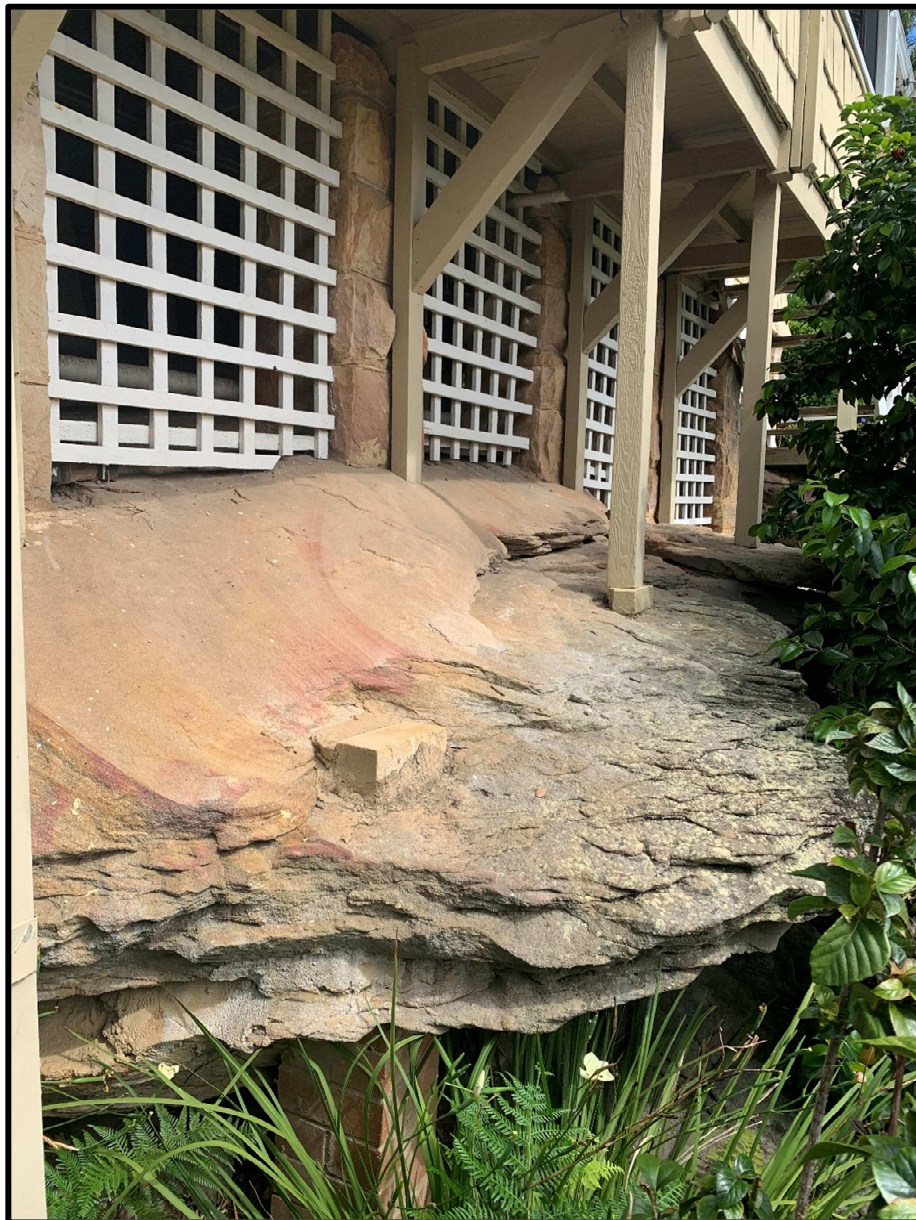
Photo 6 – View of sandstone outcrop under front section of residence.

Review of the architectural plans indicates that only very minor excavation will be required with excavation of 1-1.5 m required at the front of the existing residence with the excavation generally involving trimming of the large sandstone boulder underlying the front section of the residence. This boulder consists of medium to high strength sandstone and care should be taken when excavating adjacent to existing foundations. It is likely that temporary propping of the front section of the residence will be required until the rear wall of the lower extension is complete.
