## **GEOTECHNICAL INVESTIGATION:**

### **New Pool at 129 Upper Clontarf Street, Seaforth**

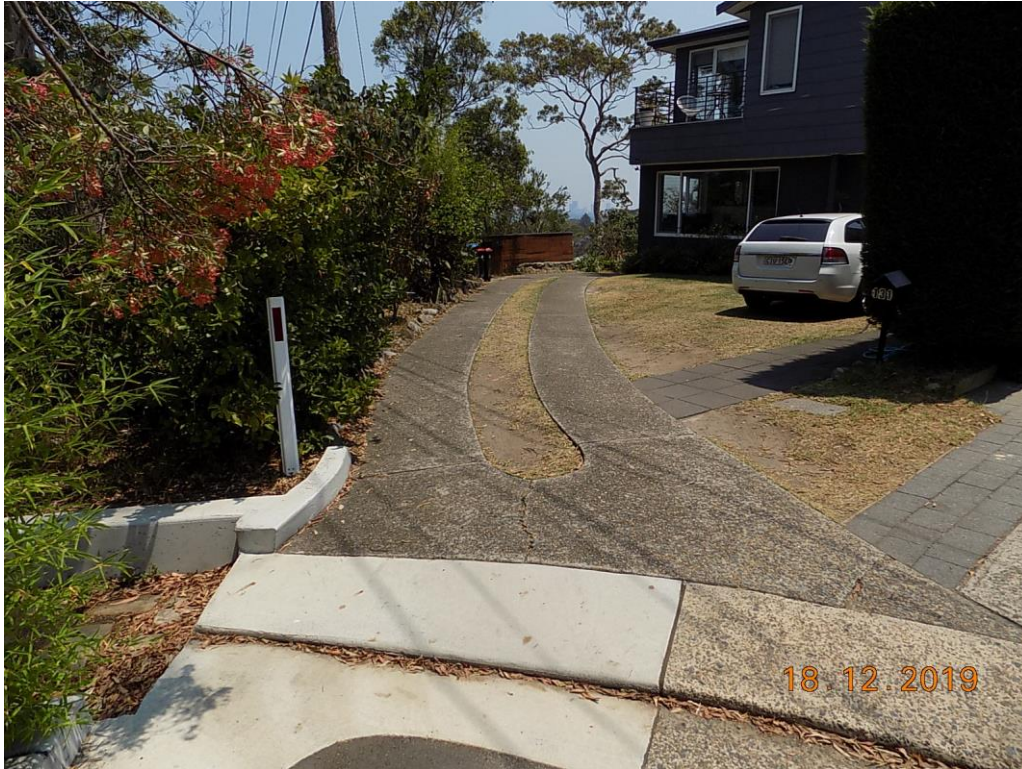
Photo 1

- 2.3** At the road frontage, a concrete driveway runs across the upper sandstone bench to a garage attached to the E side of the house (Photos 1 & 2). A sandstone cliff face falls from the downhill side of the driveway to a level lawn area at the lower common boundary (Photos 3 & 4). The cliff reaches a maximum height of ~6.0m. The majority of the cliff displays no significant geological defects. The W end of the cliff is undercut in two locations. The E location is undercut ~2.0m and has a relatively thin cantilever arm in relation to its overhang length (Photo 5). The undercut has been remediated in the past with three steel posts and a rough, stack rock blade wall. Only one of the steel posts still makes contact with the underside of the undercut joint block. This undercut is immediately adjacent to the proposed pool. See **Section 13** for recommendations regarding this undercut. The W location is undercut ~1.5m, has a

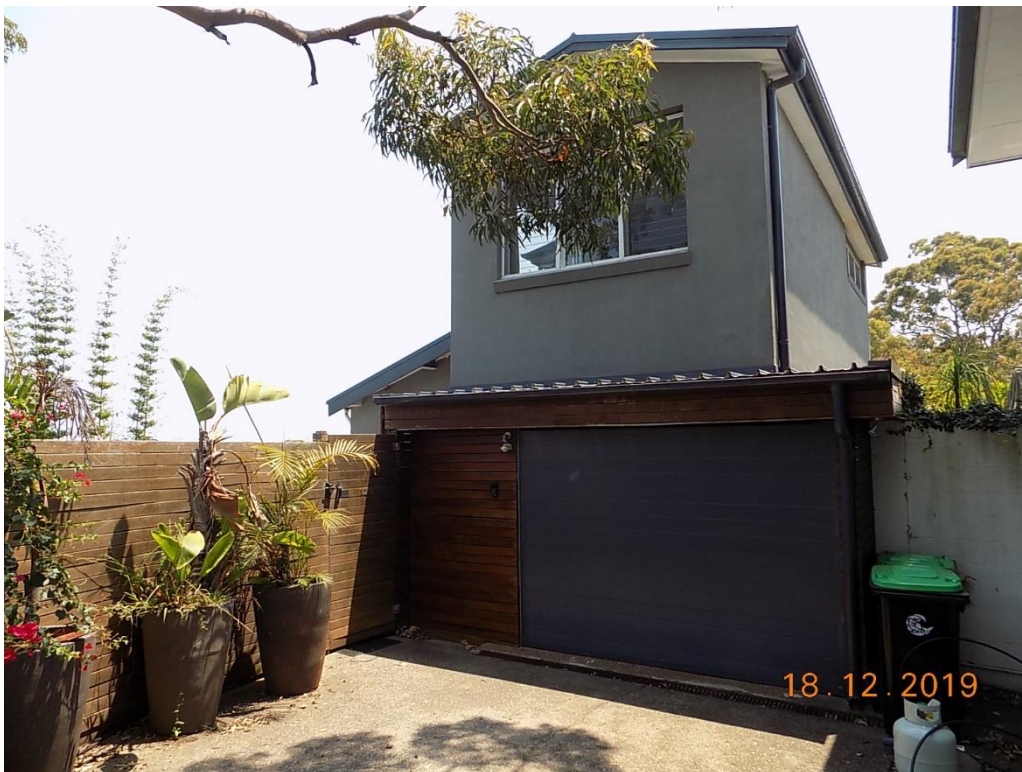
Photo 2

relatively thick cantilever arm in relation to its overhang length, and displays no signs of cracking through the cantilever arm as viewed from above or below (Photo 6). Thus, it is considered stable. The part three-storey brick house is supported on brick walls (Photo 2). No significant signs of movement were observed in the supporting brick walls. Some of the supporting walls were observed to be supported directly off outcropping sandstone.

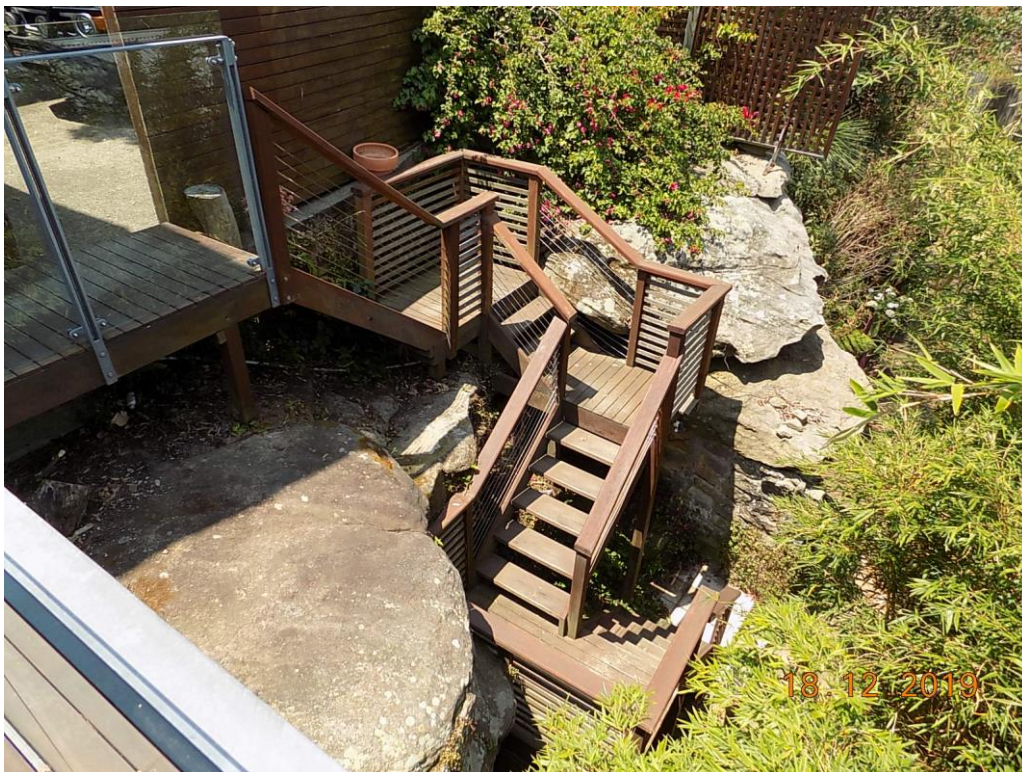
Photo 4

As Medium Strength Sandstone was observed to be outcropping across the location of the proposed pool, no subsurface investigation was undertaken (Photo 4).

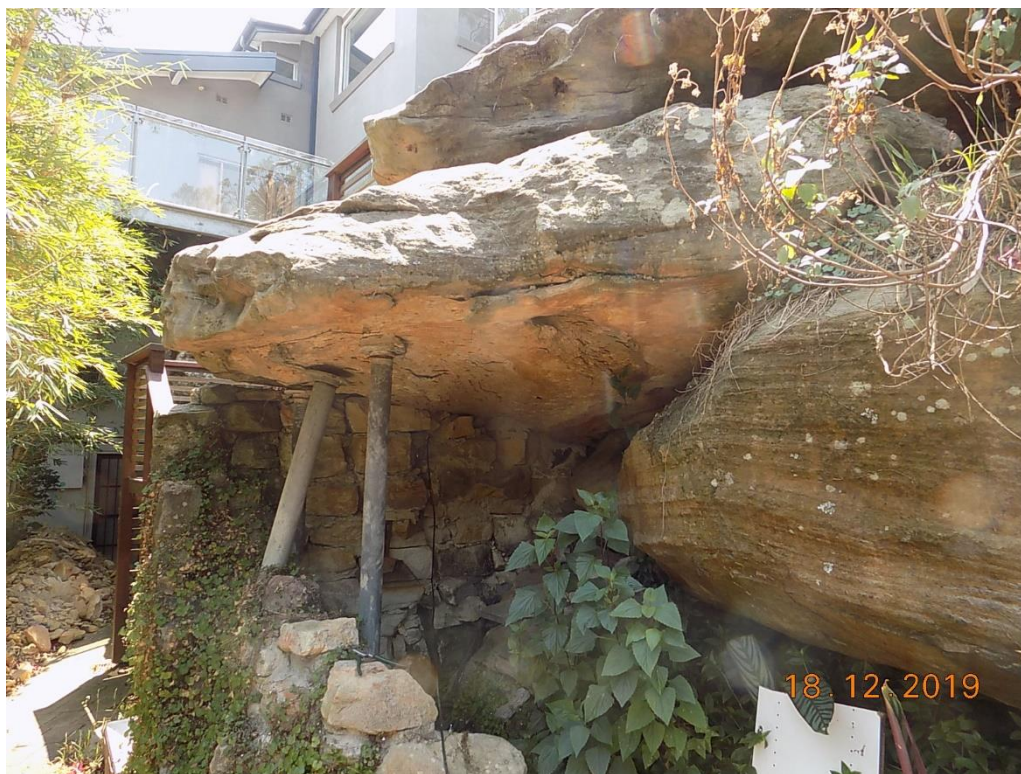
Photo 5

| HAZARDS | Hazard One |
|---|---|
| TYPE | The construction of the proposed pool impacting on the undercut cliff face causing failure (Photos 5 & 6). |

See the site plan attached showing the location of each undercut joint block. The E undercut joint block is undercut ~2.0m and has a relatively thin cantilever arm in relation to its overhang length (Photo 5). The undercut has been supported in the past with three steel posts and a rough, stack rock blade wall. Only one of the steel posts still makes contact with the underside of the undercut joint block.

It is recommended that two spaced blade walls be installed to support the overhanging joint block. This work is to be carried out before the construction of the pool commences. The blade walls are to be a minimum of 0.4m wide and are to be supported on foundations taken to rock. The top of the wall is to be in full contact with the underside of the undercut rock so non-shrink grout will be required to achieve this. The blade walls are to be designed by the Structural Engineer in consultation with Geotechnical Consultant.

Once the walls are in place, the tip of the undercut joint block may then be sawn off to not further back than the line of the joint block above (downhill edge of the rock above) and picked out without the use of pneumatic hammers.

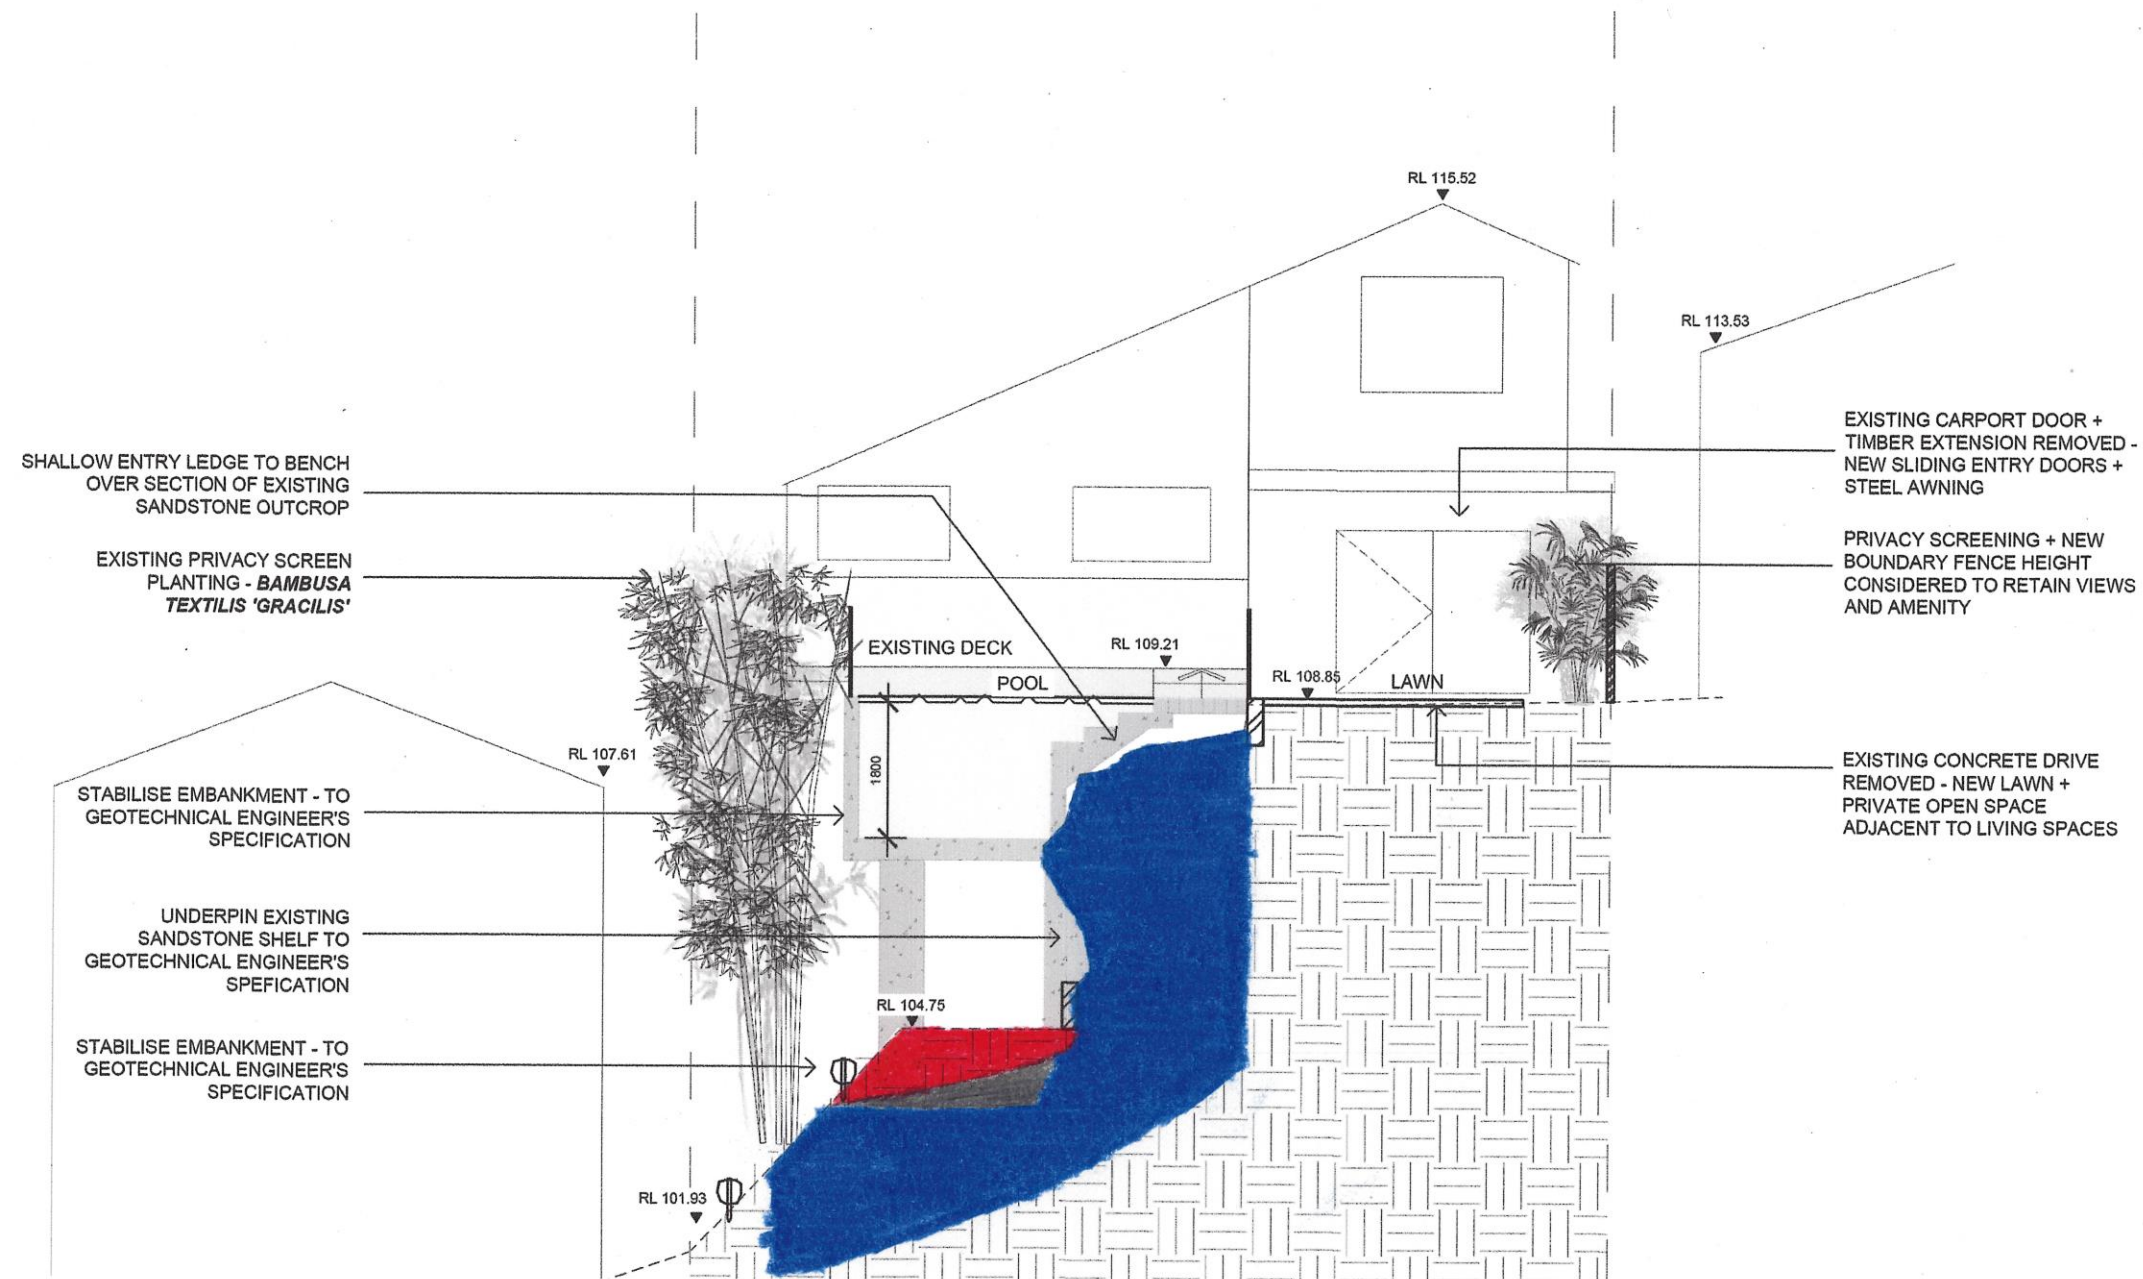
# TYPE SECTION – Diagrammatical Interpretation of expected Ground Materials

The surface features of the block are controlled by the outcropping and underlying sandstone bedrock that steps down the property forming sub-horizontal benches between the steps. Where the grade is steeper, the steps are larger, and the benches narrower. Where the slope eases, the opposite is true. The rock is typically overlain by sandy soils and firm to stiff sandy clays that fill the bench-step formation. Medium Strength Sandstone was observed to be outcropping across the location of the proposed pool and, as sandstone bedrock was observed to be outcropping immediately downslope of the base of the cliff, is expected at a maximum depth of ~1.0m below the base of the cliff. See Type Section attached for a diagrammatical representation of the expected ground materials.

- Fill
- Sandy Soil
- Sandy Clay – Firm to Stiff
- Hawkesbury Sandstone – Medium Strength
