GEOTECHNICAL INVESTIGATION:

New Pool at 6B Trentwood Park, Avalon Beach

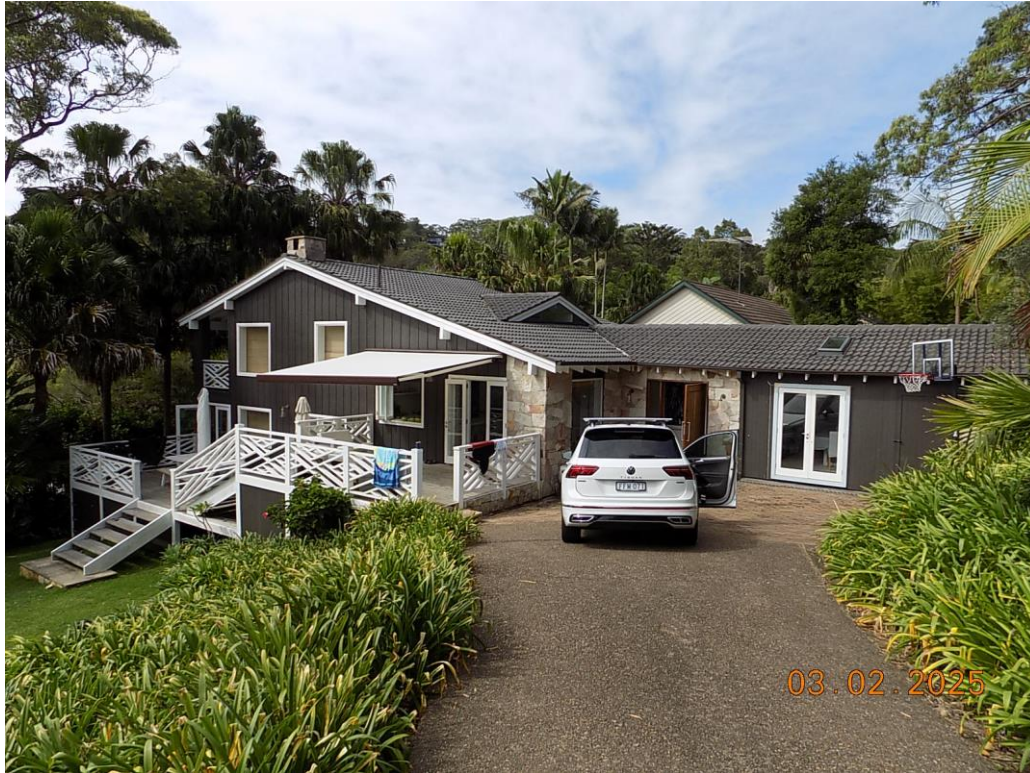
Photo 1

- 2.3** The property is accessed by a shared concrete driveway. The driveway continues to a brick parking area on the uphill side of the house (Photo 1). On the uphill side of the driveway, sandstone boulders were observed to be embedded in stable positions (Photo 2). A steeply graded fill batter provides a level platform for the driveway (Photo 3). The upper portion of the fill is densely vegetated and currently considered stable. The fill batter is supported at the base by two stable low sandstone flagging retaining walls which step up to a combined ~1.0m in height (Photo 4). These walls will be demolished as part of the proposed works. A cut for the

To prevent any damage or failure of the driveway during the proposed works it is recommended excavation spoil, construction materials and vehicles be sufficiently set back from the Zone of Influence of the excavation. In this case, vehicles on the driveway will need to be diverted a minimum of 5.0m from the edges of this excavation while the cut is open until the retaining structures are installed. The driveway is to be barricaded/taped off so no vehicles can go within the zone of influence of the cut until it is supported by retaining walls. See 'Swimming Pool Level' on the site plan attached for the minimum area of exclusion.

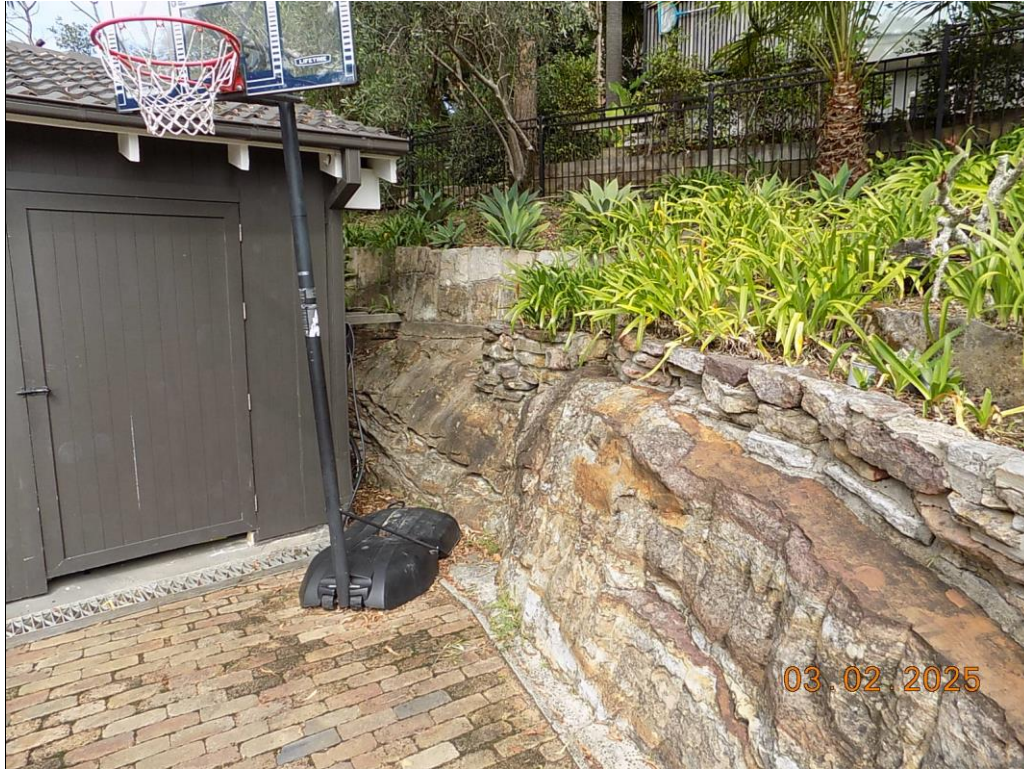
Photo 5

house on the uphill side has been taken through a thin band of Low to Medium Strength Sandstone which outcrops across the slope in this location (Photo 5). The observable portions of the rock face were seen to be free from significant geological defects that could affect its stability. The part two-story timber clad house is supported on brick walls and brick piers. No significant signs of movement were observed in the visible supporting walls, and the supporting piers stand vertical. Stable timber decking extends off the NE face off the house, the timber posts of the deck stand vertical (Photo 6).

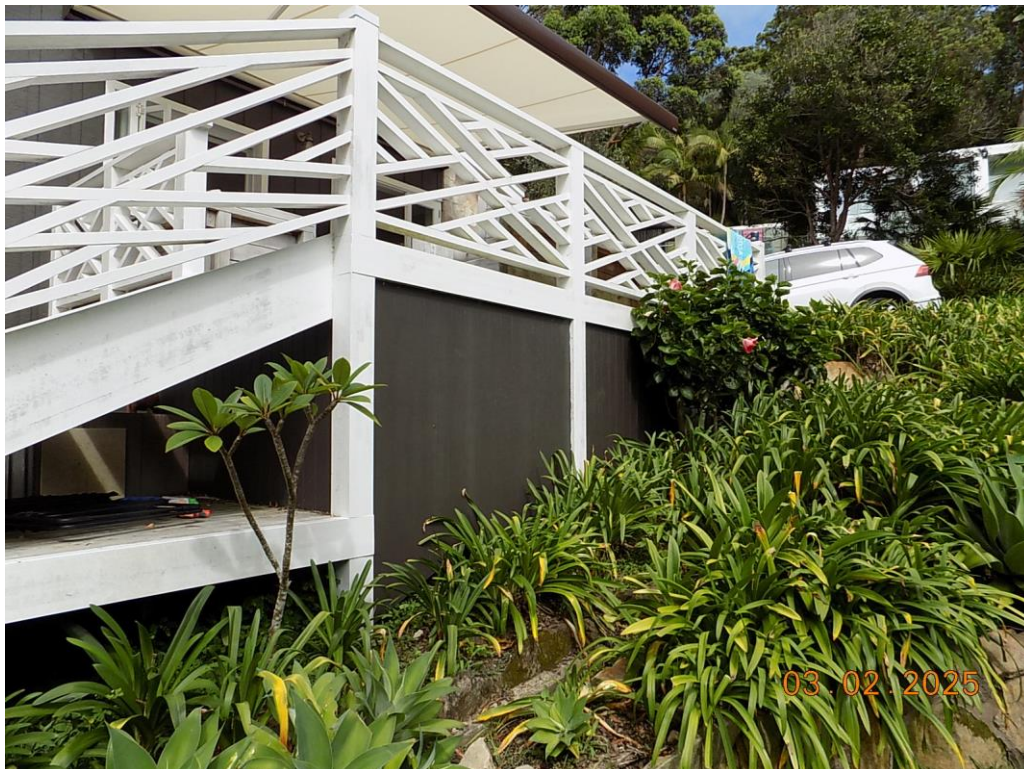
Photo 6

- ~0.6m from the supporting timber posts of the decking which extends off the NE side of the house (Photo 6)
- ~4.1m from the concrete driveway uphill from the proposed excavation (Photo 1).

As such, the supporting posts of the deck as well as a portion of the concrete driveway will lie within the zone of influence of the proposed excavation. In this instance, the zone of influence is the area above a theoretical 45° line (from horizontal) from the base of the excavation

Prior to the commencement of the excavation, the deck will need to be propped with the props supported beyond the zone of influence of the proposed excavation. Alternatively, the supporting posts of the deck can be underpinned to below the zone of influence of the cut prior to the excavation commencing. See the site plan attached for the minimum extent of the required propping/underpinning.

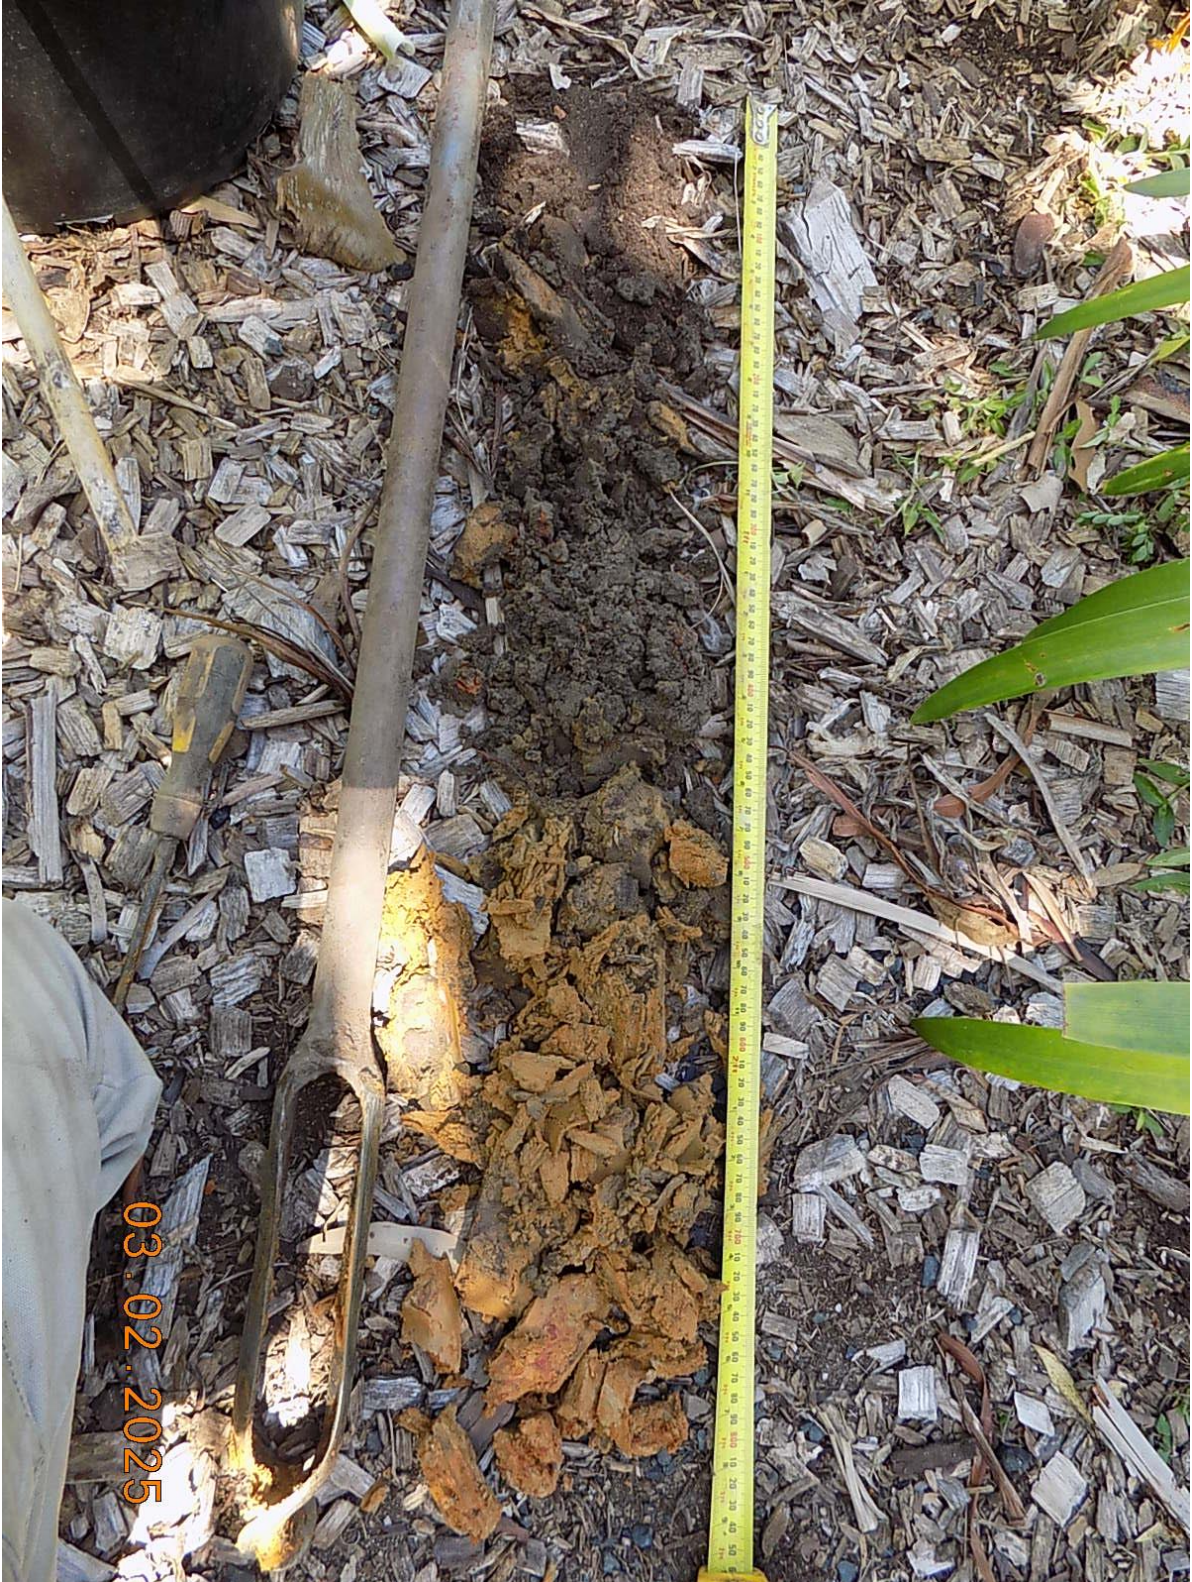
Photo 7 – AH1 – downhole is Top to Bottom

AUGER HOLE 1 (~RL30.6) – AH1 (Photo 7)

Depth (m)	Material Encountered
0.0 to 0.2	FILL , sandy clayey texture, derived from local natural material, dark brown, Medium Dense, dry, fine to medium grained.
0.2 to 0.5	TOPSOIL , clayey sandy texture, grey, Soft, dry, fine to medium grained.
0.5 to 0.8	SANDY CLAY , derived from weathered Extremely Low to Very Low Strength Rock, mottled orange, maroon and grey, Firm, dry.

End of test @ 0.8m in sandy clay. No water table encountered.

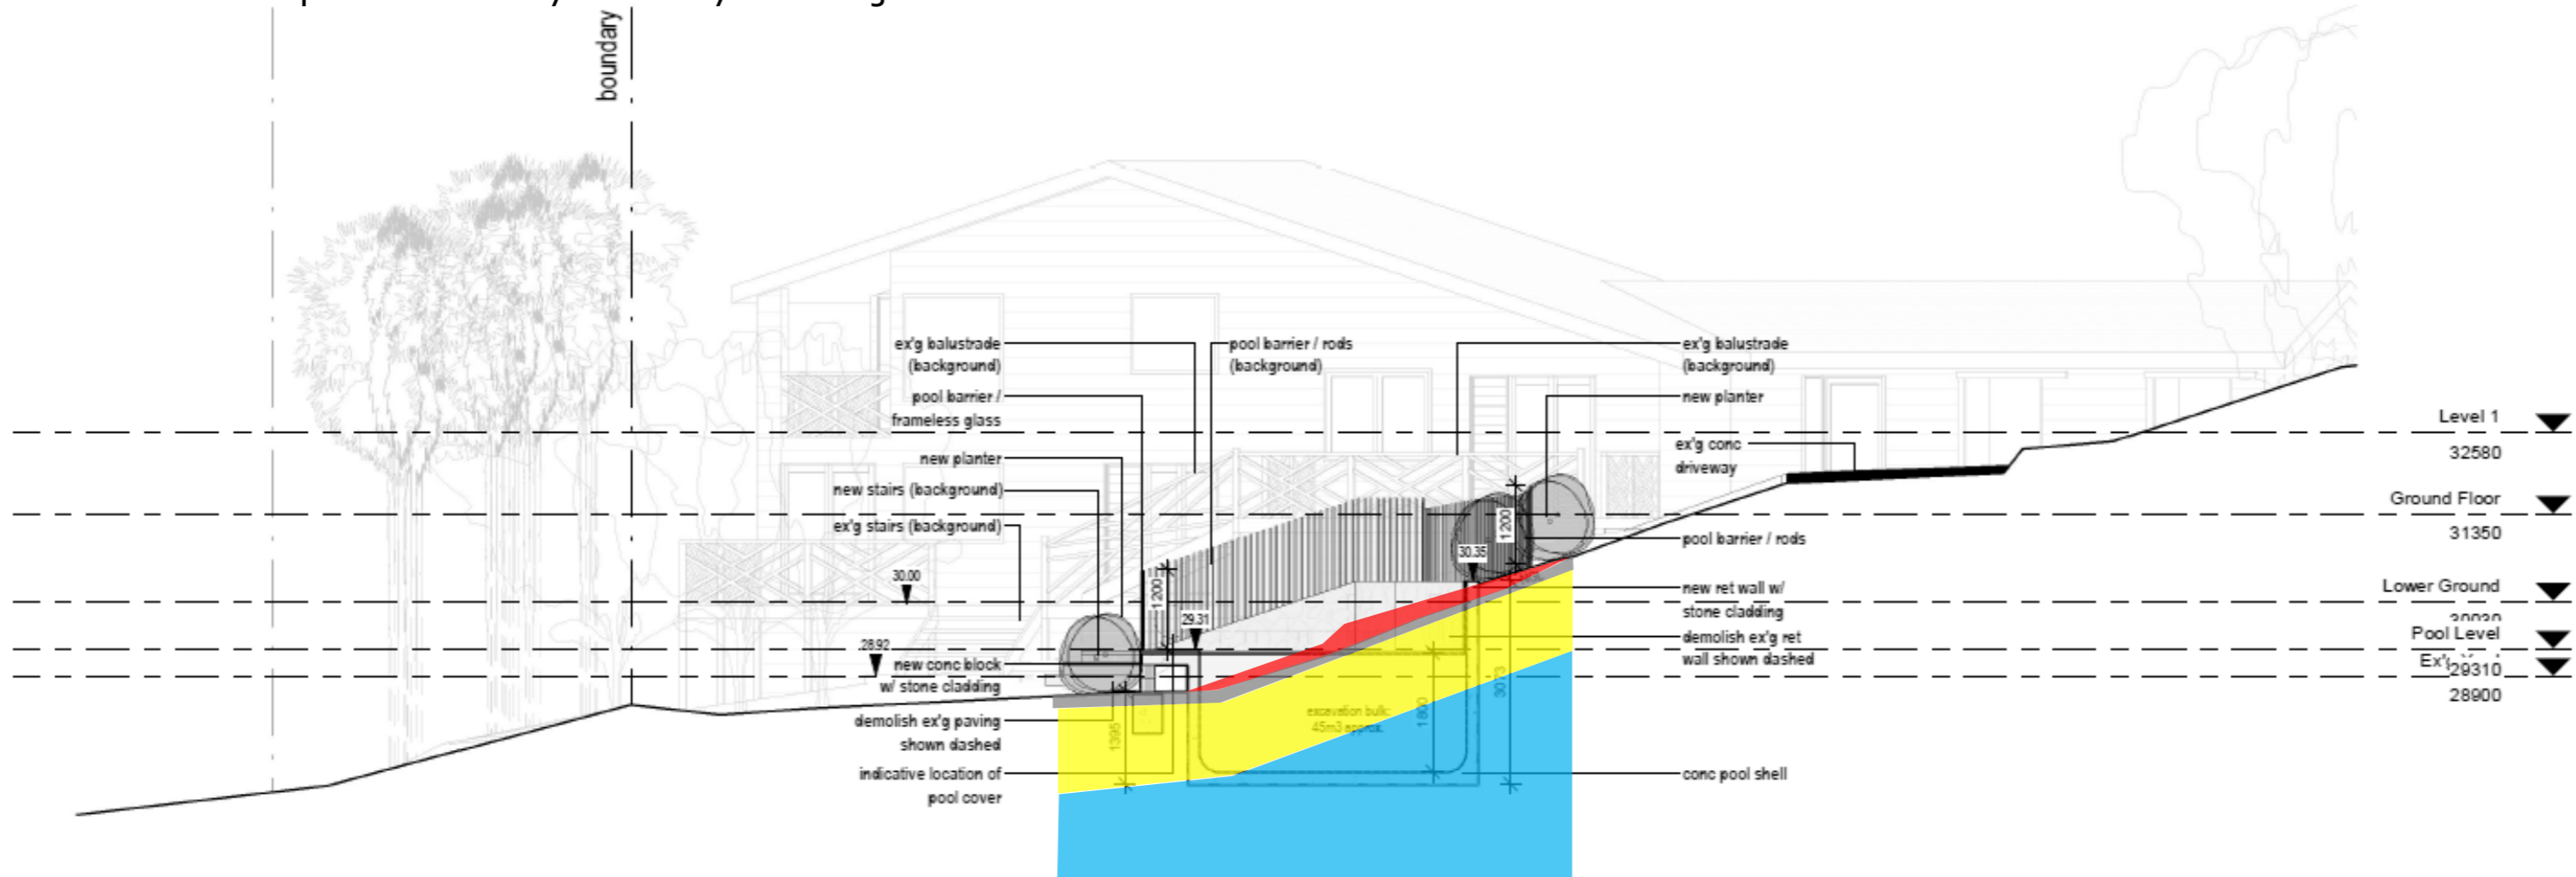
1 Section 1
1 : 100

The natural slope materials are colluvial at the near surface and residual at depth. In the location of the proposed works, the ground materials consist of shallow clayey soils over clays. Filling has been placed across the slope in the location of the proposed pool. The clays merge into the weathered zone of the underlying Extremely Low to Very Low Strength Rock at depths of ~1.4m to ~1.5m below the current surface, being deeper due to the presence of filling and a variable weathering profile. The weathered zone is interpreted as Extremely Low to Very Low Strength Rock. It is to be noted that this material can appear as a mottled stiff clay when it is cut up by excavation equipment. A band of sandstone immediately above the house can be seen outcropping through the otherwise shale-dominated profile. From our previous experience in the Narrabeen Group, it is likely any sandstone bands will be limited in thickness and extent but may be located below the footprint of the pool as 4 of the 5 tests in this location hit refusal indicating rock of Medium Strength or better. See Type Section attached for a diagrammatical representation of the expected ground materials.

Expected Ground Materials

- Fill
- Topsoil
- Clay
- Narrabeen Group Rocks – Extremely Low to Very Low Strength Rock or better
