GEOTECHNICAL RISK MANAGEMENT POLICY FOR PITTWATER FORM NO. 1 – To be submitted with Development Application

Development Application for Reform Projects Pty Ltd
Name of Applicant
Address of site 1102-1106 Barrenjoey Road, Palm Beach, NSW
Declaration made by geotechnical engineer or engineering geologist or coastal engineer (where applicable) as part of a geotechnical report
I, Jarett Mones on behalf of JK Geotechnics Pty Ltd
(Insert Name) (Trading or Company Name)
on this the 25 May 2022 certify that I am a geotechnical engineer or engineering geologist or coastal engineer as defined by the Geotechnical Risk Management Policy for Pittwater - 2009 and I am authorised by the above organisation/company to issue this document and to certify that the organisation/company has a current professional indemnity policy of at least \$10million.
l: Please mark appropriate box
have prepared the detailed Geotechnical Report referenced below in accordance with the Australia Geomechanics Society's Landslide Risk Management Guidelines (AGS 2007) and the Geotechnical Risk Management Policy for Pittwater - 2009 am willing to technically verify that the detailed Geotechnical Report referenced below ha

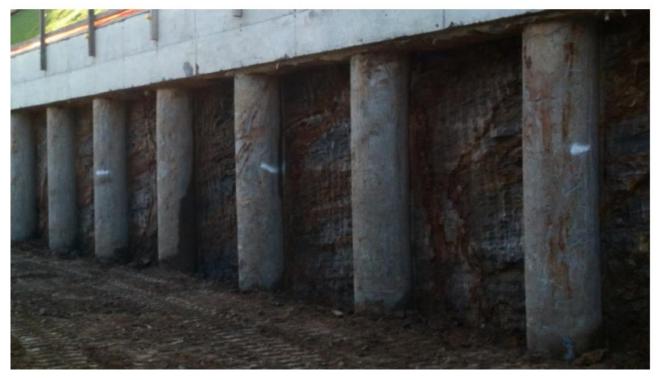
Plate 1: Photograph of Soldier Pile Wall Prior to being Shotcreted (Figure 3 from Witt Report)

The solider pile wall comprised 0.6m diameter piles spaced at about 2.5m, with mesh and shotcrete infill panels between piles. Over the lower about 0.8m to 0.9m mesh and shotcrete has not been placed and here the materials exposed were assessed to comprise moderately weathered siltstone of low to medium strength. Water seepage was observed in this face, both over the siltstone cut face and through the shotcrete panels. Some cracks varying from 'hairline' to 2mm in width were observed in the shotcrete panels but overall the soldier pile wall appeared to be in good condition. There was a concrete section about 1.1m high above the piles, which appeared to be the capping beam. Above the capping beam was about a 1m high mesh fence. The architectural section drawing by Mills Architecture & Interiors (Ref: Drawing No. DA.01) details the base of the soldier piles at RL-0.25m. We have extracted a photograph from the Witt geotechnical investigation report, as shown below in Plate 1, of the soldier pile wall prior to being shotcreted. It appears the portion below the capping beam comprises weathered rock.

Near the southern boundary, water seepage was observed below the boulder. Along the soldier pile wall, water seepage was observed both through the shotcrete and mesh panels and over the lower siltstone bedrock exposed in the cut face below the shotcrete and mesh.

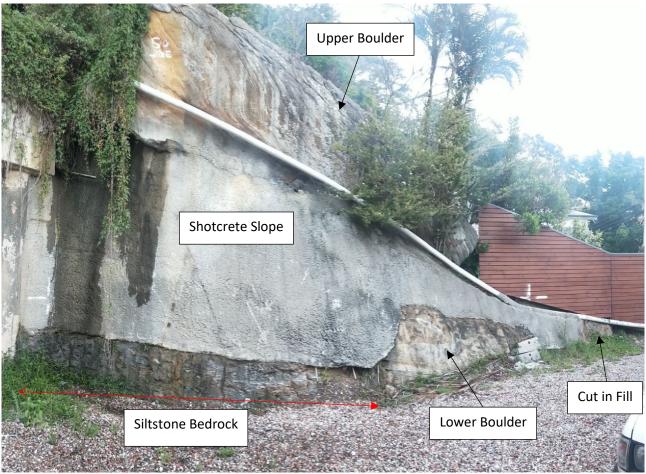
Plate 2: Photograph 1 of Large Boulders and Shotcreted Cut Face At/Near Southern Boundary (Facing South)

The below site description should be read in conjunction with Plate 2, which includes a photograph of the southern boundary area. Extending into the site near the southern boundary is a large sandstone boulder. This boulder is located in the upper portion of the profile and where excavation has extended below it the cut face has been protected with shotcrete. The boulder is approximately 2m to 3m high and extends for a length of about 7.5m. The shotcreted cut has a maximum height of approximately 3.5m and extends for a length of about 10.5m. The boulder overhangs the eastern end of the cut by about 1m to 1.5m over a length of 1.5m. Water seepage was observed below the boulder along the eastern 2m length of the shotcrete facing. A second sandstone boulder is exposed below the western end of the upper boulder. This boulder extends for a length of about 2.5m over the lower 0.7m to 1.3m of the cut. Between the eastern soldier pile wall and this lower boulder, siltstone bedrock was exposed below the shotcrete for a length of about 6m to 7m over the lower 0.8m of the cut. The siltstone bedrock was assessed to be moderately weathered and of low to medium strength. A 0.8m high vertical cut in fill was observed over a length 1m at the westernmost end of the southern cut.

The site is bound by residential development to the south, 1100 Barrenjoey Road, beyond the boundary. It appears that the upper boulder visible in the southern cut face extends an additional 2.5m to the south and overlies another large boulder that extended further to the south. This can be seen below in Plate 3. Beyond these boulders is a two-storey timber clad house. To the east of the site is a flat grass area (driveway) and then a single-storey shed. To the north is a one and two storey rendered building ('Barrenjoey House', which is heritage listed) while Barrenjoey Road bounds the site to the west. All adjoining structures appeared in good condition when viewed from the site.

- 7.1.3 Portions of the existing boulders and shotcrete (and possibly mesh and bolts) at the southern end of the site will be removed during excavation of the proposed excavation footprint. Excavation and removal of support will need to be completed with care so as not to de-stabilise the existing boulders or cause instability of the materials below the large boulder. We recommend that the boulders/cut be carefully excavated using a rock saw attachment supplemented with the use of a ripping tyne and/or rock breaker attachment to the tracked excavator. The use of rock saws and/or rock splitting techniques will provide a neat sub-vertical cut face and reduce vibrations which may otherwise cause an uncontrolled collapse over this portion of the site. The materials on which the boulder is founded currently provides support to the boulder and prevents it from rotating outwards. As part of the original excavation of this area of the site, support in the form of shotcrete has been installed. It is unclear whether mesh and soil nails were required to be installed to support this portion of the site. Consequently, care must be taken that excavation below the boulder does not destabilise it. In this regard excavation and the installation of support measures must completed in a carefully staged manner and may comprise the installation of a soil nail wall as the excavation progressively deepens. Further advice on provision of support for this section of the site should be sought from the geotechnical engineer during the design stage once there is a clearer understanding on the proposed retention system in this portion of the site.
