Report Title: Geotechnical Report 45 Hillcrest Avenue, Mona Vale  
Report Date: 27/1/21  
Author: BEN WHITE  
Author's Company/Organisation: WHITE GEOTECHNICAL GROUP PTY LTD

## **GEOTECHNICAL INVESTIGATION:**

New Pool and Landscaping at **45 Hillcrest Avenue, Mona Vale**

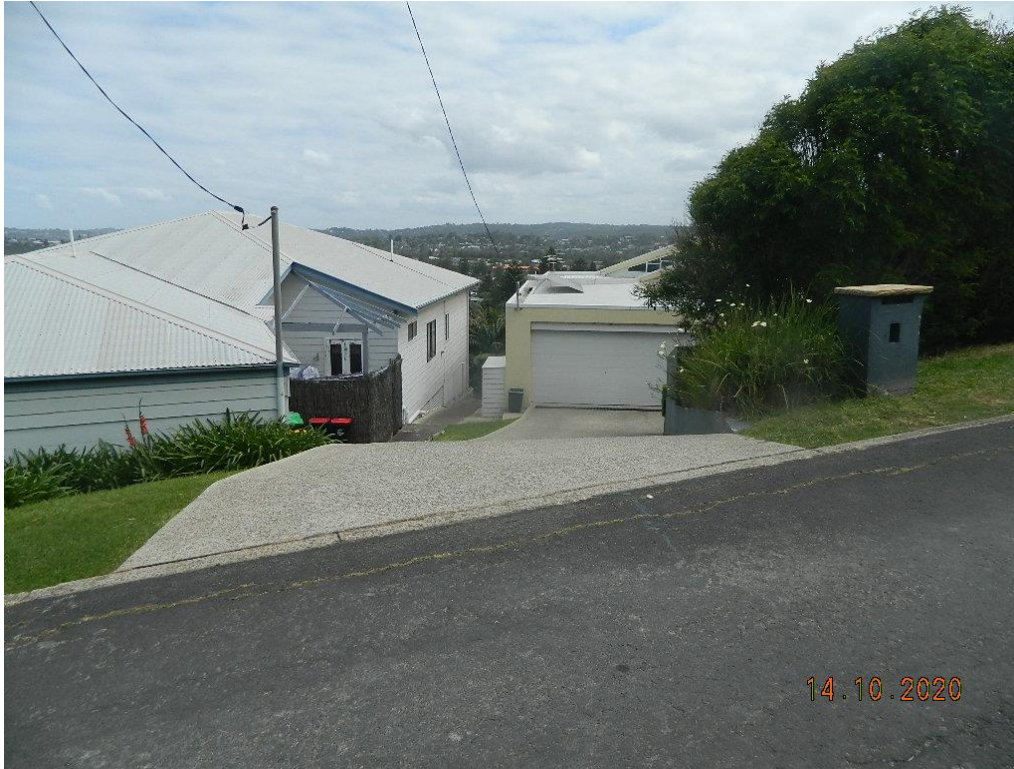
Photo 1

- 2.3** At the road frontage a concrete driveway runs down the slope to a garage attached to the house (Photos 1 & 2). Between the road frontage and the house is a garden area. The fill for the garden area is supported by a low rendered masonry retaining wall. The part two storey rendered house is supported by rendered walls (Photos 2 & 3). The external supporting walls show no significant signs of movement. The cut on the N side of the house is supported by a low sandstone flagging retaining wall and a stable sandstone block retaining wall up to ~1.6m high (Photo 4). Fill provides level lawn areas on the downhill side of the house (Photos 5 & 6). The fill is

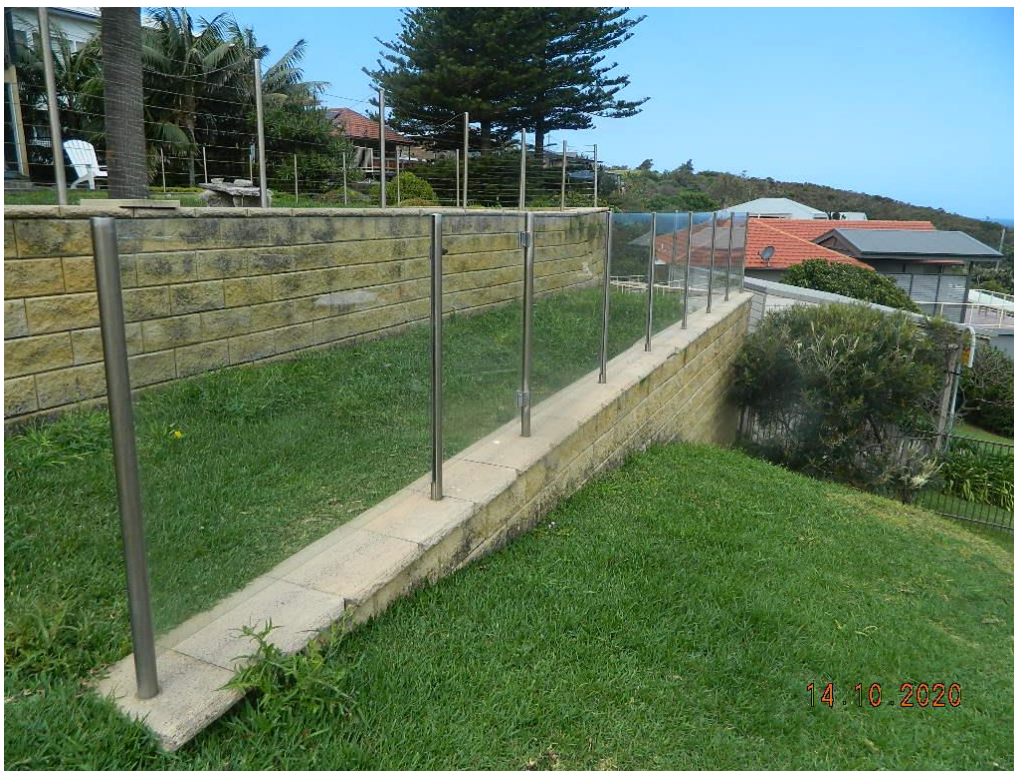
Photo 6

supported by keystone retaining walls up to ~3.6m high. The upper wall near the S corner of the fill displays stepped movement of the keystone blocks and the lower wall near the S corner displays minor settlement and cracking through the blocks (Photos 7 to 9). See '**Section 17** Ongoing Maintenance'. The fill extends downhill of the lower retaining wall on the NW side and is battered at stable angles. A gently sloping lawn extends from below the fill to the downhill property boundary (Photo 10). The adjoining neighbouring properties were observed to be in good order as seen from the street and subject property.

No geotechnical hazards were observed beside the property. The gentle to moderately graded slope that falls across the property and continues above and below is a potential hazard (**Hazard One**). The proposed excavation for the pool undercutting the NW portion of the lower keystone retaining wall (Photo 6) is a potential hazard (**Hazard Two**).

If Medium Strength Rock or better is encountered, excavations through Medium Strength Rock or better should be carried out to minimise the potential to cause vibration damage to the subject keystone retaining walls (Photo 6) and neighbouring pool to the NW. The excavation is set back ~0.5m from the lower keystone retaining wall, ~3.0, from the upper

The keystone retaining walls (Photos 6 to 9) are to be monitored by the owners on an annual basis. A photographic record of these inspections is to be kept. Should further movement occur the walls are to be remediated so they meet current engineering standards. We can carry out these inspections upon request.

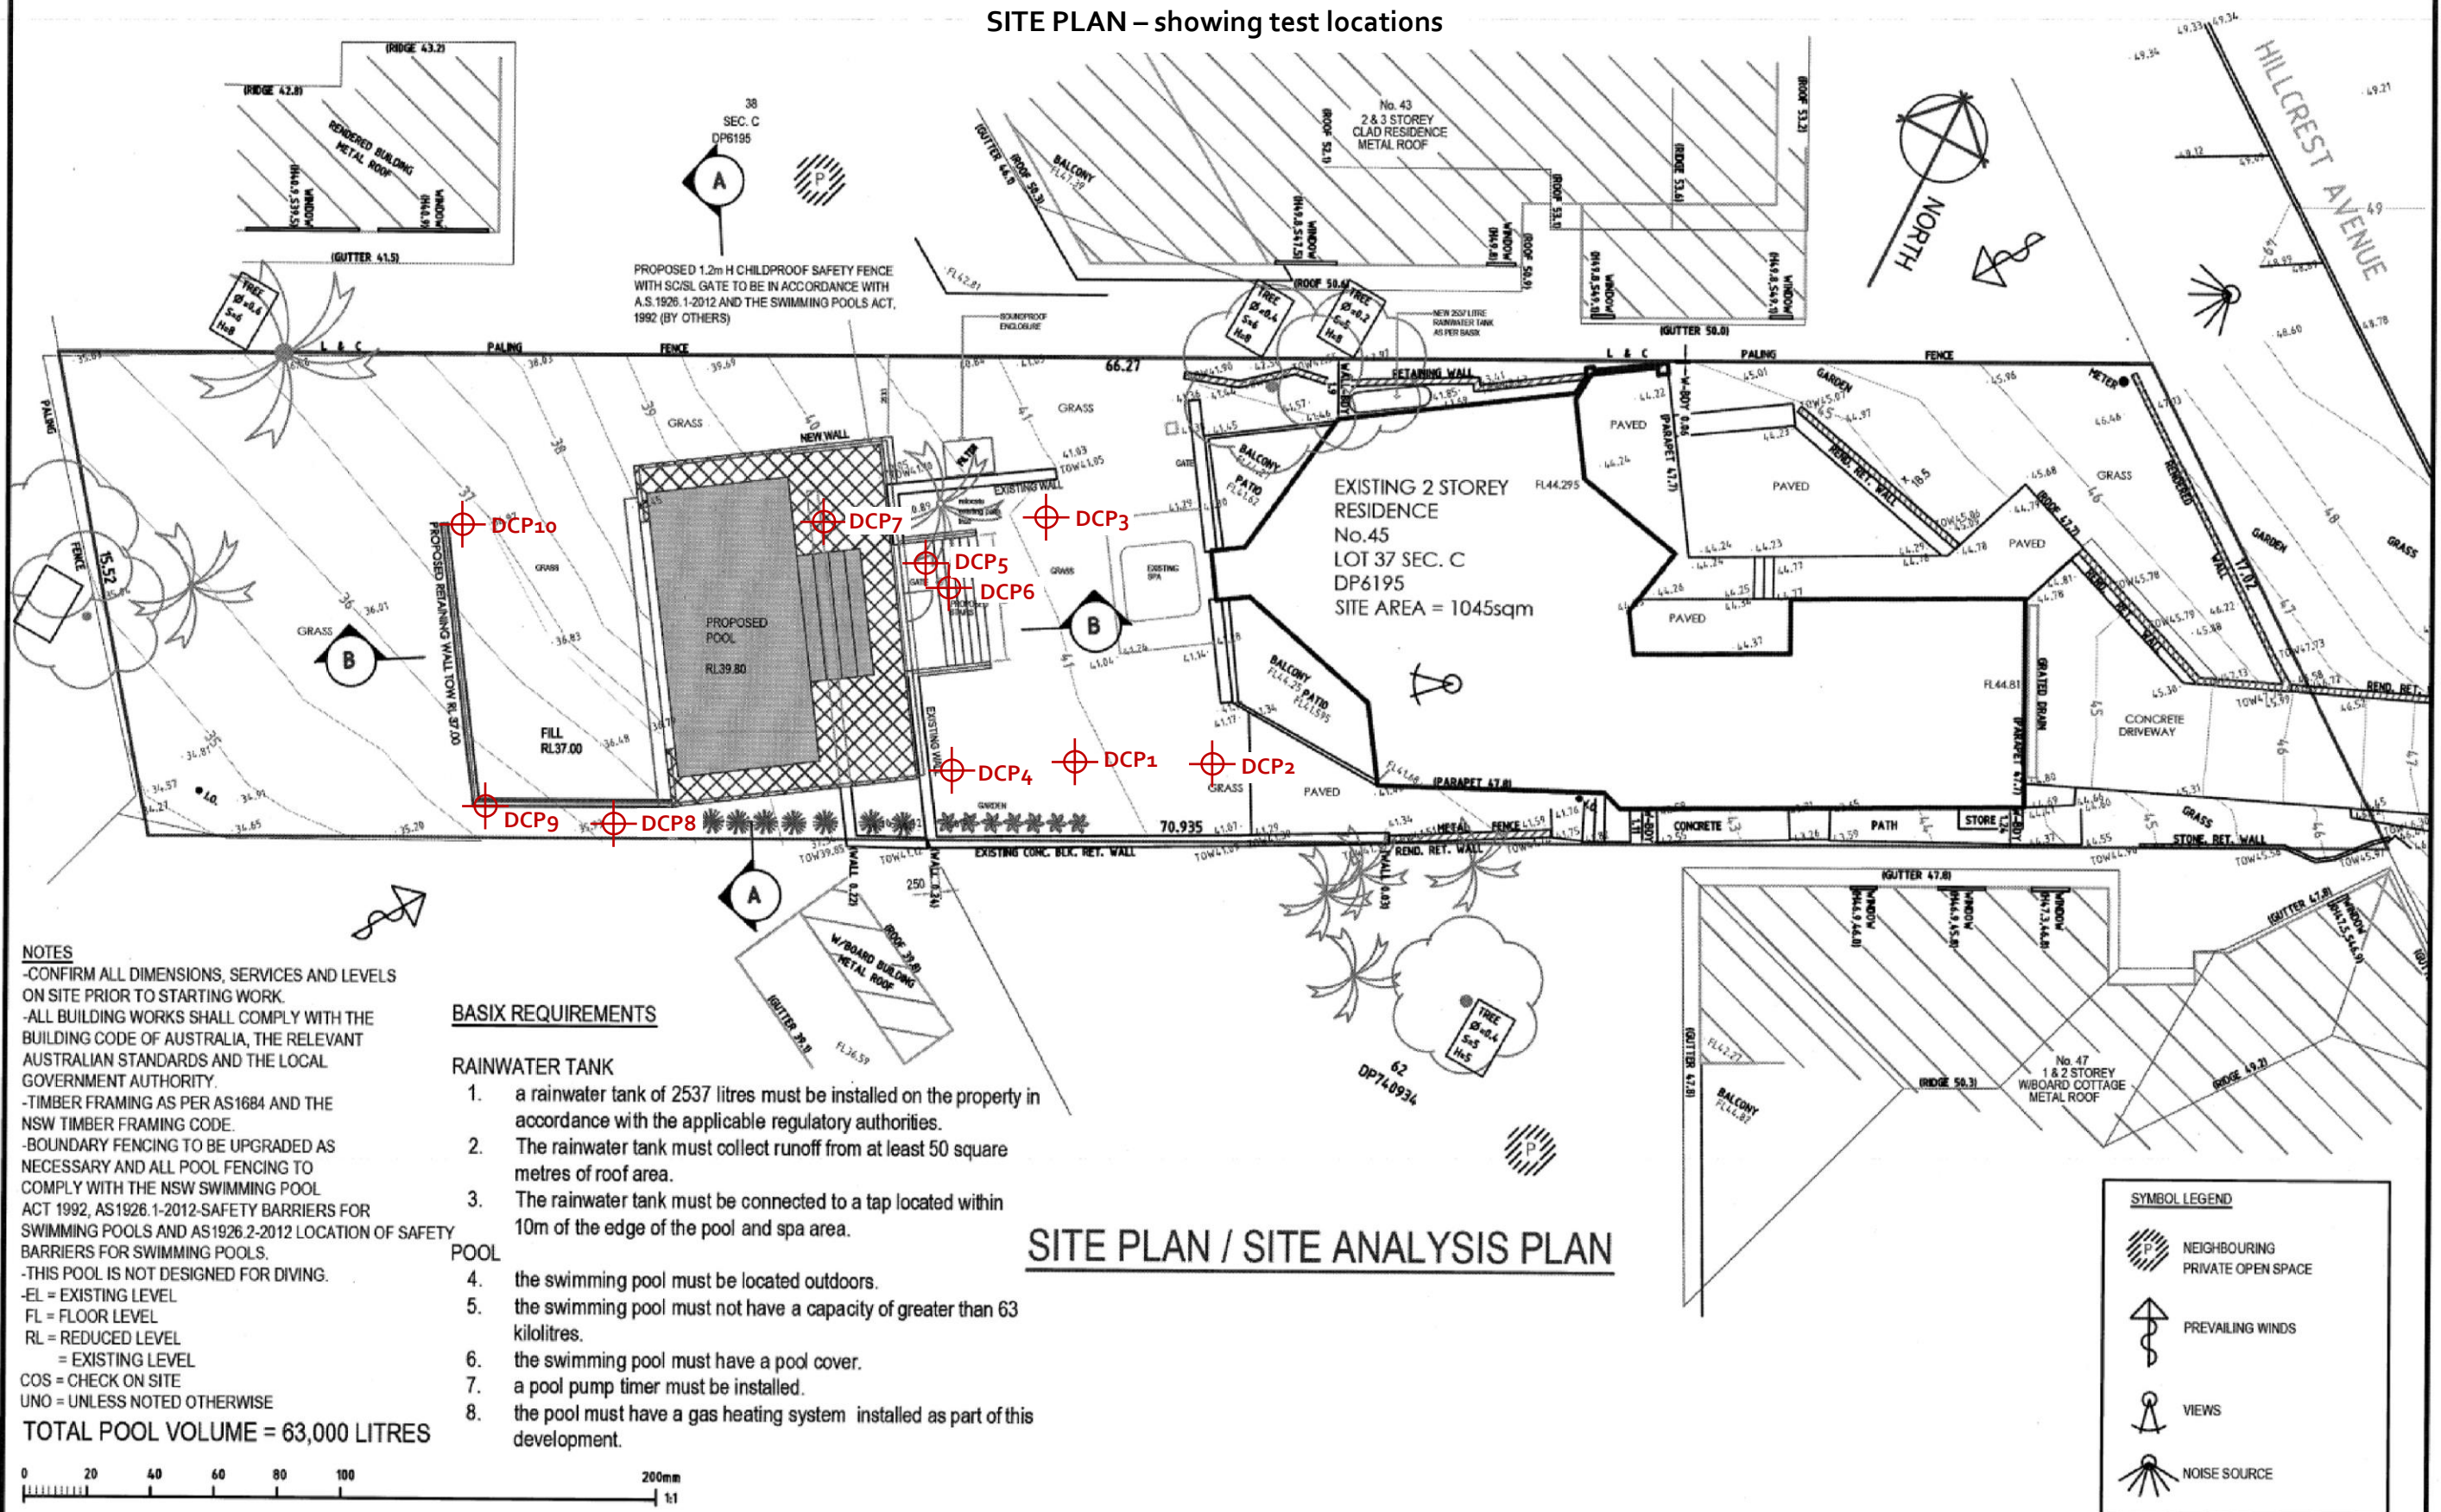
# SITE PLAN – showing test locations

Ten Dynamic Cone Penetrometer (DCP) tests were put down to determine the relative density of the overlying soil and the depth to weathered rock. The locations of the tests are shown on the site plan. It should be noted that a level of caution should be applied when interpreting DCP test results. The test will not pass through hard buried objects so in some instances it can be difficult to determine whether refusal has occurred on an obstruction in the profile or on the natural rock surface. This may have occurred for DCP5. Due to the possibility that the actual ground conditions vary from our interpretation there should be allowances in the excavation and foundation budget to account for this. We refer to the appended "Important Information about Your Report" to further clarify. The results are as follows:

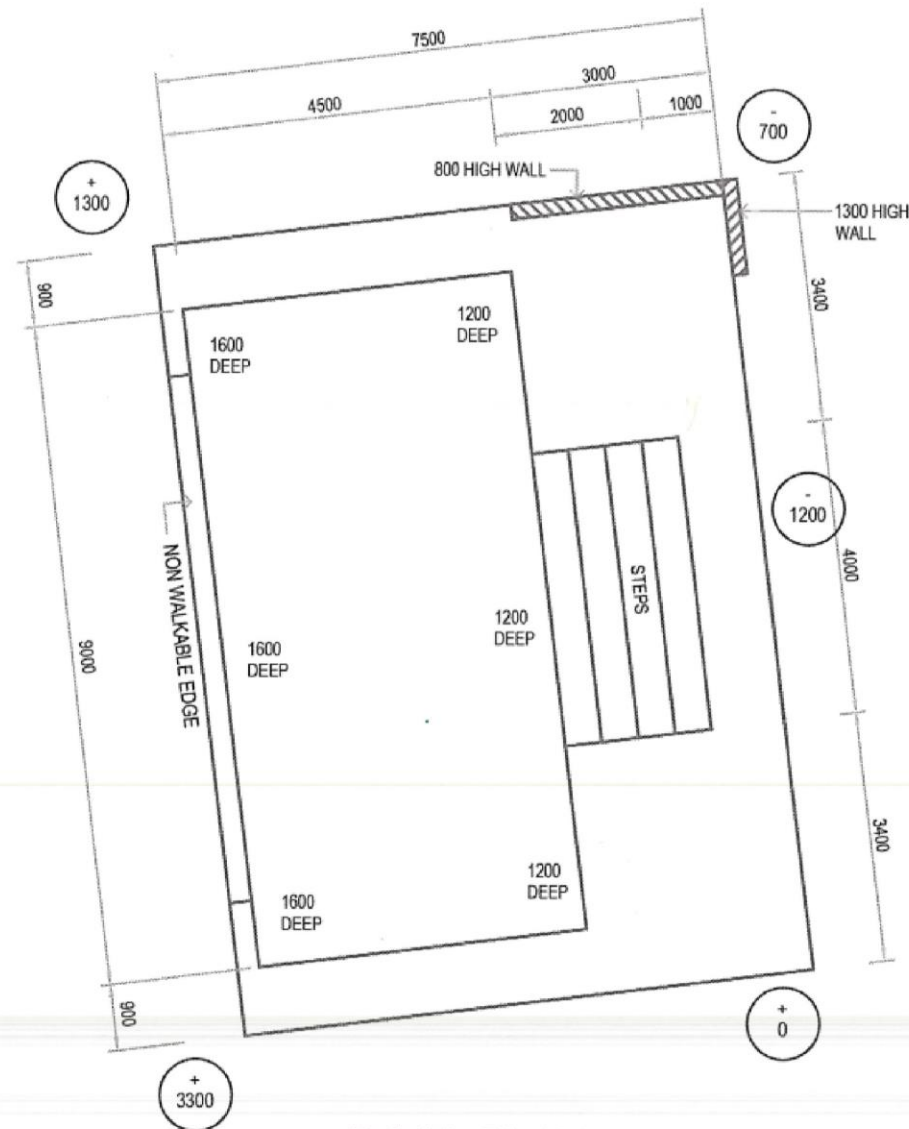
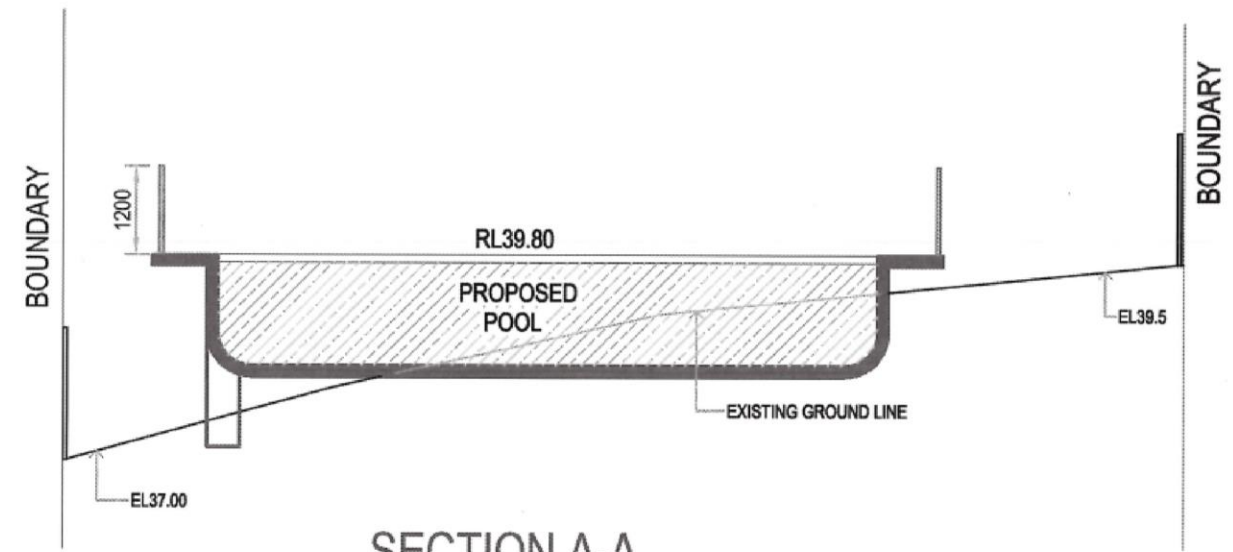
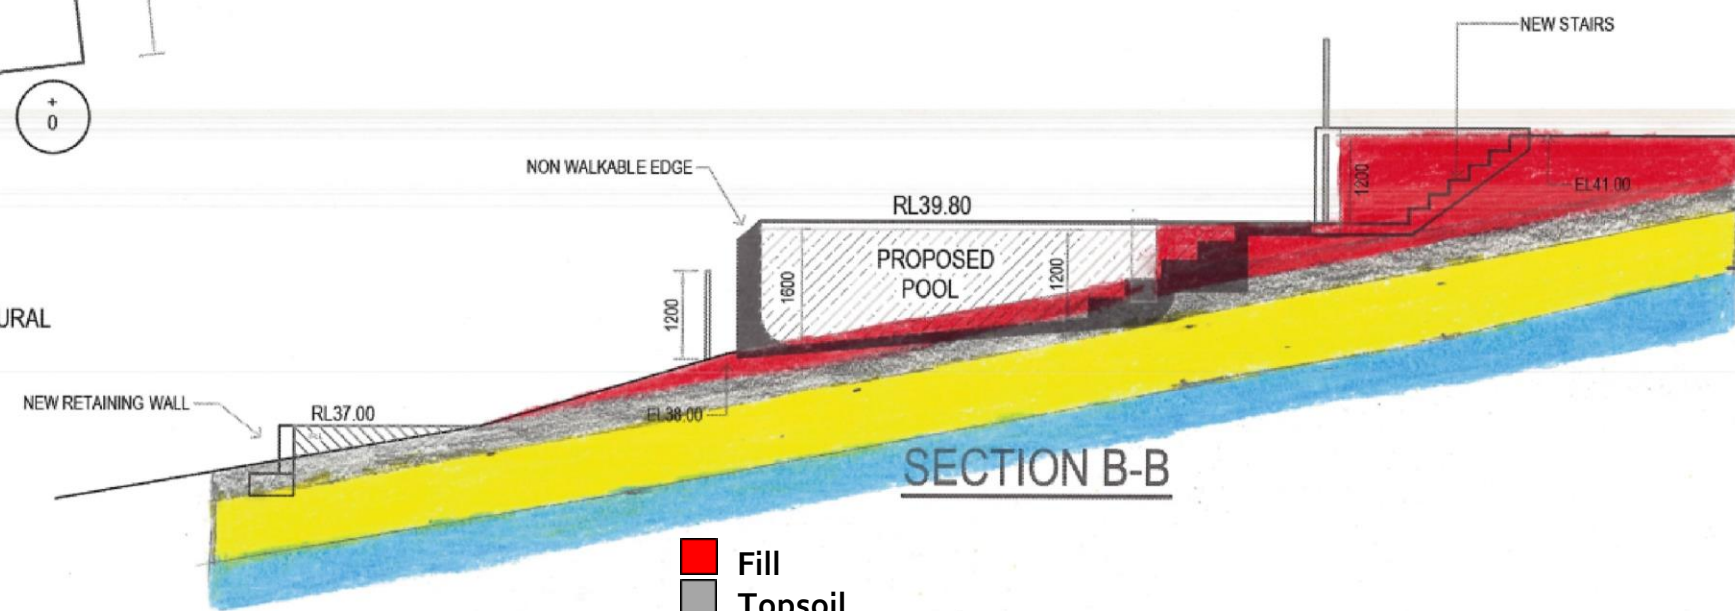
# TYPE SECTION – Diagrammatical Interpretation of expected Ground Materials

The slope materials are colluvial at the near surface and residual at depth. In the test locations, the ground materials consist of fill and sandy soil over sandy clays. Fill has been placed to form level lawn areas on the downhill side of the house. The clays merge into the weathered zone of the under lying rocks at depths of between 1.0m to 2.9m below the current surface, being deeper in the filled areas. The weathered zone of the underlying rock is interpreted as Extremely Low to Low Strength Rock. It is to be noted that this material is a soft rock and can appear as a mottled stiff clay when it is cut up by excavation equipment. See Type Section attached for a diagrammatical representation of the expected ground materials.
