Arboricultural Impact Assessment

252 Hudson Parade Clareville

Prepared by Alex Austin

April 2023

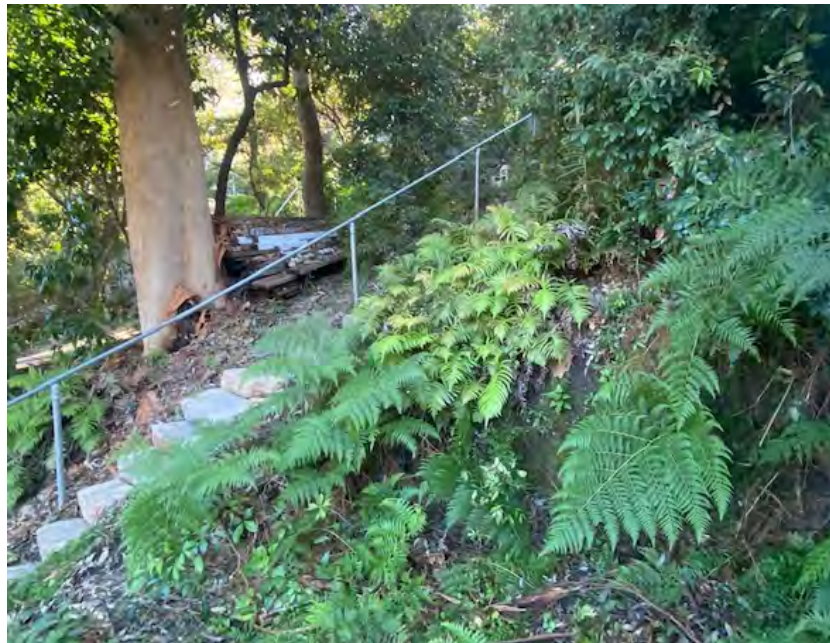
Tree 37 *Angophora costata* (Sydney Red Gum) is a large tree with High Landscape Significance located in the neighbouring property of 250 Hudson Parade at the northern end of the site. The tree has good health and average structure. The tree has a 9.36m TPZ and a 3.14m SRZ. Observations included; Crossing/rubbing branches (Large rubbing branch with significant flattening), Deadwood > 60mm, Mechanical damage (Pile of timber against trunk), Sap exudation.

Figure 9: The steps on the subject site are next to the trunk of tree 37 and the timber pile at the base of the tree that should be moved can be observed. (Source: Austin 27th July 2022)

Recommendations included; Move timber pile at base away from trunk and Prune the large rubbing branch - Remove top side branch back to collar.

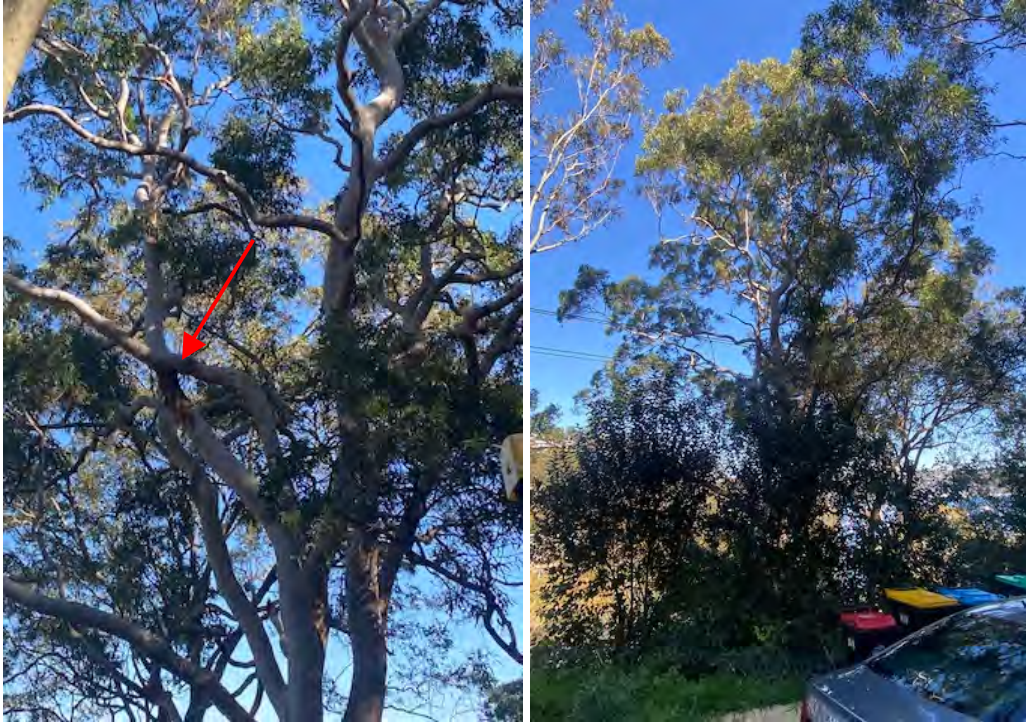
Figures 10 & 11: The large rubbing branch in tree 37 overhanging the site (Left) and the canopy of tree 37 when viewed from the street. (Right). (Source: Austin 27th July 2022)

Recommendations included; Move timber pile at base away from trunk and Prune the large rubbing branch - Remove top side branch back to collar.

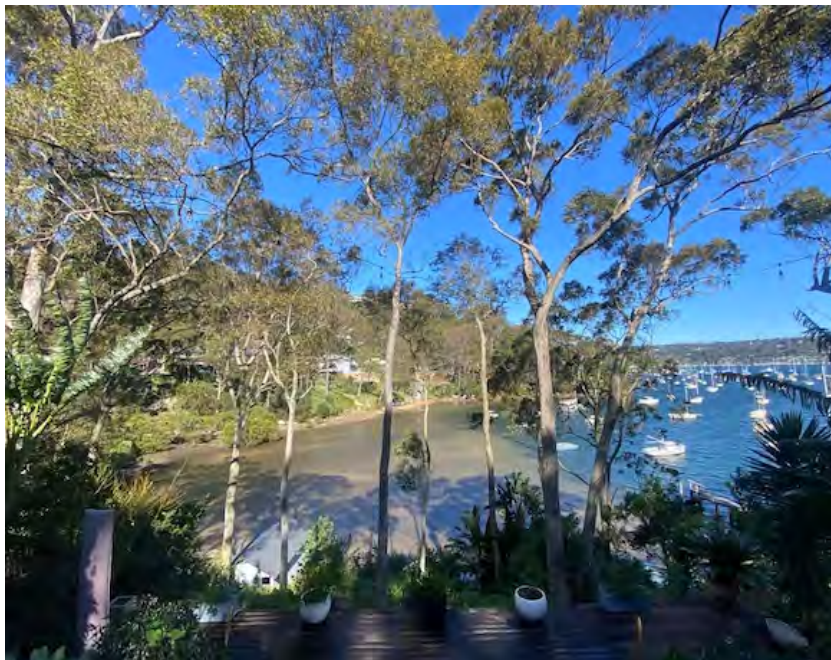
Trees 40 – 48 *Corymbia maculata* (Spotted gums) are located on the water front and have intertwining canopies. Trees 40, 45, 46 & 48 are of A retention value and the remainder of the trees in this area received a B retention value. Trees 40 & 48 are located on neighbouring properties.

Figure 12: Trees 40 - 48 *Corymbia maculata* (Spotted gums) are located on the waterfront. (Source: Austin 27th July 2022)

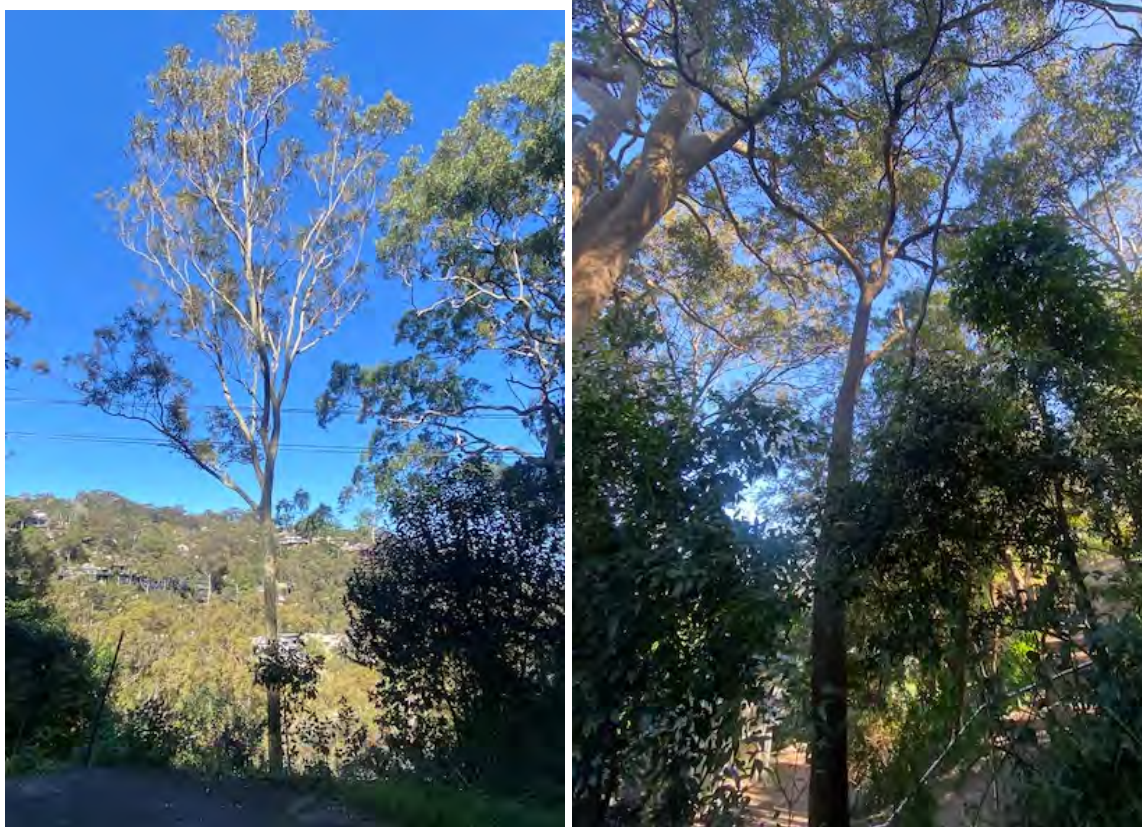
Tree 35 *Corymbia maculata* (Spotted gum) that has average health and good structure. The tree has a 4.3m TPZ and 2.3m SRZ. Observations included Deadwood < 30mm, Dieback that resulted in the average health allocation and B Retention Value. The tree is located in the middle of the Hudson Parade end of the site and provides considerable constraint for any proposed development.

Figures 13 & 14: Tree 35 in the landscape (Left) and tree 36 located in the neighbouring property of 250 Hudson Parade. (Source: Austin 27th July 2022)

Tree 36 *Eucalyptus globoides* (White Stringybark) is a medium sized tree located in the neighbouring property of 250 Hudson Parade at the northern end of the site. The tree has good health and average structure. The tree has a 3.6m TPZ and a 2.1m SRZ. Observations included; Deadwood > 60mm, Suppressed. Recommendations include; Remove deadwood over phone line. Move timber pile at base away from trunk.

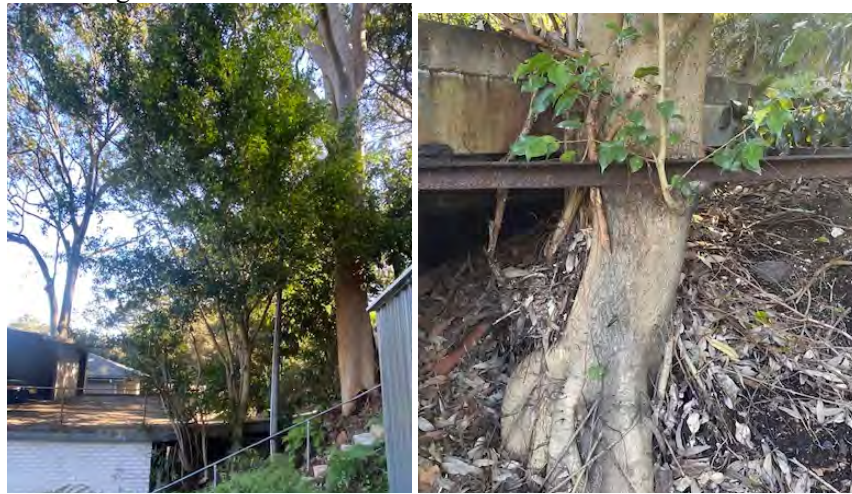
Tree 38 *Ficus benjamina* (Weeping Fig) is a small tree at the base of Tree 37 located on the neighbouring property of 250 Hudson Parade with good health and poor structure. Observations included Co-dominant stems, Inappropriate location, Infrastructure contact to the driveway supports. This tree is an exempt species that should be considered for removal as it is likely to cause damage to the neighbours property. The TPZ of Tree 37 extends far beyond that of Tree 38 and any analysis of Tree 37 covers impacts to Tree 38. The condition of this tree should be discussed with the neighbour.

Figures 17 & 18: Tree 38 in the landscape (Left) and the contact between the trunk and the neighbours driveway supports. (Right). (Source: Austin 27th July 2022)

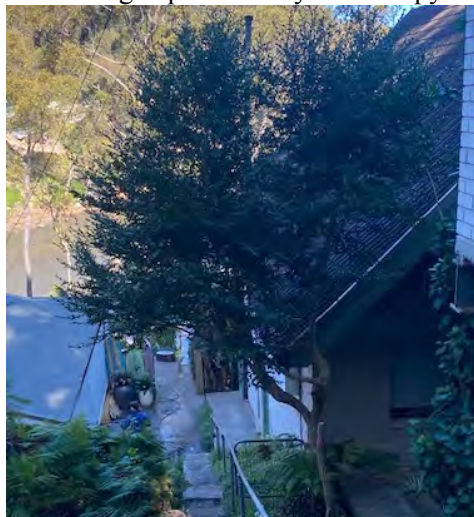
Tree 39 *Camellia sasanqua* (Camellia) is a small tree located on the neighbouring property of 250 Hudson Parade next to the steps on the subject site. The canopy overhangs the subject site access steps and considerable screening is provided by the canopy.

Figure 19: Tree 39 *Camellia sasanqua* (Camellia) can be observed. (Source: Austin 27th July 2022)

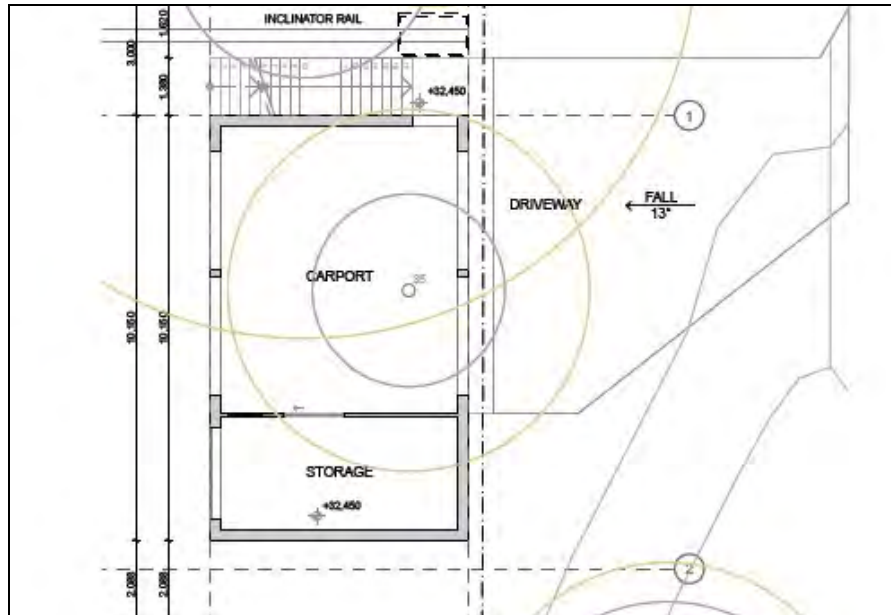
Tree 35 *Corymbia maculata* (Spotted gum) is a B retention Value tree that conflicts with the proposed carport footprint. Tree 35 requires removal to facilitate the project as no alternatives for redesign of a garage and driveway were possible due to the significant site constraints.

Figure 22: The proposed carport plan showing TPZ and SRZ of Tree 35 conflicting with the location of the carport. (Source: Proposed Plans by ANNE ROBSON ARCHITECTURE PTY LTD dated 29/03/2023)

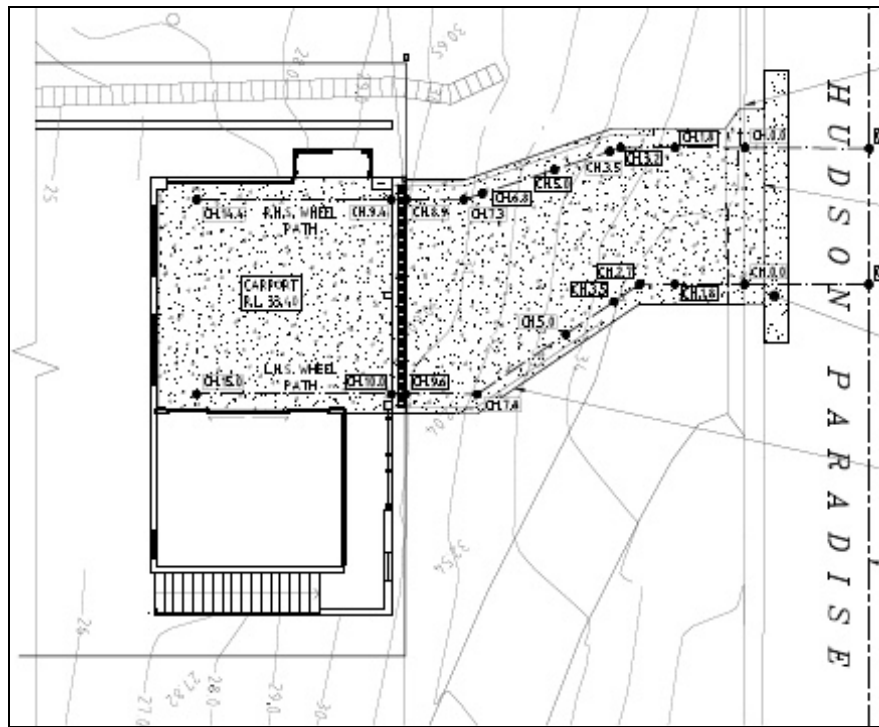
Figure 23: The proposed driveway layout is restricted in its layout due to significant site constraints and conflicts with the location of Tree 35. (Source: Driveway Plan and Long Sections, by Taylor Consulting, dated 30th August 2022)

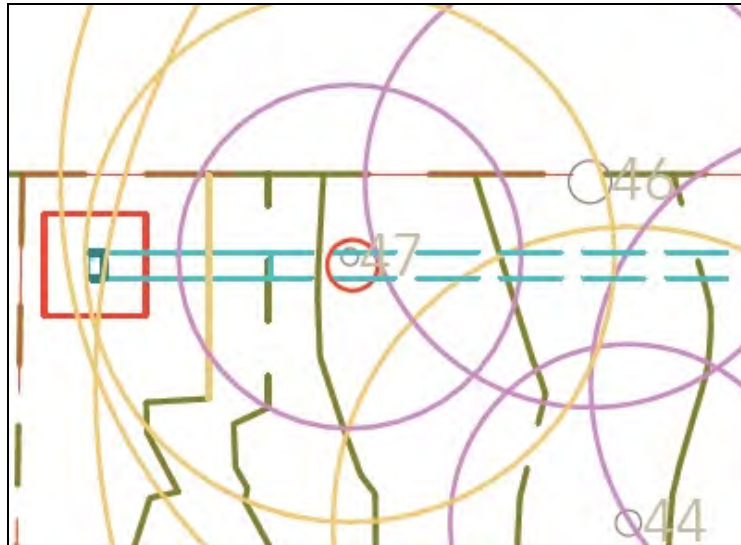
Tree 47 *Corymbia maculata* (Spotted gum) is a B retention Value tree that conflicts with the inclinator path. Considerable unsuccessful attempts were undertaken by the Architect and the Inclinator engineer to incorporate this tree within the design. Tree 47 requires removal to facilitate the inclinator path to the water level. .

Figure 22: The tree impact plan showing the conflict between Tree 47 and the proposed inclinator path and footing. (Source: Proposed Plans by ANNE ROBSON ARCHITECTURE PTY LTD dated 29/03/2023)

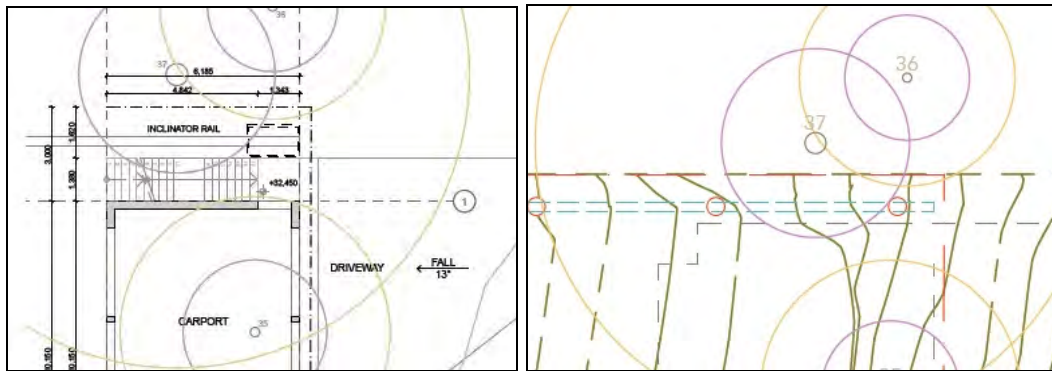
The tree has a 9.36m TPZ and a 3.14m SRZ. The works are outside the SRZ and at or above existing grade. No noticeable impact to the health of 37 is expected and the tree will remain viable during and post construction.

Figures 24 & 25: The proposed 8.72% encroachment into the TPZ of Trees numbered 36, 37 & 38 garage/granny flat (Left) and the inclinator pier locations outside the SRZ as well as the natural contours which result in minor excavation can be observed (Right). (Source: Proposed Plans by ANNE ROBSON ARCHITECTURE PTY LTD dated 29/03/2023)

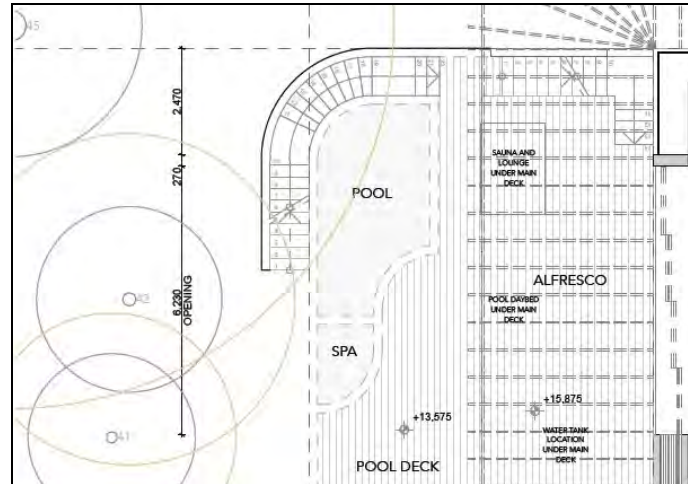
A Minor <10% encroachment is expected with the proposed pool into the TPZ's of Trees 42 & 45 *Corymbia maculata* (Spotted gums) at the waterfront end of the site. The proposed pool design has been created to minimize excavation in the TPZ's of Trees 42 & 45 to <10% of TPZ area. The proposed construction location result in minor excavation in the TPZ that will be tolerated by the trees. Pool surrounds are to be timber decks which provide air and water transfer to the soil providing good growing environment.

No noticeable impact to the health of Trees 41, 42 & 45 *Corymbia maculata* (Spotted gums) is expected and the tree will remain viable during and post construction if the protection measures in this report are adhered to .

Figure 26: The proposed location of the pool and minor TPZ encroachment to Tree 42 & 45. (Source: Proposed Plans by ANNE ROBSON ARCHITECTURE PTY LTD dated 29/03/2023)

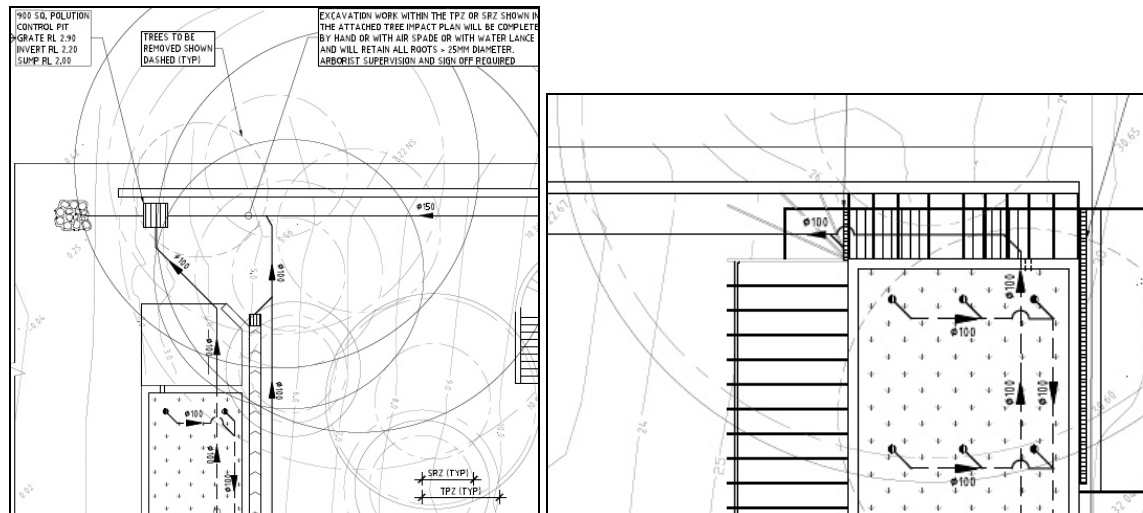
Storm water lines will need to be run above grade through the TPZs and SRZs of trees 36, 44, 45 & 46. Existing land shape requires minor hand excavation for installation.

Figures 27 & 28: The proposed location of the stormwater lines at the lower waterfront end of the site (Left) and at the carport (Right). (Source: Storm Water Plans, by Taylor Consulting, dated April 2023)

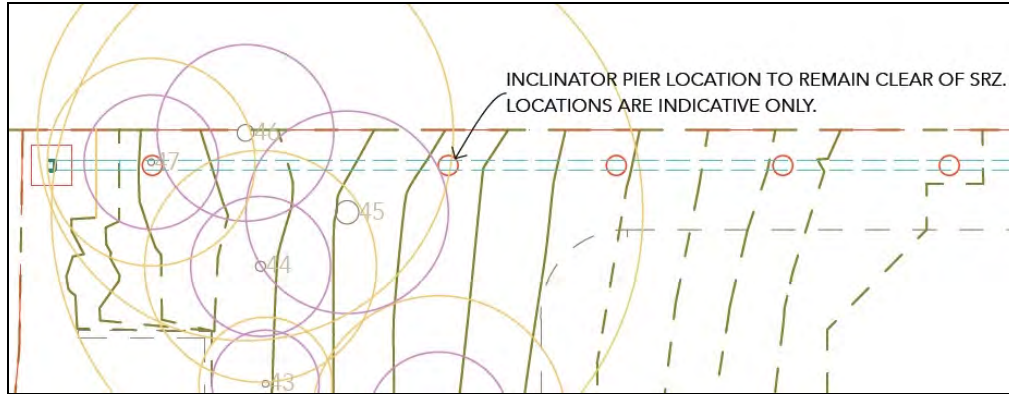
The inclinator runs through the trunk of Tree 47 necessitating removal. With the proposed removal of tree 47, the inclinator path and footings have been designed to avoid the SRZ of the trees to be retained. Piers are to be strategically placed as to avoid impacts to the trees.

Figure 29: The proposed location of the inclinator piers are outside of all SRZ's of trees to be retained. (Source: Proposed Plans by ANNE ROBSON ARCHITECTURE PTY LTD dated 29/03/2023)

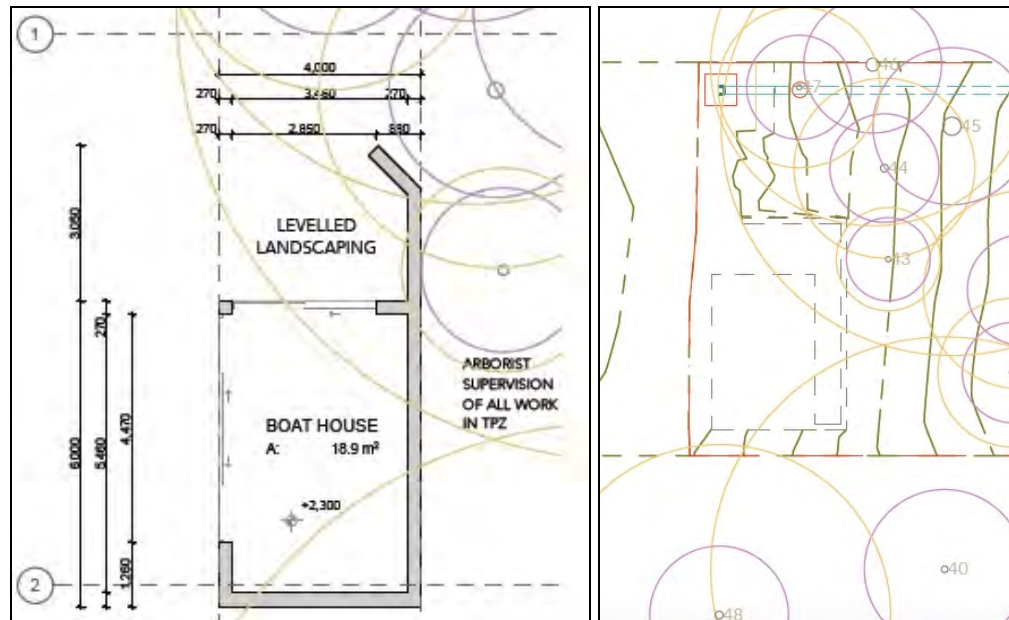
The proposed construction location and geographical features result in minor excavation in the TPZs that will be tolerated by the trees.

No noticeable impact to the health of site trees 43 & 44 Neighbours trees 40 and 48 *Corymbia maculata* (Spotted gums) is expected and the tree will remain viable during and post construction if the protection measures in this report are adhered to

Figures 30 & 31: The proposed location of the boathouse results in a minor encroachment of <10% of trees to be retained (Left) and the existing contours that result in the need for minor excavation (Right). (Source: Proposed Boat Shed Plan DA11 by ANNE ROBSON ARCHITECTURE PTY LTD dated 27/4/2023 left & Tree Impact Plan ANNE ROBSON ARCHITECTURE PTY LTD dated 18/4/2023 Right)
