GEOTECHNICAL RISK MANAGEMENT POLICY FOR PITTWATER
FORM NO. 1 – To be submitted with Development Application

Address of site 74 Grandview Drive, Newport

GEOTECHNICAL INVESTIGATION:

Alterations and Additions at **74 Grandview Drive, Newport**

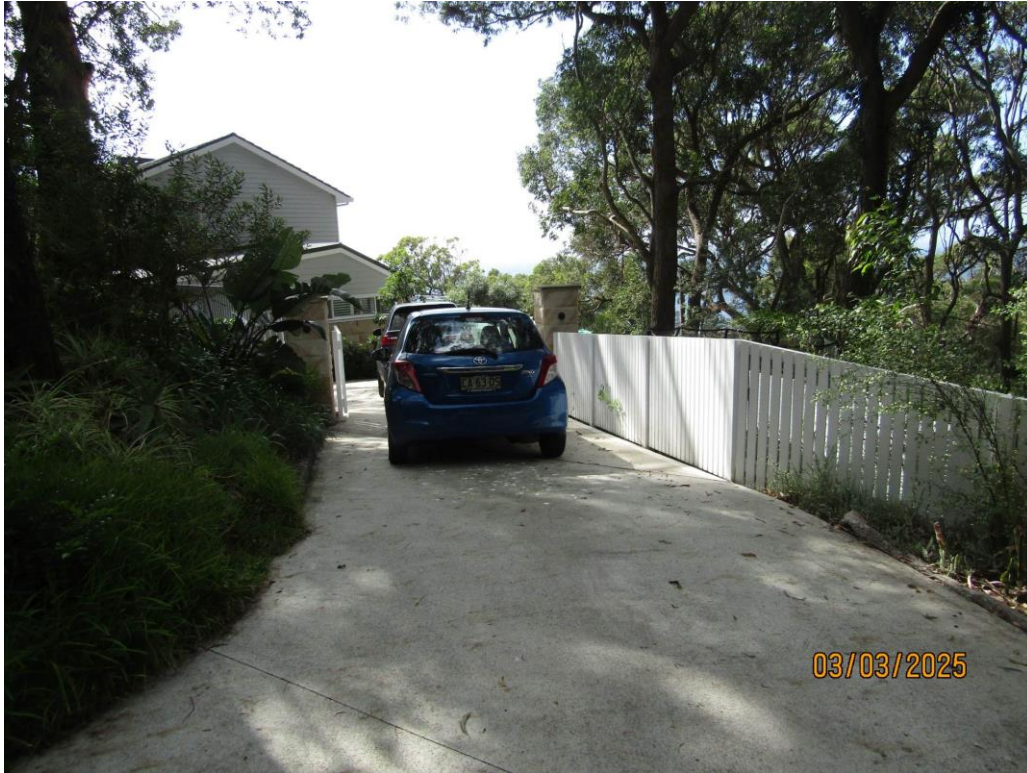
Photo 1

2.3 At the road frontage, a concrete driveway runs to a garage on the ground floor of the house (Photos 1 & 2). A cut and fill provides a level platform for the driveway. The cut and fill is supported by a mortared sandstone block and rendered masonry retaining walls up to $\sim 1.5\text{m}$ high (Photos 3 & 4). The sandstone block wall displays some cacking through the mortar but shows no signs of deflection and is considered to be currently stable. The part two-storey house is supported on masonry walls (Photos 2 & 5). The external supporting walls show no significant signs of movement. A stable sandstone block retaining wall up to $\sim 2.4\text{m}$ high supports a cut for the uphill side of the house and the fill for the road reserve above (Photo 6). A pool that shows no significant signs of movement is located at the downhill side of the house

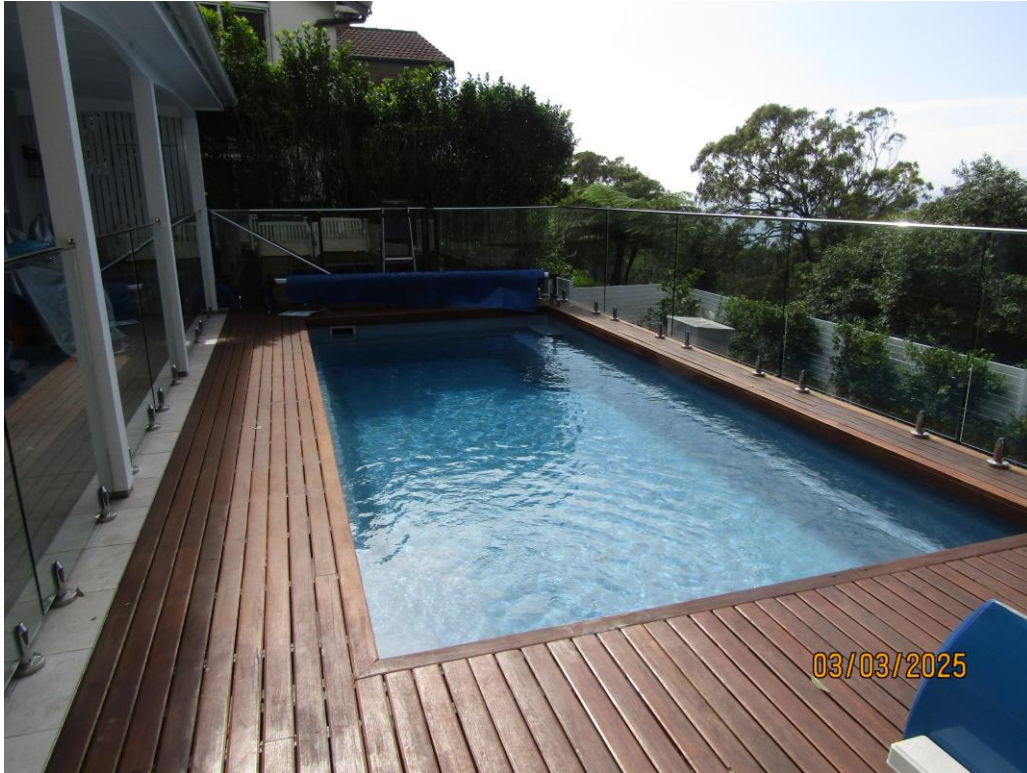
Photo 7

(Photo 7). A concrete crib retaining wall reaching ~4.0m high supports a fill for the downhill side of the property / road reserve and a cut for the road below (Photo 8). The condition of this retaining wall was difficult to determine as it has a thick covering of vegetation at the time of the inspection. However, from what could be seen of the wall and its surrounds, it appears stable.

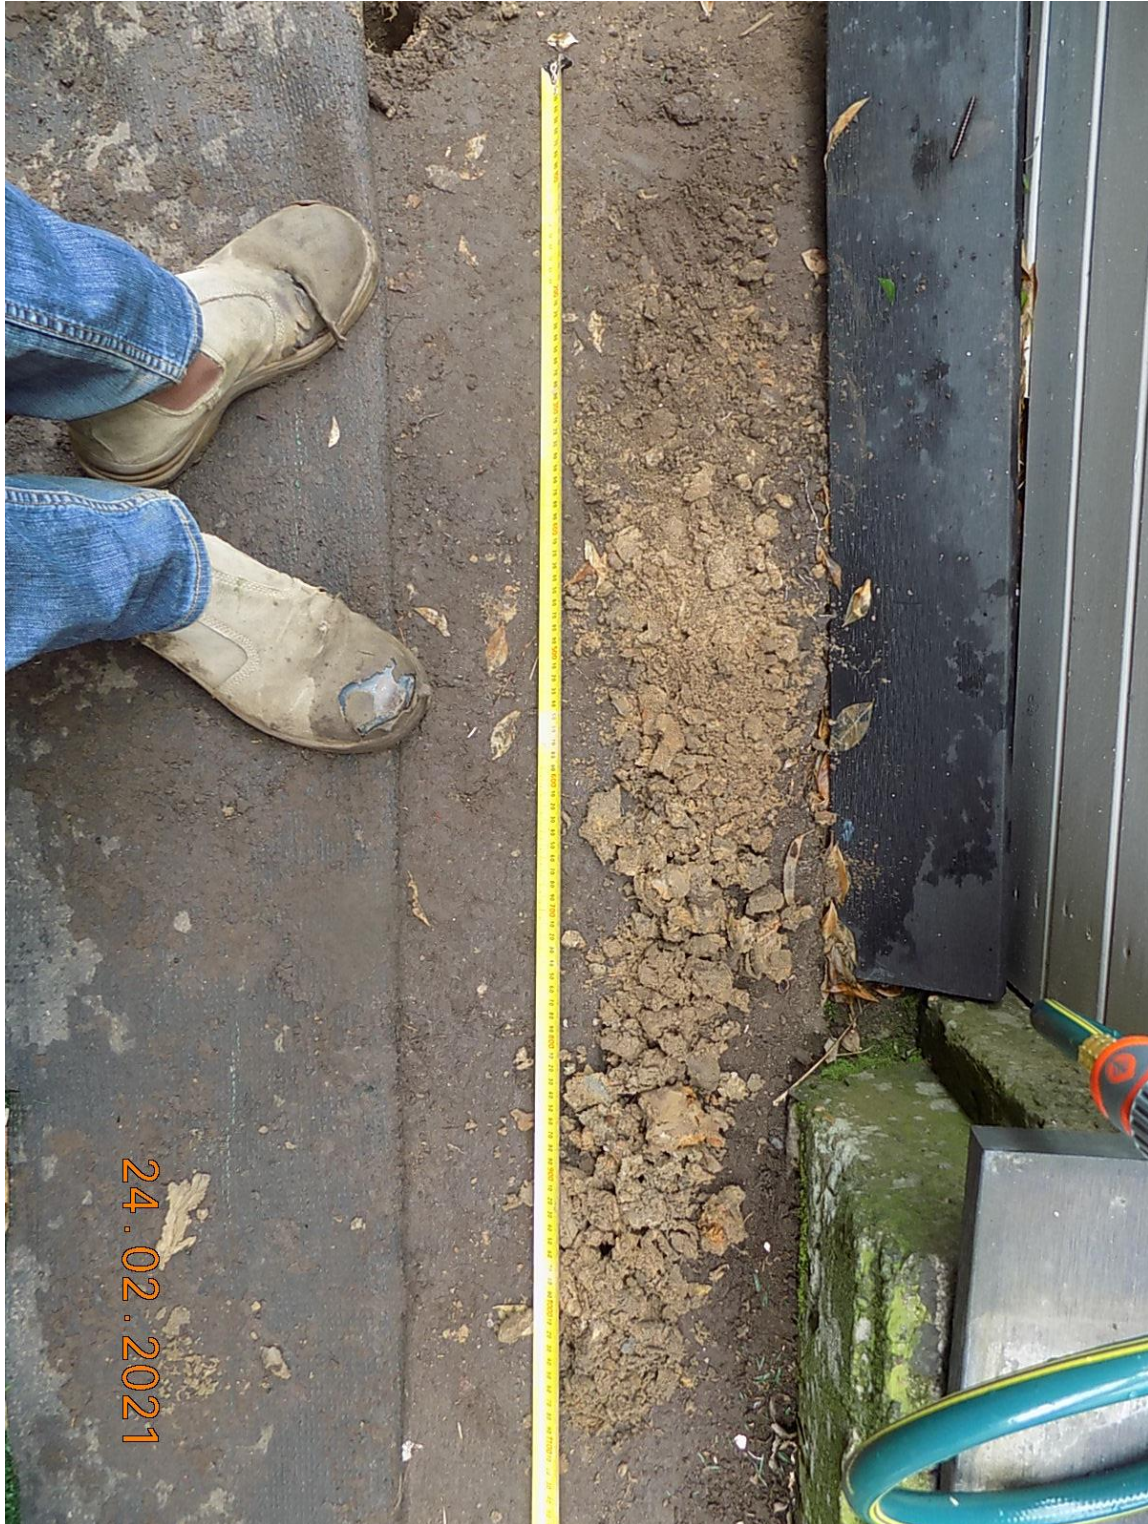
AUGER HOLE 1 (~RL99.9) – AH1 (Photo 9)

| Depth (m) | Material Encountered |
|---|---|
| 0.0 to 0.6 | FILL , disturbed sandy soil, dark brown and brown, loose to medium dense, dry, fine to coarse grained with fine trace organic matter and trace clay. |
| 0.6 to 0.9 | FILL , disturbed clay, brown, firm, damp, fine to coarse grained with fine trace organic matter. |
| 0.9 to 1.1 | FILL , disturbed sandy soil, dark brown and brown, loose to medium dense, dry, fine to coarse grained with fine trace organic matter and trace clay. |

Refusal @ 1.1m in fill. No water table encountered.

Photo 9: AH1 – Downhole is from top to bottom.

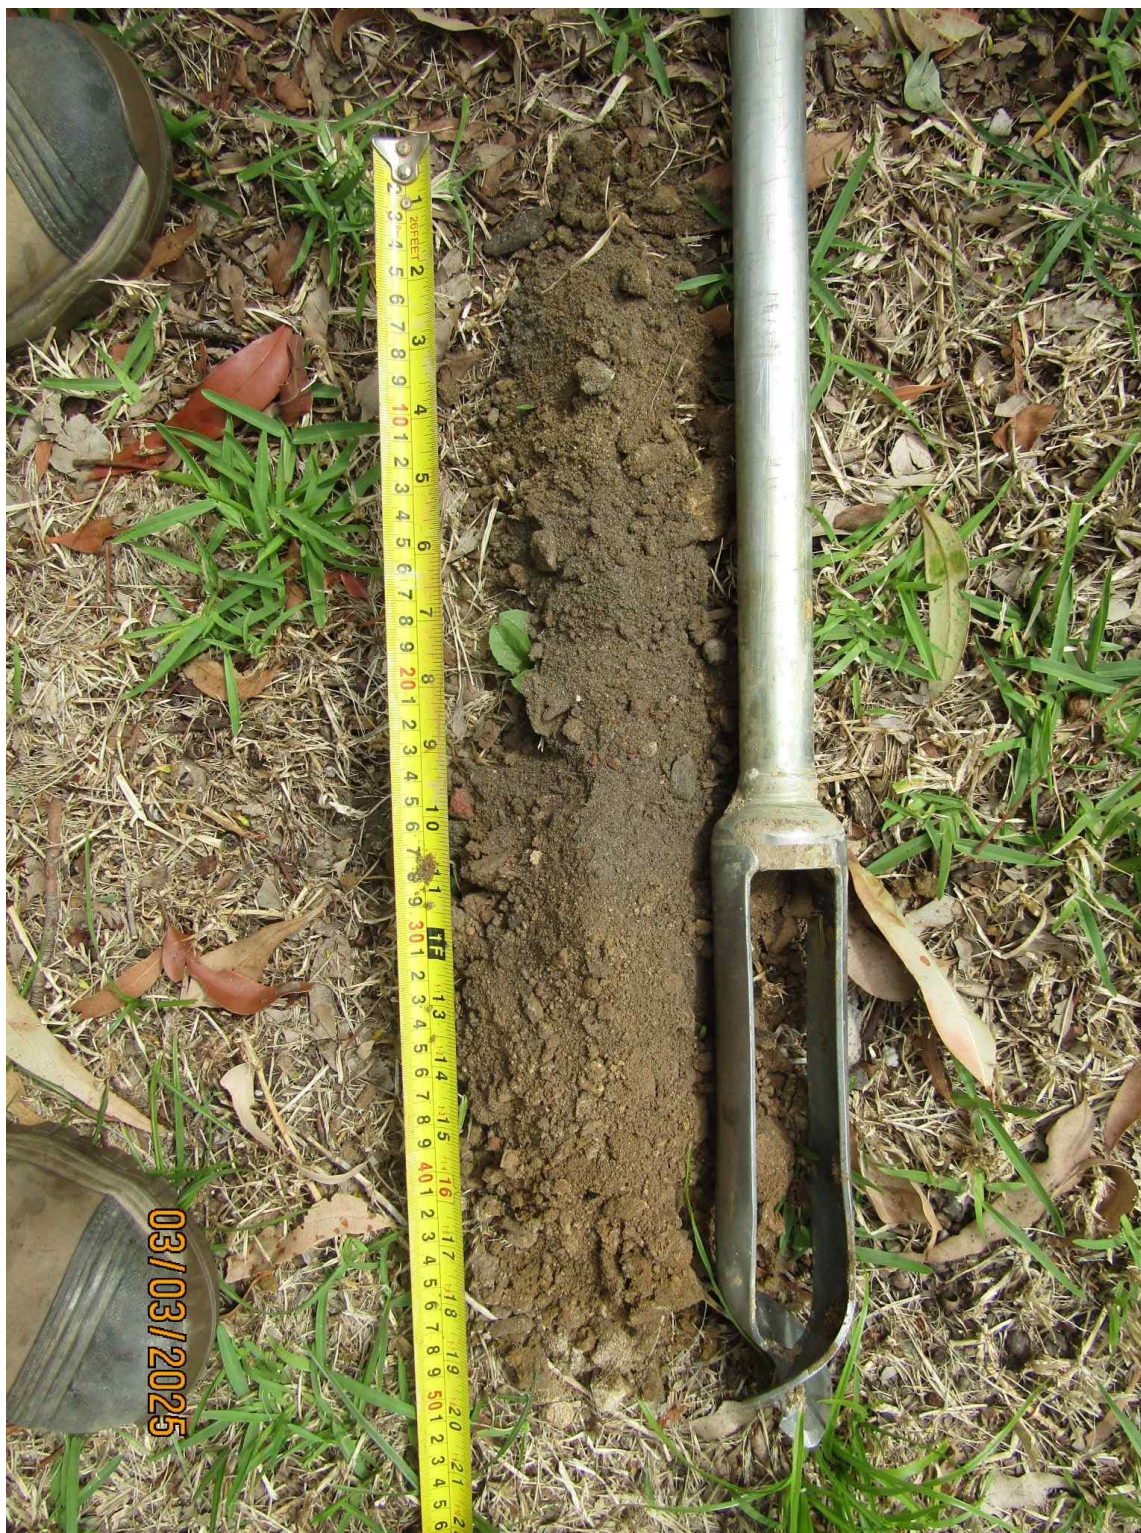
AUGER HOLE 2 (~RL99.0) – AH2 (Photo 10)

| Depth (m) | Material Encountered |
|---|--|
| 0.0 to 0.5 | FILL , silty soil and clay, with some rock fragments, brown, dry, fine to coarse grained. |

Refusal @ 0.5m in fill. No water table encountered.

Photo 10: AH2 – Downhole is from top to bottom

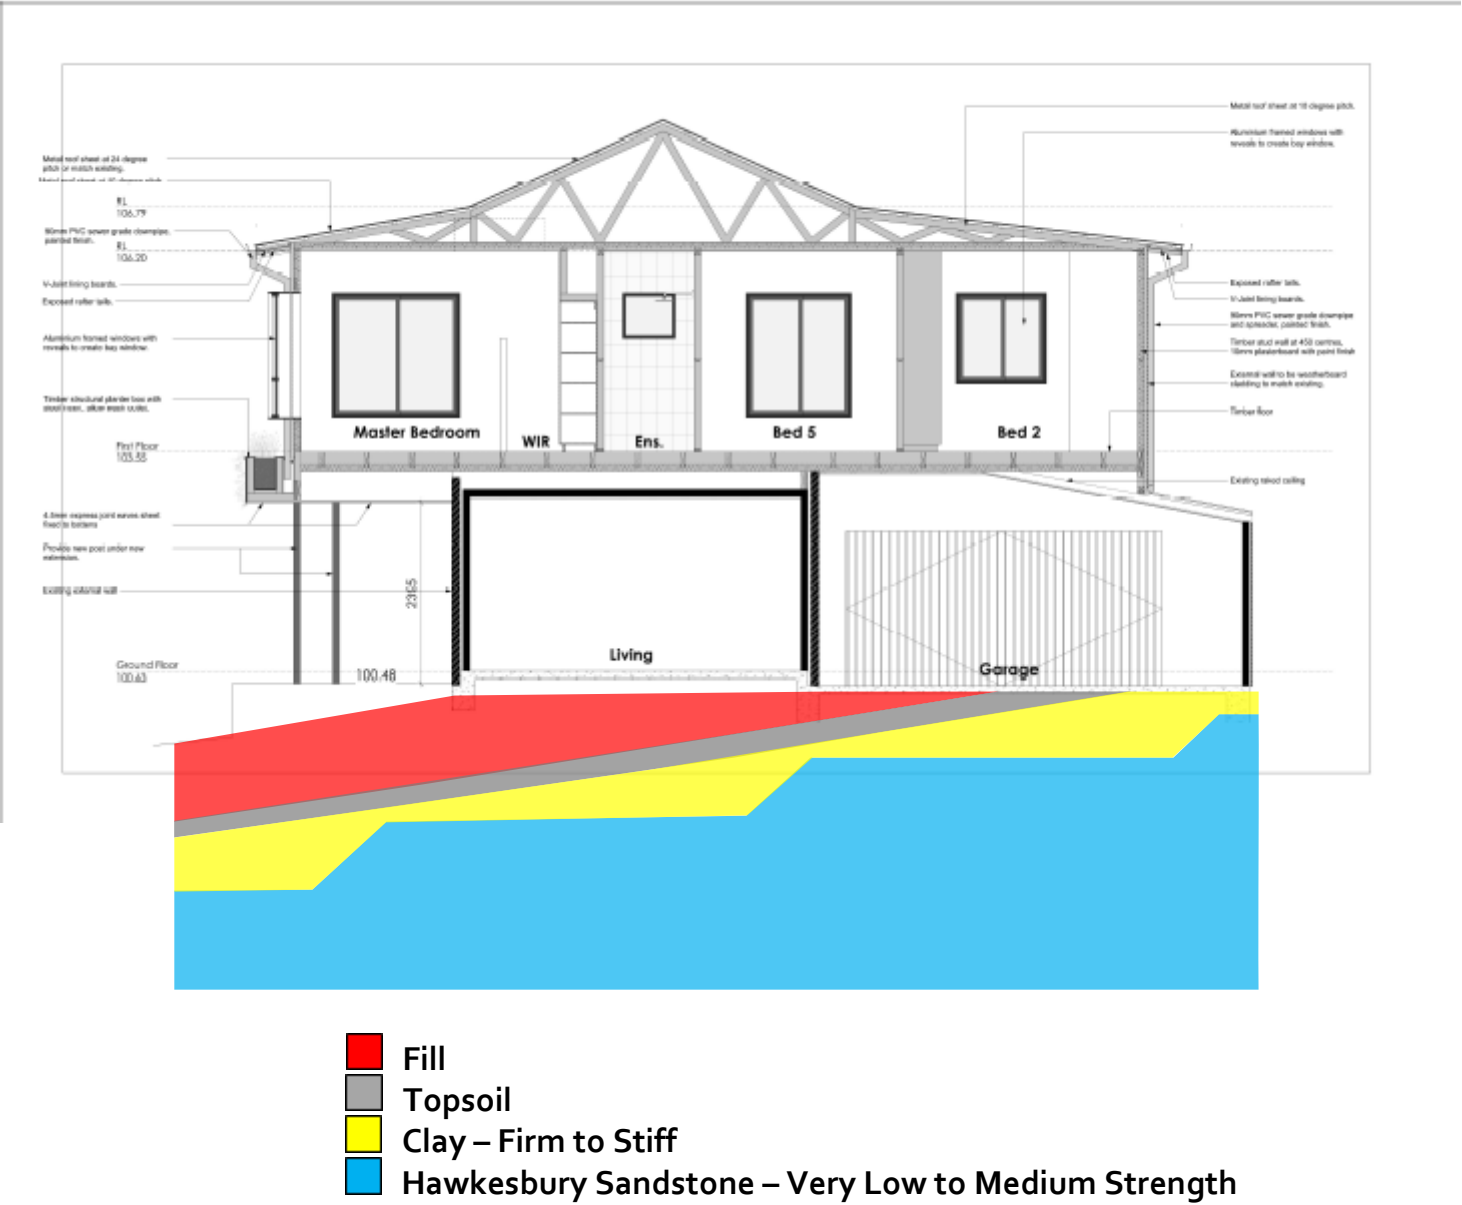
TYPE SECTION – Diagrammatical Interpretation of expected Ground Materials

grade is steeper, the steps are larger and the benches narrower. Where the slope eases, the opposite is true. The rock is overlain by fill, topsoil and clay that fills the bench step formation. Fill to an estimated maximum depth of ~2.5m provides level platforms for lawn and garden areas across the property and for the road reserve. In the DCP2 to 4 test locations, weathered rock was encountered at depths of between ~1.8m to ~3.0m below the current surface, being deeper where the fill is deeper. It is interpreted that DCP1 was terminated in fill. The rock underlying the property is interpreted to be Very Low Strength Sandstone or better. See Type Section attached for a diagrammatical representation of the expected ground materials.
