GEOTECHNICAL INVESTIGATION:

New Shade Structure at 4 Laura Street, Seaforth

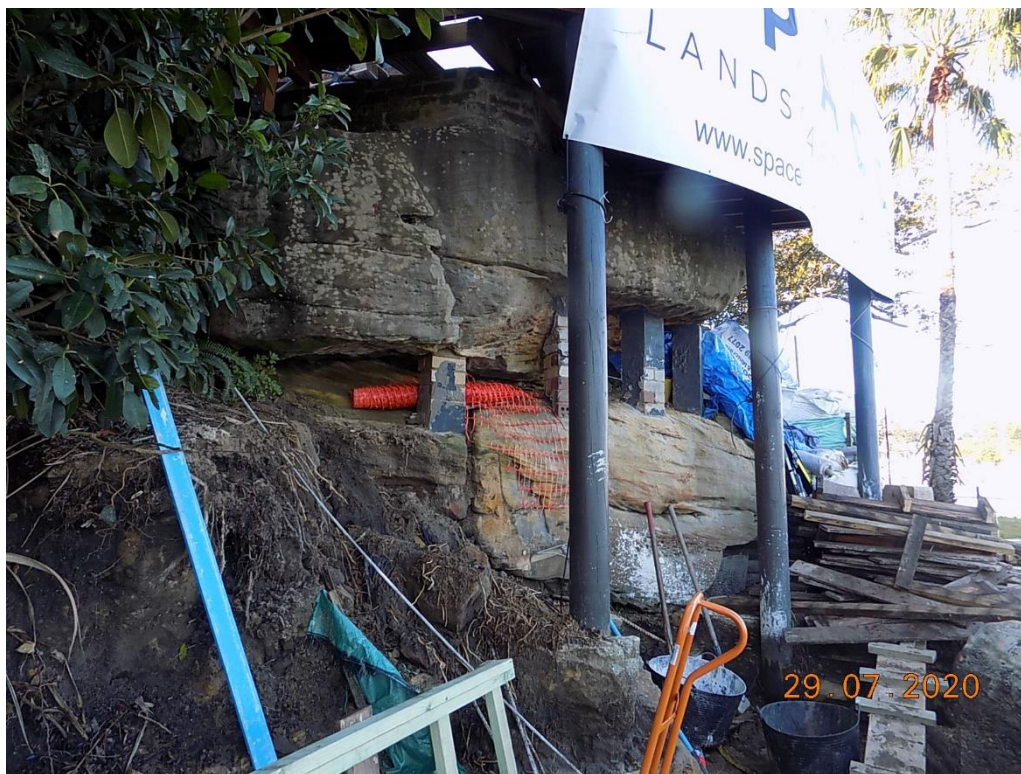
Photo 1

- 2.3** Sandstone bedrock is visible at the waterfront and also in the steep slope immediately above (Photos 1 & 2). Several loose boulders are scattered along the waterfront (Photo 1). These appear to be in stable positions. One in particular is lodged at a high angle and has come to rest on several other boulders (Photo 3). This boulder has been in place for a long time and is currently considered stable. The slope around and above the waterfront is currently under construction as part of a separate DA (Photo 1 to 3). Above the waterfront slope, the pool and part three level masonry house step up the slope with the footprint of these structures covering the upper portion of the block (Photos 4 & 5). No signs of movement were observed in the

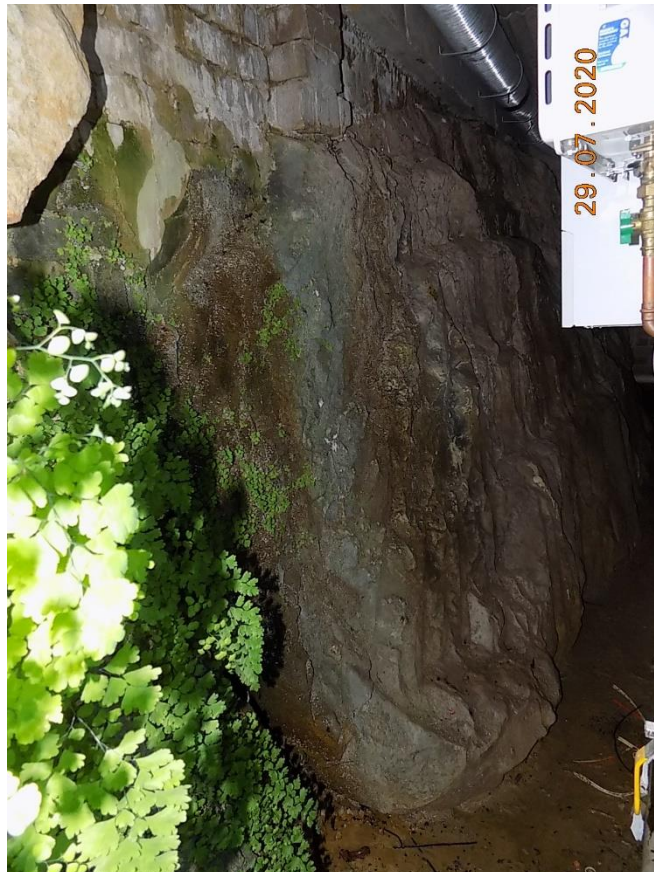
Photo 6

supporting walls of the house or in the pool. A cut behind the lower level of the house is through stable sandstone bedrock (Photo 6).
