Report Title: Geotechnical Report 34 Lumeah Avenue, Elanora Heights
Report Date: 1/3/21

GEOTECHNICAL INVESTIGATION:

New House and Pool at **34 Lumeah Avenue, Elanora Heights**

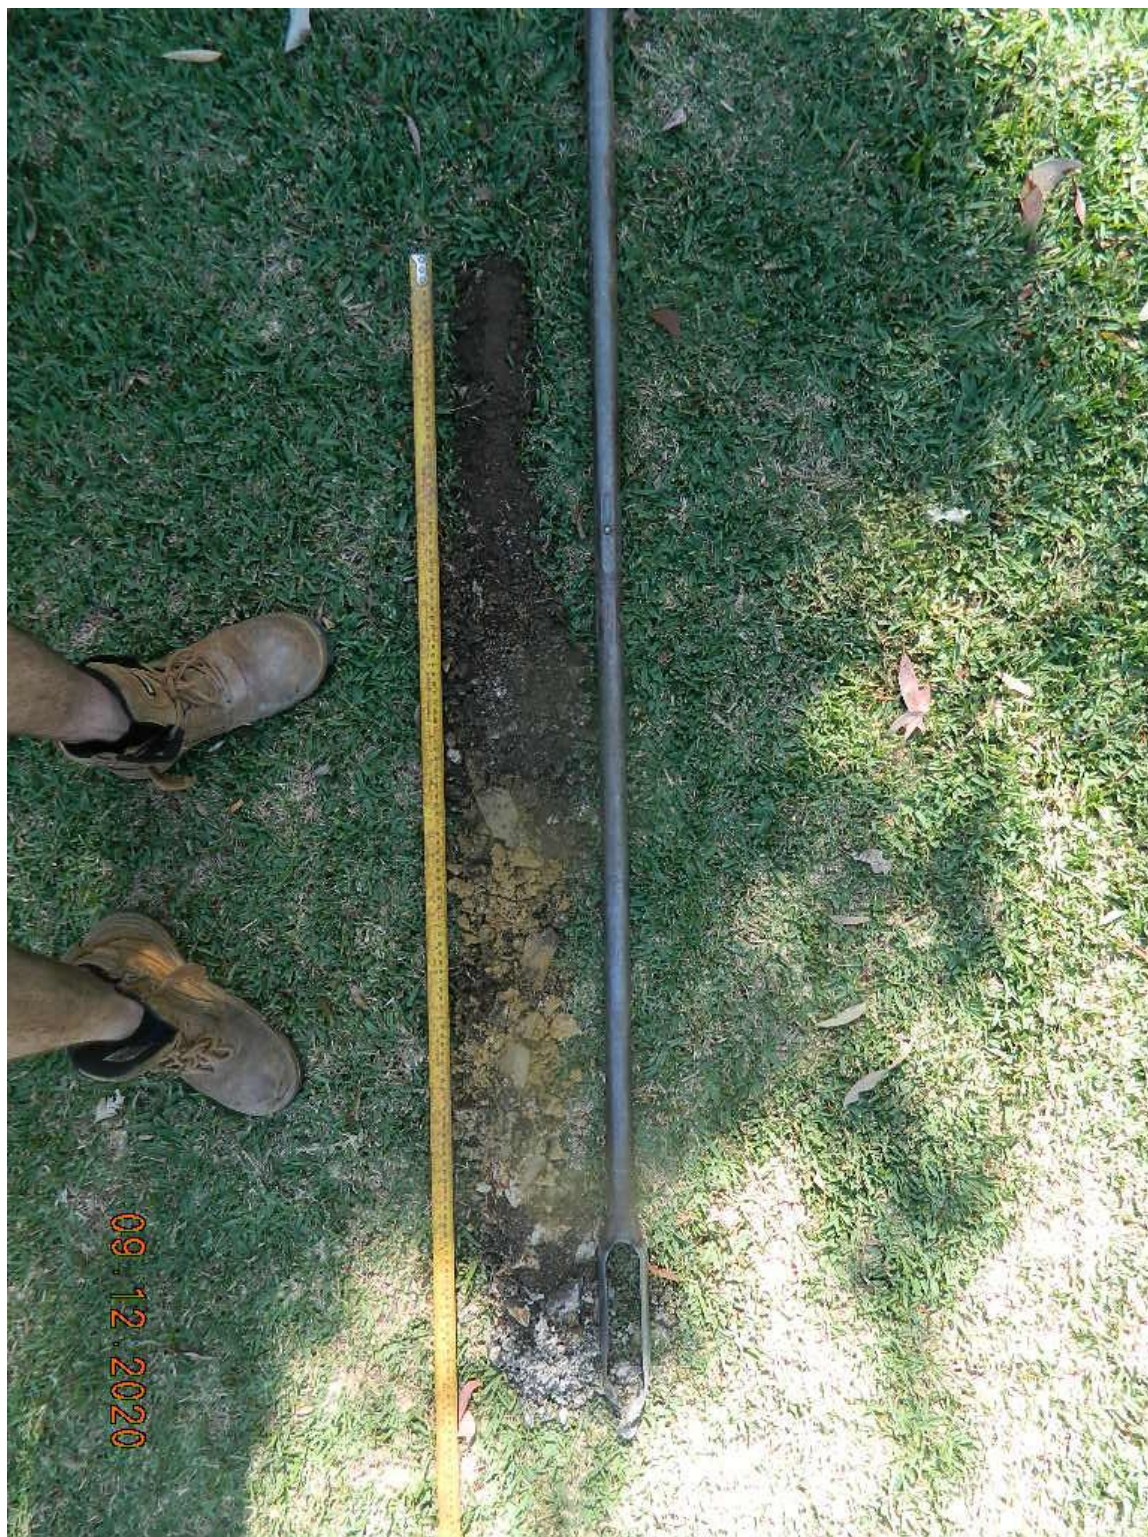
AUGER HOLE 1 (~RL78.6) – AH1 (photo 7)

Depth (m)	Material Encountered
0.0 to 0.6	TOPSOIL , sandy soil, dark brown, moist, fine to medium grained with fine trace organic matter.
0.6 to 1.0	SANDY CLAY , light orange/brown, soft to firm, damp.
1.0 to 1.3	SANDY CLAY , white and orange red, firm to stiff, damp.

Refusal @ 1.3m auger grinding on rock surface. No watertable encountered.

Photo 7: AH1 – Downhole is from top to bottom.

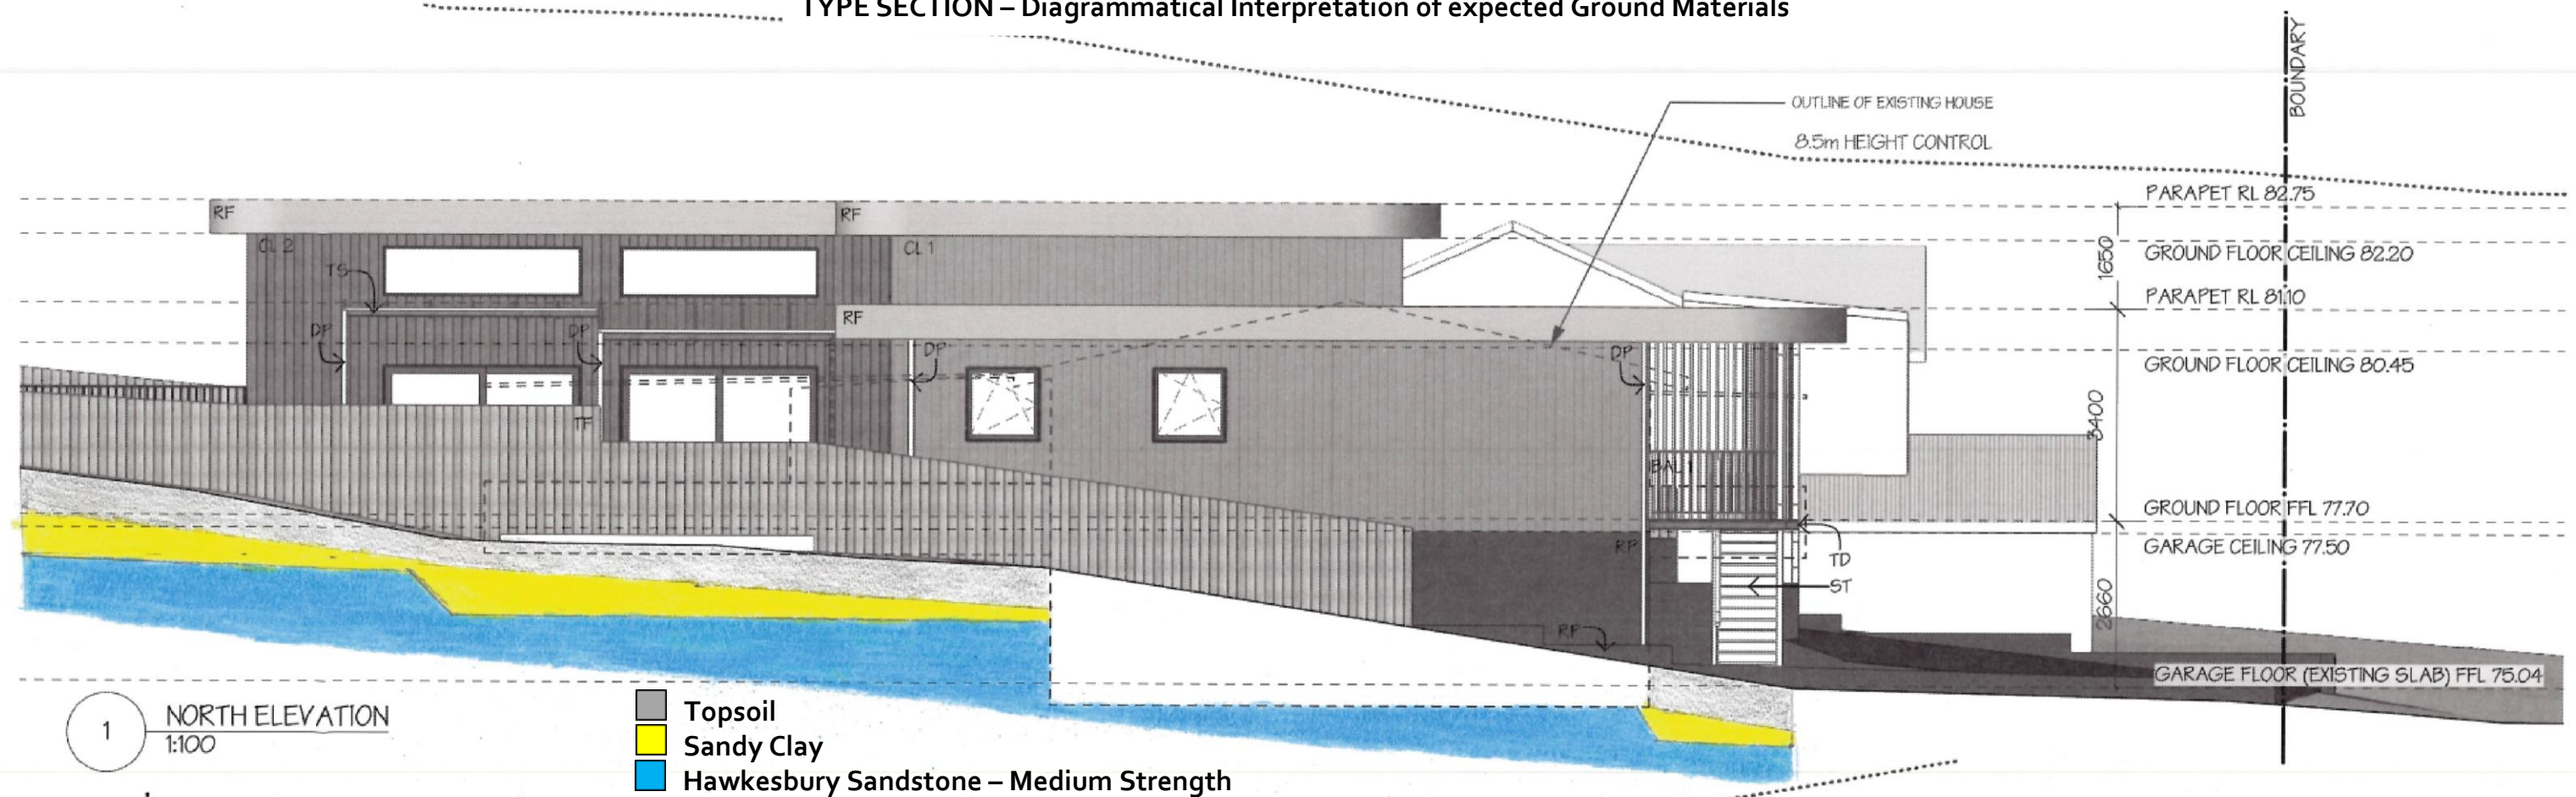
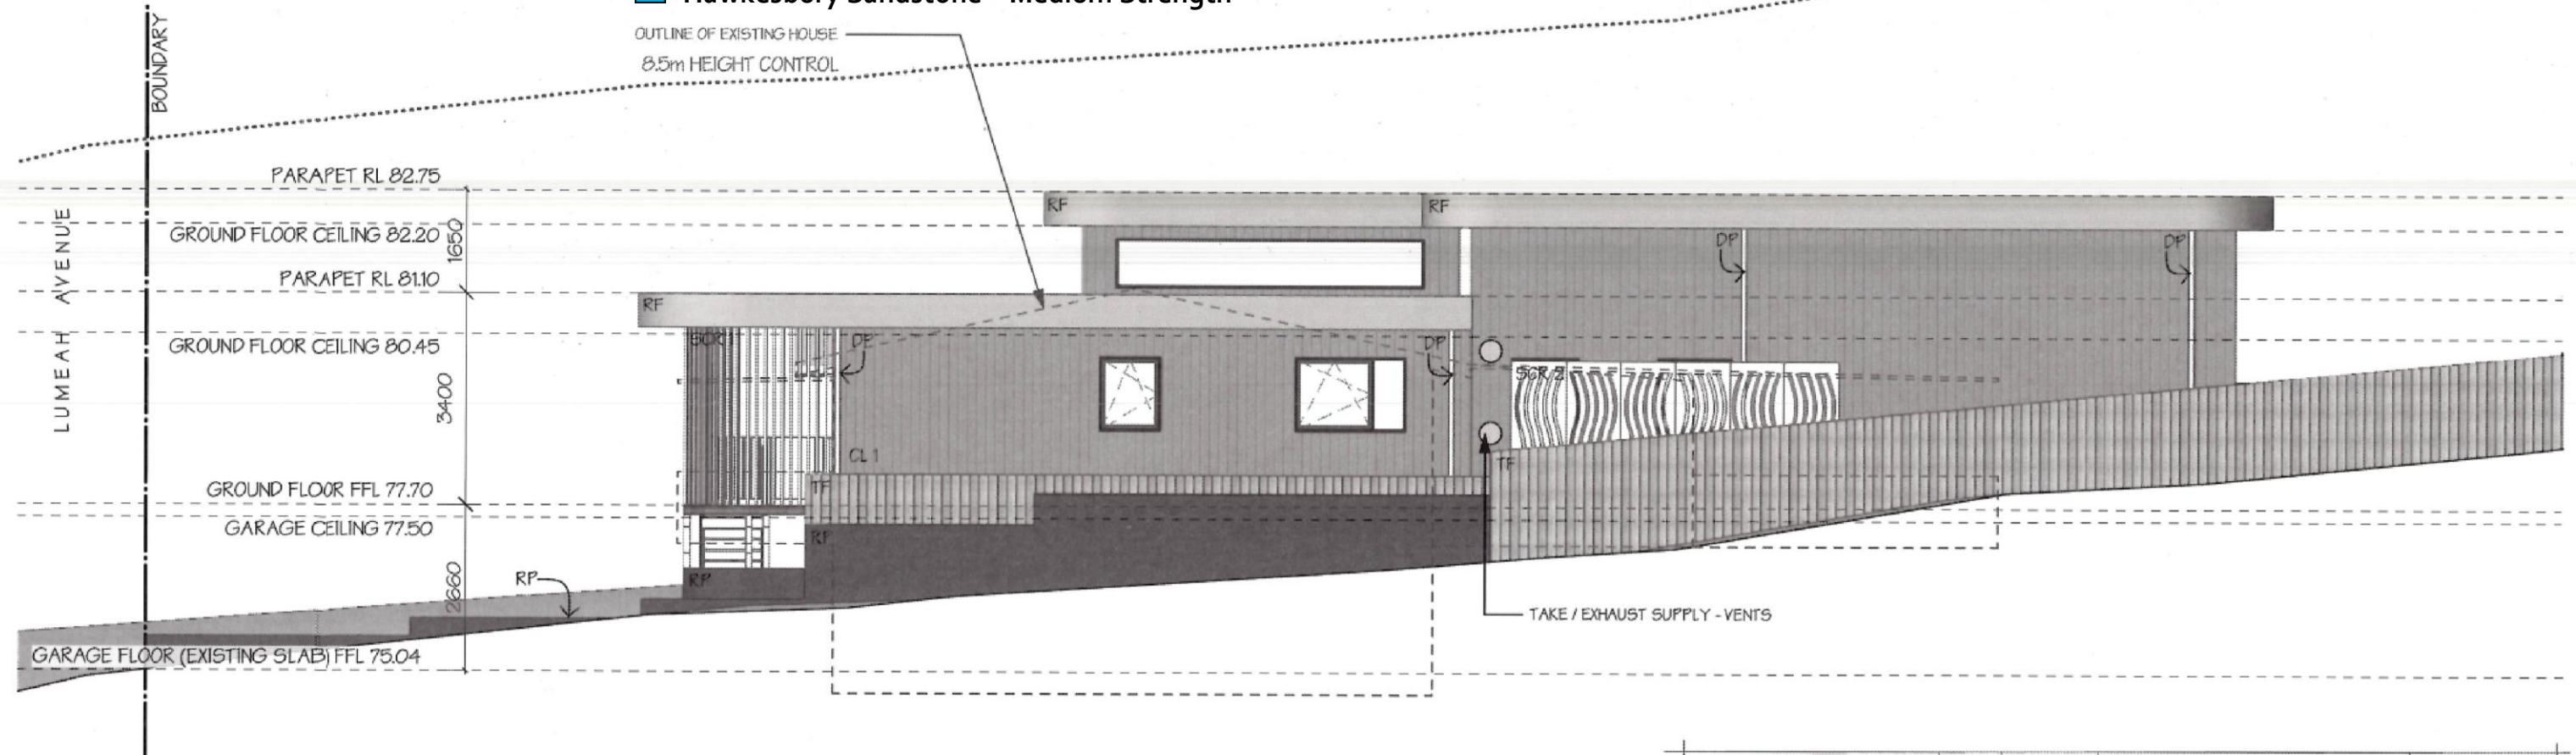
TYPE SECTION – Diagrammatical Interpretation of expected Ground Materials

The surface features of the block are controlled by the underlying sandstone bedrock that steps down the property forming sub-horizontal benches between the steps. Where the grade is steeper, the steps are larger and the benches narrower. Where the slope eases, the opposite is true. The rock is overlain by sandy topsoil and sandy clays that fill the bench step formation. In the test locations, the depth to rock ranged from the surface to ~1.3m below. The sandstone underlying the property is estimated to be Medium Strength or better. See Type Section attached for a diagrammatical representation of the expected ground materials.
