Arboricultural Impact Assessment

**Chapel and Function Centre Development
Frenchs Forest Bushland Cemetery (FFBC)
1 Hakea Avenue
Davidson NSW 2085**

27 March 2020

Arboricultural Impact Assessment for fifty-seven (57) trees located within Frenchs Forest Bushland Cemetery, 1 Hakea Avenue, Davidson, NSW

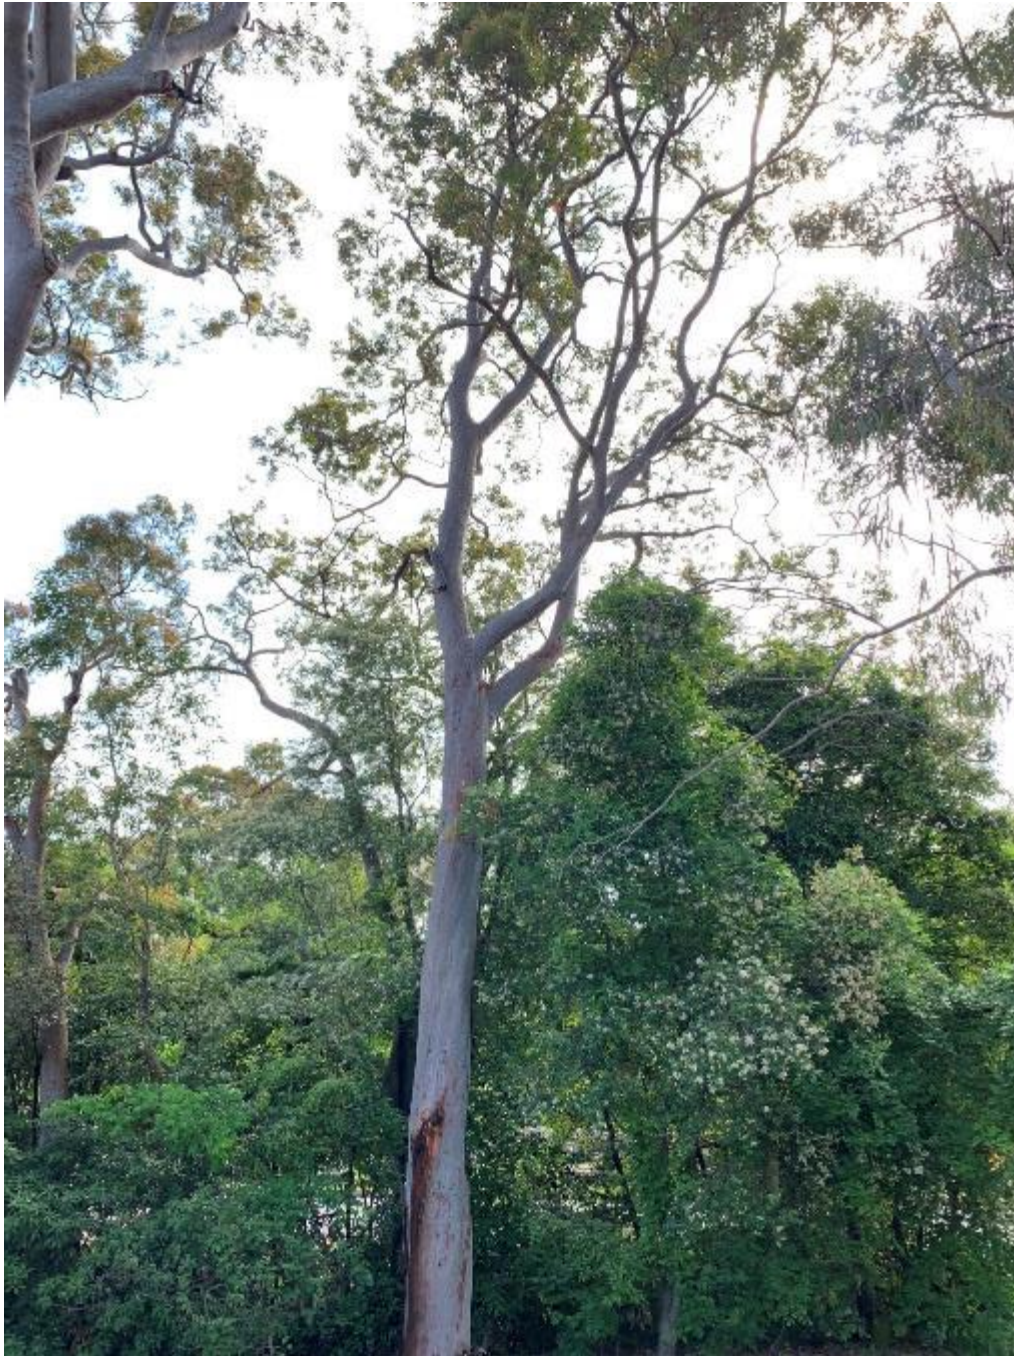
- 6.2.3 Tree 204 was a mature *Angophora costata* (Smooth-barked apple myrtle). The tree was located to the south of the proposed chapel site and provides significant amenity value within the landscape.
- 6.2.4 Tree 204 was of good health and structure and has a life expectancy of greater than fifty years (>50 years).
- 6.2.5 The TPZ for Tree 204 was 9.6m, with an SRZ of 3.0m, measured at a radial distance from the centre of the trunk.

Figure 6. View to the west of Tree 204 (Smooth-barked apple myrtle) in its growing environment. (Tom Axford, December 2018).

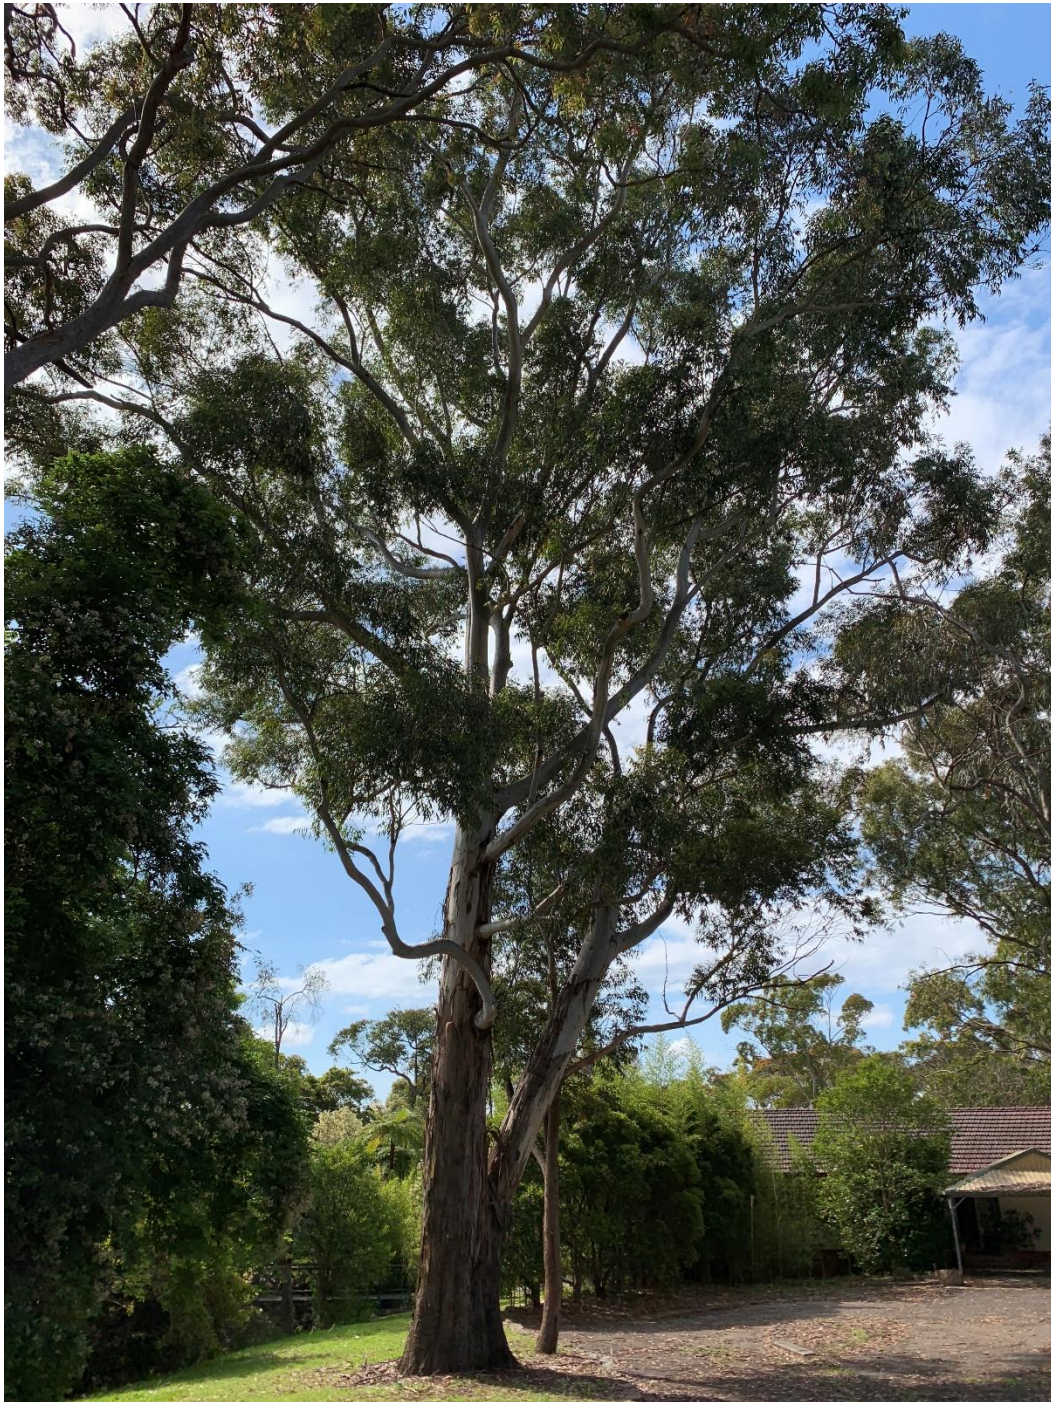
- 6.2.6 Tree 207 was a mature *Eucalyptus pilularis* (Blackbutt). This was a large tree that provided significant amenity value within the immediate landscape
- 6.2.7 Tree 207 was of good health and fair structure and has a life expectancy of 25–50 years.
- 6.2.8 The TPZ for Tree 207 was 15.0m, with an SRZ of 4.1m, measured at a radial distance from the centre of the trunk.

Figure 8. View to the north of Tree 207 (Blackbutt) in its growing environment. (Tom Axford, December 2018).

- 7.2.5 Trees 206 is a mature *Syzygium paniculatum* (Magenta brush cherry) (Figure 15) while Tree 207 is a mature *Eucalyptus pilularis* (Blackbutt) (Figure 8) growing to the south of the proposed chapel. The trees would have a direct footprint conflict with the proposed new Ash Garden and as such have been recommended for removal.

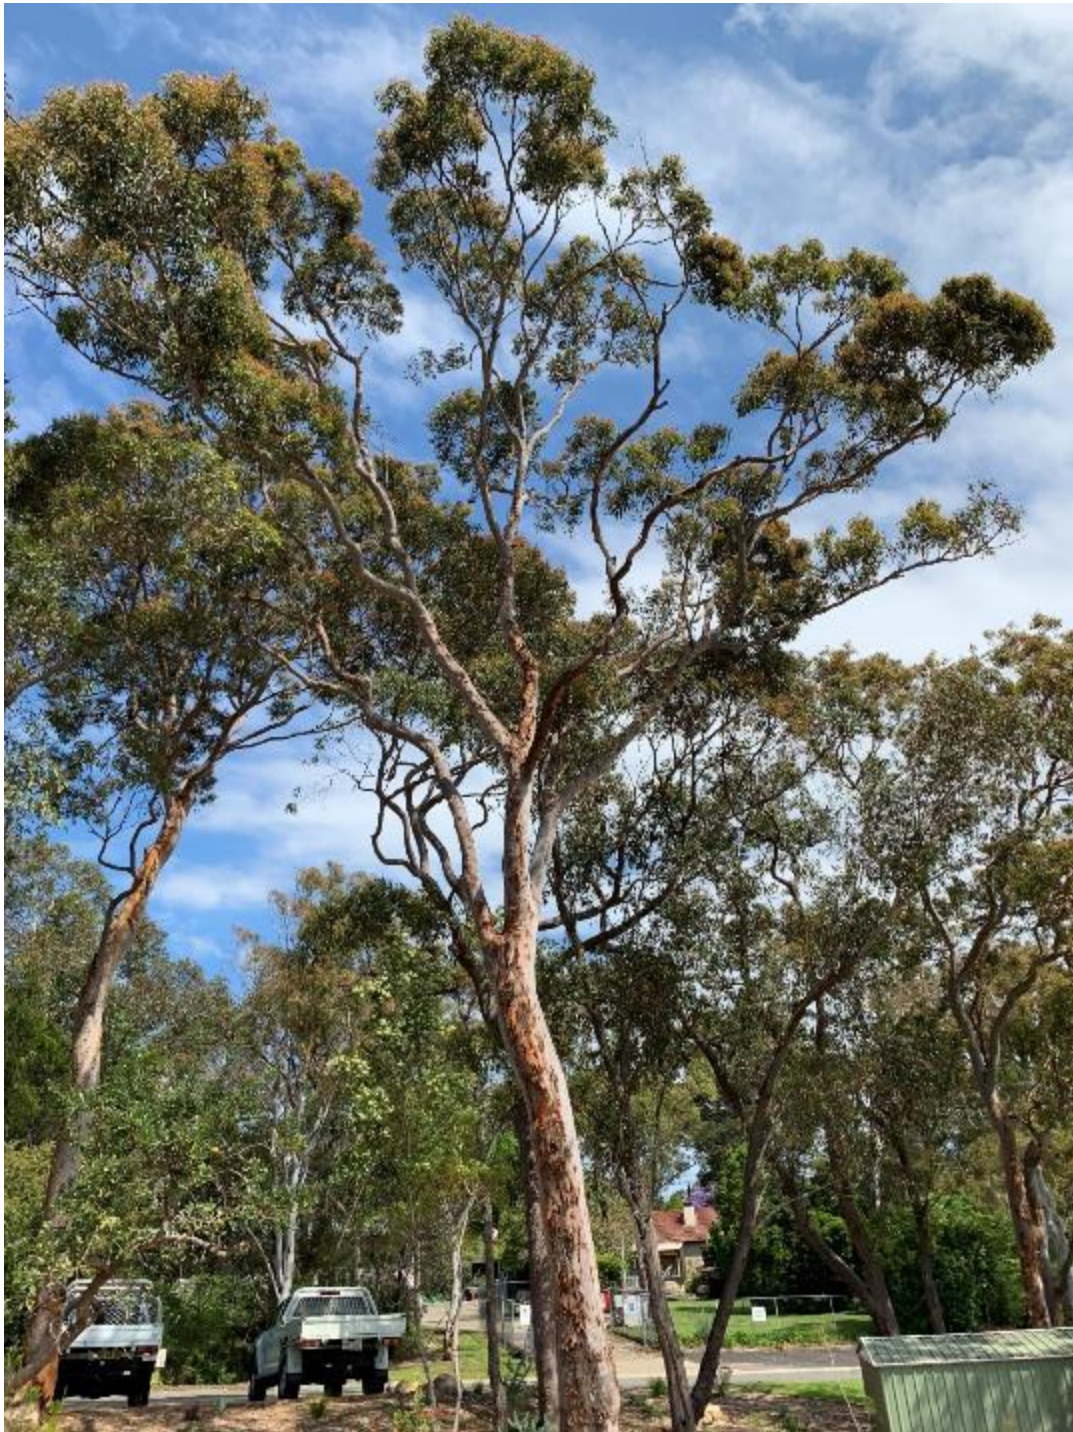
- 6.2.9 Tree 281 was an *Angophora costata* (Smooth-barked apple myrtle). The tree was located to the east of the proposed function centre site and provided significant amenity value within the landscape
- 6.2.10 Tree 281 was of good health and structure and has a life expectancy of 25–50 years.
- 6.2.11 The TPZ for Tree 281 was 6.6m, with an SRZ of 2.9m, measured at a radial distance from the centre of the trunk.

Figure 9. View to the east of Tree 281 (Smooth-barked Apple Myrtle) in its growing environment. (Tom Axford, December 2018).

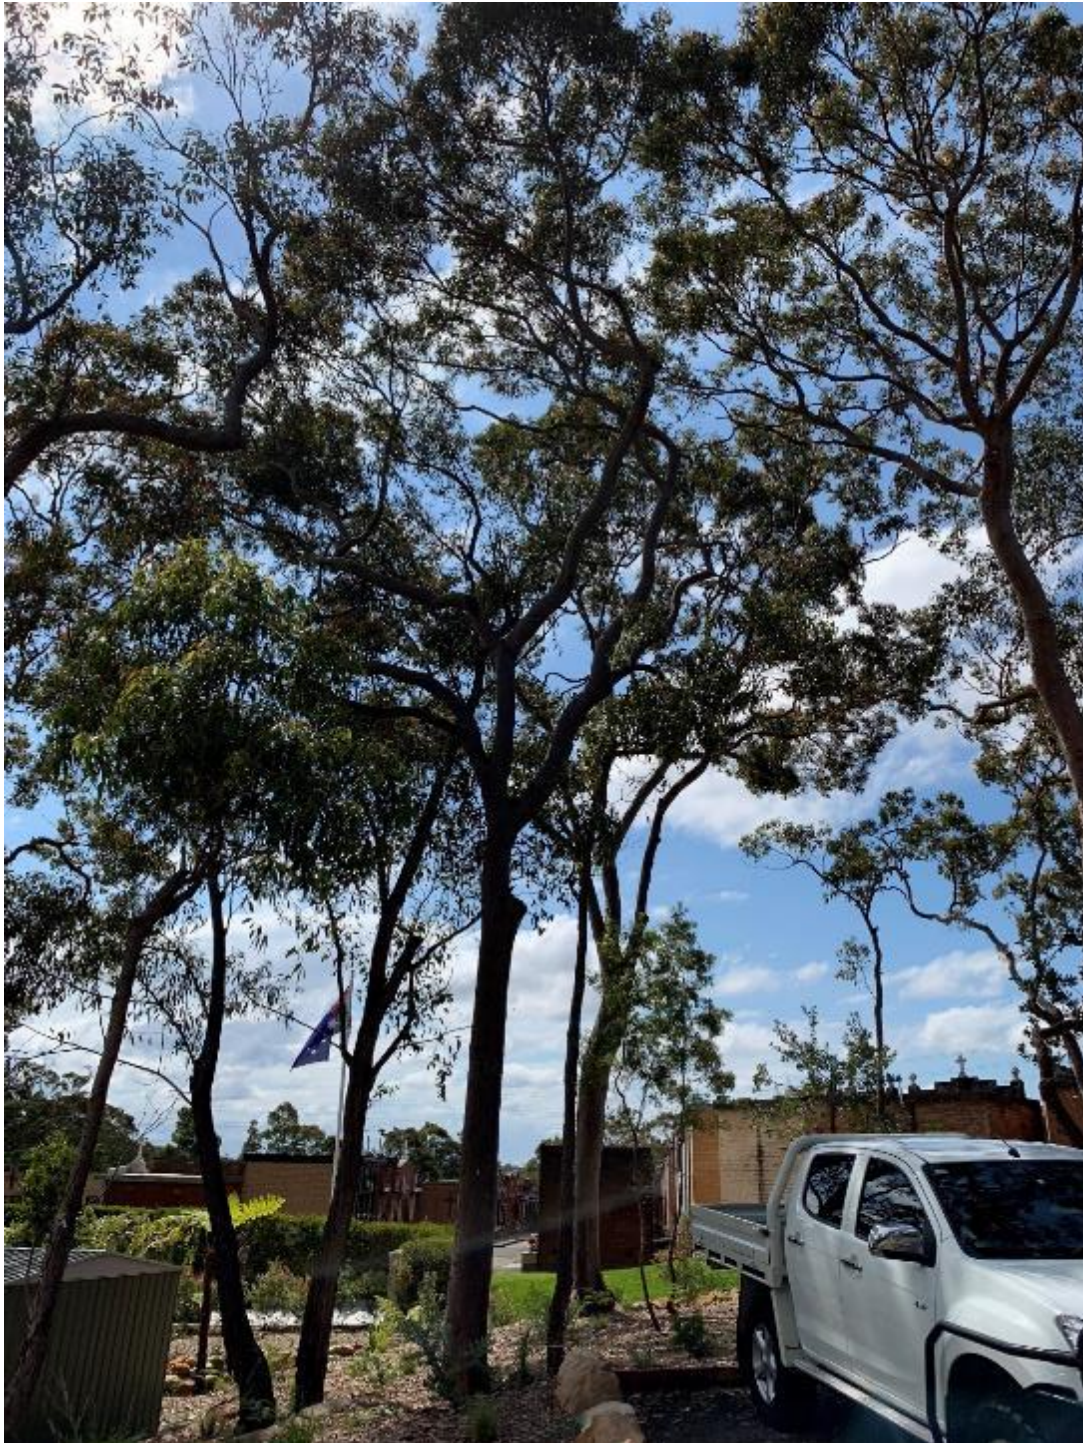
- 6.2.12 Tree 285 was an *Angophora costata* (Smooth-barked apple myrtle). The tree was located to the east of the proposed function centre site and provided significant amenity value within the landscape.
- 6.2.13 Tree 285 was of good health and structure and has a life expectancy of 25–50 years.
- 6.2.14 The TPZ for Tree 285 was 5.4m, with an SRZ of 2.6m, measured at a radial distance from the centre of the trunk.

Figure 10. View to the north of Tree 285 (Smooth-barked apple myrtle) in its growing environment. (Tom Axford, December 2018).

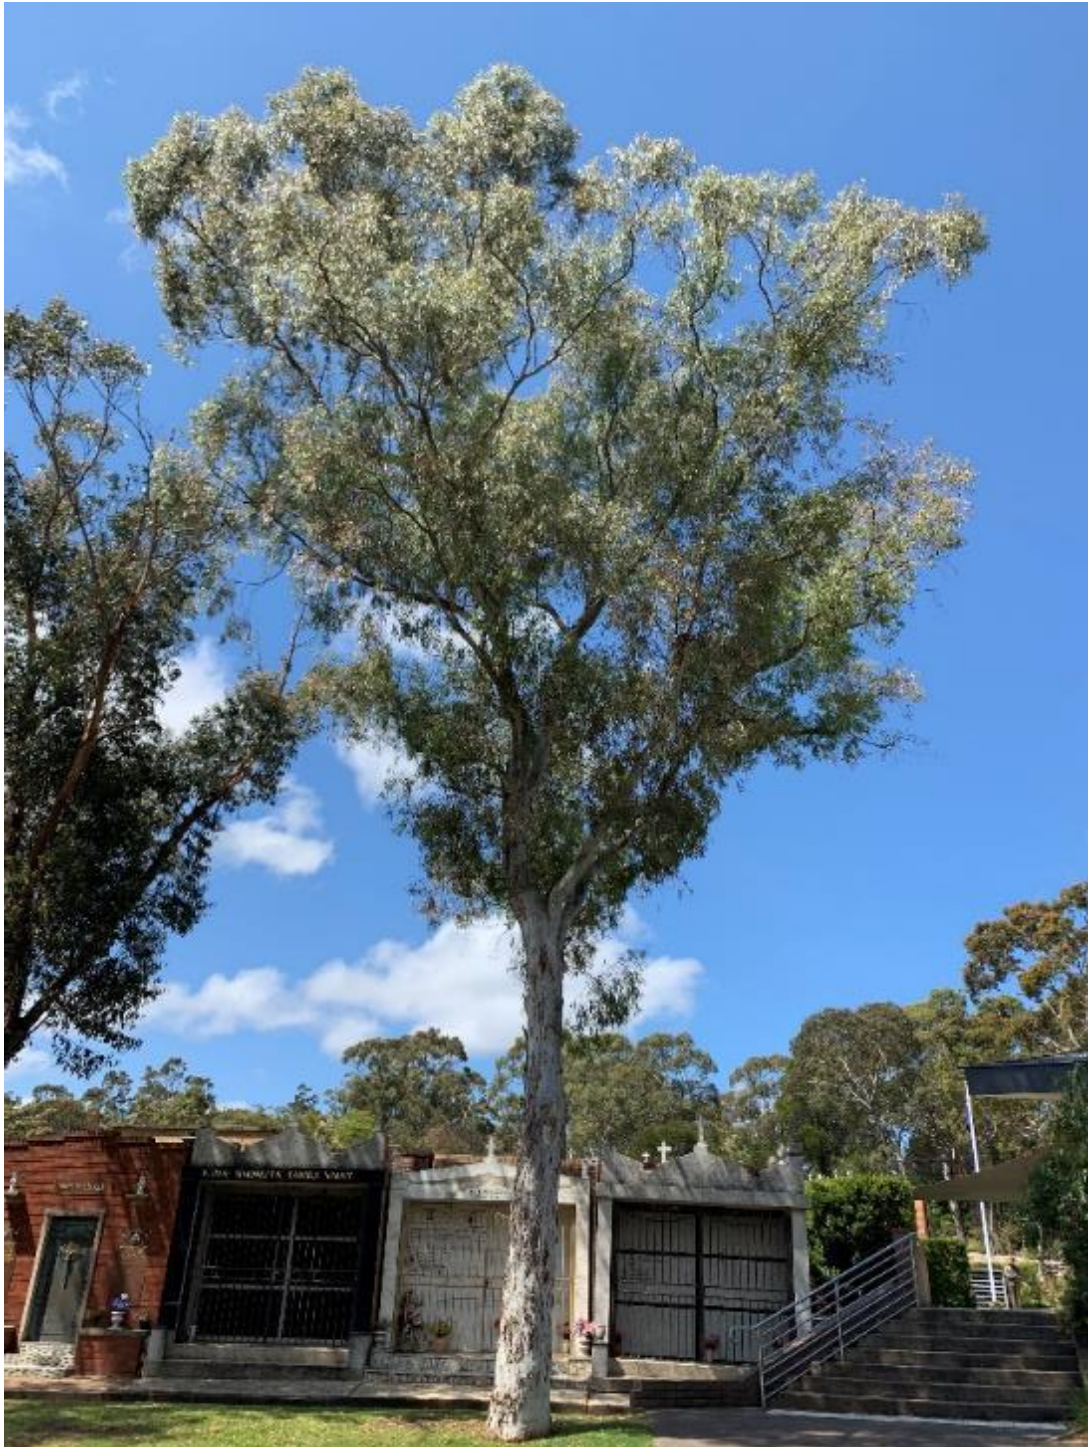
- 6.3.3 Tree 220 is a mature *Eucalyptus scoparia* (Wallangarra white gum). It provided amenity value and shading to the edge of the carparking area to the west of the proposed function centre.
- 6.3.4 Tree 220 is of moderate size with fair health and good structure with a ULE of 15–25 years.
- 6.3.5 The TPZ for Tree 220 was 6.6m, with an SRZ of 2.9m, measured at a radial distance from the centre of the trunk.

Figure 12. View to north of Tree 220 (Wallangarra White Gum) in its growing environment. (Tom Axford, December 2018).

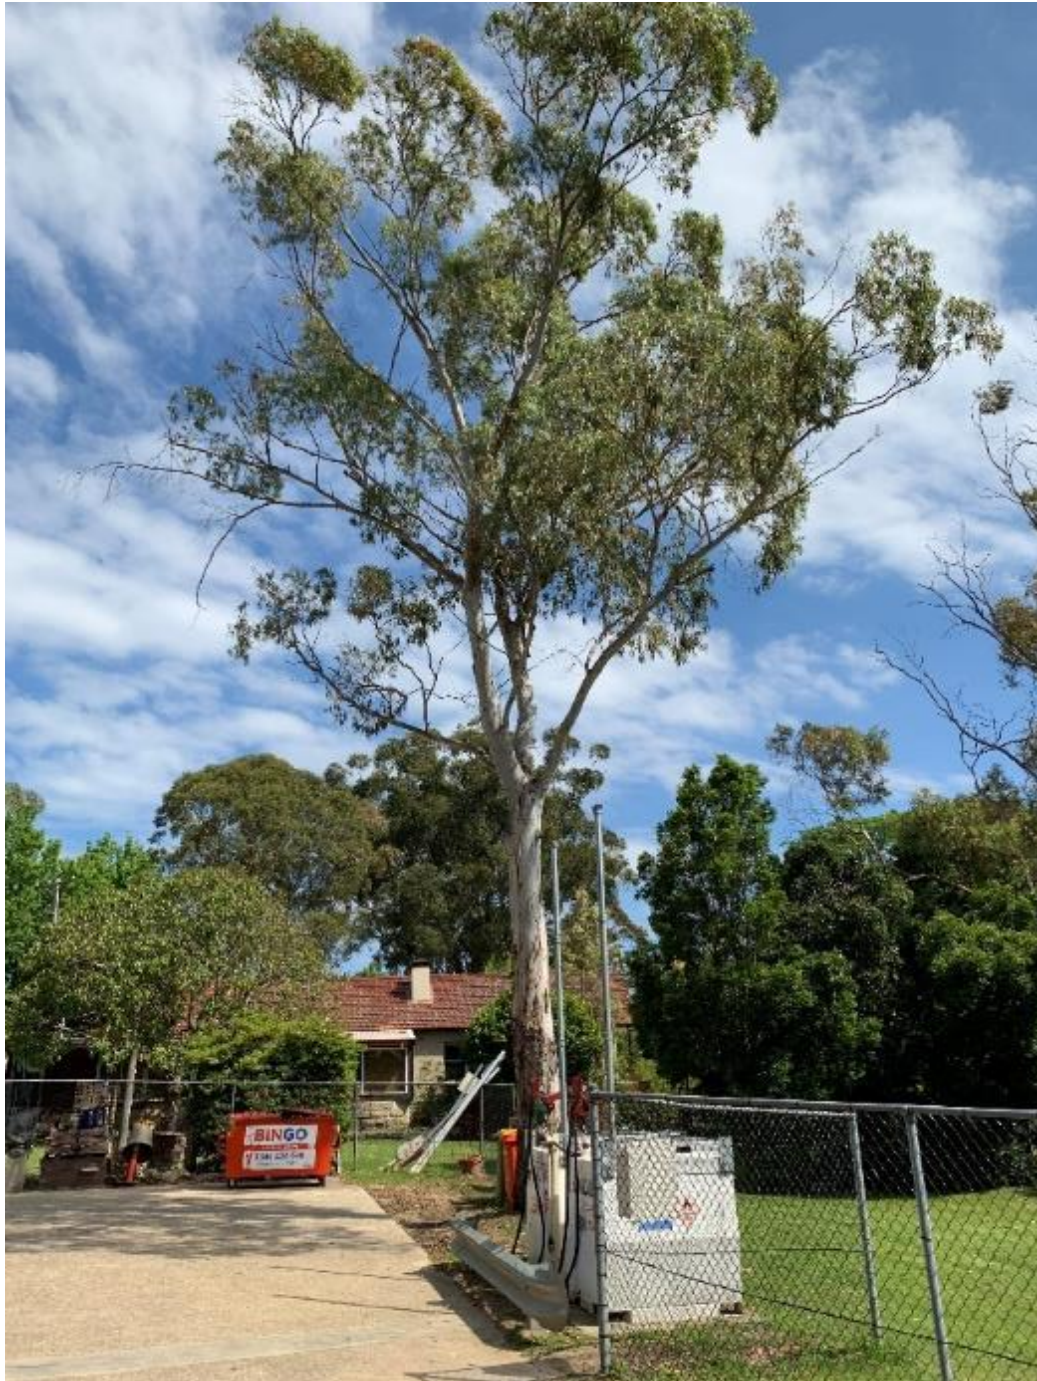
- 6.3.6 Tree 217 is a mature *Eucalyptus scoparia* (Wallangarra white gum). It provided amenity value and shading to the north of the existing chapel building.
- 6.3.7 Tree 217 is of moderate size with good health and fair structure with a ULE of 15–25 years.
- 6.3.8 The TPZ for Tree 217 was 7.4m, with an SRZ of 3m, measured at a radial distance from the centre of the trunk.

Figure 14. View to east of Tree 217 (Wallangarra White Gum) in its growing environment. (Tom Axford, December 2018).

- 7.2.4 Tree 217 is a semi-mature *Eucalyptus scoparia* (Wallangarra white gum) (Figure 14) growing in an inappropriate location to the north of the proposed chapel and adjacent the work shed concrete parking area. It will have a major TPZ encroachment from the proposed new chapel driveway and landscaping works and as such is recommended for removal.

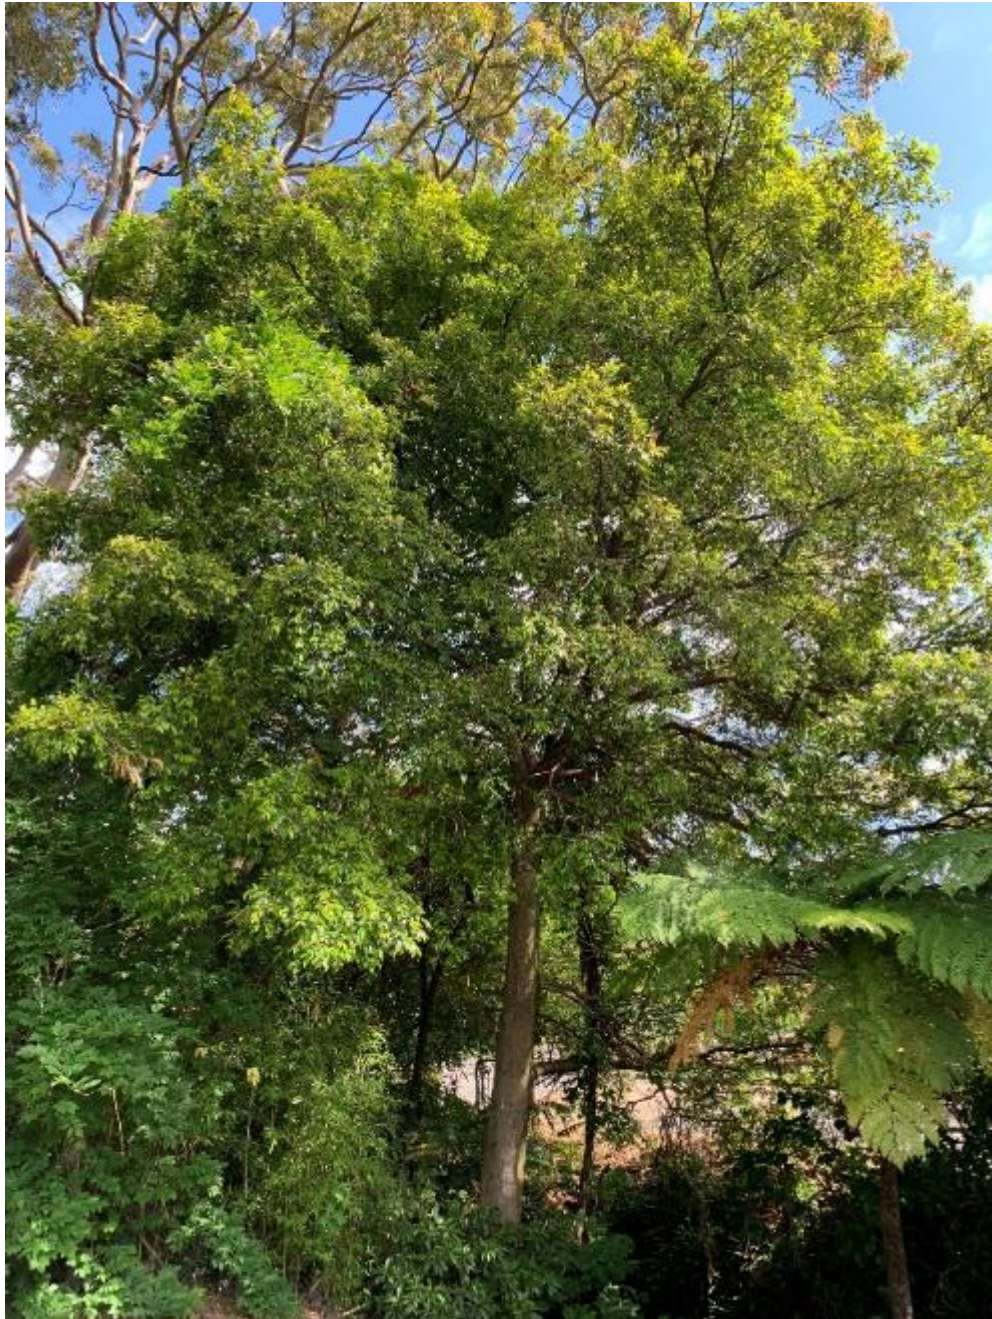
- 6.3.9 Tree 206 is a mature *Syzygium paniculatum* (Magenta brush cherry). It provided amenity value and shading to the south of the existing chapel building along the edge of a natural drainage depression.
- 6.3.10 Tree 206 is of moderate size with good health and fair structure with a ULE of 25–50 years.
- 6.3.11 The TPZ for Tree 206 was 4.8m, with an SRZ of 2.4m, measured at a radial distance from the centre of the trunk.

Figure 15. View to the north of Tree 206 (Magenta brush cherry) in its growing environment. (Tom Axford, December 2018).

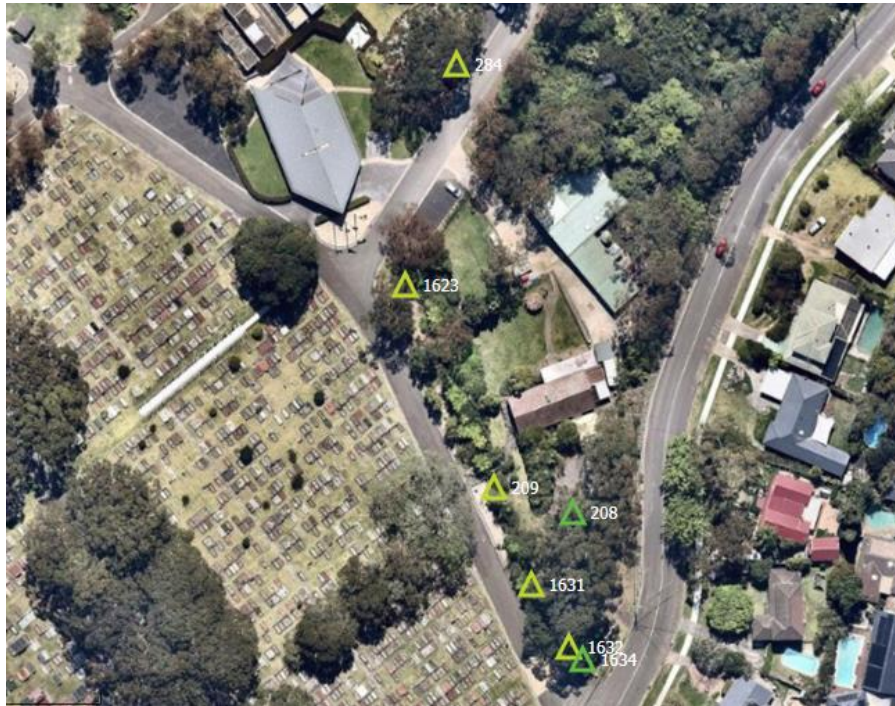
6.5.2 Category U Trees were 208 209 284 1623 1631 1632 1634.

Figure 18. Aerial image showing location of Remove Retention Value Trees (Nil/No Retention Value). Note icon colour indicates trees current risk rating (not Retention Value). Tree attributes are to be obtained from Appendix C – Tree Assessment Data. (ArborPlan, March 2020).

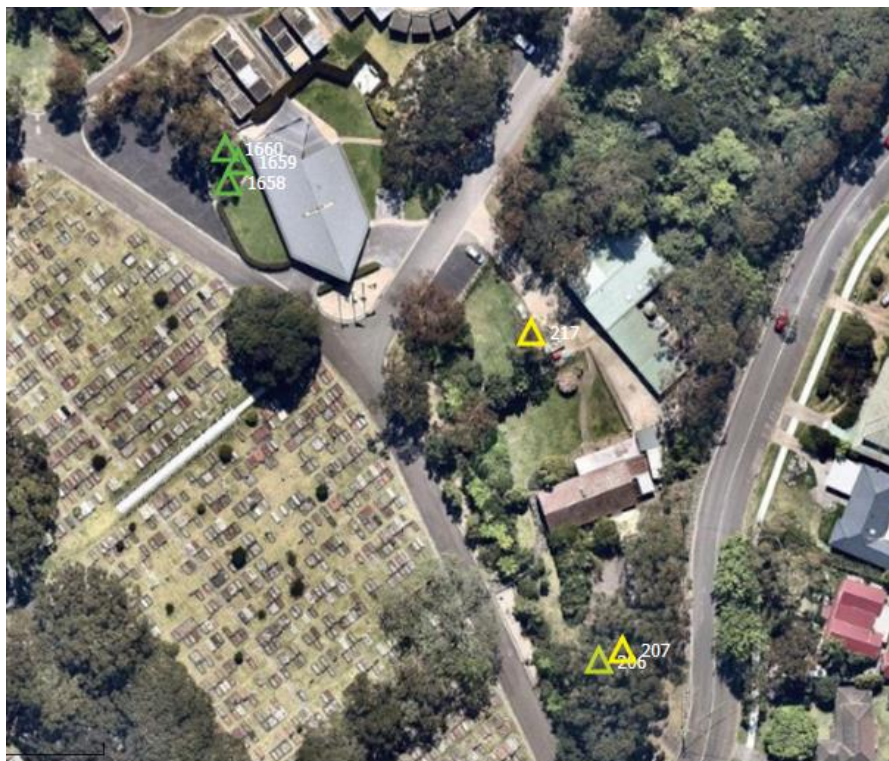
Figure 19. Aerial image showing location of the six (6) trees requiring removal due to major TPZ encroachment
Tree attributes are to be obtained from Appendix C – Tree Assessment Data. (ArborPlan, March 2020).

- 8.1.1 Six (6) trees would require removal to facilitate this development. These are:
- One (1) x High retention value (Category A) tree – 207
 - Two (2) x Moderate retention value (Category B) trees – 206 and 217
 - Three (3) x Low retention value (Category C) trees – 1658, 1659 and 1660.
- 8.1.2 Seven (7) trees were recommended for removal irrespective of future development on the site. These are trees 208, 209, 284, 1623, 1631, 1632 and 1634.
