## Geotechnical Assessment

**Project:** Secondary Dwelling  
24 Oliver Street, Freshwater NSW

**Ref:** AG 22394  
6 September 2022

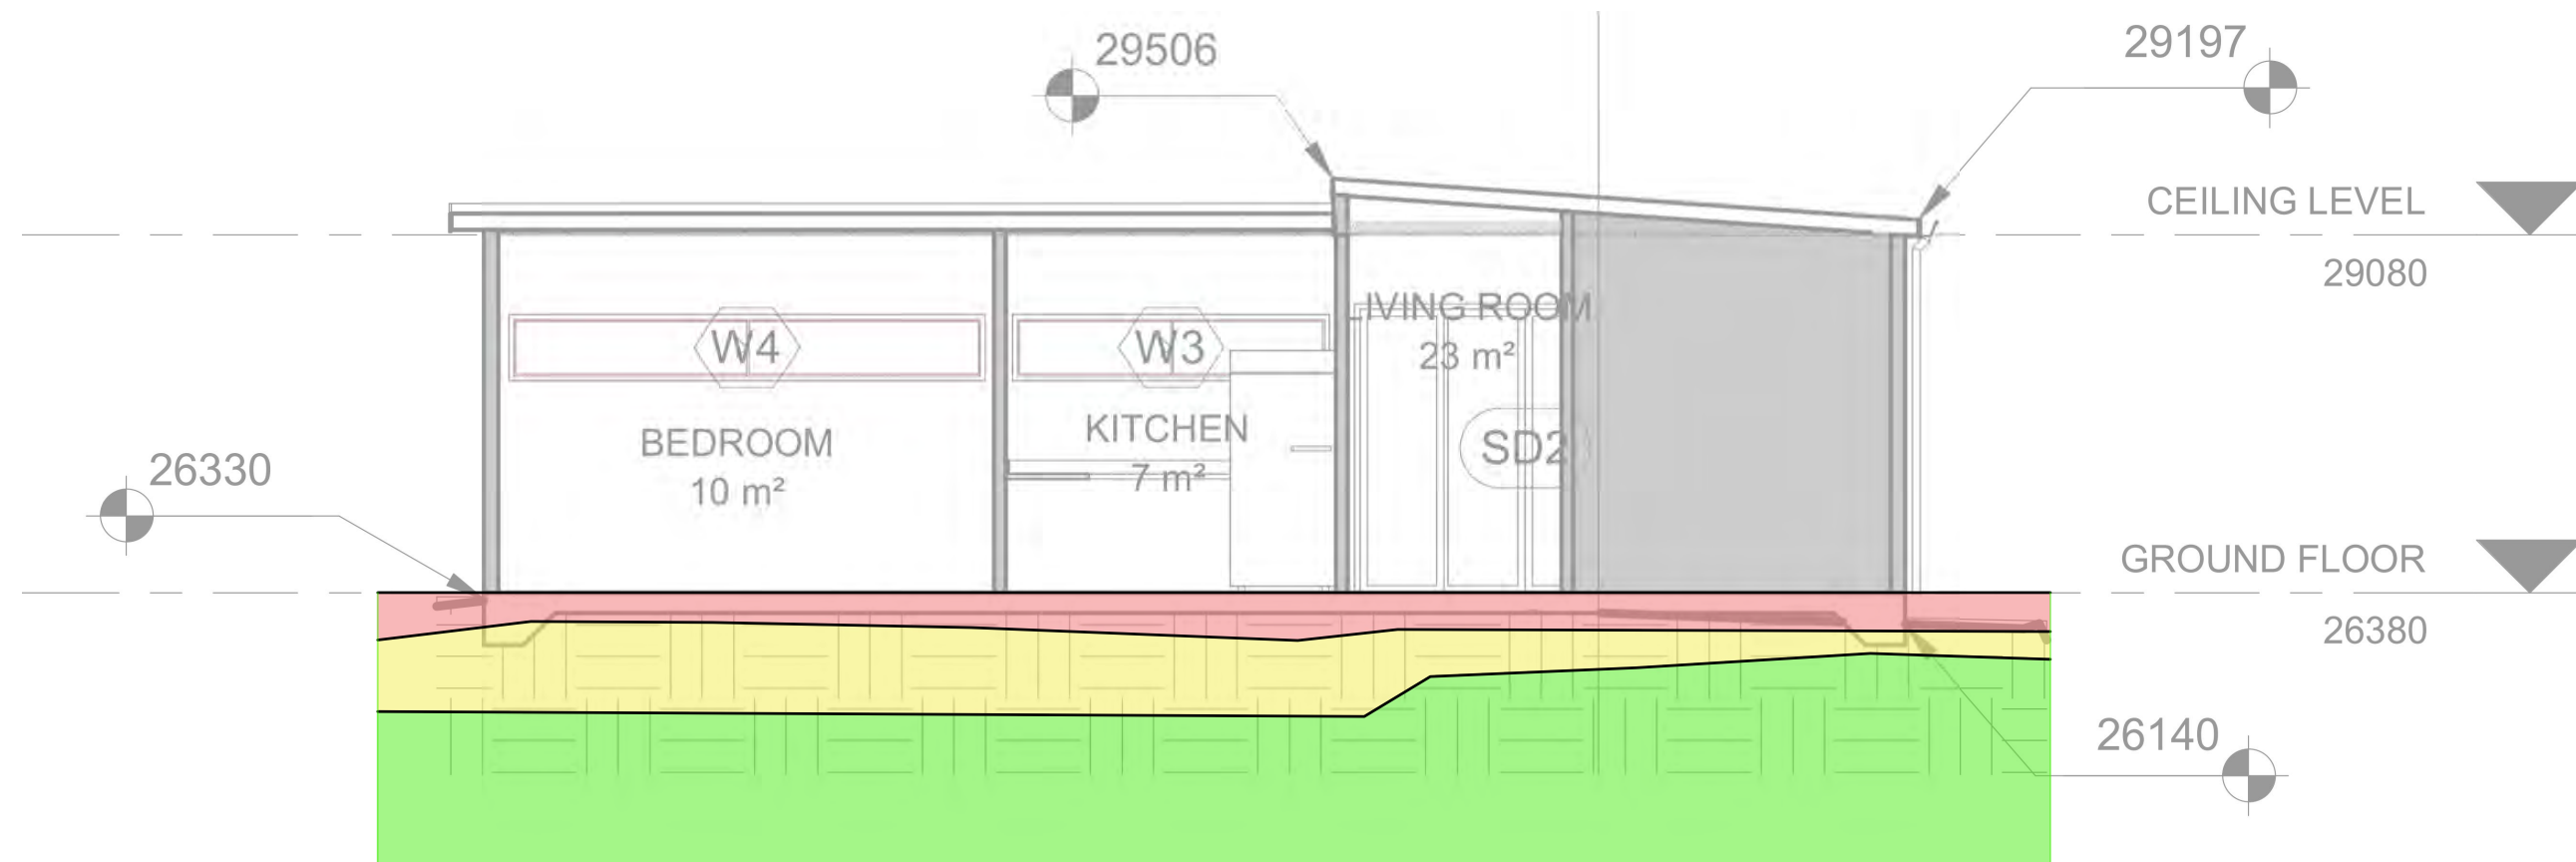
**INFERRED GEOLOGICAL SECTION**  
SCALE NTS

The soil profile consists of shallow uncontrolled fill and silty topsoil (O & A Horizons), silty sand (B Horizon) and weathered bedrock (C Horizon). Based on our observations and the results of testing on site, we would expect weathered sandstone bedrock to be found within 0.40 to 1.5 metres below current surface levels across the area of the proposed works.

INTERPRETED SUBSURFACE SECTION ONLY.  
ACTUAL GROUND CONDITIONS MAY VARY.
