Preliminary Geotechnical Assessment

For Alterations and Additions at
58 Parni Place, Frenchs Forest NSW

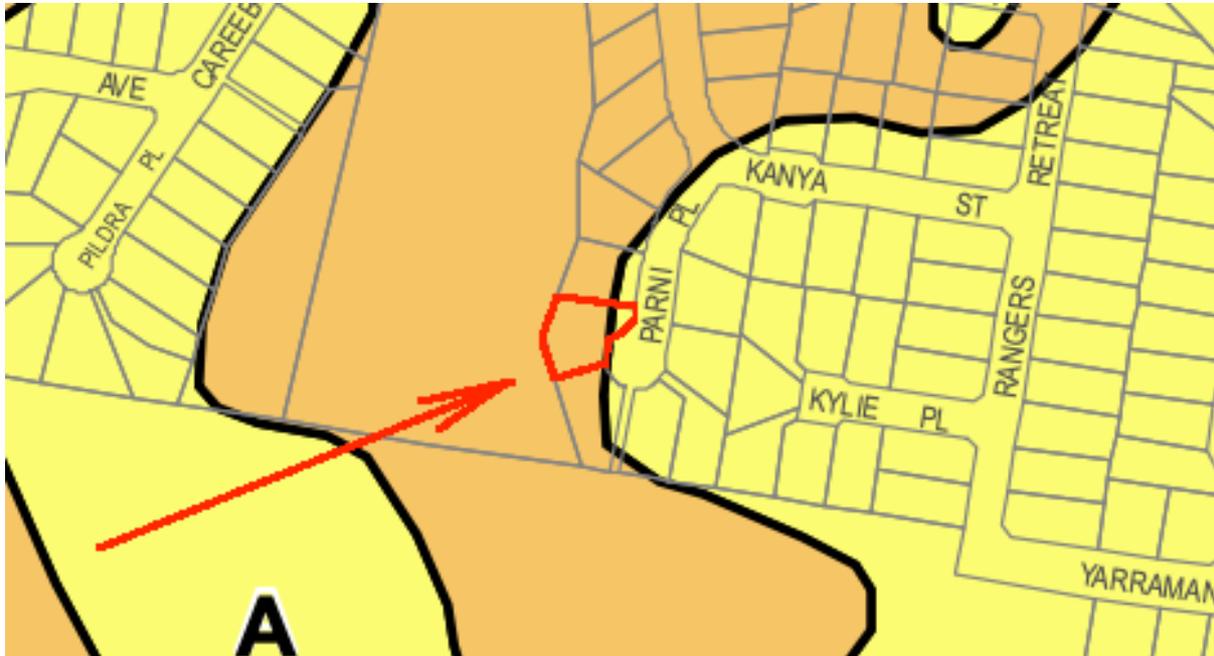
WARRINGAH LANDSLIP RISK MAP

The site is mapped as **Area A & B** on the Landslip Risk Map LSR_008 (**Image 1**, below).
