Geotechnical Investigation Report

**Proposed Residential Development
888 Barrenjoey Road, Palm Beach NSW**

18 May 2021

12949-GR-1-1

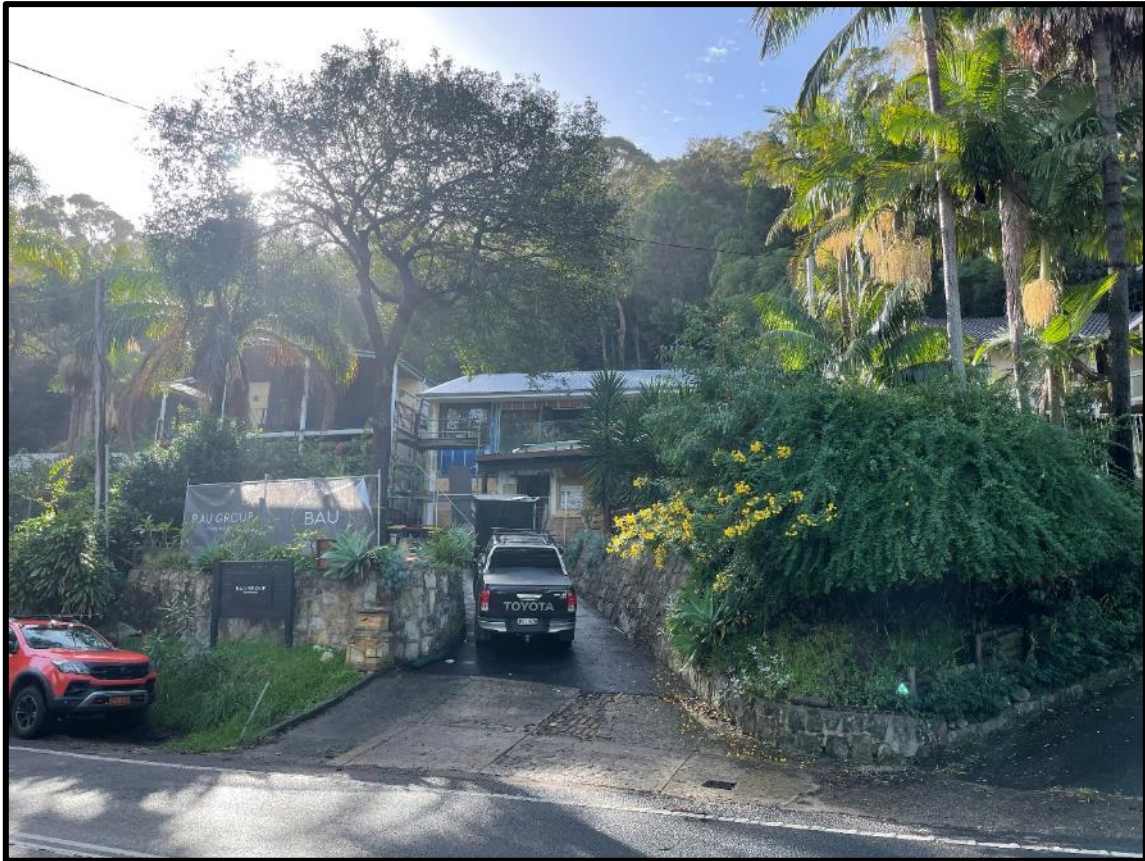
Photo 1 – View of site from Barrenjoey Road, looking north east.

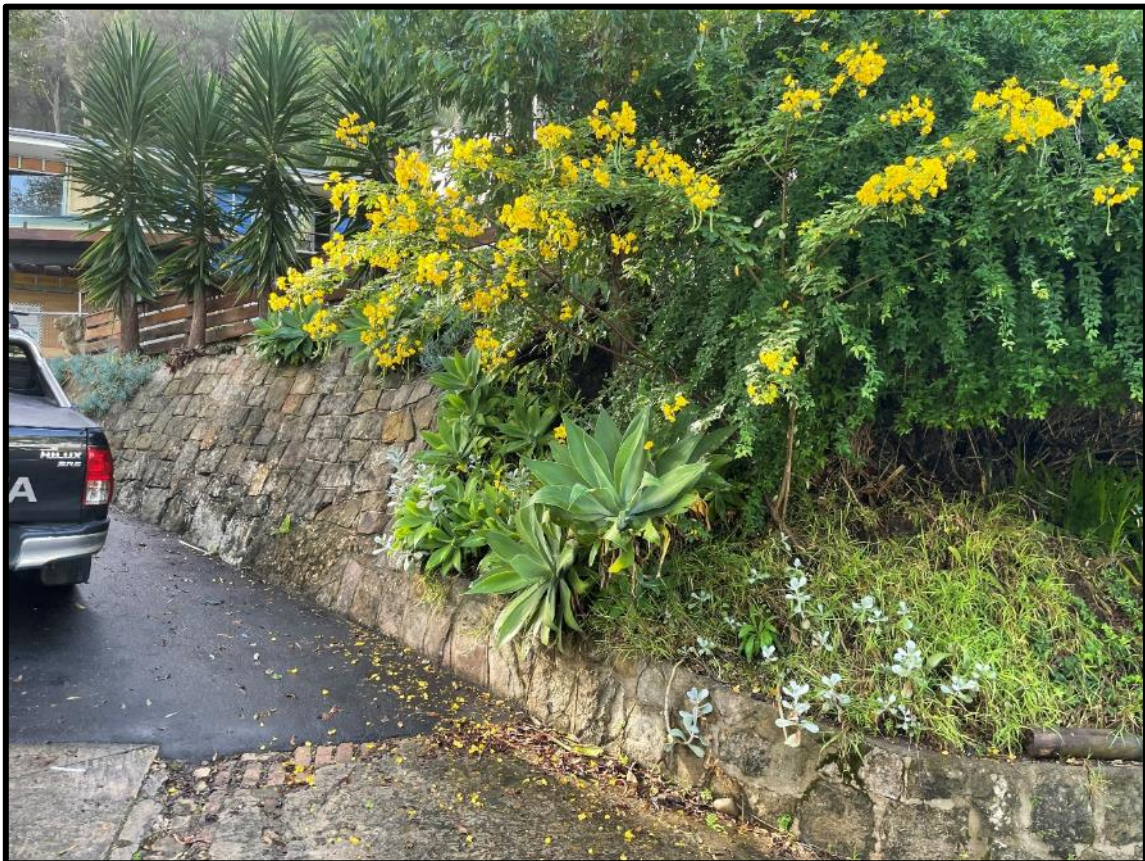
Photo 2 – View of location of proposed garage, looking east.

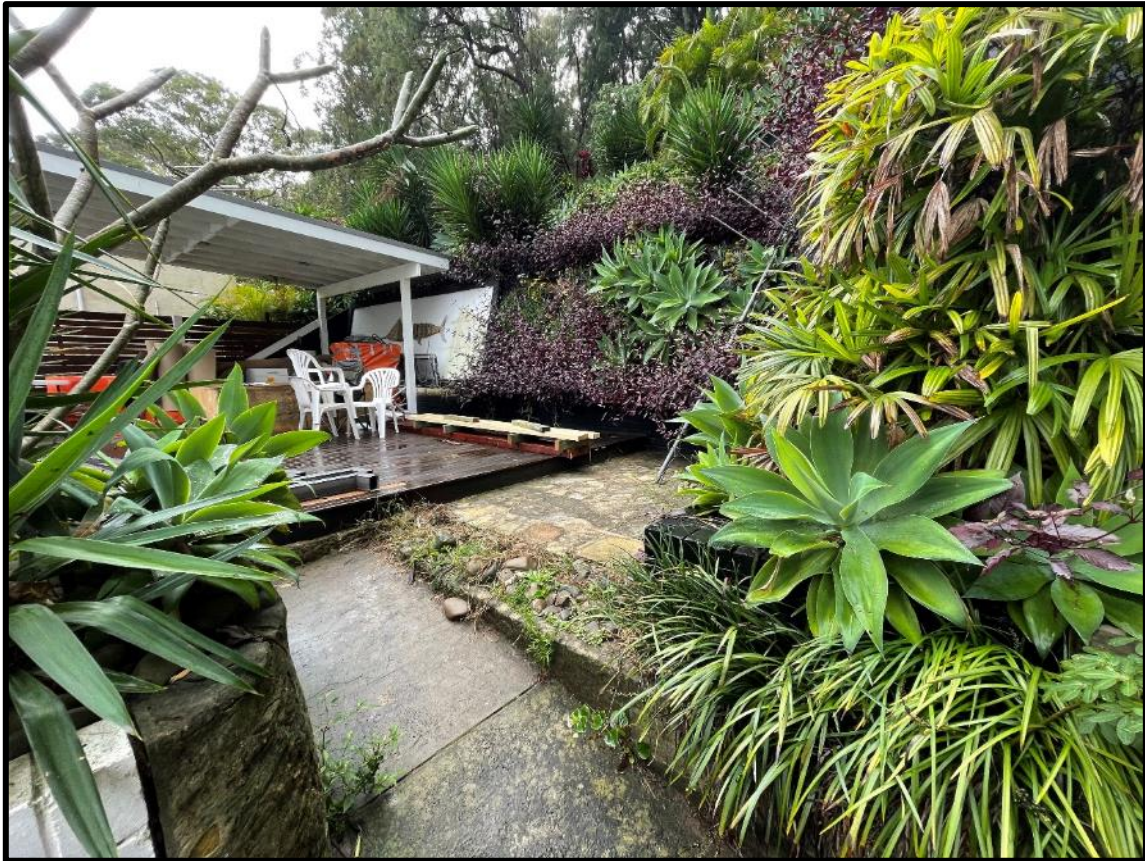
Photo 3 – View of location of proposed swimming pool, looking north-north-east.

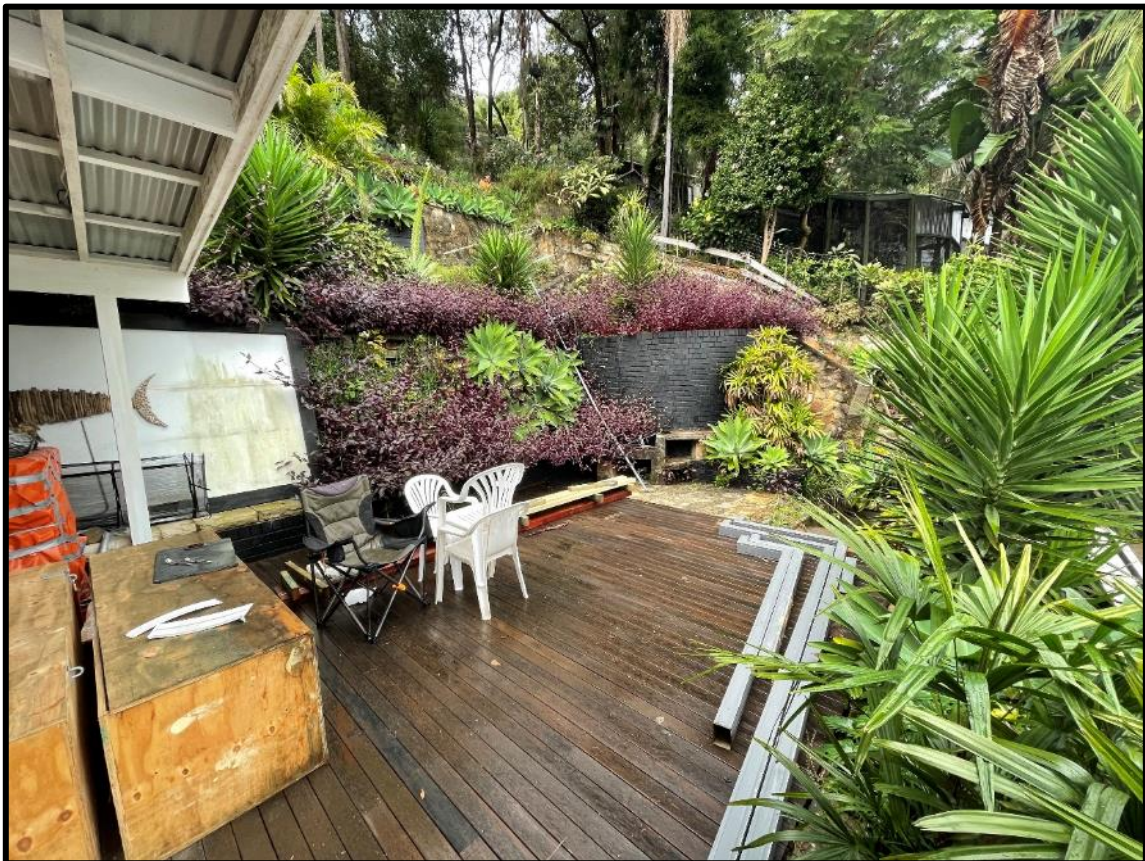
Photo 4 - View of location of proposed swimming pool, looking north-south-east.

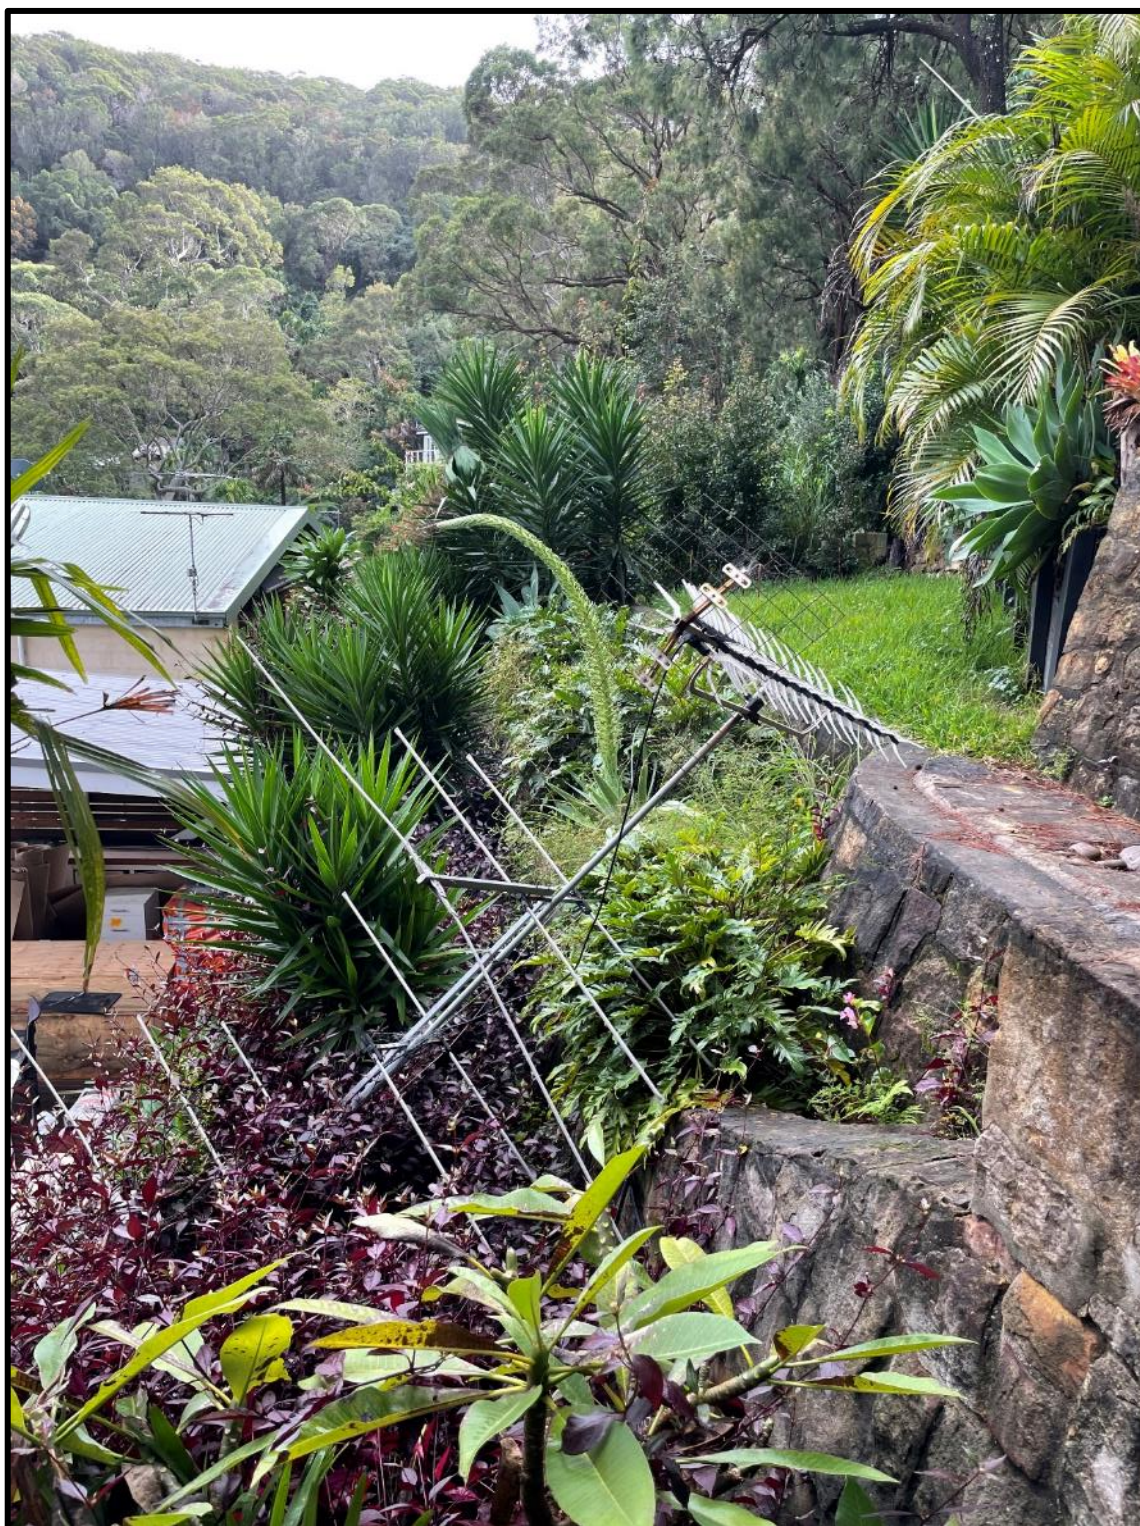
Photo 5 – View of terraced gardens and lawn area upslope from proposed pool location.

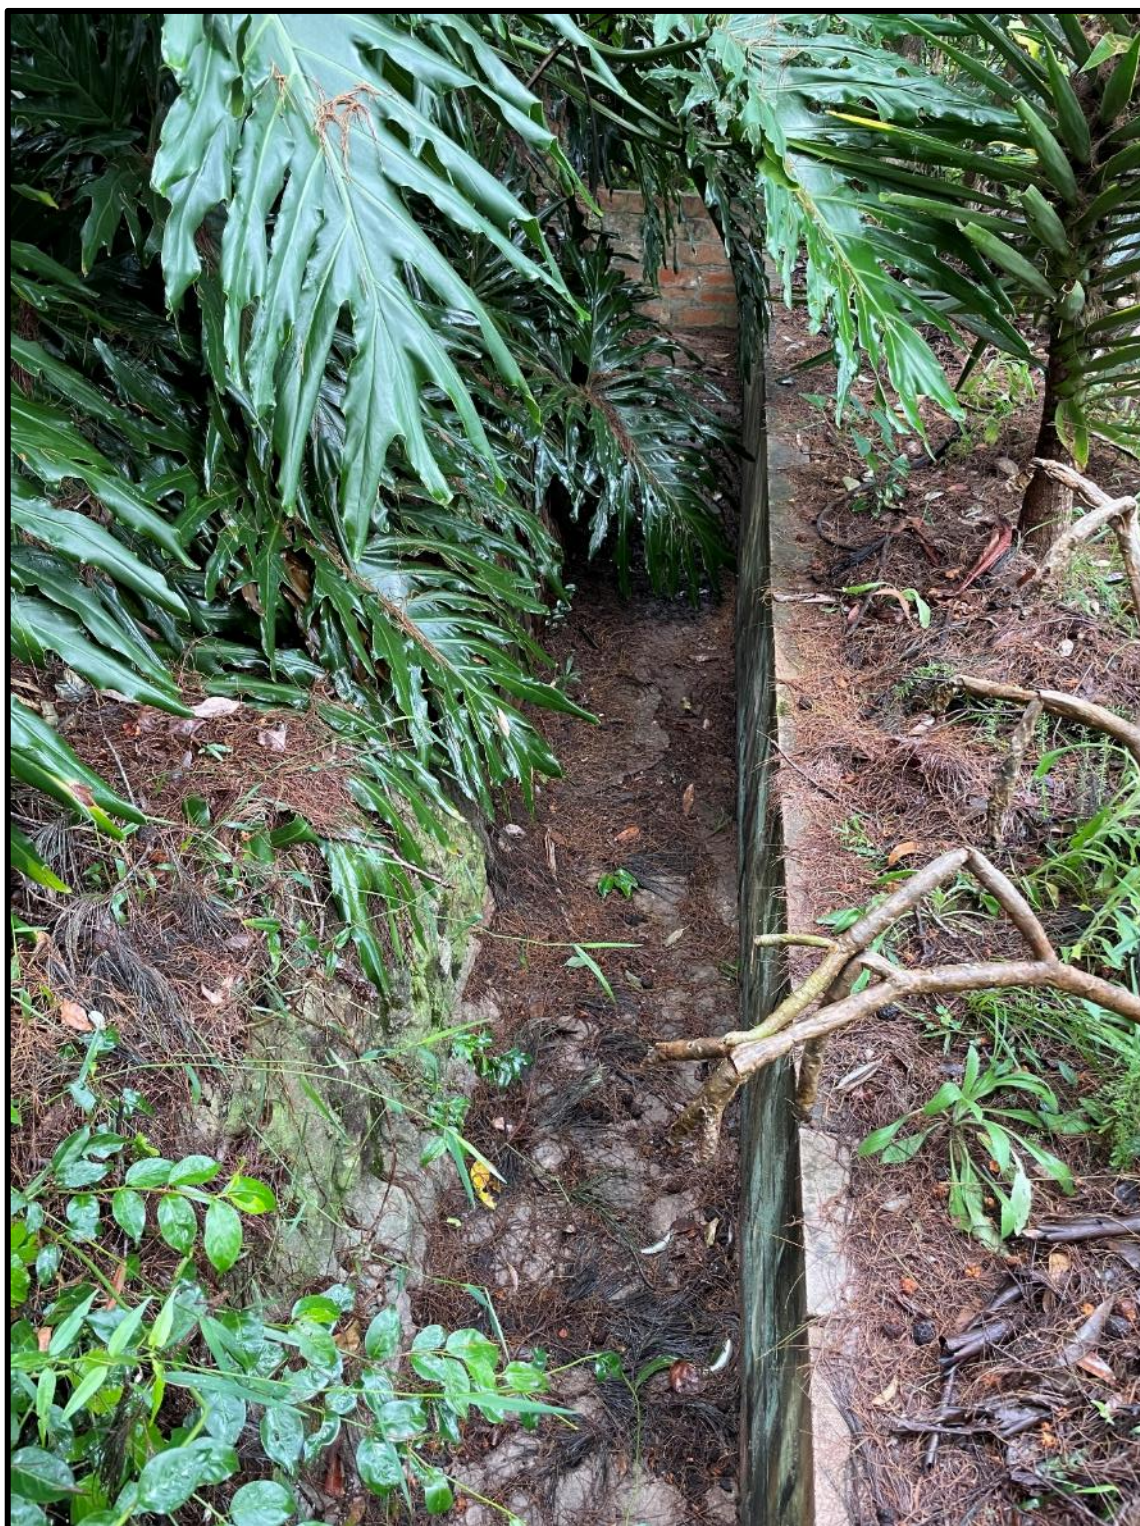
Photo 6 – View of concrete drain traversing north/south across rear section of site.

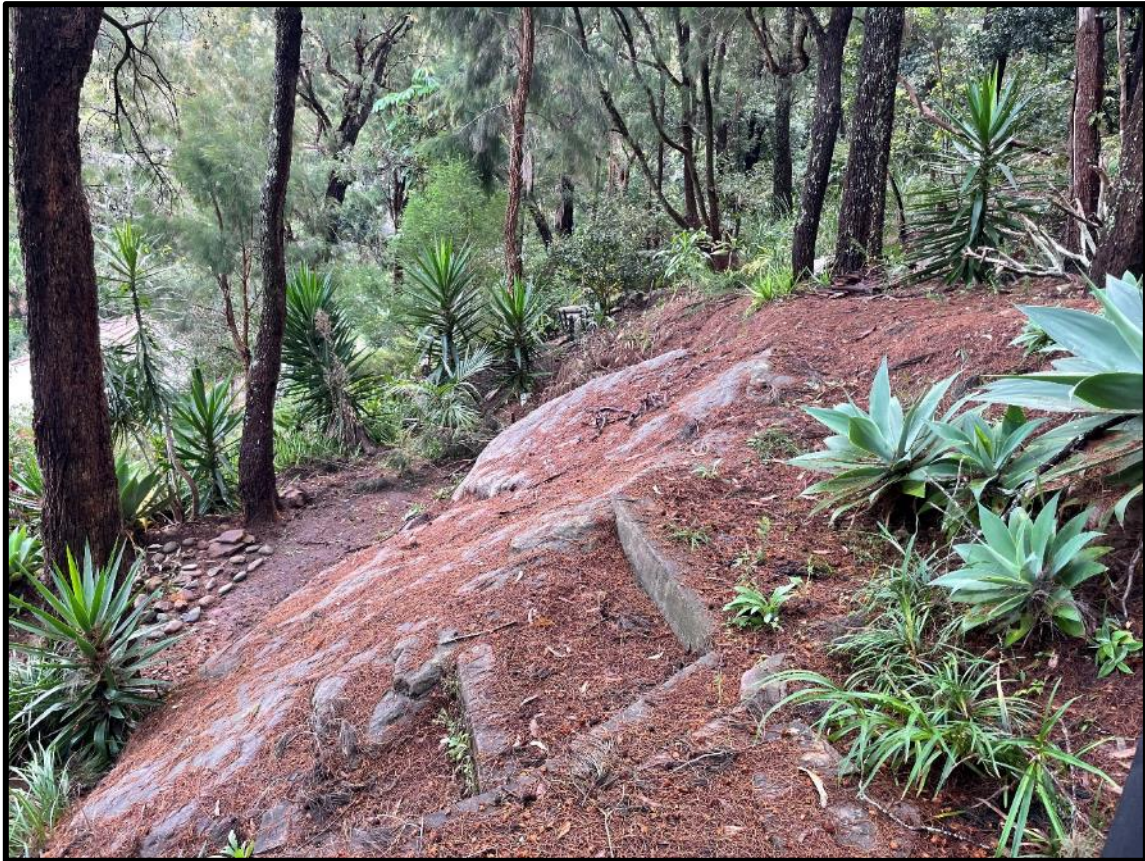
Photo 7 – Large sandstone boulder/outcrop in rear section of site on W side of concrete drain.

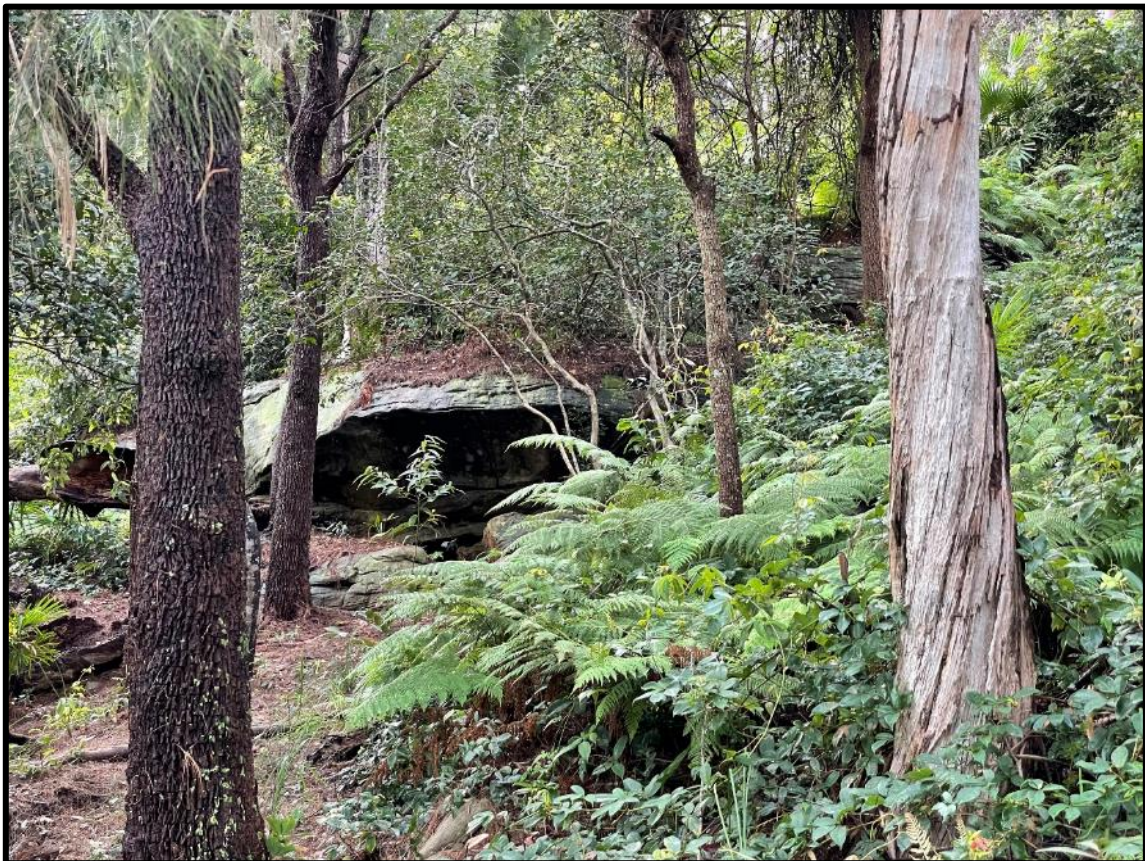
Photo 8 – Very large sandstone boulder/outcrop near north-eastern corner of site.

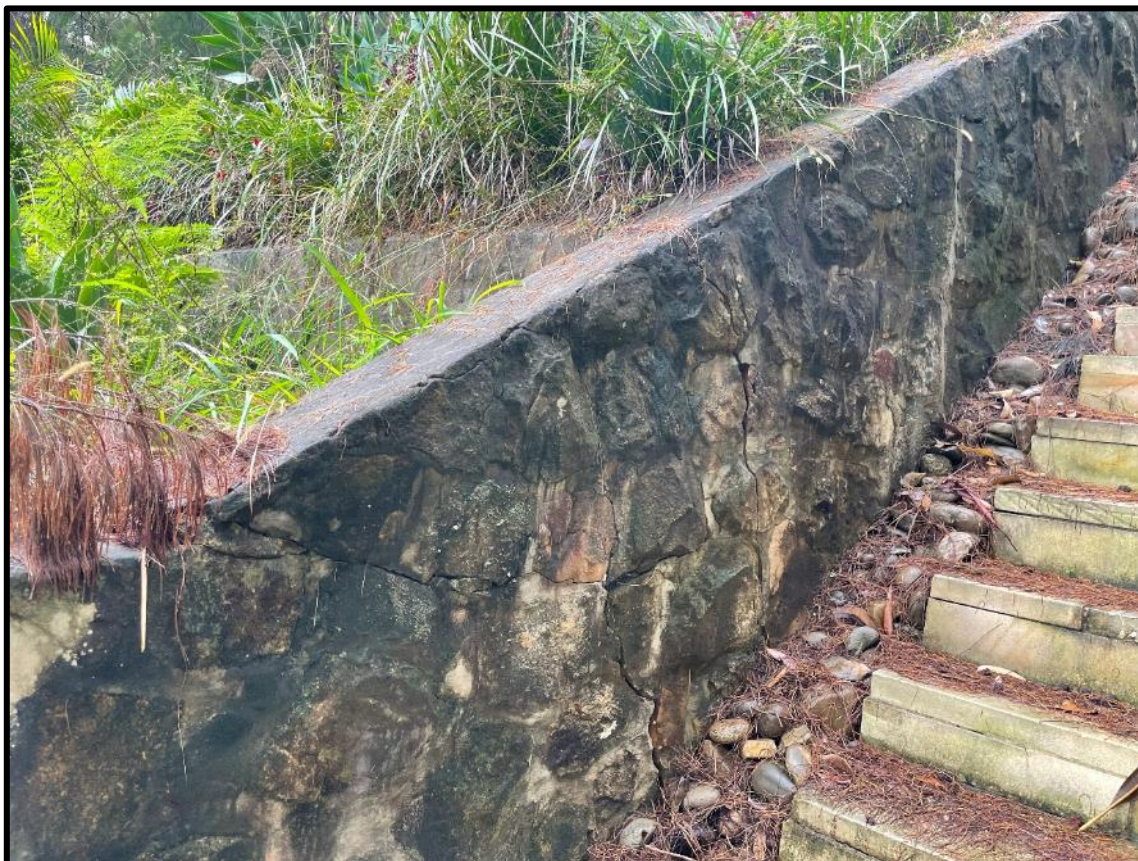
Photo 9 – View of typical sandstone rock wall with minor cracking.
