## **Geotechnical Assessment**

**Project:** Alterations and Additions  
122 Parkes Road, Collaroy Plateau NSW

**REF: AG 20003**  
15<sup>th</sup> January, 2019

For Alterations and Additions at  
**122 Parkes Road, Collaroy Plateau NSW**

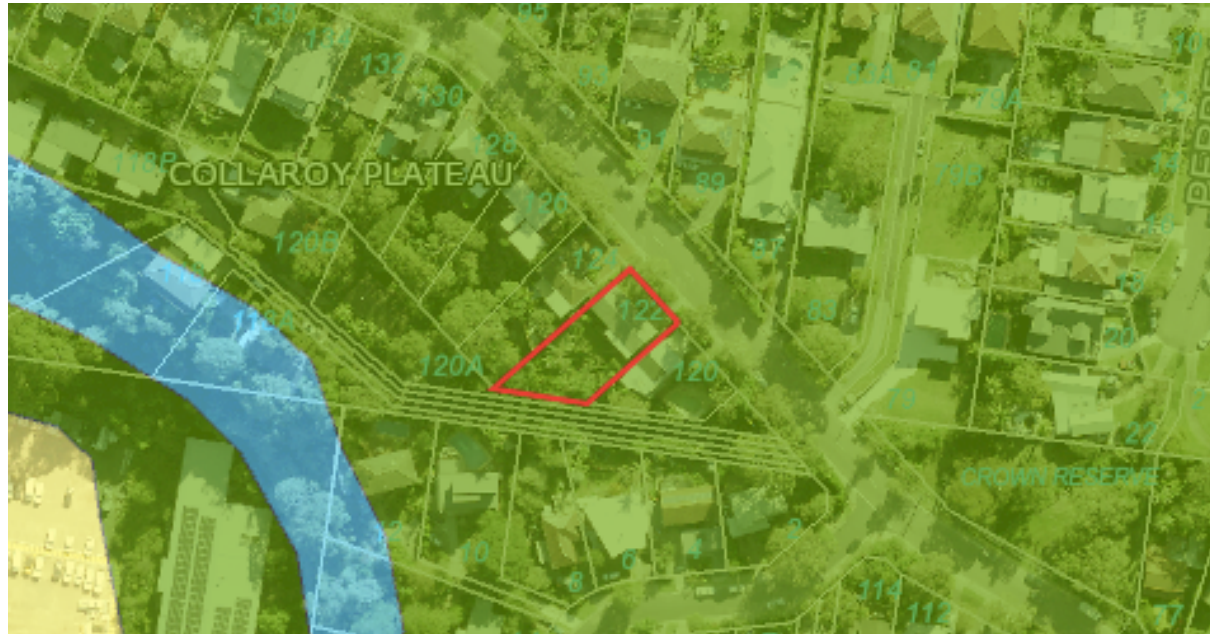
**WARRINGAH LANDSLIP RISK MAP**

- No evidence of significant soil creep, tension cracks or other indicators of slope instability were identified at the time of our inspection.
- The damage to the low brick wall, toward the south-western boundary of the site, was likely the result of poor construction, and inadequate design, and cannot be attributed to slope instability.
- The property is classified as **Area D** with reference to Northern Beaches Council WLEP Landslip Risk Map (WLEP Landslip Risk Map **Image 2** below).

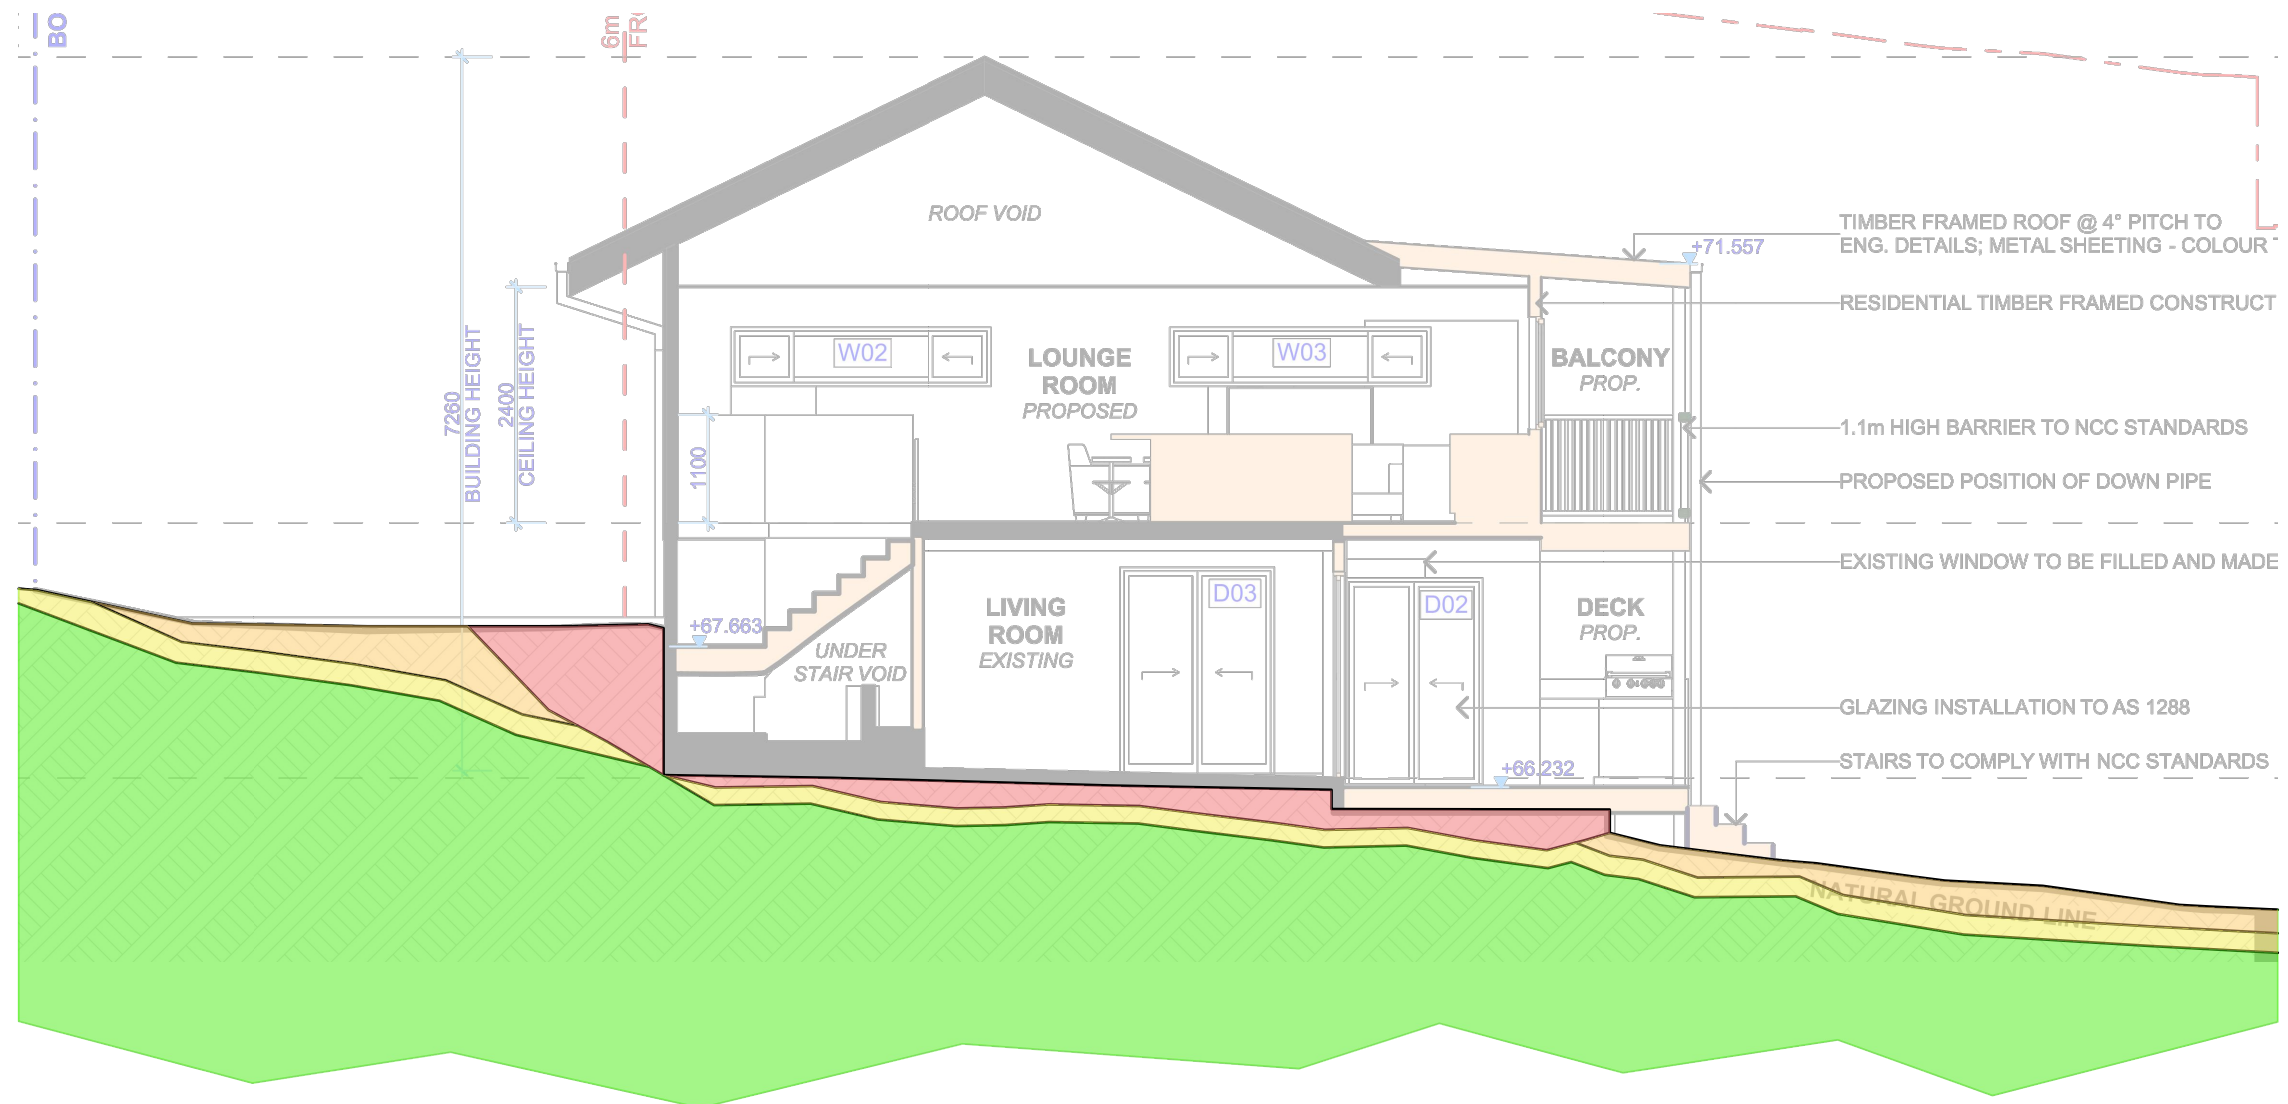
INFERRED GEOLOGICAL SECTION

INTERPRETED SUBSURFACE SECTION ONLY.  
ACTUAL GROUND CONDITIONS MAY VARY.
