Hazardous Building Materials (HBM) Register

2 Dee Why Parade
Dee Why NSW 2099

Prepared for
Dee Why RSL Club

Project 99758.00
August 2020

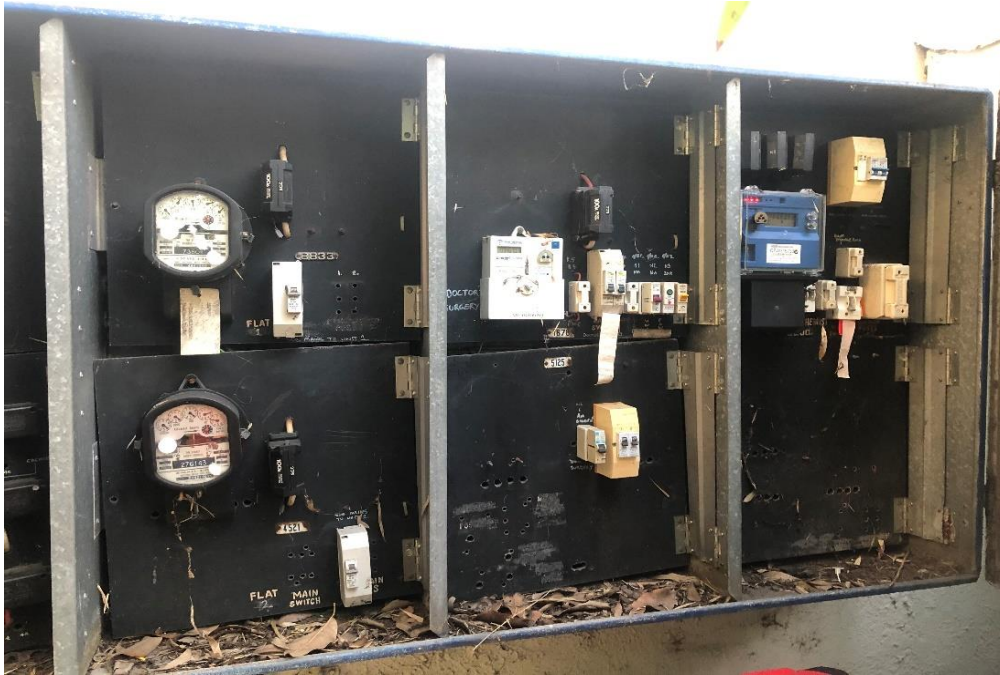
Photograph 1: 2 Dee Why Parade, Dee Why, external, southeast corner, electrical box, electrical backing board(s), suspected asbestos.

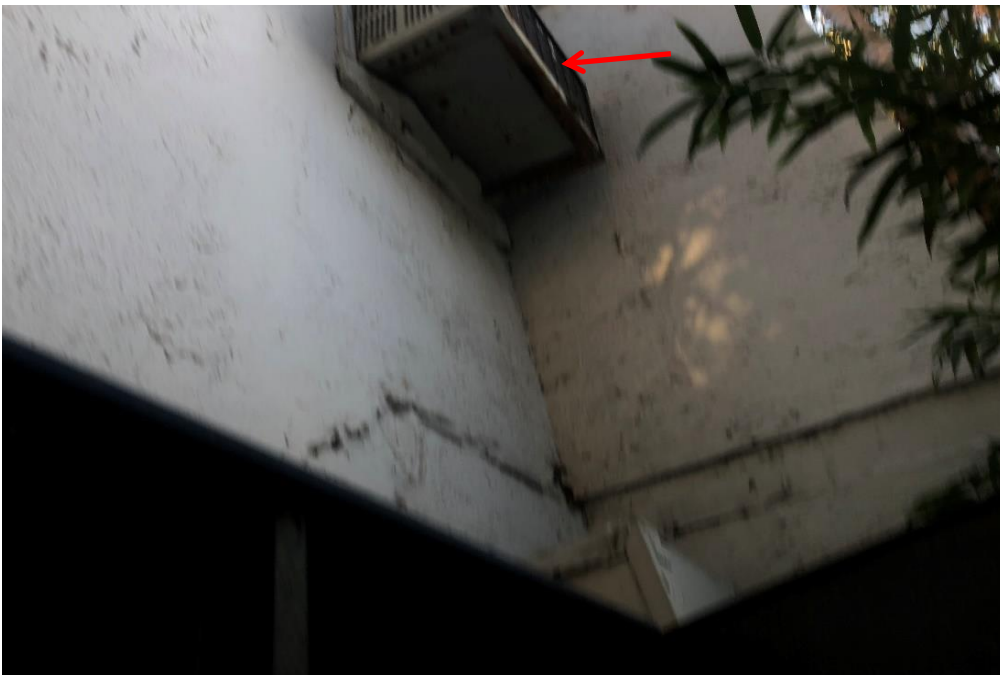
Photograph 2: 2 Dee Why Parade, Dee Why, external, southeast corner and throughout, A/C unit(s), bulk internal insulation, suspected SMF.

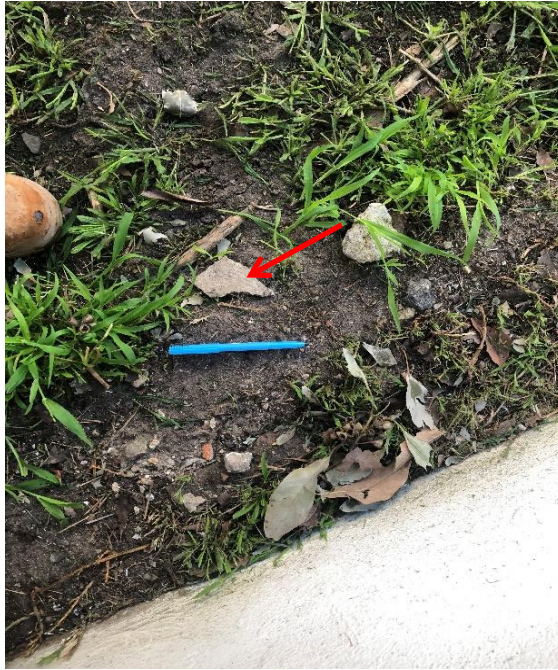
Photograph 3: 2 Dee Why Parade, Dee Why, external, south east corner, ground debris, fibre cement sheeting, asbestos detected by analysis.

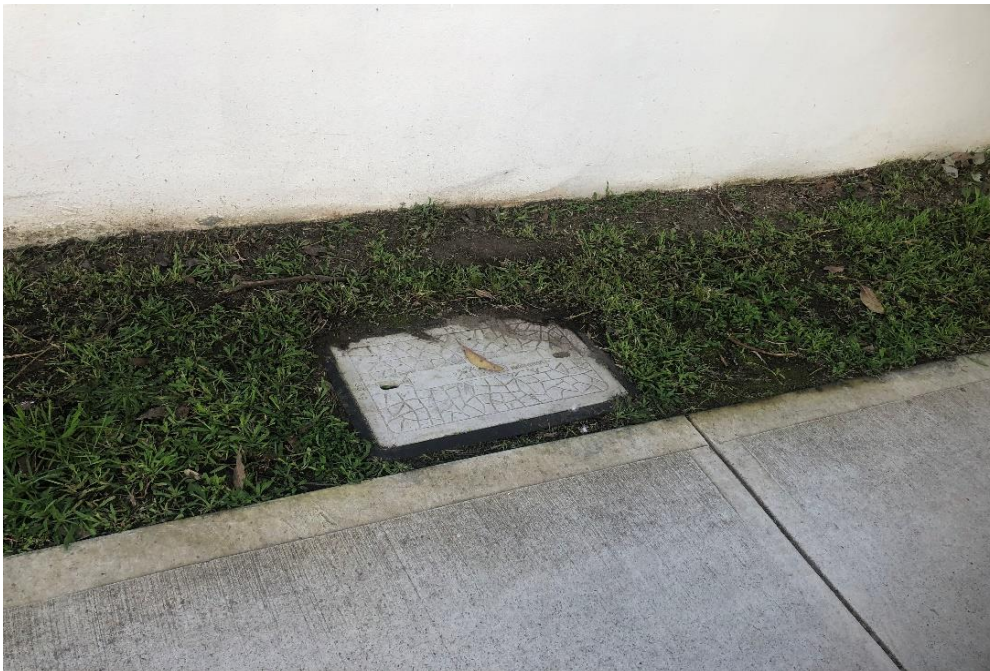
Photograph 4: 2 Dee Why Parade, Dee Why, external, southern elevation, service pit, suspected non-asbestos.

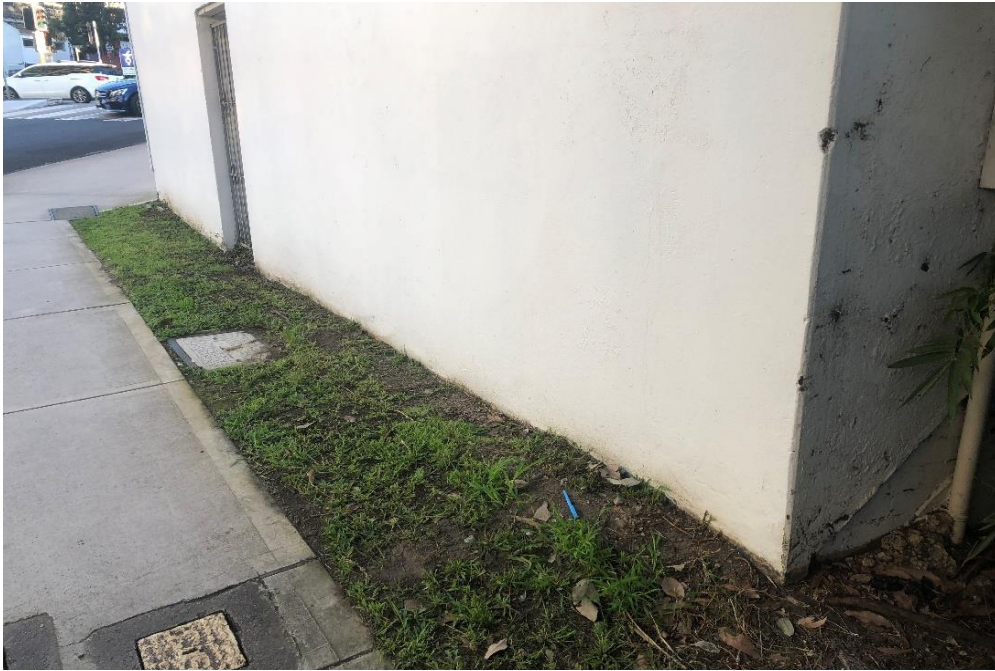
Photograph 5: 2 Dee Why Parade, Dee Why, external, surface throughout, paint covering, white paint, lead paint (>0.1% lead w/w).

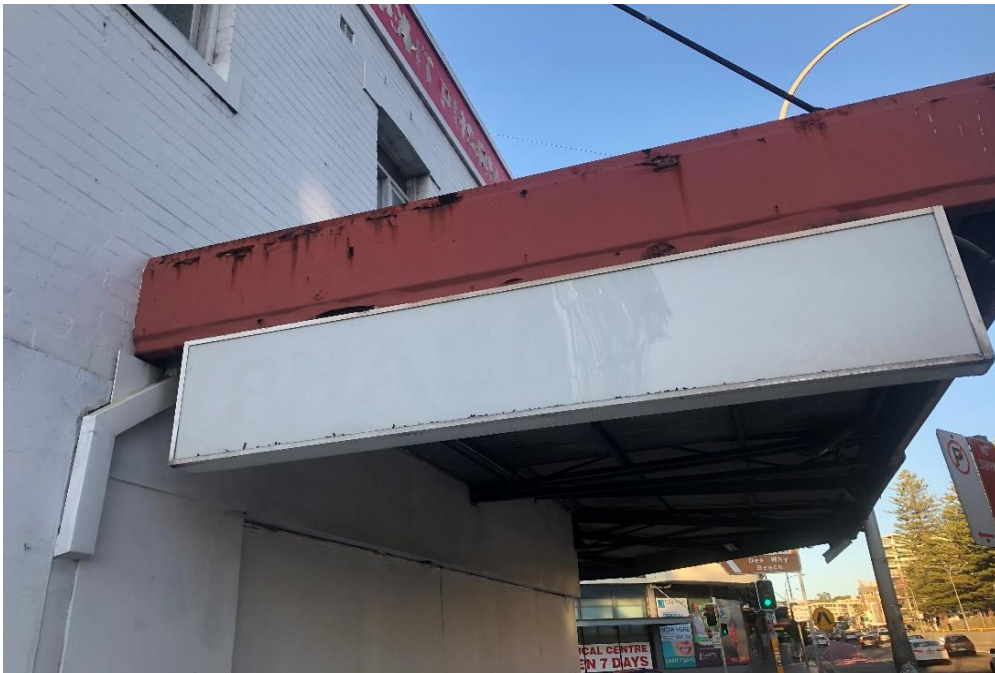
Photograph 6: 2 Dee Why Parade, Dee Why, external, surfaces throughout, paint covering, light red paint, lead paint (>0.1% lead w/w).

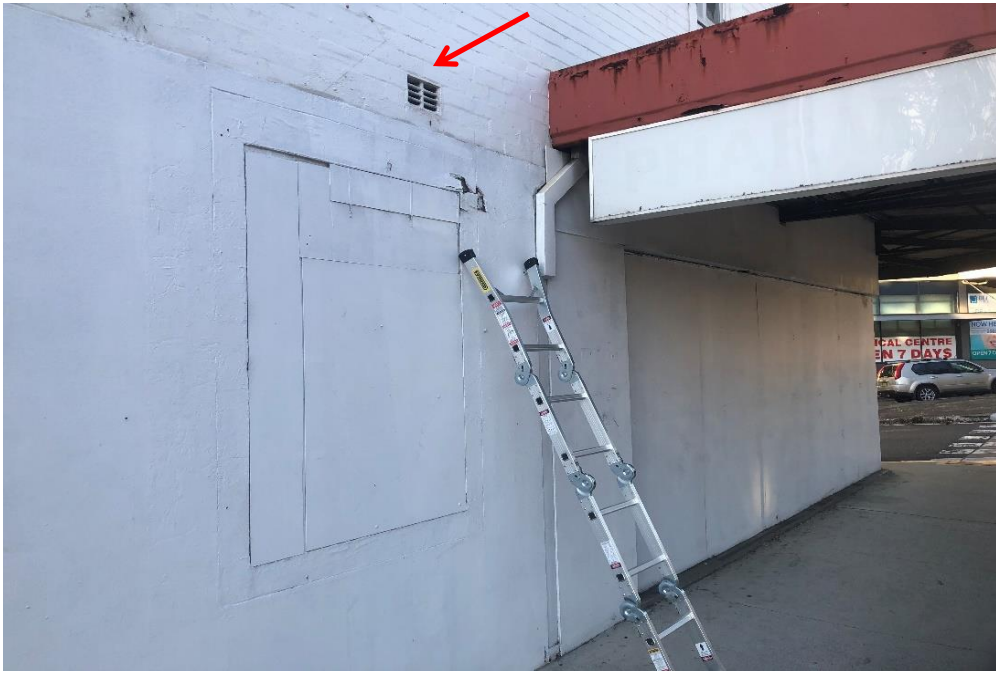
Photograph 7: 2 Dee Why Parade, Dee Why, external, surfaces throughout, paint covering, typical off-white paint, non-lead paint ($\leq 0.1\%$ lead w/w)

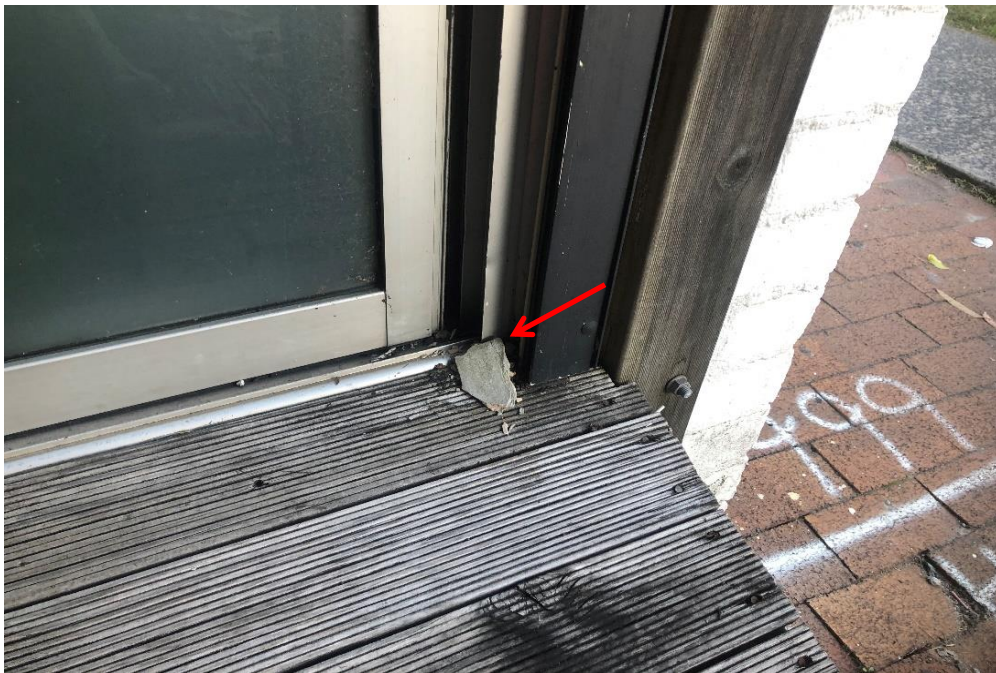
Photograph 8: 2 Dee Why Parade, Dee Why, external, western elevation, ramp to hair salon, ground debris, fibre cement sheeting, no asbestos detected by analysis.

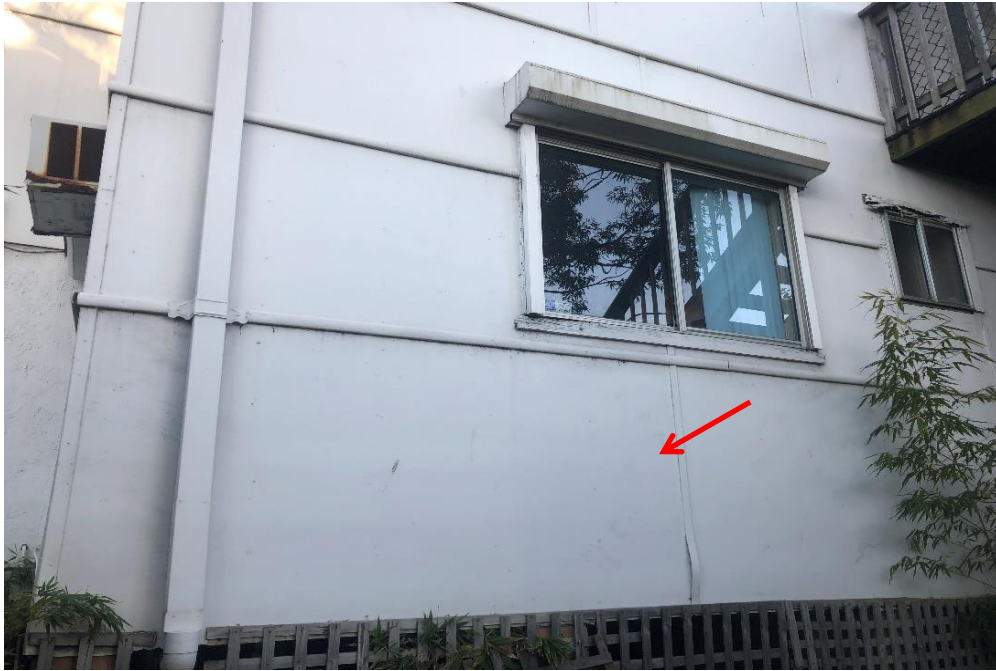
Photograph 9: 2 Dee Why Parade, Dee Why, external, throughout, wall material, fibre cement sheeting, no asbestos detected by analysis.

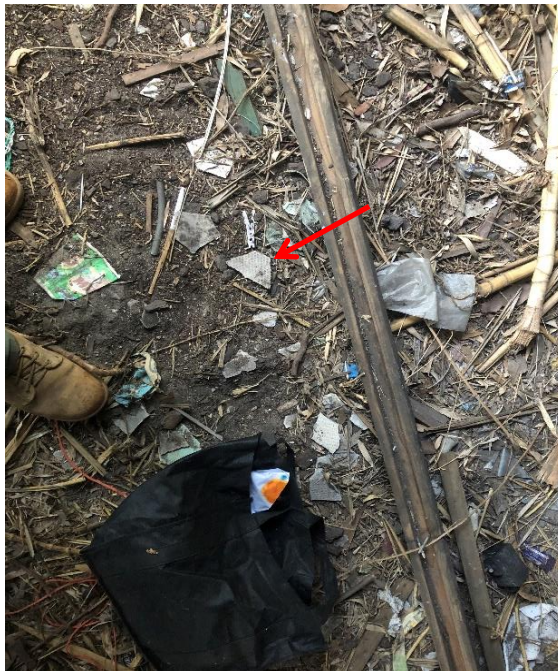
Photograph 10: 2 Dee Why Parade, Dee Why, external, eastern elevation, entrance to subfloor and throughout subfloor, ground debris, fibre cement sheeting, asbestos detected by analysis.

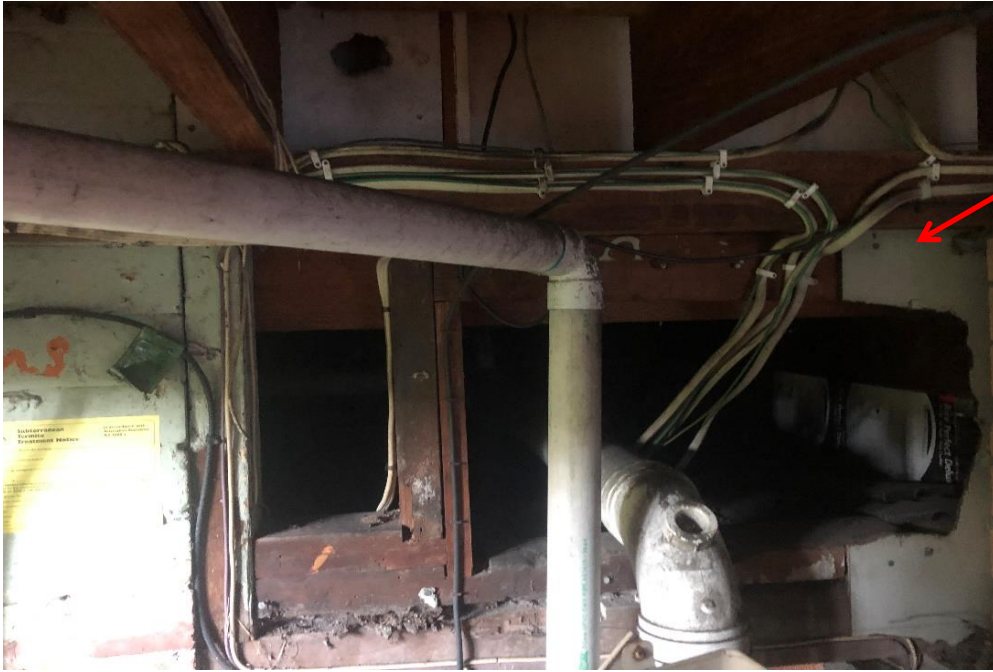
Photograph 11: 2 Dee Why Parade, Dee Why, external, subfloor areas, infill panels, throughout, fibre cement sheeting, asbestos detected by analysis.

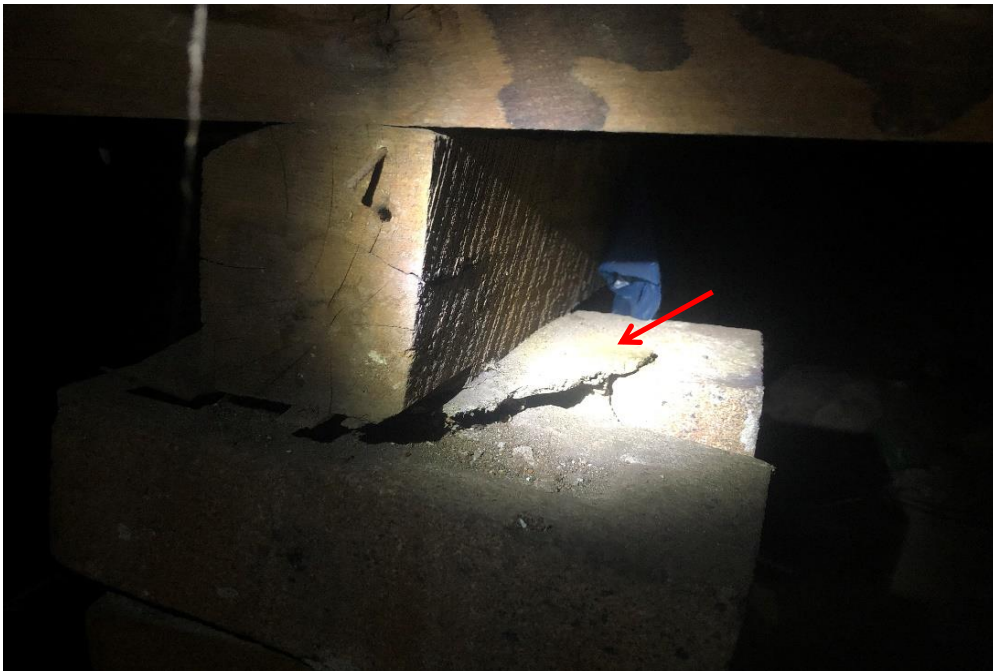
Photograph 12: 2 Dee Why Parade, Dee Why, external, subfloor areas, packing material, fibre cement sheeting, asbestos detected by analysis.

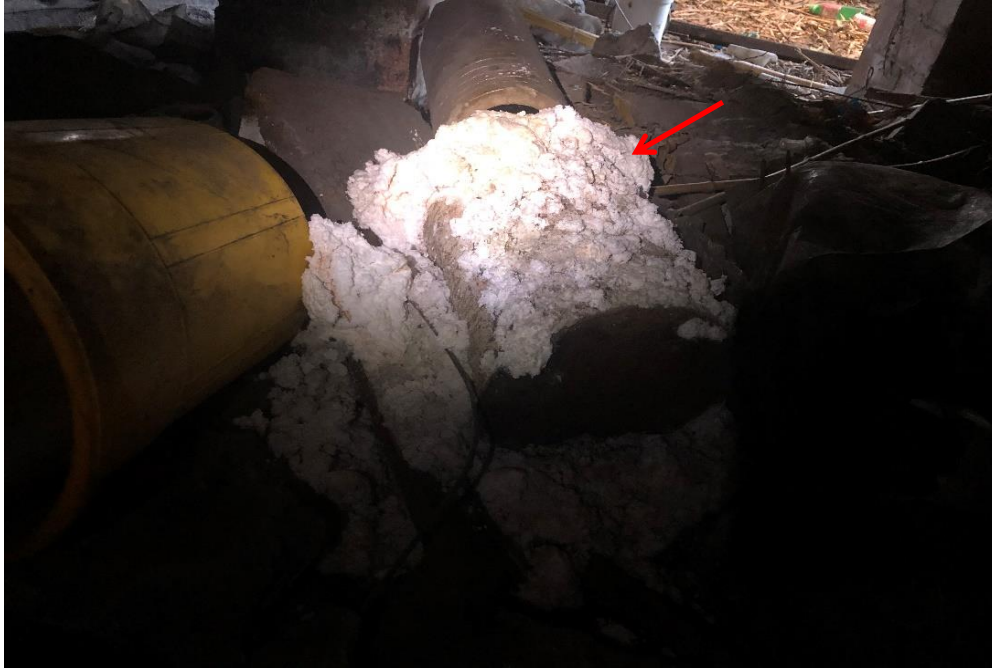
Photograph 13: 2 Dee Why Parade, Dee Why, external, subfloor areas, central subfloor area, suspect insulation material, no asbestos detected by analysis.

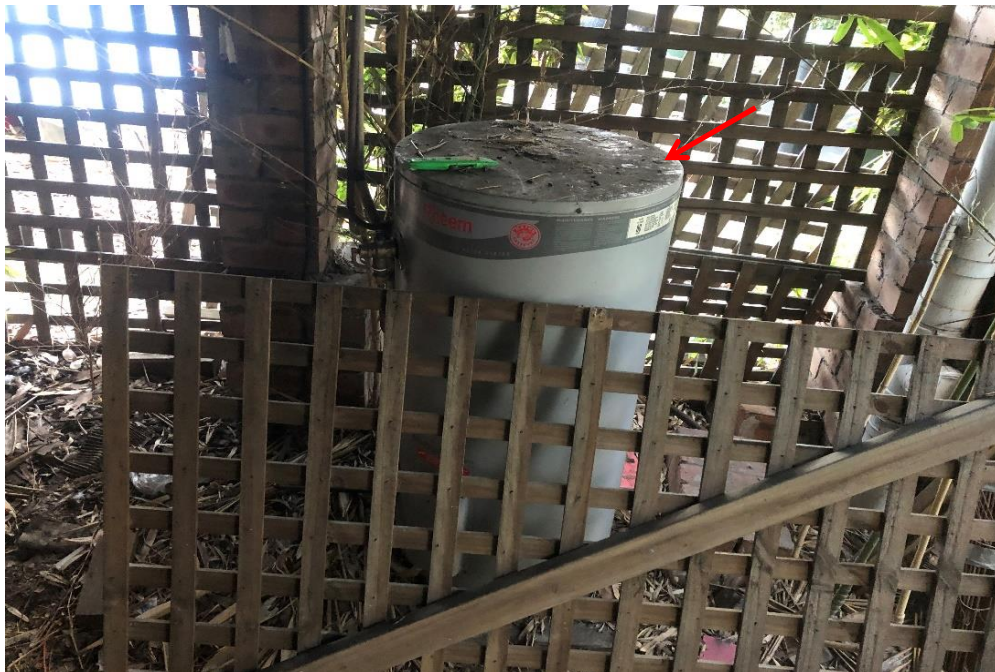
Photograph 14: 2 Dee Why Parade, Dee Why, external, subfloor areas, rheem hot water system, bulk internal insulation, suspected SMF.

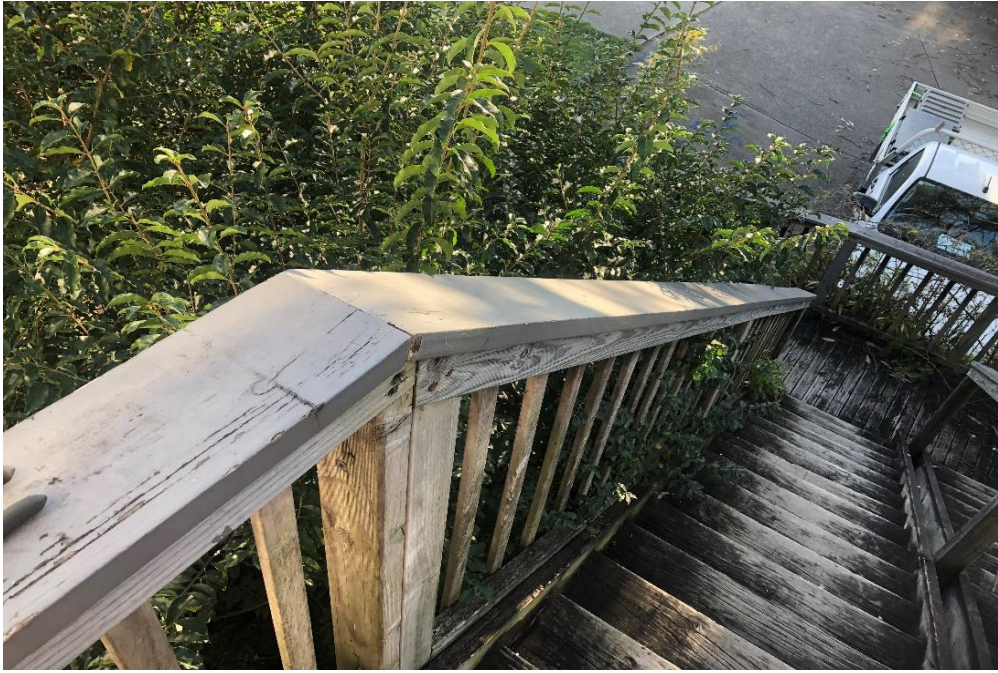
Photograph 15: 2 Dee Why Parade, Dee Why, external, north elevation, stair handrail to level 2, paint covering, typical grey paint, non-lead paint ($\leq 0.1\%$ lead w/w)

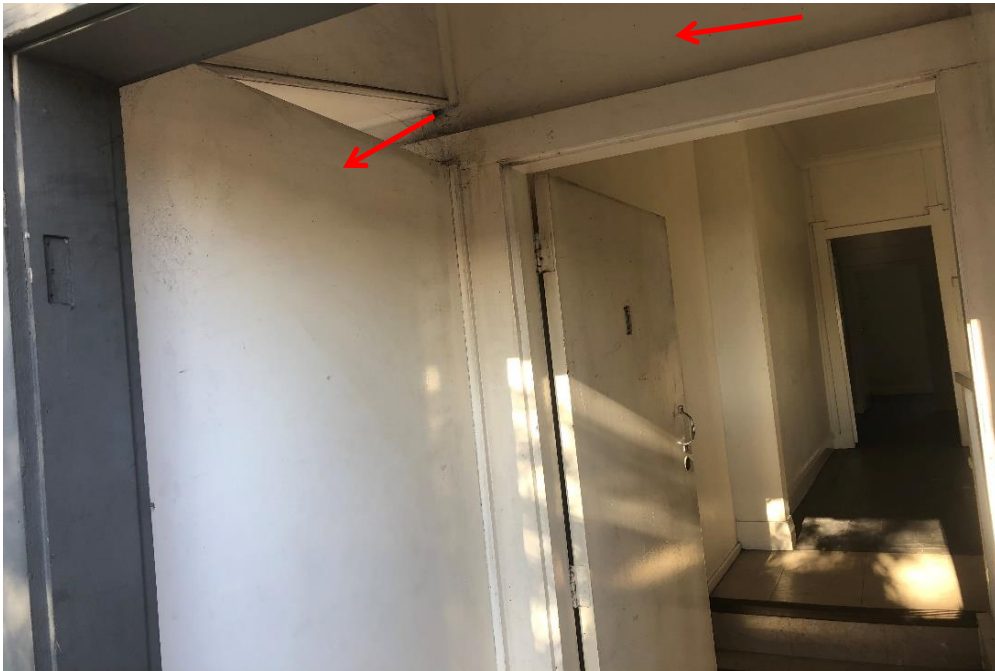
Photograph 16: 2 Dee Why Parade, Dee Why, external, level 2, adjacent apartment front doors, partition and walls, fibre cement sheeting, no asbestos detected by analysis.

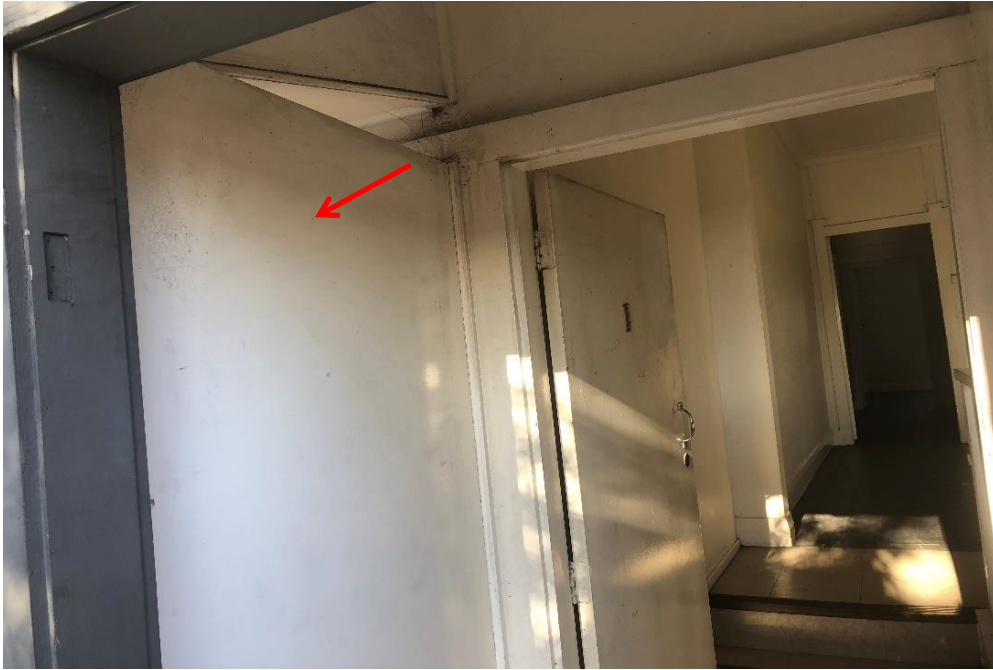
Photograph 17: 2 Dee Why Parade, Dee Why, external, level 2, adjacent apartment front doors, partition and walls, paint covering, typical gloss cream paint, non-lead paint ($\leq 0.1\%$ lead w/w)

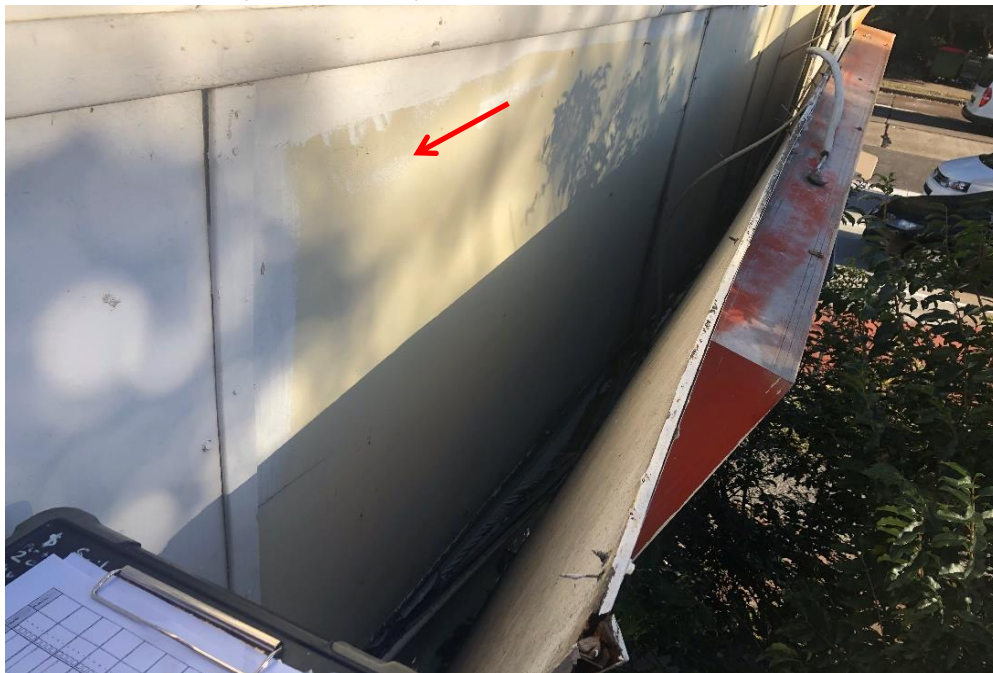
Photograph 18: 2 Dee Why Parade, Dee Why, external, walls throughout, undercoat paint covering, typical cream paint, non-lead paint ($\leq 0.1\%$ lead w/w)

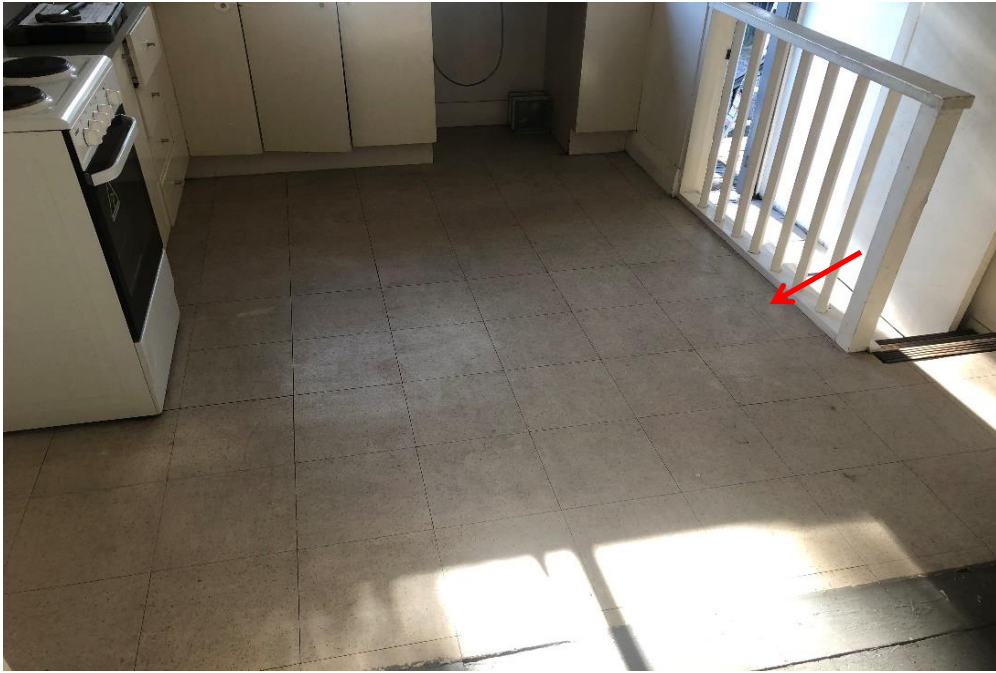
Photograph 19: 2 Dee Why Parade, Dee Why, internal, level 2, apartment 1 and 2, kitchen floor covering, beige dappled grey vinyl floor tile, no asbestos detected by analysis.

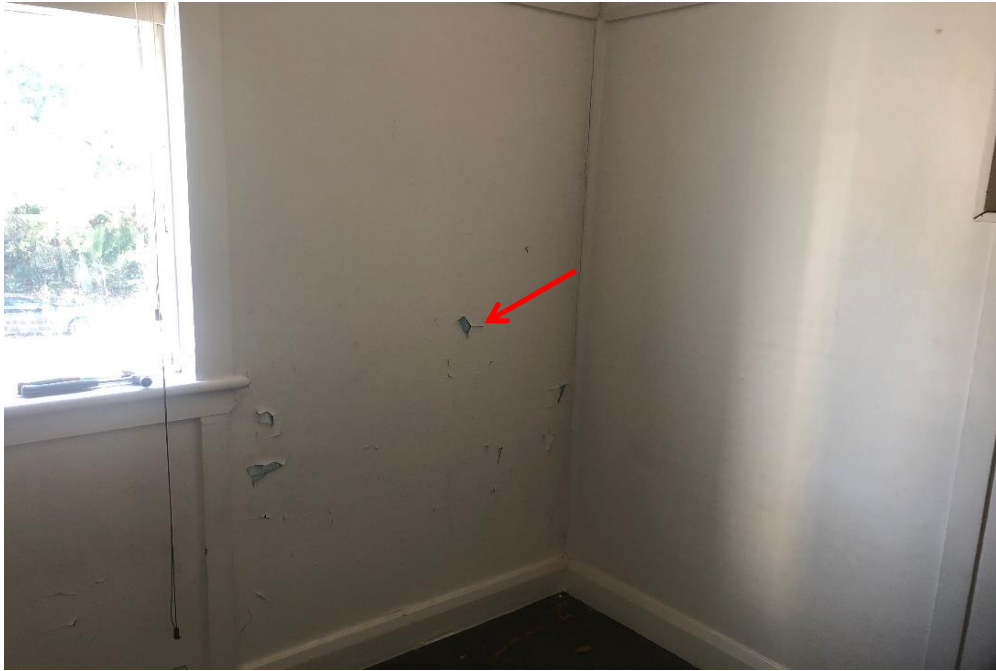
Photograph 21: 2 Dee Why Parade, Dee Why, internal, level 2, apartment 1 and 2, wall paint covering, throughout, typical white paint, non-lead paint ($\leq 0.1\%$ lead w/w).

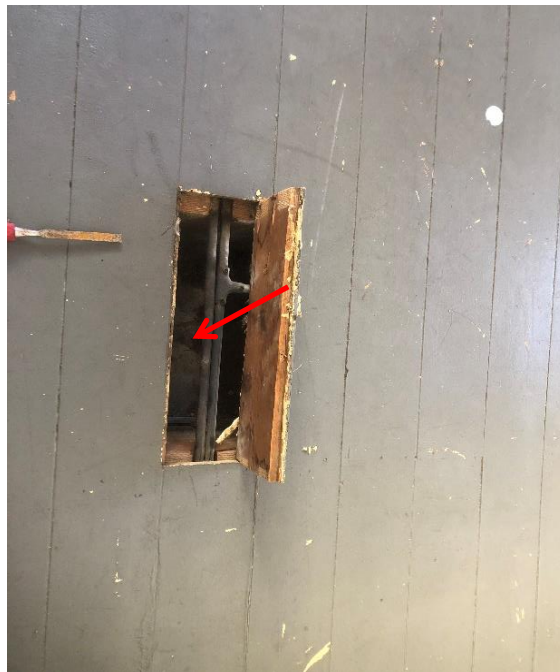
Photograph 22: 2 Dee Why Parade, Dee Why, internal, level 2, apartment 1, main bedroom, cavity below floorboards (possibly throughout), fibre cement sheeting, asbestos (assumed).

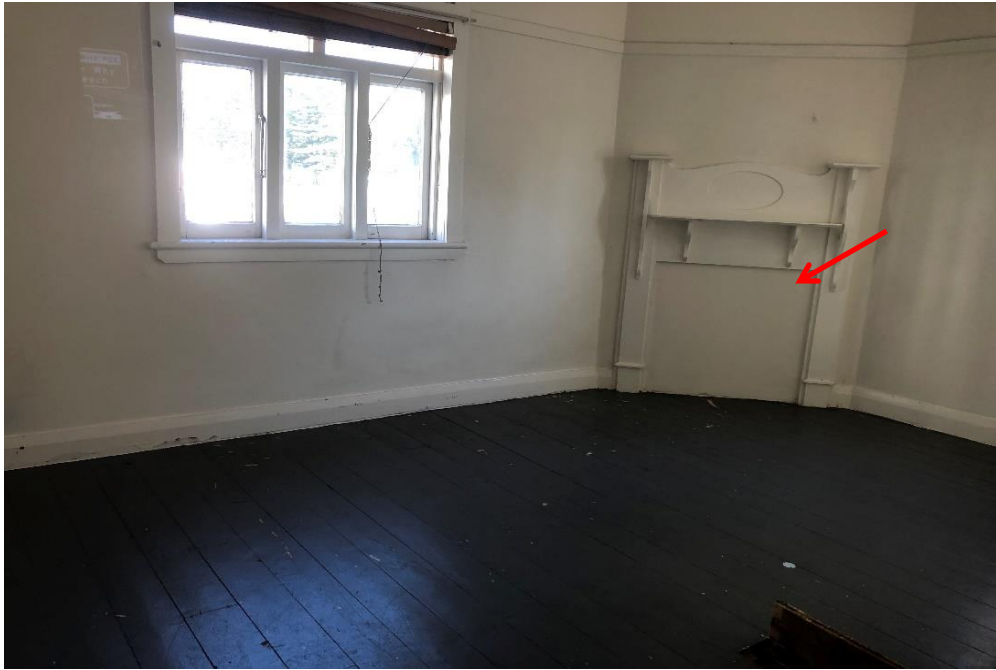
Photograph 23: 2 Dee Why Parade, Dee Why, internal, level 2 apartment 1 and 2, fireplaces, throughout, internal component(s), inaccessible.

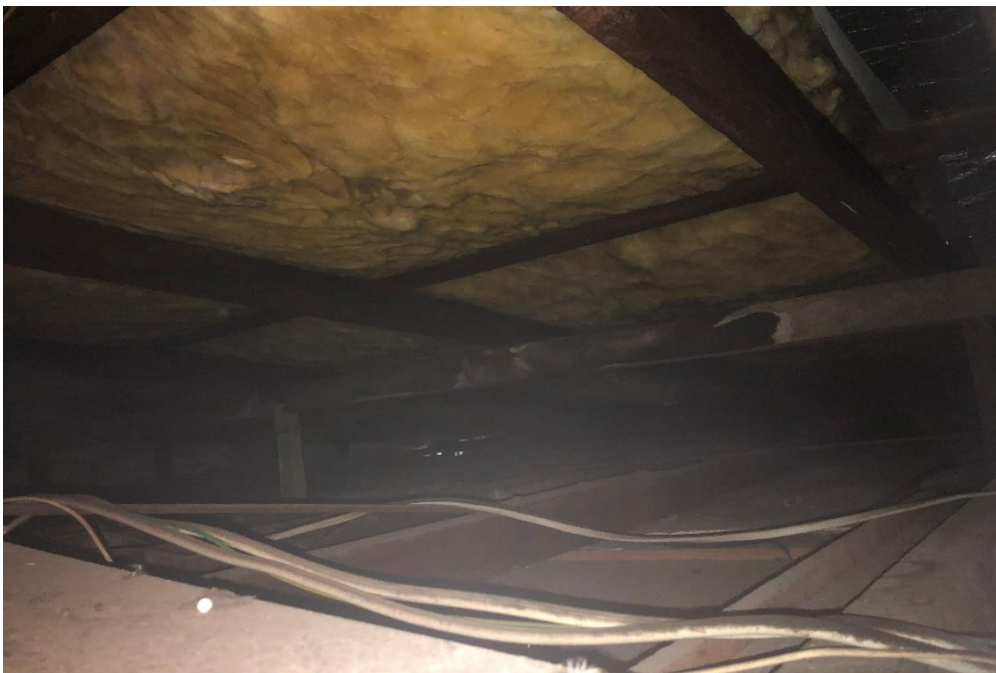
Photograph 24: 2 Dee Why Parade, Dee Why, internal, level 2, apartment 1, roof space, ceiling dust, elevated lead (10.2 mg/m2).

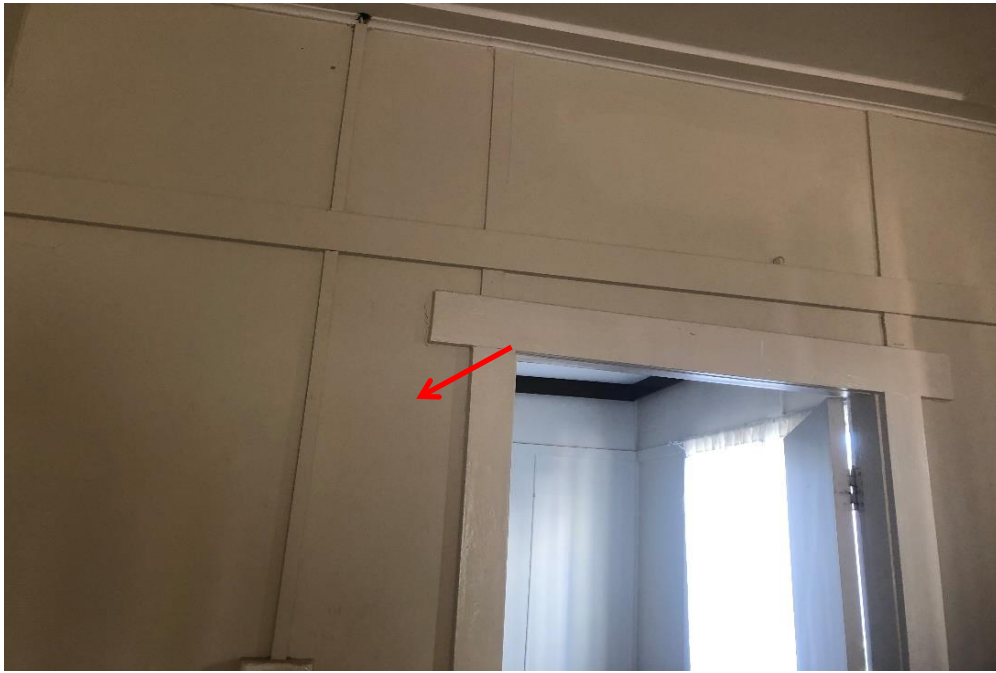
Photograph 25: 2 Dee Why Parade, Dee Why, internal, level 2, apartment 2, SE bedroom, north wall, fibre cement sheeting, asbestos detected by analysis.

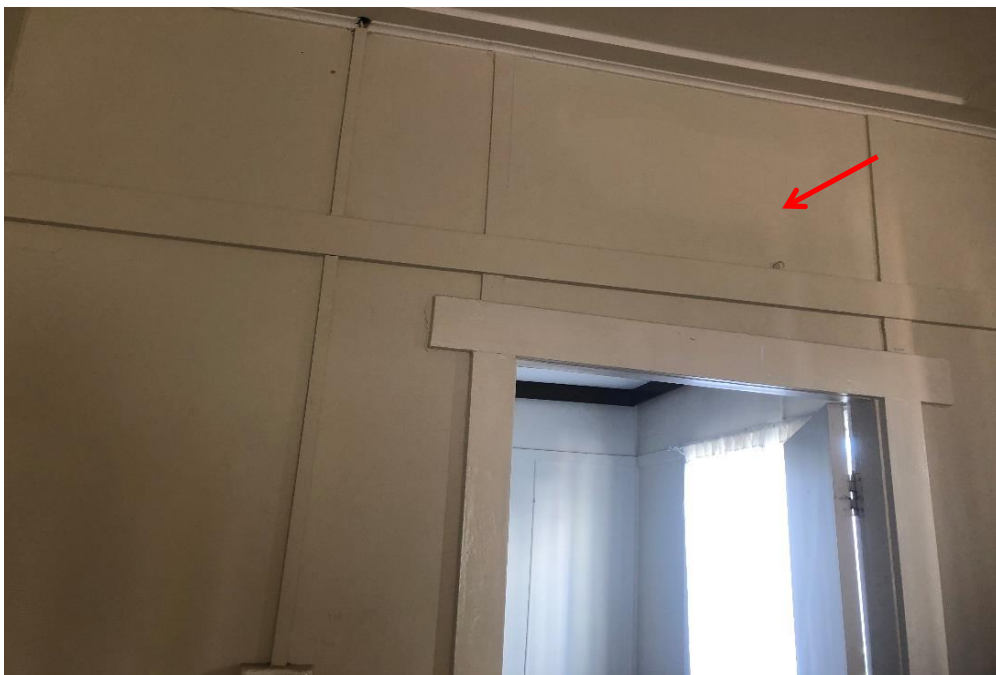
Photograph 26: 2 Dee Why Parade, Dee Why, internal, level 2, apartment 2, internal walls, paint covering, typical cream paint, non-lead paint ($\leq 0.1\%$ lead w/w)

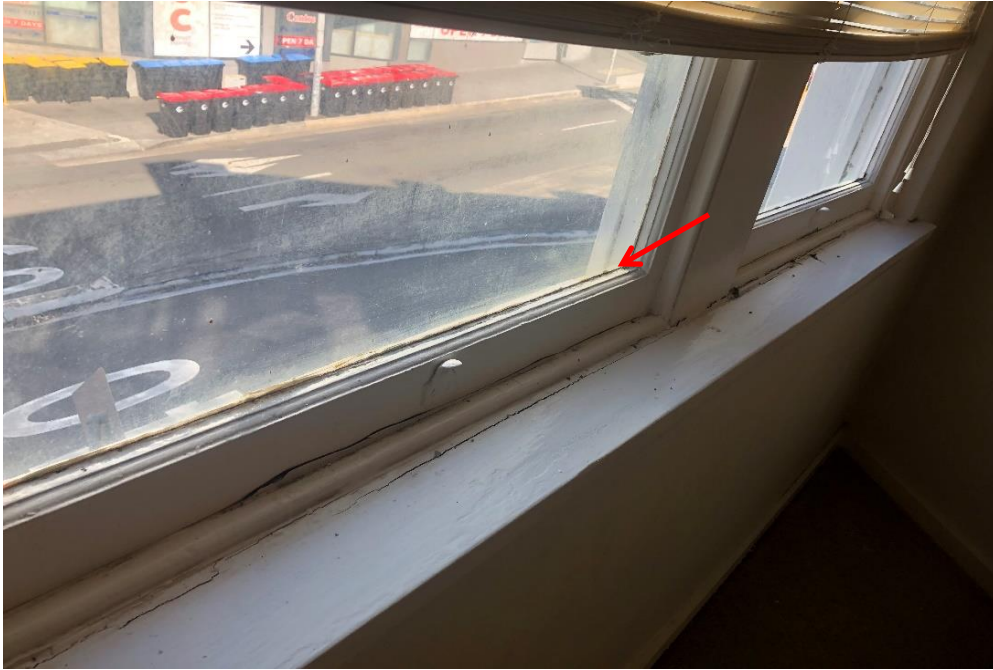
Photograph 27: 2 Dee Why Parade, Dee Why, internal, level 2, apartment 1 and 2, window mastic to non-sliding windows, bituminous material, no asbestos detected by analysis.

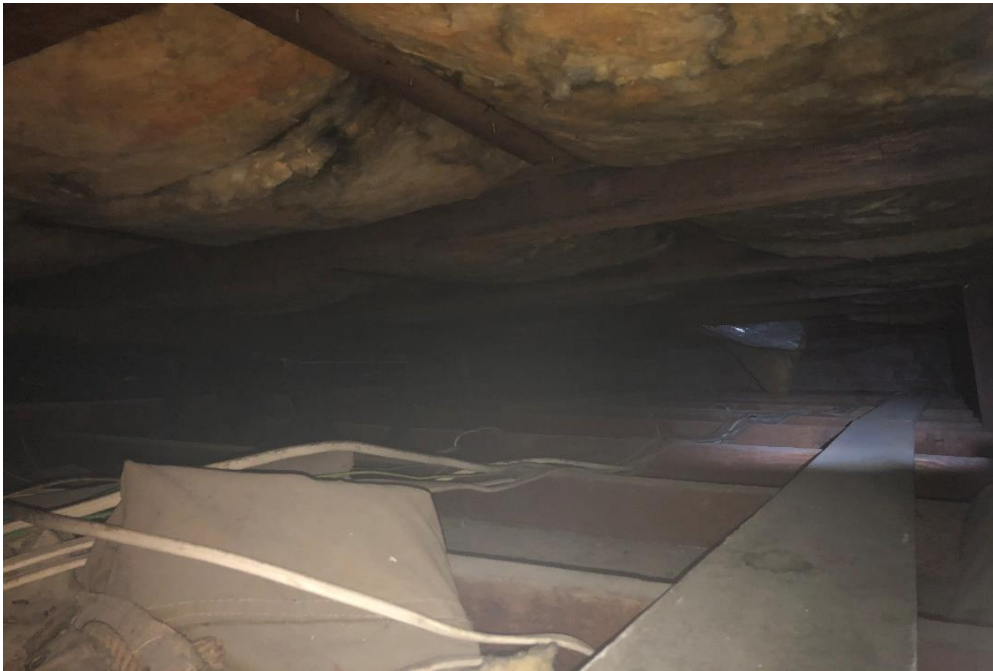
Photograph 28: 2 Dee Why Parade, Dee Why, internal, level 2, apartment 2, roof space, ceiling dust, elevated lead (77.8 mg/m²).

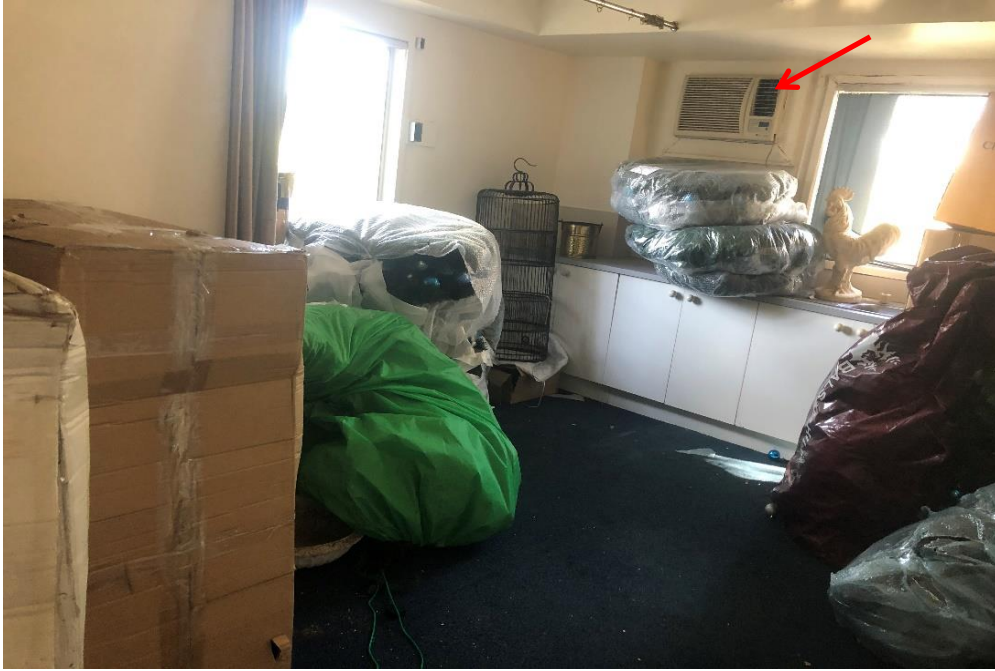
Photograph 29: 2 Dee Why Parade, Dee Why, internal, ground floor, A/C units, throughout, bulk internal insulation, suspected SMF.

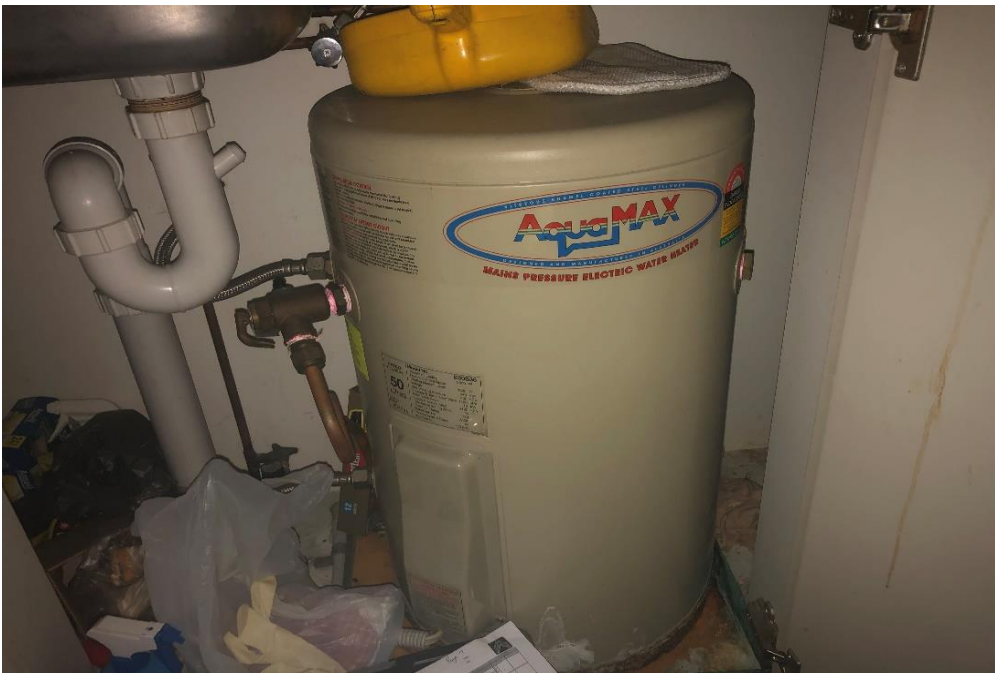
Photograph 30: 2 Dee Why Parade, Dee Why, internal, ground floor, kitchenette, aqua max hot water system, bulk internal insulation, suspected SMF.

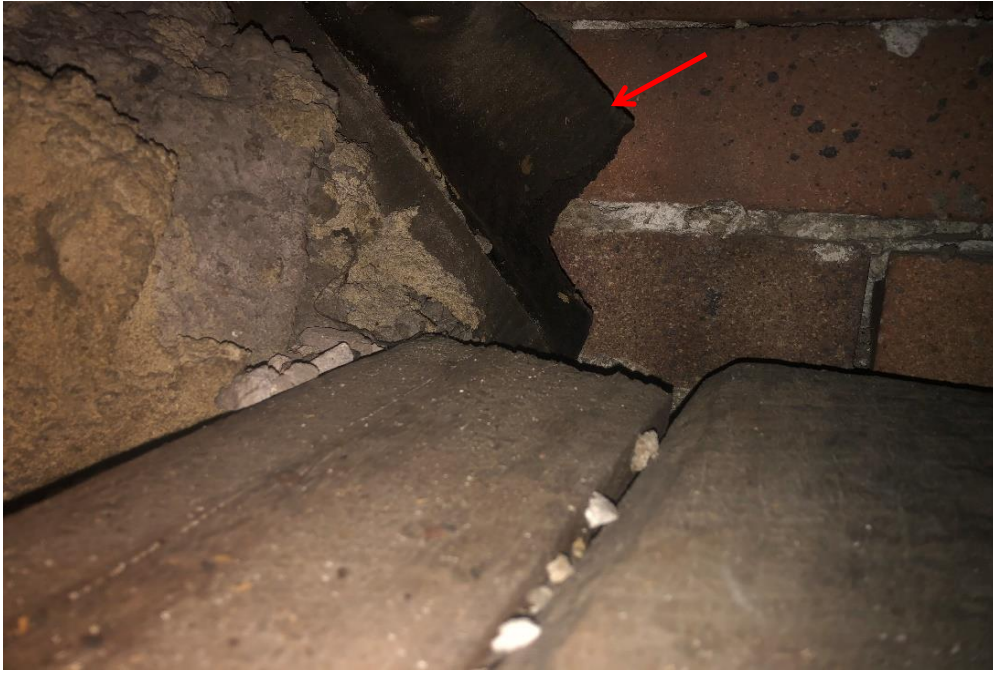
Photograph 31: 2 Dee Why Parade, Dee Why, internal, ground floor, mezzanine area, SW corner, bituminous material, no asbestos detected by analysis.

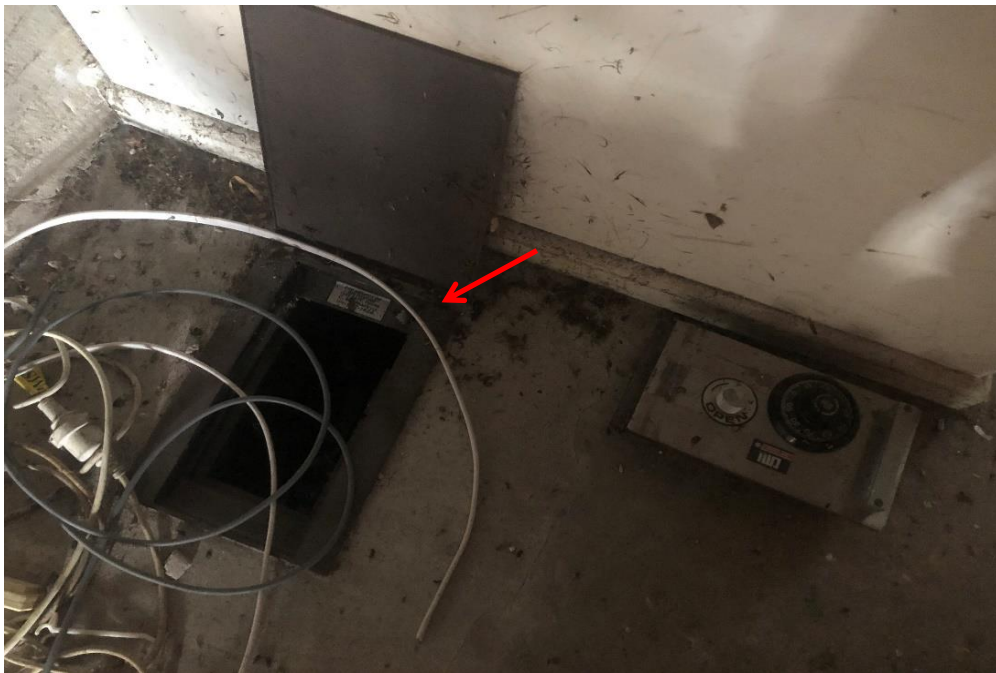
Photograph 32: 2 Dee Why Parade, Dee Why, internal, basement storage area, north elevation, in floor safe, safe lining, suspected non-asbestos.

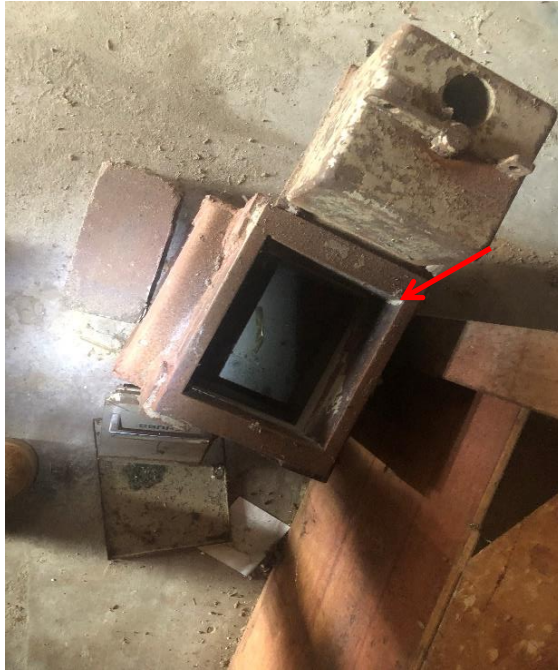
Photograph 33: 2 Dee Why Parade, Dee Why, internal, basement storage area, west elevation, chubb safety deposit box, safe lining, suspected non-asbestos.
