**RE: 23 Robertson Road Scotland Island, Arborist Report Addendum**

## **Arborists Impact Assessment Report: 23 and 25-33 Robertson Road, Scotland Island.**

February 16, 2018

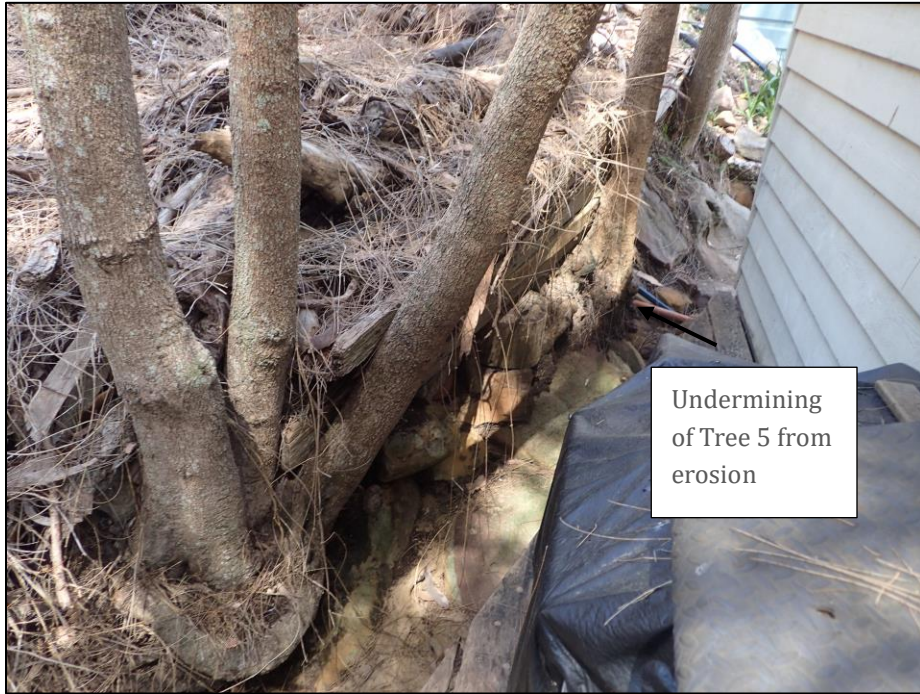
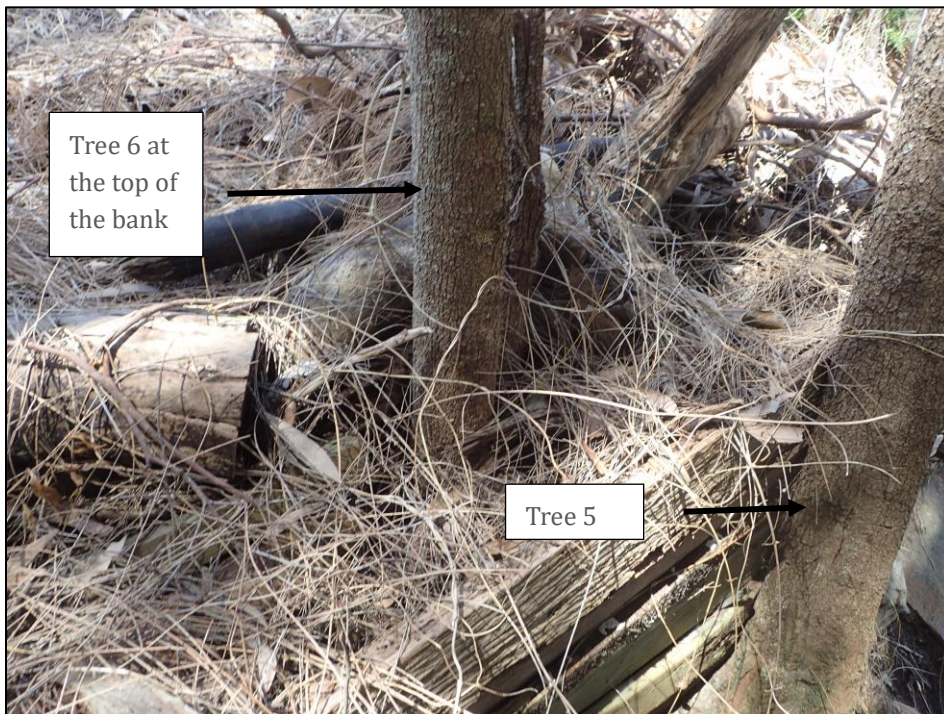
**Summary:** Tree 5 is an *Allocasuarina littoralis* with a moderate sized tree with a height of 11m and DBH of 350mm. The tree is growing below the bank (currently impacted by erosion) and behind shed. At the time of survey, it was noted to be very undermined with buttress roots exposed as a result of the shoreline erosion at the subject site. The tree identifies with the Pittwater Spotted Gum Forest ECC and subsequently is considered to have a high retention value. Although, as a result of erosion and undermining it is considered to have a short (Safe Useful Life Expectancy) SULE and Estimated Life Expectancy (ELE) of 5-15 years as continuing erosion will likely result in the loss of this tree in the near future

**Summary:** Tree 6 is a young *Allocasuarina littoralis* tree with a height of 9m and DBH of 110mm. The tree is growing with a slight lean on top and near the edge of the bank, which is being impacted by active erosion and at risk of failure from the ongoing bank erosion. The tree identifies with the Pittwater Spotted Gum Forest ECC and subsequently is considered to have a high retention value. The tree is considered to be a Young tree under the SULE tree assessment framework. The ELE of the tree is considered to be short (5-15 years) as continuing erosion will likely result in the loss of this tree in this period if not addressed.

Photos of the tree taken during the previous assessment (H2OConsulting Group 2020) are provided below

**Recommendation:** Remove Tree 5 to accommodate the seawall. The seawall will stabilise the bank and minimise potential for ongoing impacts to the adjacent EEC. Replace the tree with additional plantings that align with the Pittwater Spotted Gum Forest ECC on the subject site.

**Recommendation:** Remove Tree 6 to accommodate the seawall. The seawall will stabilise the bank and minimise potential for ongoing impacts to the adjacent EEC. Replace the tree with additional plantings that align with the Pittwater Spotted Gum Forest ECC on the subject site.

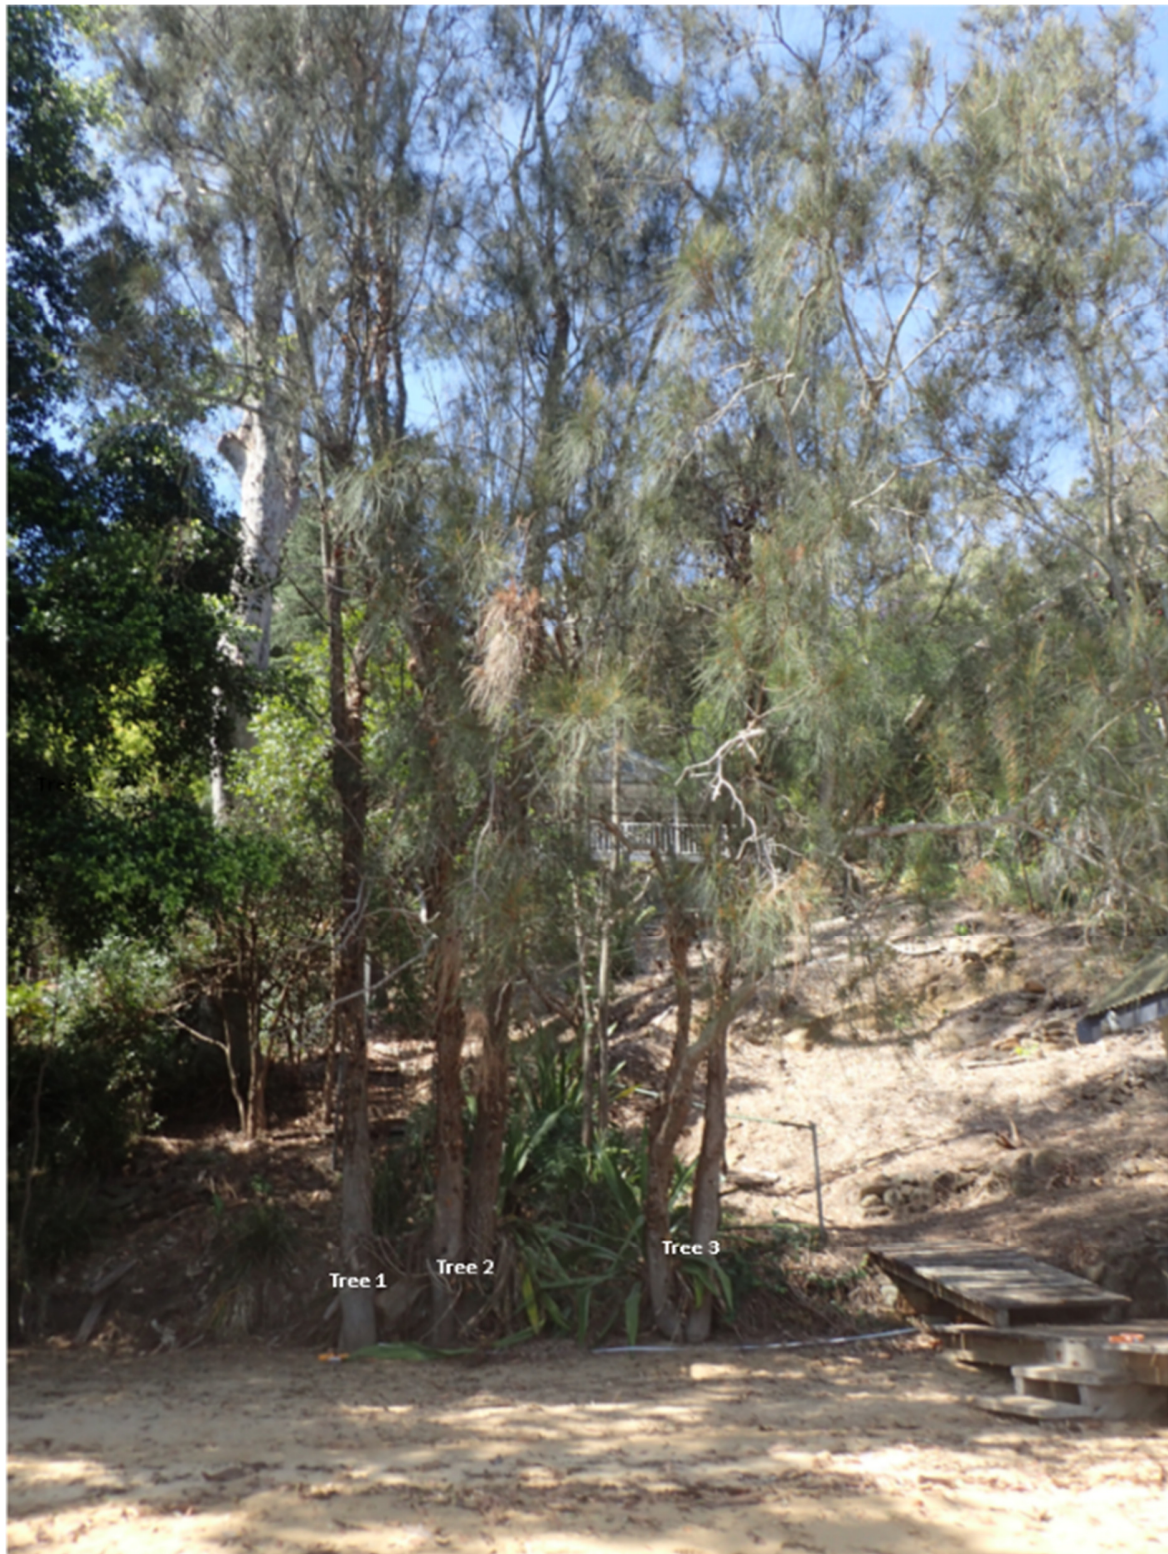
Plate 1: Trees 1 to 3 adjacent to No: 23.

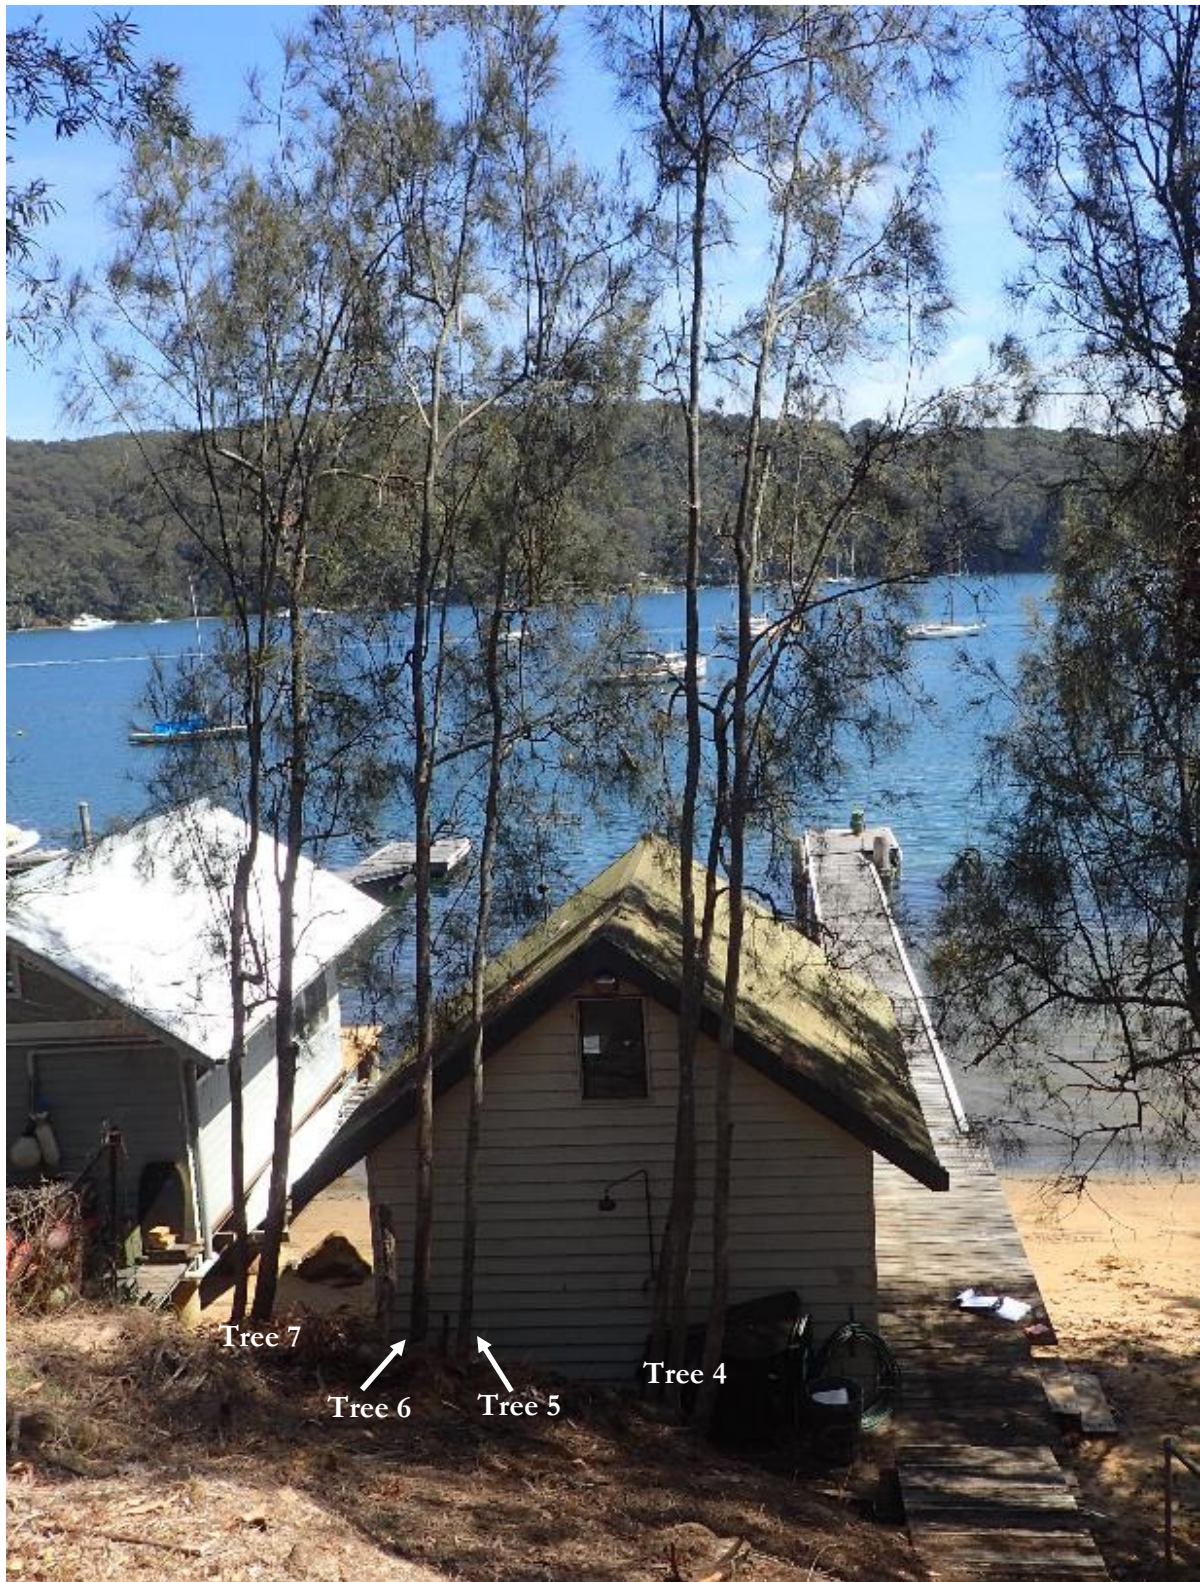
Any digging or soil disturbance at the back of the boat shed at 23 Robertson Road, Scotland Island will occur within the SRZ, and consequently has potential to impact on the roots of *A. littoralis* trees 4, 5, 6 and 7 (Table 3, Figure 6). Of these trees, tree 4 and 7 that are on lean over the boat shed may require removal, while tree 5 may require trimming of some lower branches, if works are required to raise the boat shed roof by greater than 100 mm, or any works to the roof of the boat shed require clearer access. It should also be noted, that these trees are likely to fail if continued shoreline erosion occurs at the site, irrespective of this proposal. Trees, 1 – 3, 5, 6, 15 and 16 can be retained where recommendations given in this report are implemented, as the works will be typically confined to the existing footprint.

Plate 2: Trees 4 to 7 behind No: 23 boatshed.

- ❖ It is recommended that trees 4 and 7 be removed to allow for the raising of the boat shed roof at 23 Robertson Road, Scotland Island.
- ❖ Given that the works are expected to require minimal ground disturbance and are confined to the existing footprint of the boatsheds it is recommended that the remaining trees be retained.

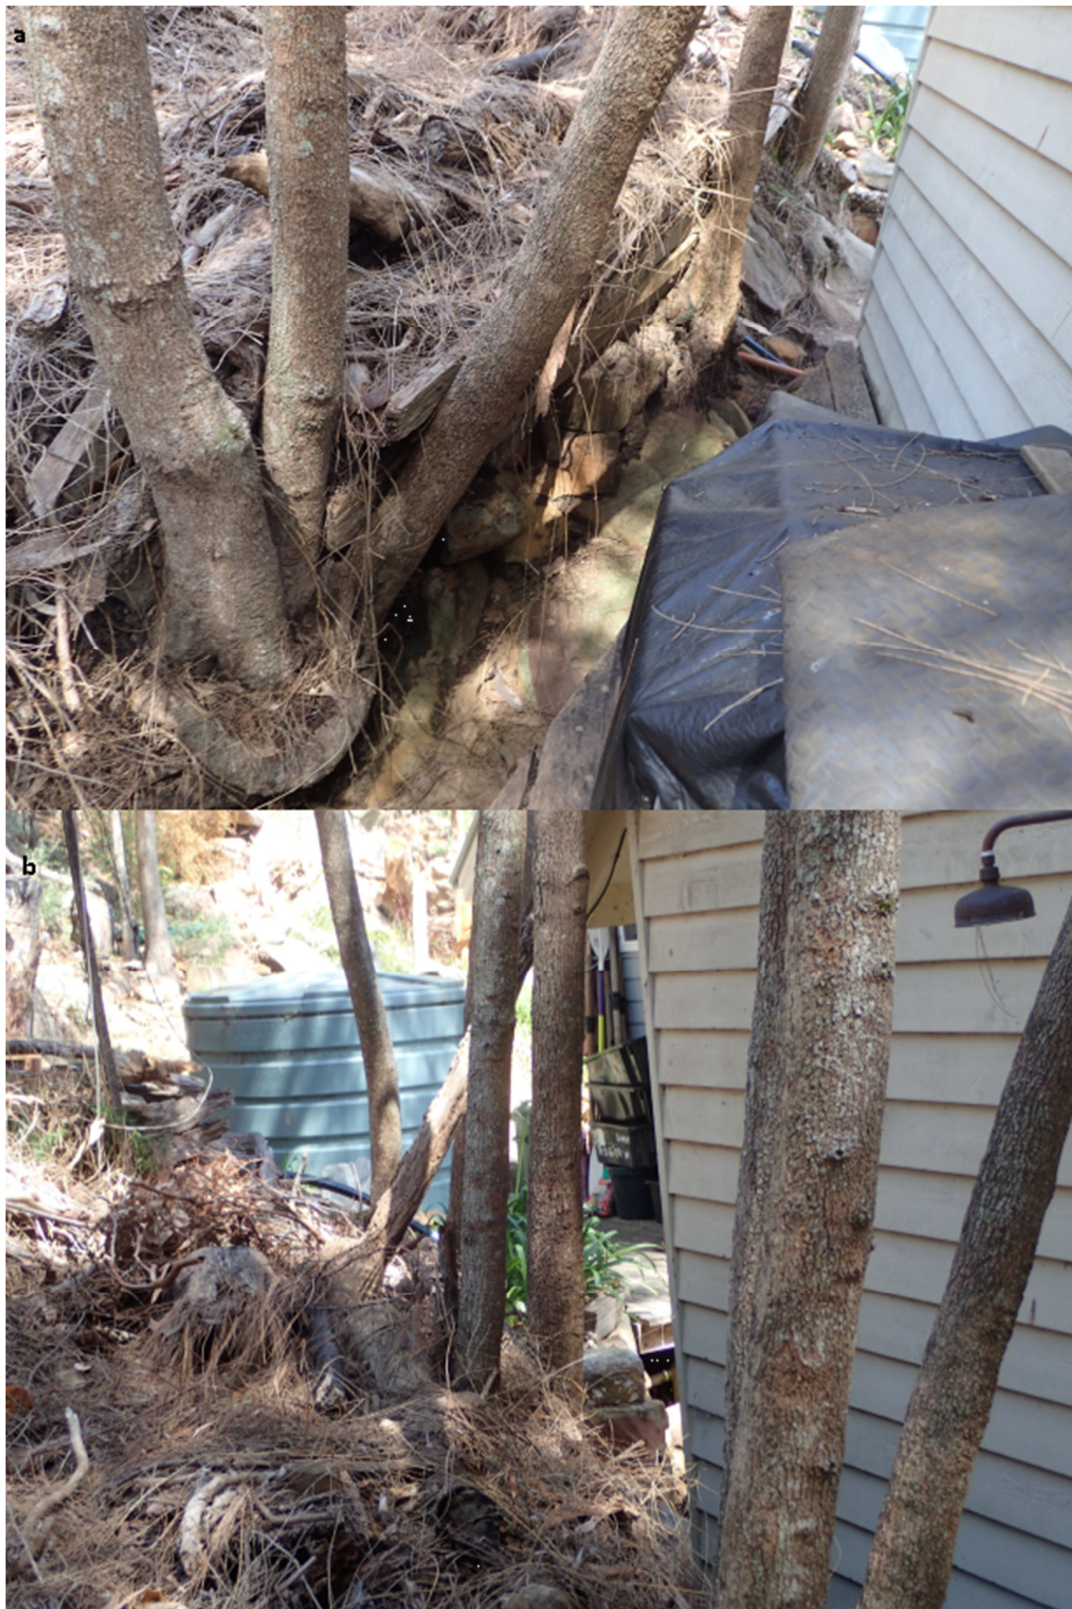
The *A. littoralis* trees have a high retention value, but many are at risk of eventual failure and loss from continued undermining from shoreline erosion. The following actions are recommended regarding tree retention and removal:

Plate 3: Trees 4 to 7 behind No: 23 boatshed (a) showing undermining and shoreline erosion, and (b) growing close and over the boatshed.

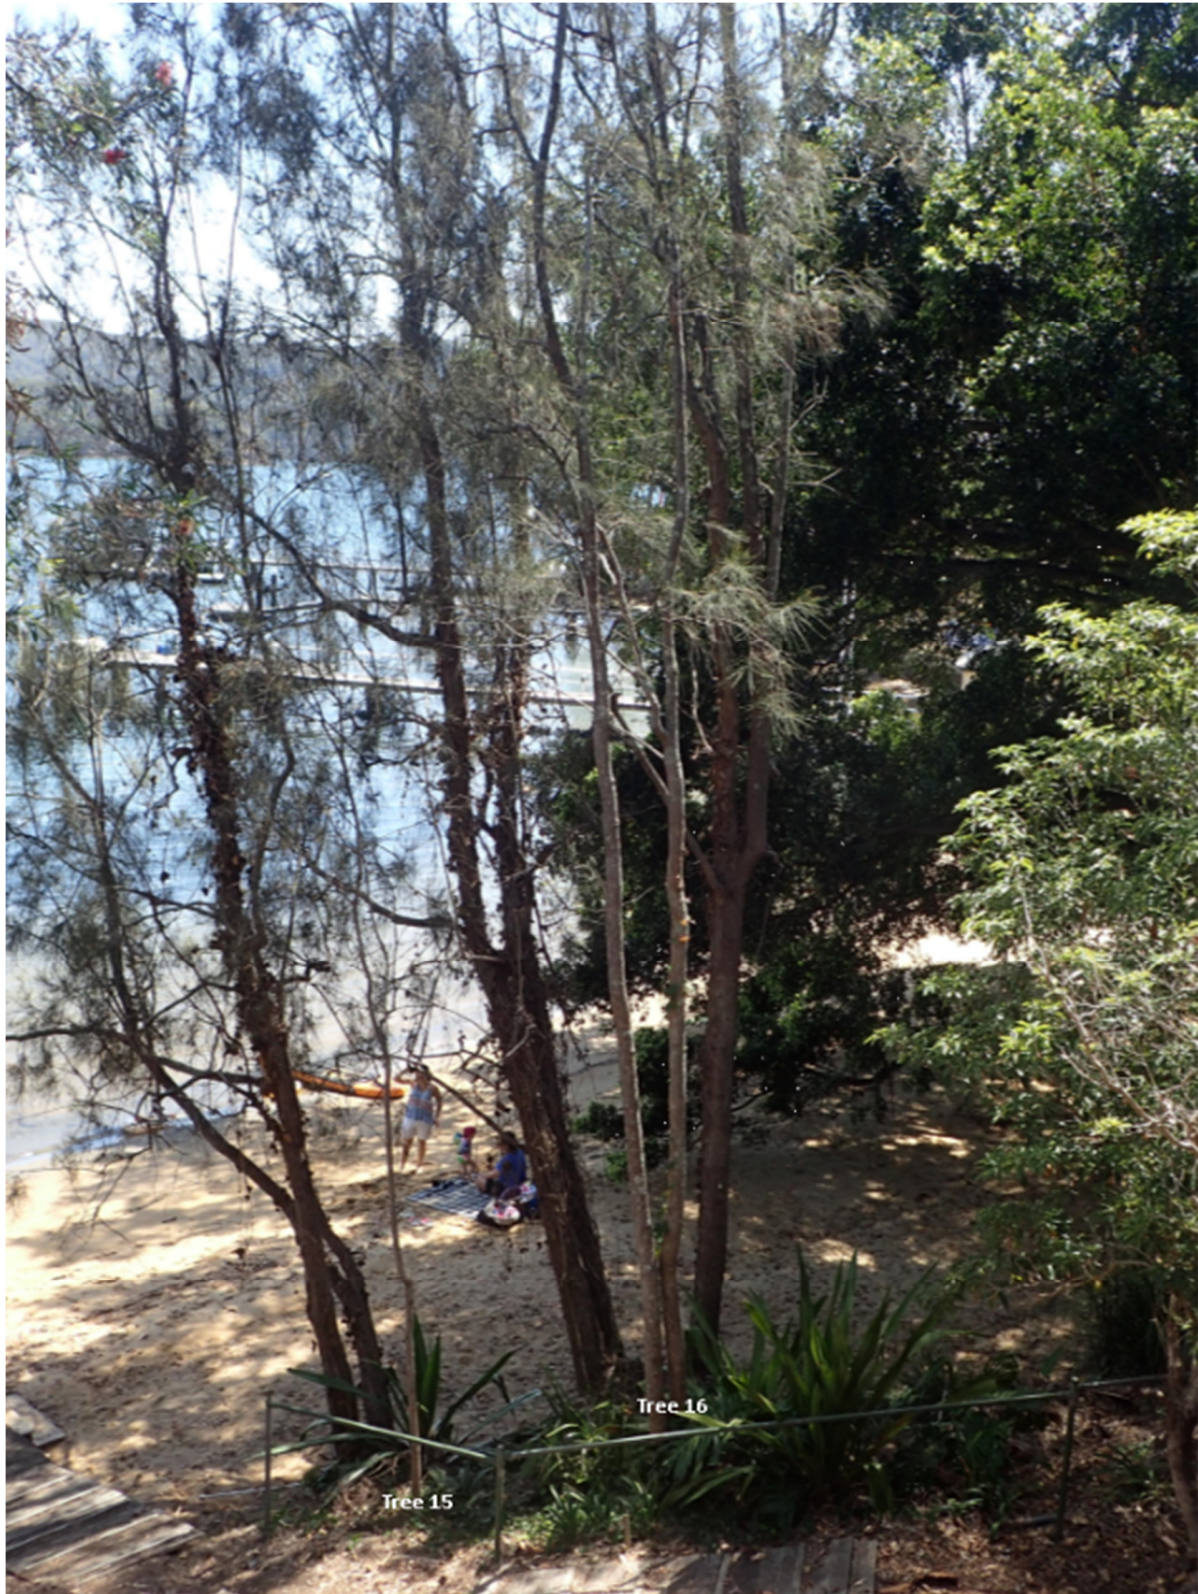
Plate 4: Trees 15 and 16 near the No: 23 boatshed, with trees 1-3 in the background.

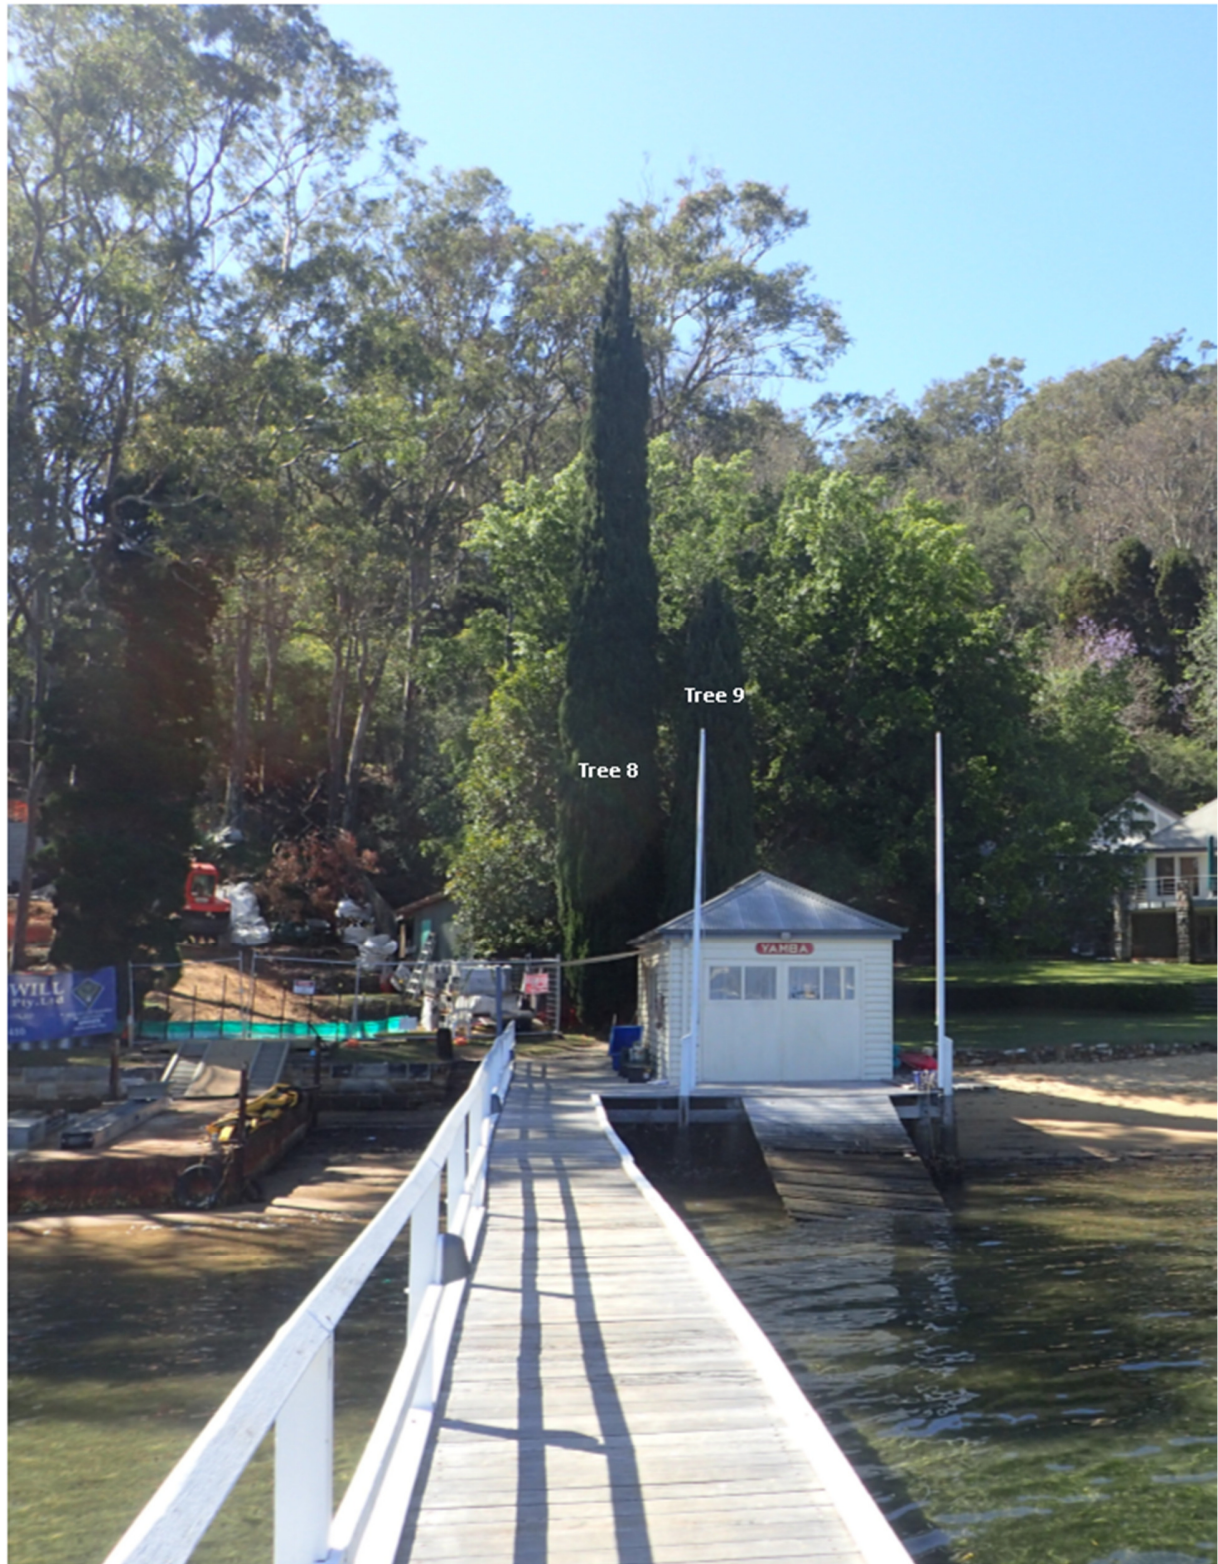
Plate 5: Trees 8 and 9 near the No: 25-33 boatshed.

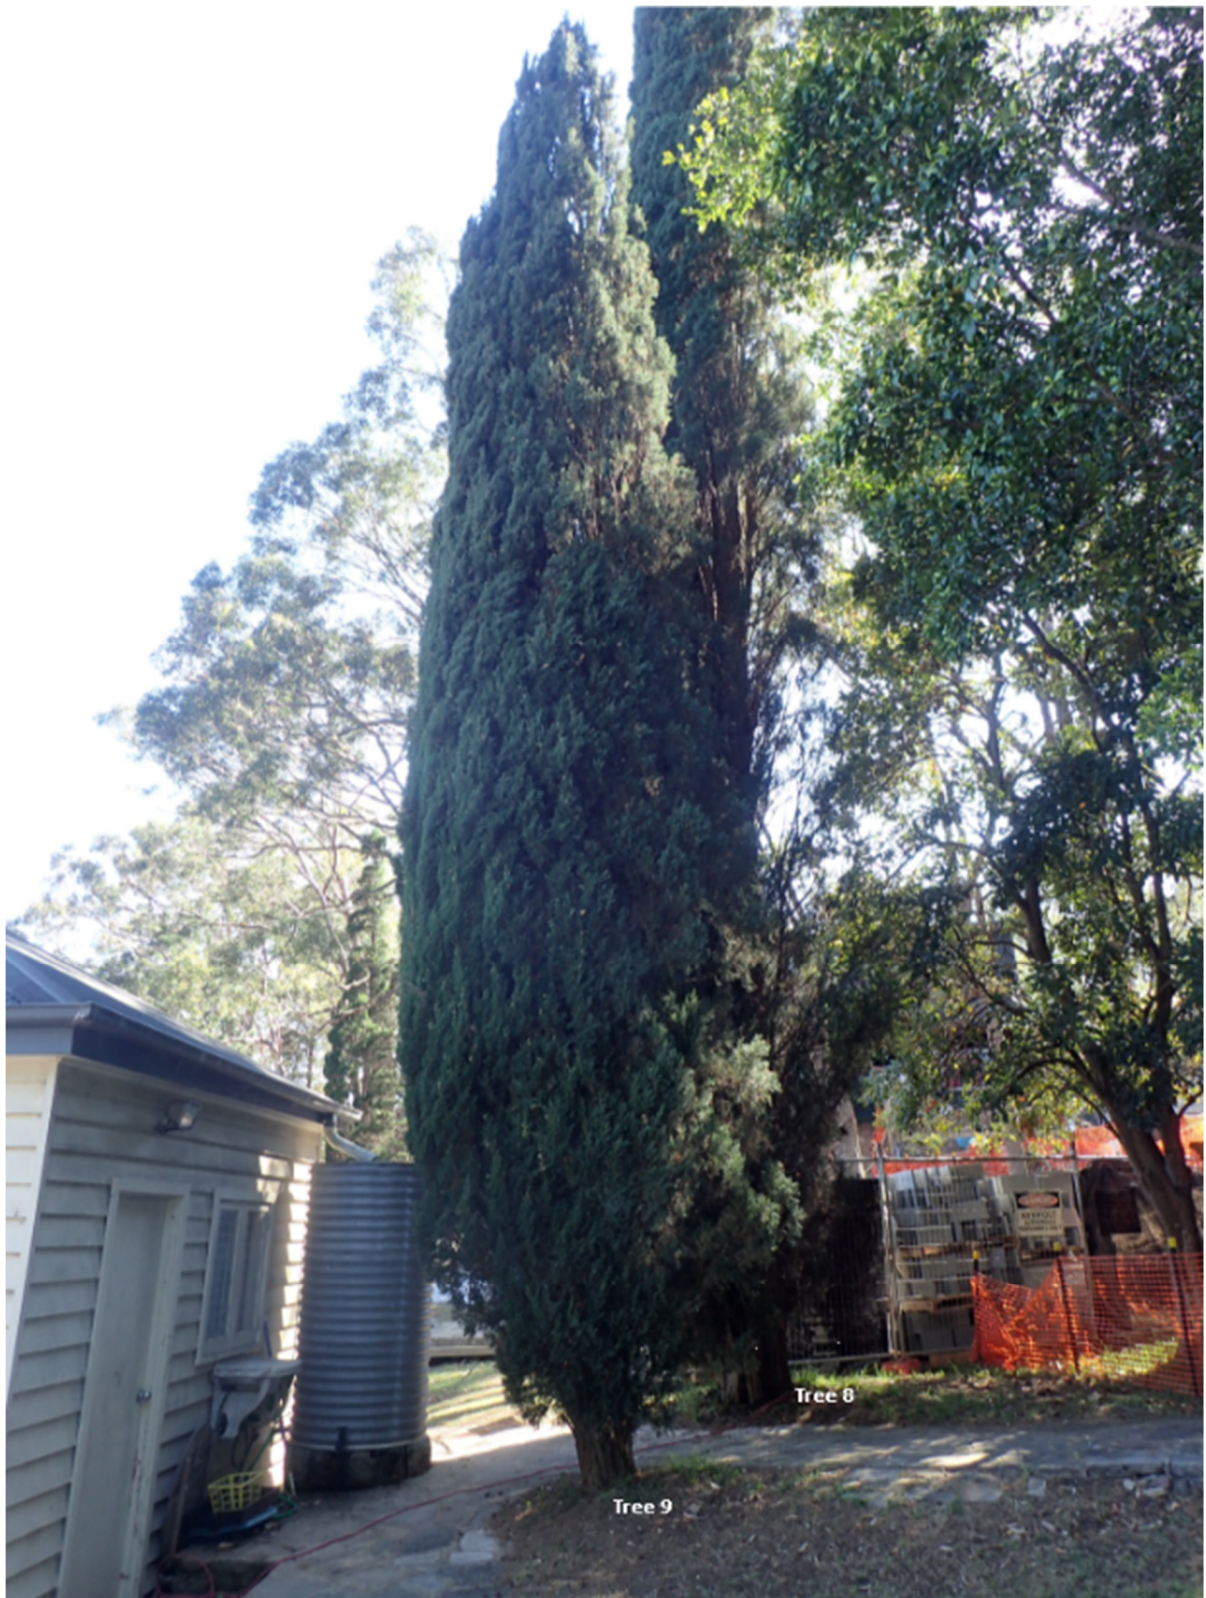
Plate 6: Trees 8 and 9 close to the back of No: 25-33 boatshed.
