Report Title: RISK ANALYSIS & MANAGEMENT FOR PROPOSED DUAL LEVEL COVERED VERANDAH AT 57 ROBERTSON ROAD, SCOTLAND ISLAND – MT 31454
Report Date: 10/4/2018
Author : PETER THOMPSON
Author's Company/Organisation : JACK HODGSON CONSULTANTS PTY LTD

**RISK ANALYSIS & MANAGEMENT  
FOR  
PROPOSED DUAL LEVEL COVERED VERANDAH  
AT  
57 ROBERTSON ROAD SCOTLAND ISLAND**

MT 31455

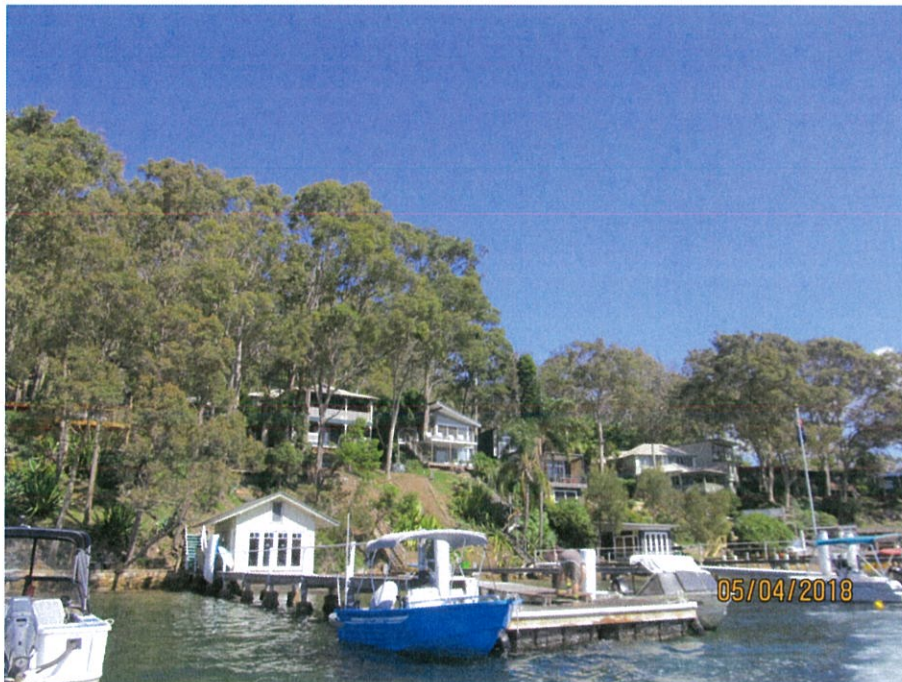
**Photo 1**

3.3 Access to the property is by water. A wooden jetty extends into Pittwater to the north from the north eastern corner of the property (Photo 1). A boat house sits next to the western side of the jetty (Photo 2). A pathway with steps leads up to the residence from the end of the jetty (Photo 3). The steps form an "S" shape and run past the western boundary in places (Photo 4). The slope is covered in grass and has several trees scattered across the front of the property. There are two tanks on the lower level beneath an existing deck area at the northern side of the residence (Photo 5). Behind these tanks are some utility rooms. Access to the rear of the property is through the residence. The dwelling is situated close to the southern boundary with water tanks between it and the boundary (Photo 6). Between the boundary and the tanks is a wooden retaining wall (Photo 6).

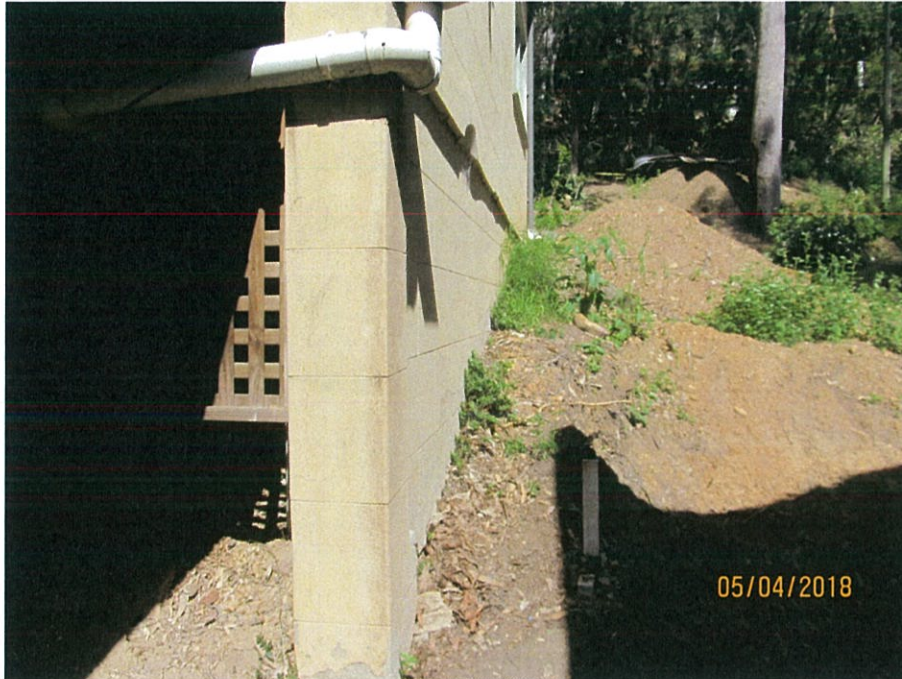
Photo 7

3.4 The two story timber house is in good condition. The supporting brick walls and piers show no signs of movement (Photo 7). No evidence of significant cracking or movement was observed at the time of our inspection.

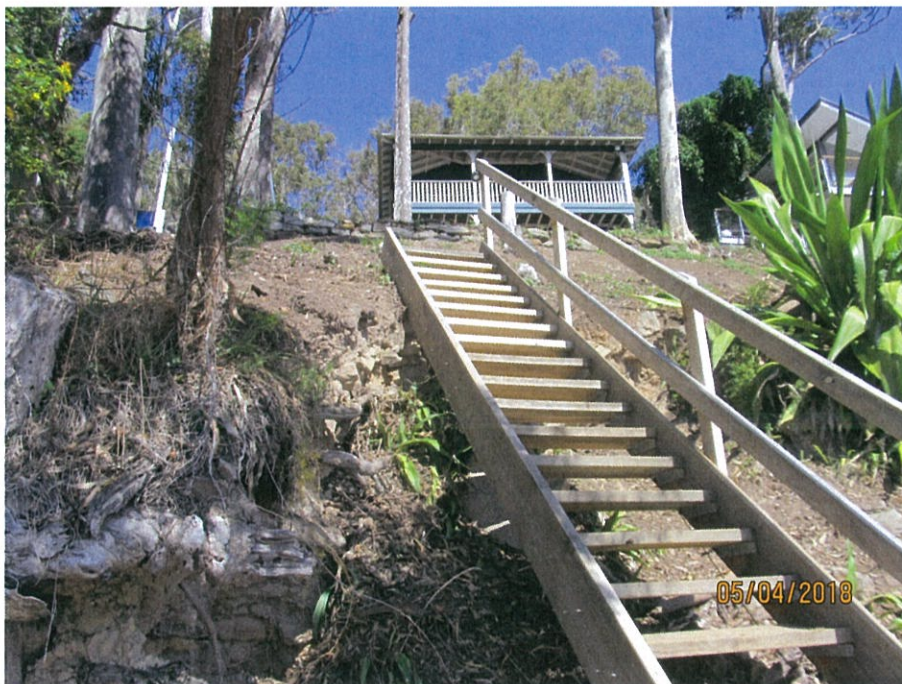
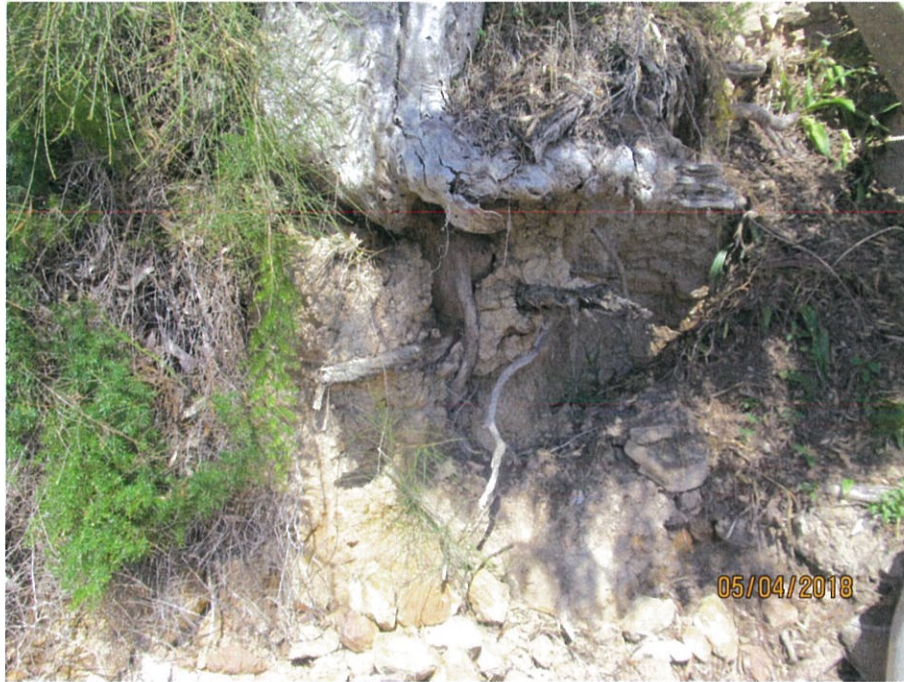
The areas beside the site are also classed slip affected hazard areas. These blocks have similar elevation and geomorphology to the subject property. No geotechnical hazards likely to adversely affect the subject property were observed beside the site to the south east. At the time of our inspection the property on the north western side of the property showed a lack of vegetation on some of the slope leading to the water's edge (Photos 8 & 9). Water paths were visible in the topsoil. Next to the north eastern corner boundary is a dead tree stump and root system with substantial erosion showing under the root system (Photos 10 & 11). This will require attention in the near term.

Assessment of the tree stump mentioned in **Section 7.4** should be undertaken and appropriate action taken as necessary. It is not considered this issue provides any risk to the subject site that requires further assessment at this time. As no other geotechnical hazards likely to adversely impact upon the subject site were observed beside the site, no risk analysis is required.

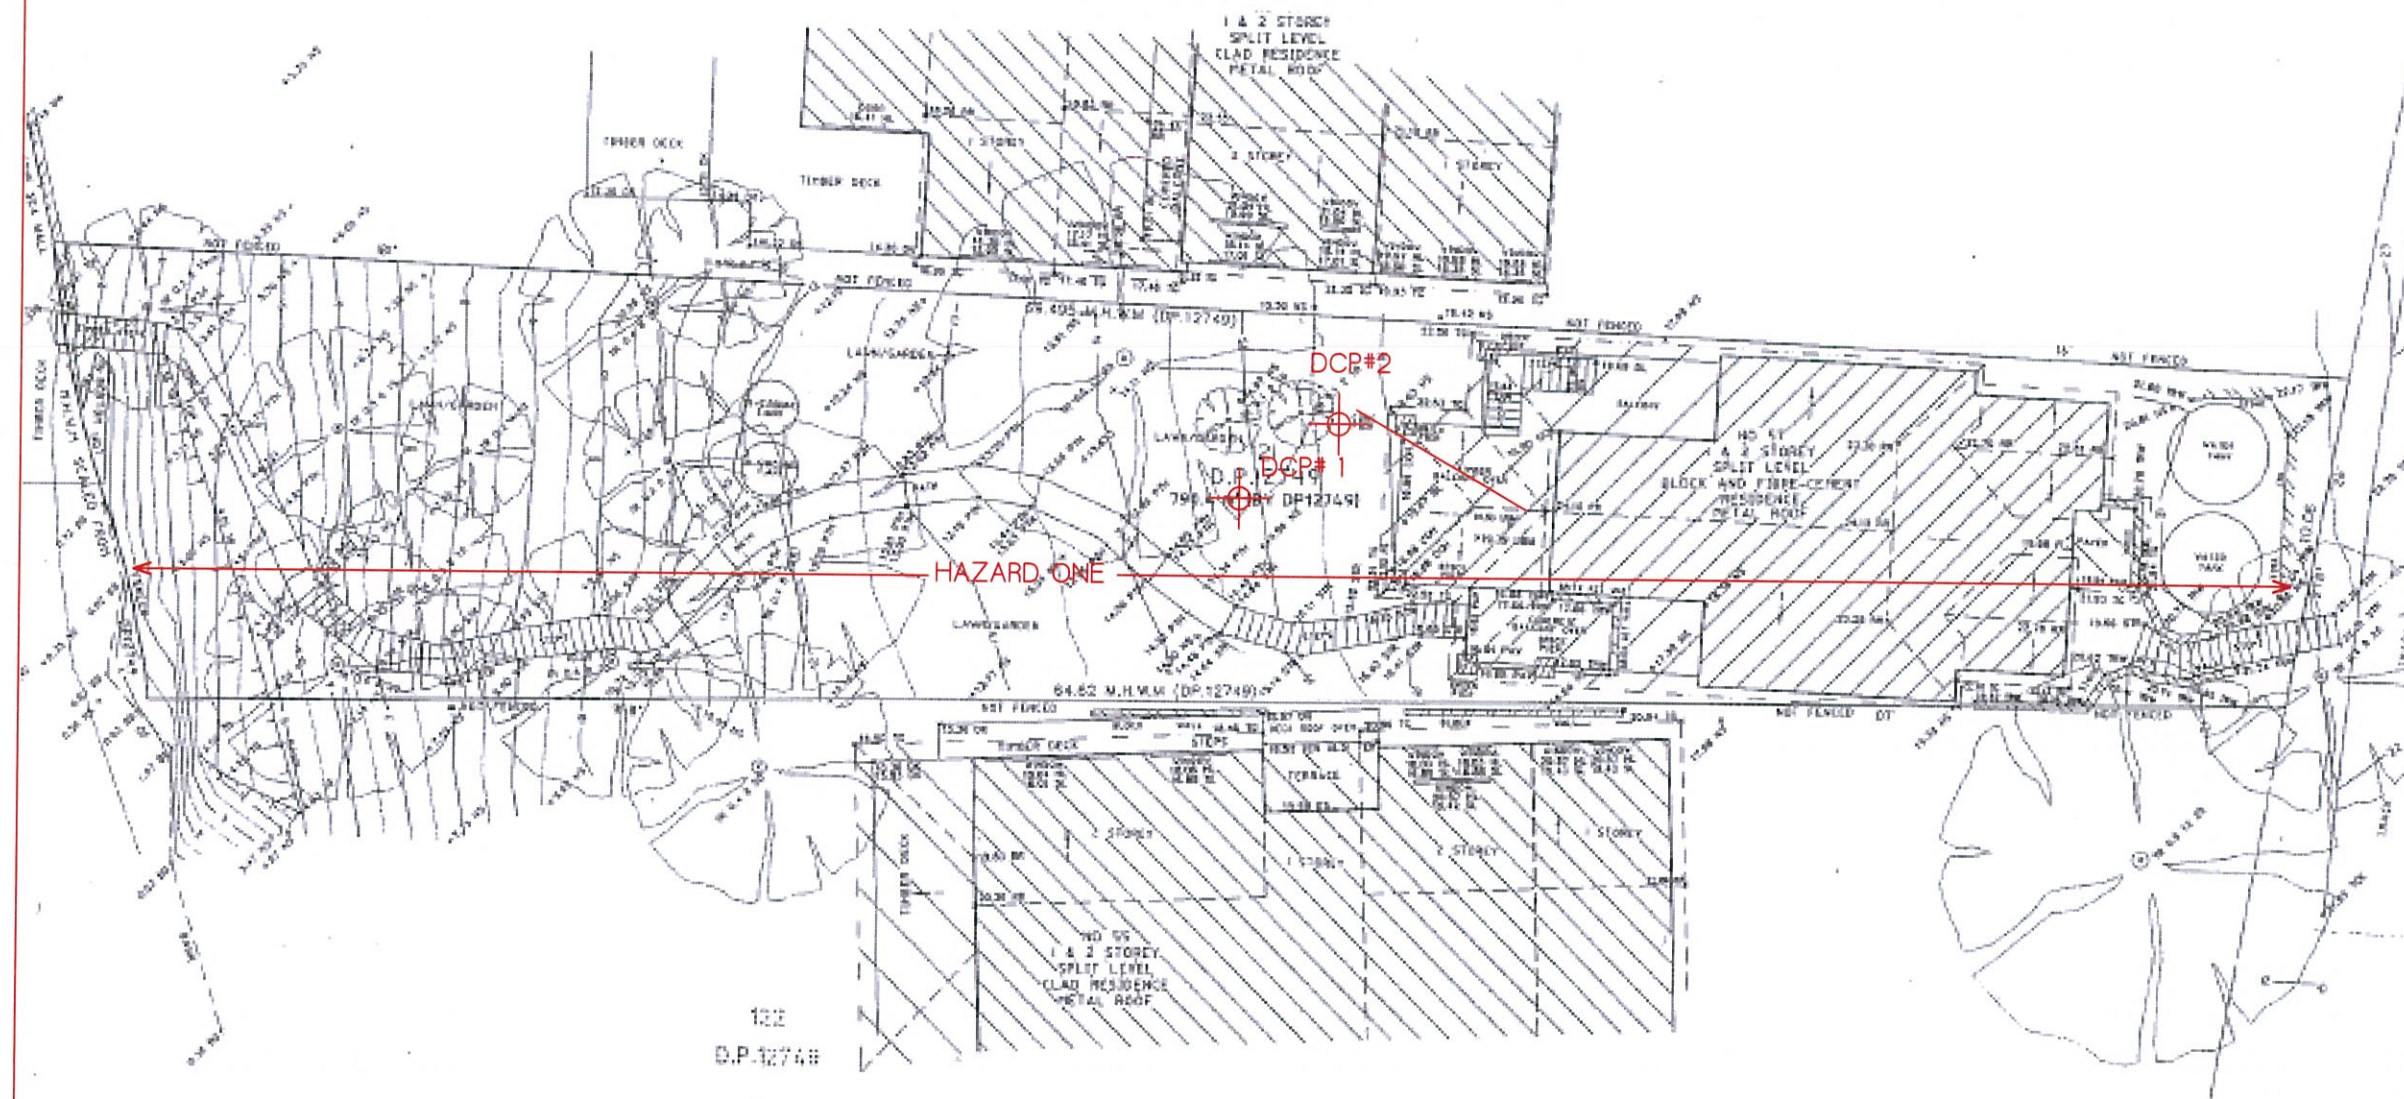
SITE PLAN - DCP LOCATION & HAZARD ONE

5.1 Two Dynamic Cone Penetrometer (DCP) test was conducted in the location shown on the site plan. The test was conducted to the Australian Standard for ground testing: AS 1289.6.3.2 – 1997 (R2013). The results of these tests are as follows:

The site is classed slip affected under Council's Policy and is included in the council's H1 hazard zone. This is even though the whole block is not classified. A failure of the slope across the property is considered a potential hazard (**HAZARD ONE**).
