Geotechnical Assessment

Project: Alterations & Additions
2097 Pittwater Road, Church Point NSW

Ref: AG 22521
5 December 2022

For Alterations & Additions at
2097 Pittwater Road, Church Point NSW

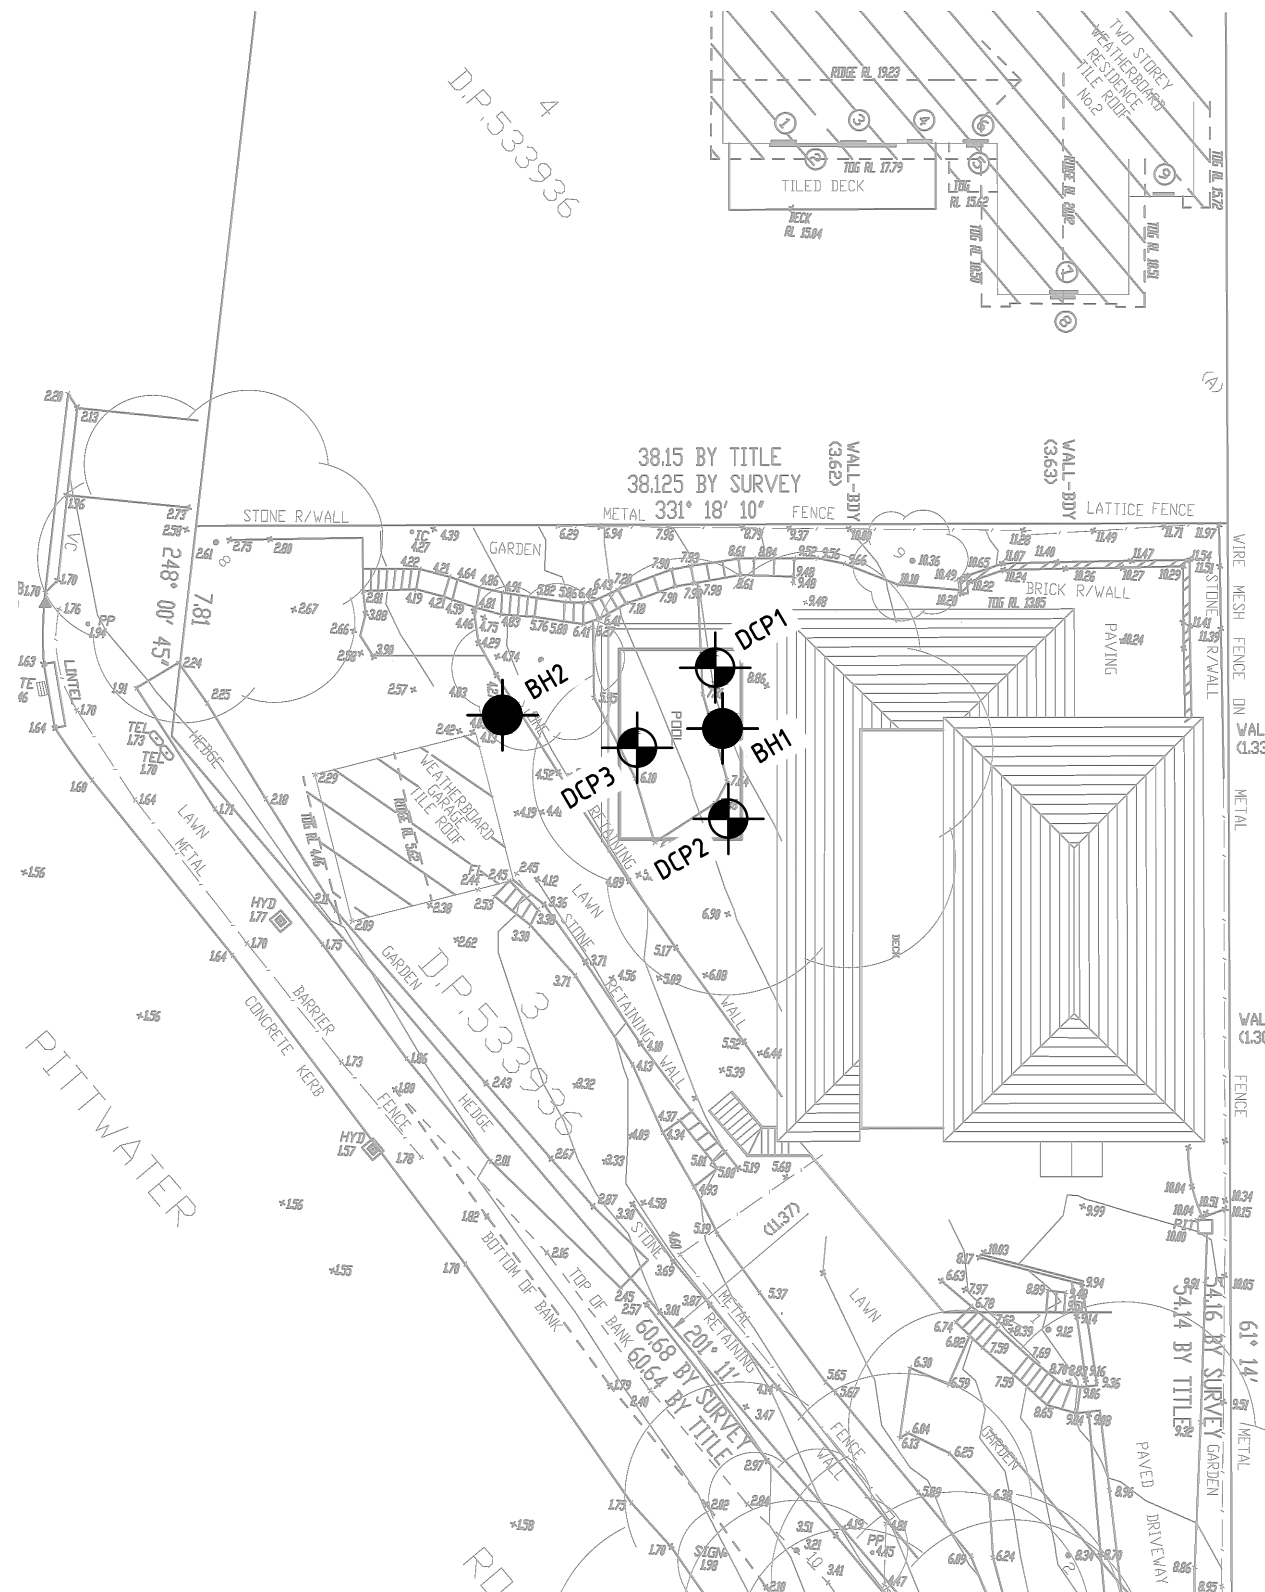
DATE:	05/12/2022
SCALE:	AS SHOWN @ A3
DRAWING TITLE:	SITE PLAN
DRAWING NO:	AG 22521- S1

**SITE PLAN/GROUND TEST LOCATIONS
AT 2097 PITTWATER ROAD
CHURCH POINT NSW**
