GEOTECHNICAL INVESTIGATION:

Alterations and Additions at **101 Woodland Street, Balgowlah Heights**

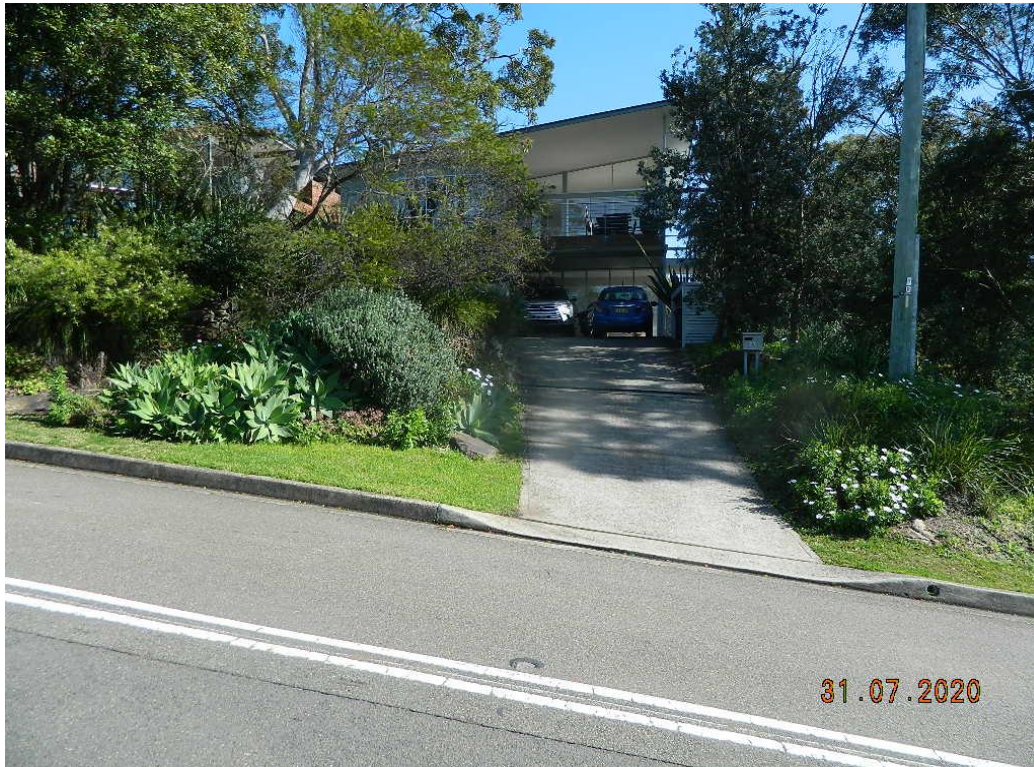
Photo 1

- 2.3** At the road frontage a concrete driveway runs up the slope to a carport on the E side the house (Photo 1). Hawkesbury Sandstone bedrock is outcropping on the S side of the driveway (Photo 2). Sandstone joint blocks are located on the S and N sides of the driveway (Photo 3). The two storey rendered house is supported by rendered masonry walls and a concrete slab (Photos 4 & 5). The external supporting walls show no significant signs of movement. A stable sandstone stack rock wall supports fill along part of the S common boundary (Photo 6). A pool in good condition is located on the W side of the property (Photo 7). A concrete block wall/retaining wall ~1.8m high in

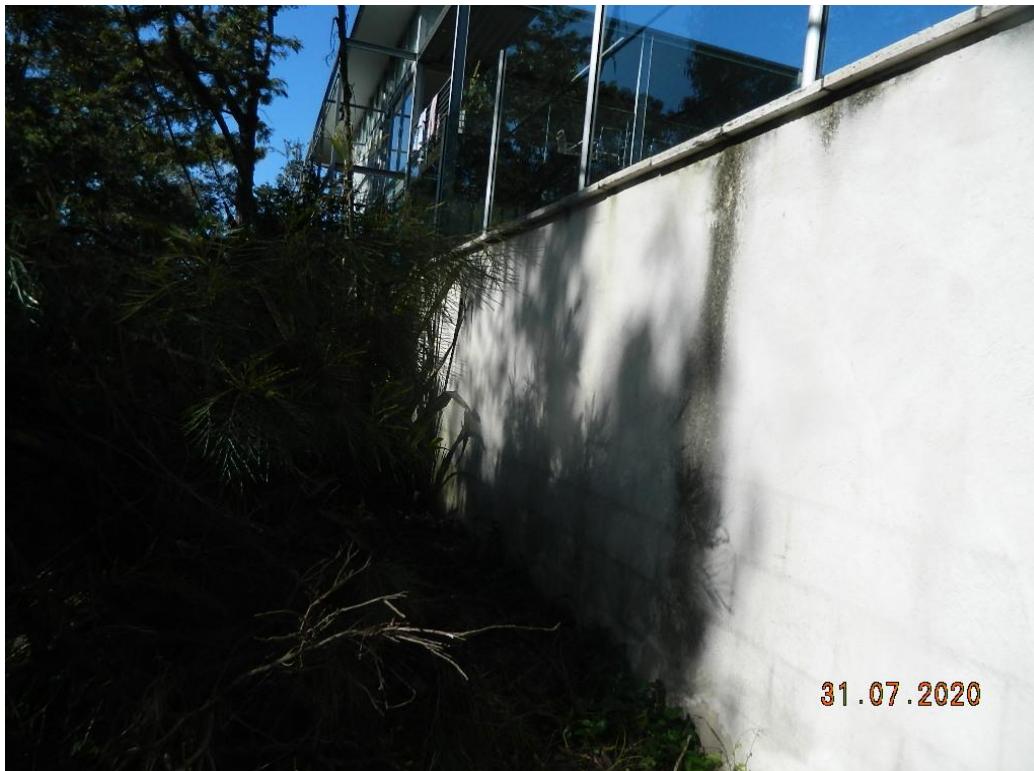
Photo 8

good condition supports the pool pavement and lawn fill (Photo 8). No signs of slope instability were observed on the property. The adjoining neighbouring properties were observed to be in good order as seen from the street and subject property.

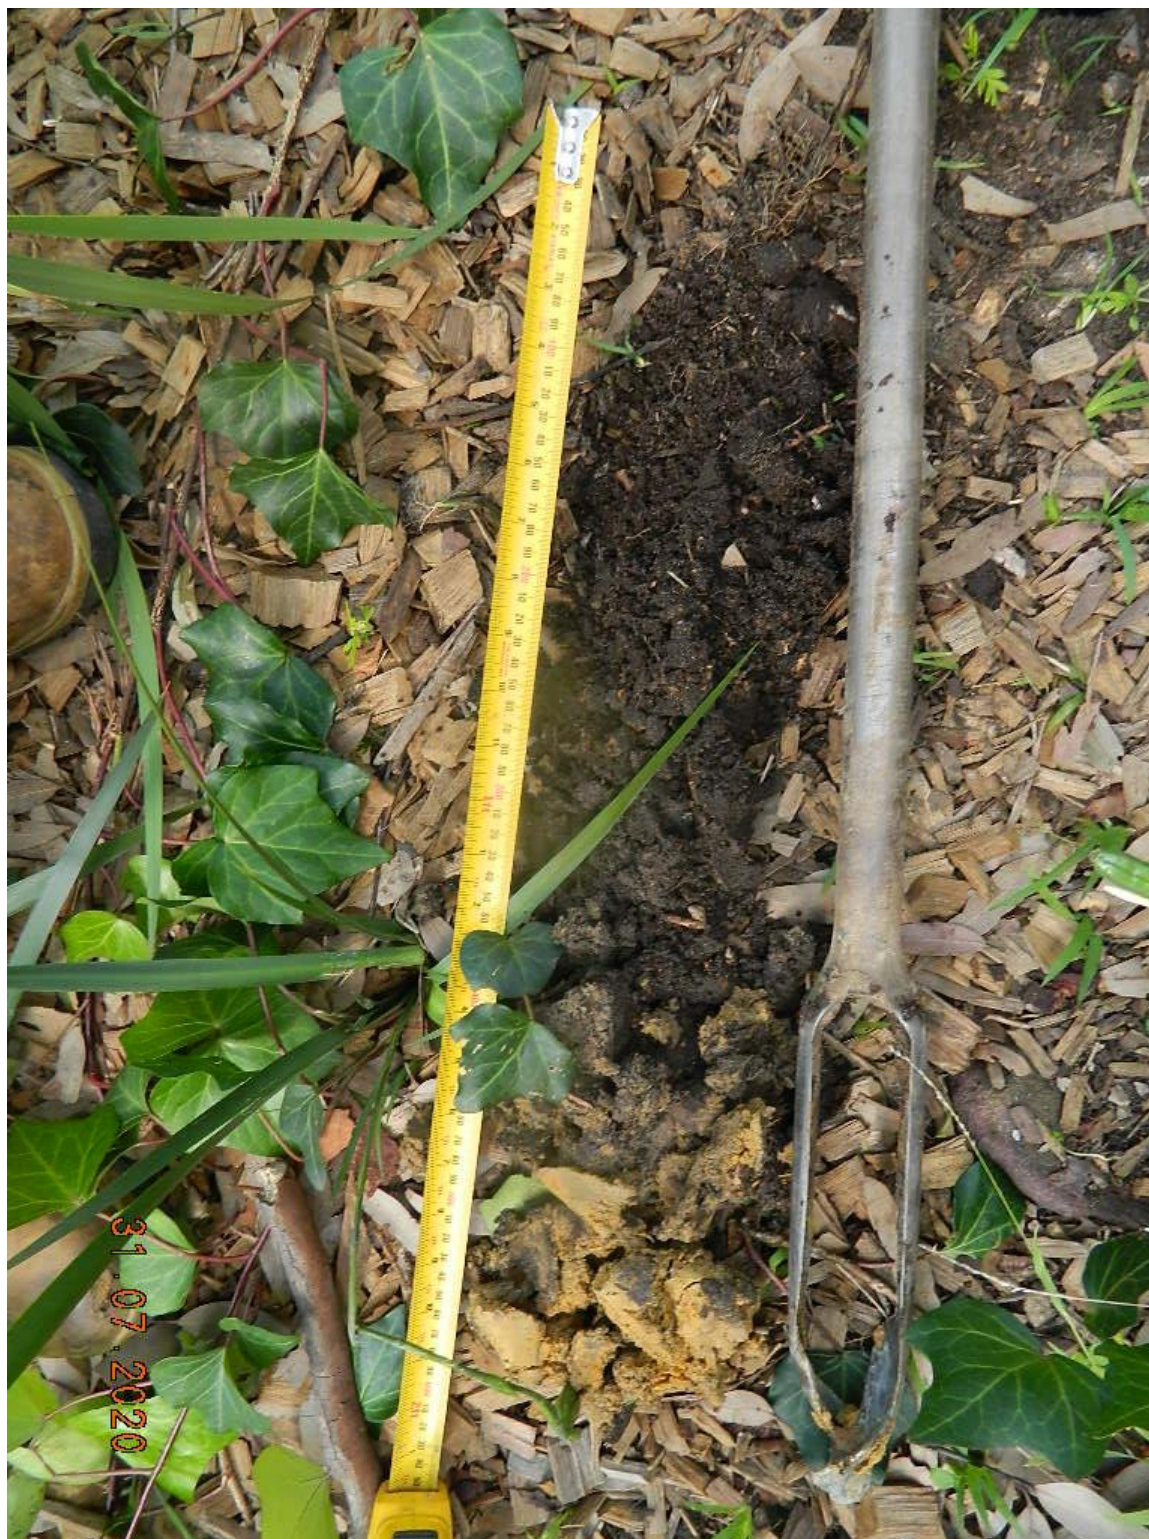
AUGER HOLE 1 (~RL63.4) – AH1 (photo 9)

Depth (m)	Material Encountered
0.0 to 0.4	TOPSOIL , dark brown, fine to medium grained, moist with fine trace organic matter.
0.4 to 0.6	SANDY CLAY , light orange brown, firm to stiff, moist.

End of Test @ 0.6m in sandy clay. No watertable encountered.

Photo 9: AH1 – Downhole is from top to bottom

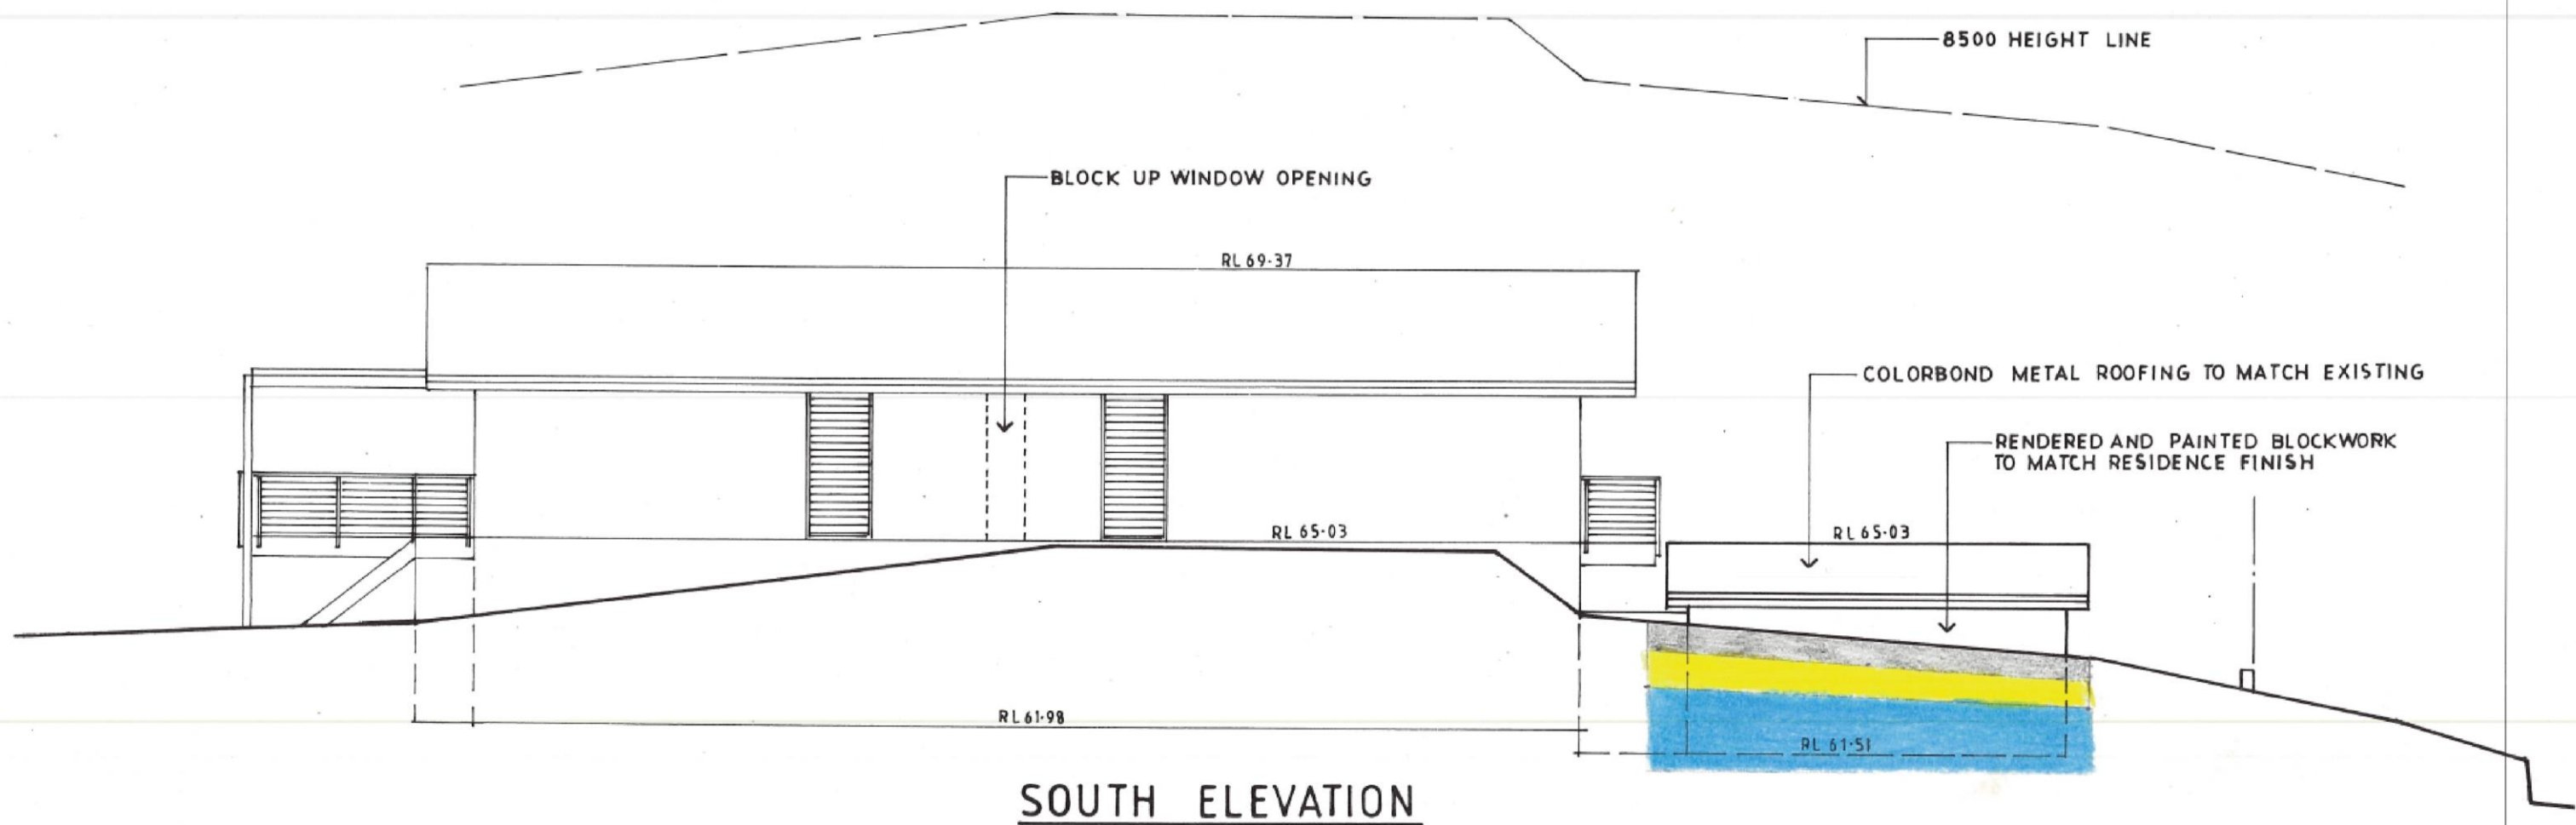
TYPE SECTION – Diagrammatical Interpretation of expected Ground Materials

The surface features of the block are controlled by the underlying sandstone bedrock that steps down the property forming sub-horizontal benches between the steps. Where the grade is steeper, the steps are larger and the benches narrower. Where the slope eases, the opposite is true. The rock is overlain by fill, topsoil and sandy clay that fills the bench step formation. Fill provides level platforms on the N and W sides of the house. In the test locations, the depth to rock ranged from between ~0.8 to ~1.1m below the current surface. The sandstone underlying the property is estimated to be Medium Strength or better. See Type Section attached for a diagrammatical representation of the expected ground materials.

- Topsoil
- Sandy Clay
- Hawkesbury Sandstone – Medium Strength
