Report Title: Geotechnical Report 14 Capua Place, Avalon

Report Date: 10/9/19

## **GEOTECHNICAL INVESTIGATION:**

### **Alterations and Additions and New Garage at 14 Capua Place, Avalon**

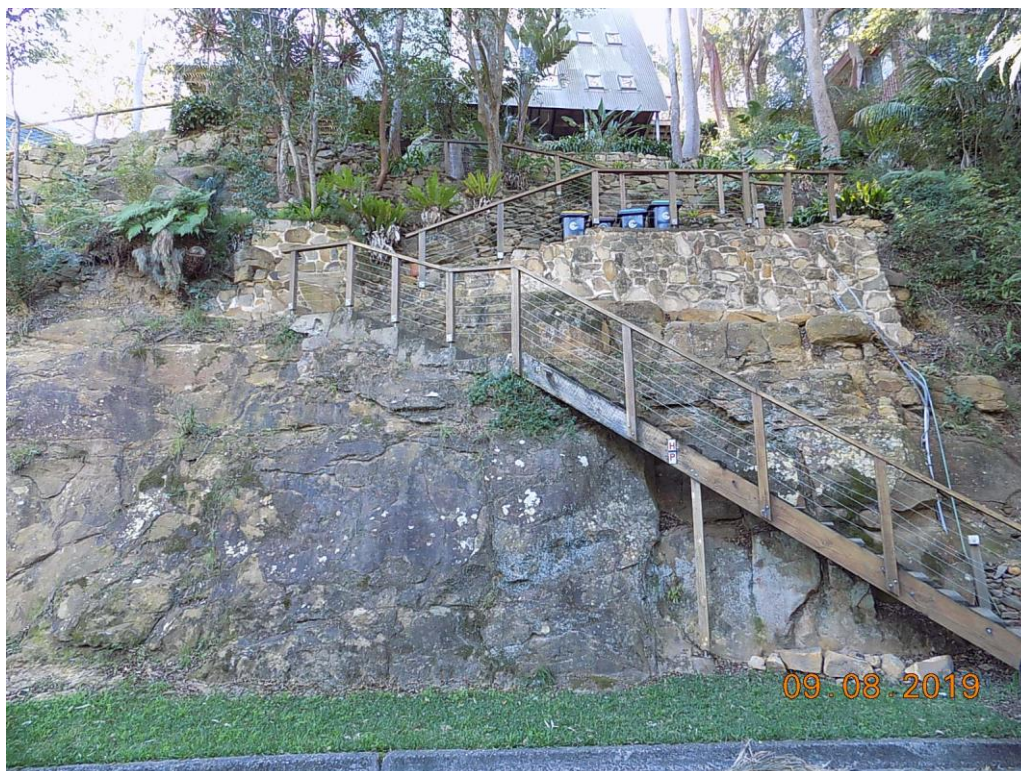
Photo 1

- 2.3** A ~9m high cliff face rises from the road frontage to Capua Place (Photo 1). No significant undercutting or other geological defects were observed in the cliff face. Some filling has been placed to terraced the slope between the cliff and the downhill side of the house. The terraces are supported by a series of stable stack rock retaining walls (Photos 2 & 3). On the W side of the house, the slope has been terraced with

No geotechnical hazards were observed above, below, or beside the property. The sandstone cliff face that rises from the road frontage is a potential hazard (**Hazard One**).

HAZARDS	Hazard One
TYPE	The sandstone cliff face on the property failing and impacting on the proposed works (Photo 1).
LIKELIHOOD	'Rare' ( $10^{-5}$ )
CONSEQUENCES TO PROPERTY	'Major' (40%)
RISK TO PROPERTY	'Low' ( $6 \times 10^{-5}$ )
RISK TO LIFE	$9.96 \times 10^{-6}$ /annum
COMMENTS	This level of risk is 'ACCEPTABLE'.

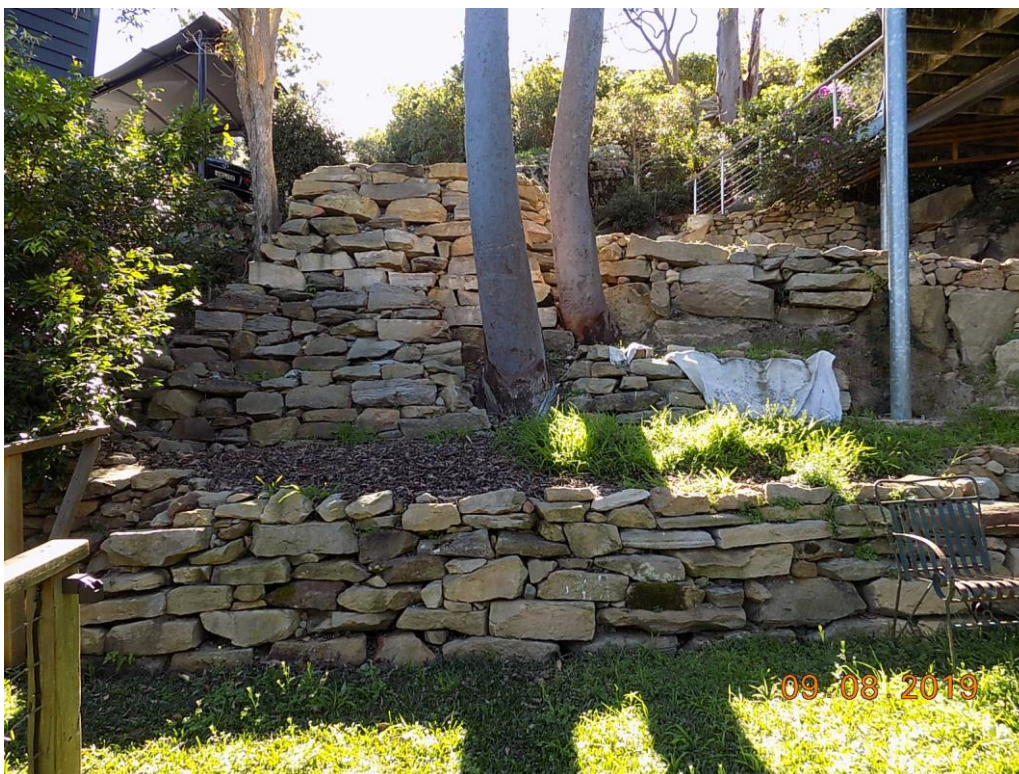
Photo 4

two stable stack rock retaining walls (Photo 4). These walls support a fill for a gravel parking area. The part two-storey timber framed and clad house is supported on steel posts and brick piers (Photo 5). The supporting posts and piers stand vertical. A gravel driveway runs under the house to a car parking area. The cut for the parking area is partially supported by a stack rock retaining wall and is partially unsupported (Photo 6). A new retaining wall will be constructed in this location as part of the proposed works. A brick and gravel ROW runs along the uphill side of the house (Photo 7). The ROW is accessed from Riviera Avenue. Competent Medium Strength Sandstone outcrops and steps up the slope that rises above the ROW and continues to the upper boundary (Photo 8).

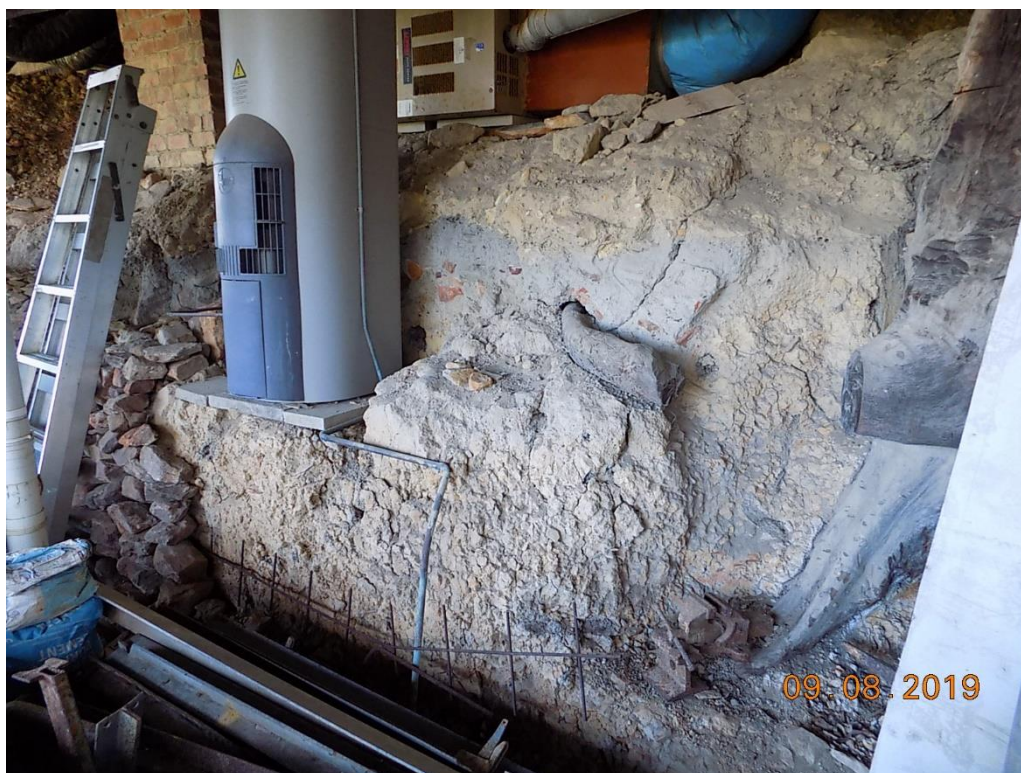
Photo 6

The subsurface materials were exposed in an exposed cut under the house (Photo 6). The exposed profile consisted of a thin manmade fill over stiff to hard clays. The clays merge into the underlying weathered rock at an average depth of ~0.8m below the current surface. The

weathered zone in this location is interpreted to be Very Low Strength Shale. As Medium Strength Sandstone was encountered in the other tests and was observed to be outcropping above and below this location, this is interpreted as a thin band of shale that extends through the otherwise sandstone-dominated profile. See Type Section attached for a diagrammatical representation of the expected ground materials.

A new retaining wall will be constructed under the house to support the existing excavation. For cantilever or singly-propped retaining walls, it is suggested the design be based on a triangular pressure distribution of lateral pressures using the parameters shown in Table 1.
