| Project name | 32 GOLF AVE MONA VALE |

| Company | RTS CIVIL CONSULTING ENGINEERS |

Company: QURON PTY LTD  
Responsible person: DEAN CLOGHER  
Division:  
Street: 2A LAMROCK AVE  
City: RUSSELL LEA  
Phone:  
Fax:  
Mobile: 0408 924 445  
E-Mail: ADMIN@QURON.COM.AU

## Section Inspection - 7/02/2024 - STORMWATER

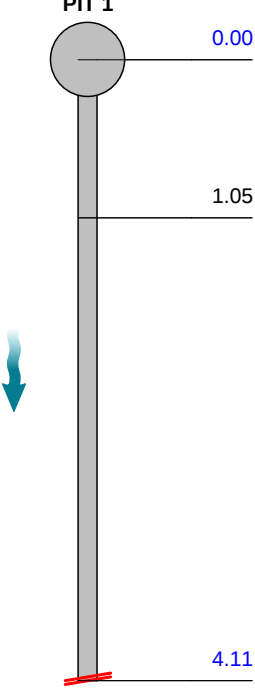
| 1:50 | [m] | Code | Observation Text | MPEG | Photo | Grade |
|---|---|---|---|---|---|---|
| | 1.05 | DER | Deposits in the invert, gravel or rubble, Obstruction: 5-20% at 6<br>o'clock | 00:00:12 | | |
| | 4.11 | SAOB | Inspection (survey) abandoned, obstruction, Obstruction:<br>51-75% / ROOTS/RUBBLE | 00:01:12 | | |

| Construction Features | | | | | Miscellaneous Features | | | | |
|---|---|---|---|---|---|---|---|---|---|
| 0 | 0.0 | 0.0 | 0.0 | 1 | 1 | 30.0 | 7.3 | 30.0 | 3 |

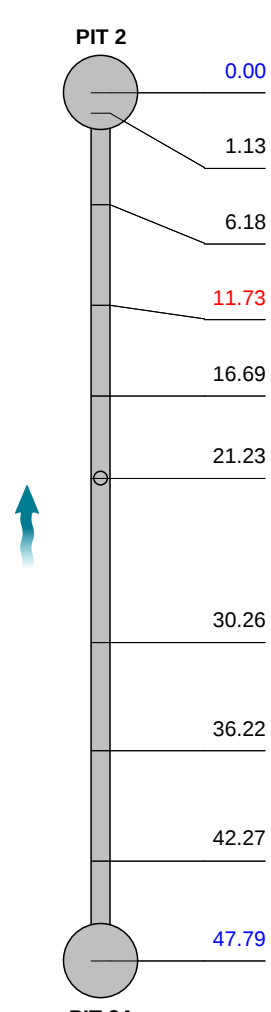
| 1:416 | [m] | Code | Observation Text | MPEG | Photo | Grade |
|---|---|---|---|---|---|---|
| | 1.13 | DER | Deposits in the invert, gravel or rubble, Obstruction: <5% at 6 o'clock | 00:00:22 | | |
| | 6.18 | JDL | Displaced joint, longitudinal displacement, longitudinal displacement: >30mm at 12 o'clock | 00:01:00 | | |
| | 11.73 | DV | Vertical deformation, length of deformation: > 1000mm, change in diameter: 11-15% at 12 o'clock | 00:01:37 | STORMWATER_470<br>0f0c6-431 | |
| | 16.69 | DER | Deposits in the invert, gravel or rubble, Obstruction: 5-20% at 6 o'clock | 00:02:29 | | |
| | 30.26 | JDL | Displaced joint, longitudinal displacement, longitudinal displacement: 21-30mm at 12 o'clock | 00:03:57 | | |
| | 36.22 | JDL | Displaced joint, longitudinal displacement, longitudinal displacement: >30mm at 12 o'clock | 00:04:32 | | |
| | 42.27 | JDL | Displaced joint, longitudinal displacement, longitudinal displacement: 21-30mm at 12 o'clock | 00:05:20 | | |

| Construction Features | | | | | Miscellaneous Features | | | | |
|---|---|---|---|---|---|---|---|---|---|
| 5 | 30.0 | 0.9 | 44.0 | 3 | 2 | 30.0 | 0.7 | 35.0 | 3 |

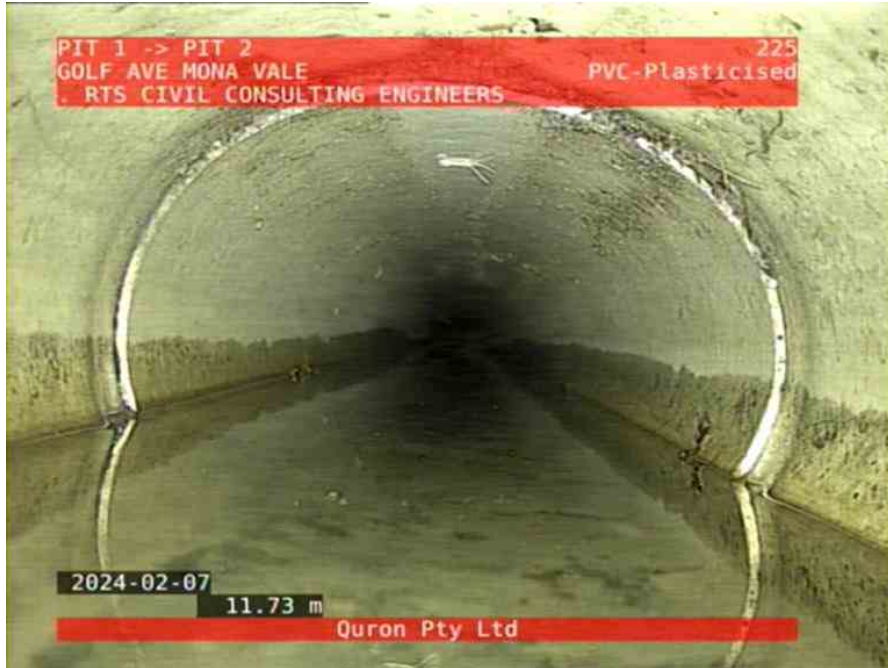
STORMWATER\_4700f0c6-4319-4fee-91a3-776cce582d7a\_20240207\_090046\_642.jpg,  
00:01:37, 11.73

Vertical deformation, length of deformation: > 1000mm, change in diameter: 11-15% at 12 o'clock
