Geotechnical Assessment

Project: New Dwelling & Swimming Pool
11 Loch Street, Freshwater NSW

Ref: AG 24413
4 December 2024

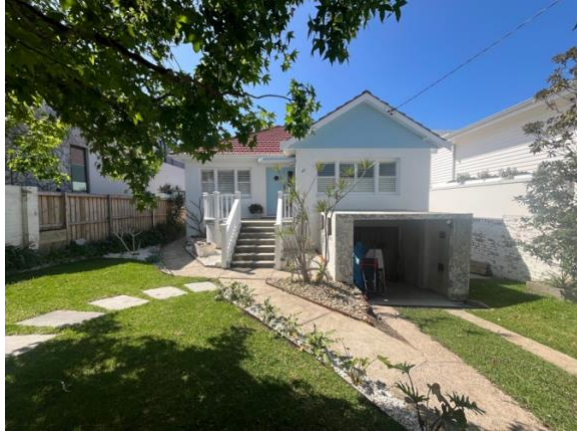
Photo 1: Residence frontage

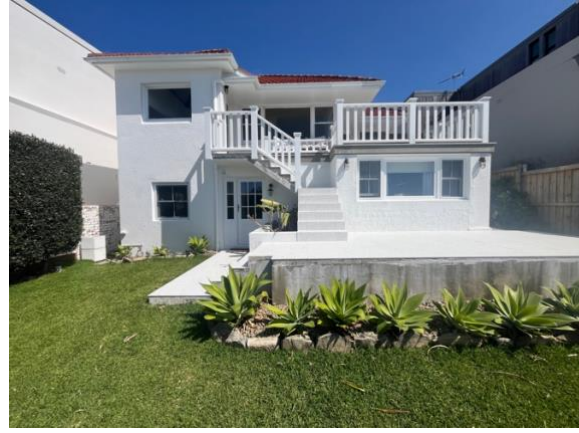
Photo 2: Residence rear

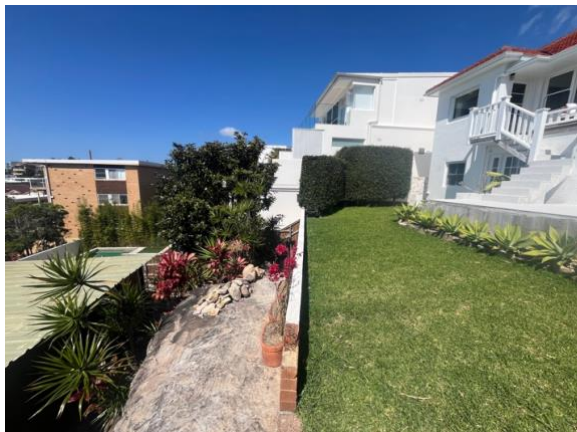
Photo 3: Brick wall partially over bedrock in rear yard

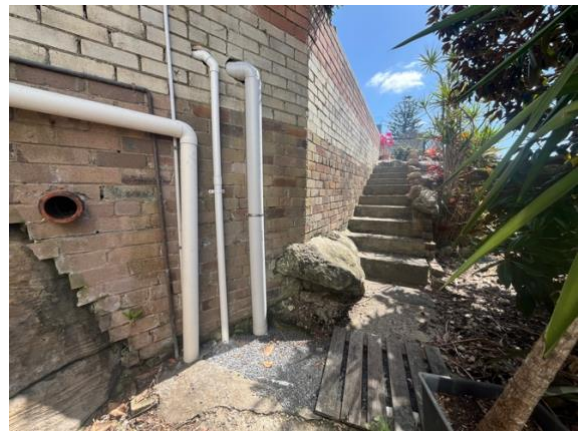
Photo 4: Brick wall in rear yard

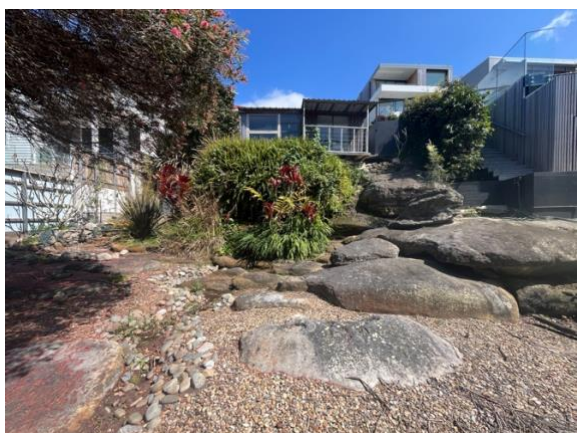
Photo 5: Looking west from rear boundary at timber studio in rear yard.

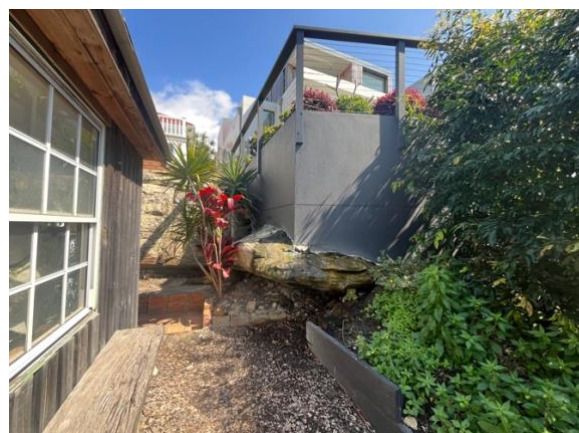
- **Hazard One:** Failure of the proposed excavations.
- **Hazard Two:** Failure of the undercut rock on the northern boundary and impacting the retaining wall on the adjoining property to the north (Photo 6)
- **Hazard Three:** Mobilisation of joint blocks / boulders at the rear of the site as a result of construction activities
- **Hazard Four:** Mobilisation of joint blocks / boulders at the rear of the site as a result of natural processes

HAZARDS	HAZARD ONE	HAZARD TWO
TYPE	Failure of the proposed excavations	Failure of the undercut rock on the northern boundary and impacting the retaining wall on the adjoining property to the north (Photo 6)
LIKELIHOOD	'Possible' (10^{-3})	'Possible' (10^{-3})
CONSEQUENCES TO PROPERTY	'Minor' (5%)	'Minor' (5%)
RISK TO PROPERTY	'Moderate' (2×10^{-3})	'Moderate' (2×10^{-3})
RISK TO LIFE	4.5×10^{-4} /annum	4.5×10^{-4} /annum
COMMENTS	Following implementation of the recommendations outlined in Section 3.7, the above risk levels would reduce to 'Acceptable' levels within the site.	Following implementation of the recommendations outlined in Section 3.7, the above risk levels would reduce to 'Acceptable' levels within the site.
HAZARDS	HAZARD THREE	HAZARD FOUR
TYPE	Mobilisation of joint blocks / boulders at the rear of the site as a result of construction activities	Mobilisation of joint blocks / boulders at the rear of the site as a result of natural processes

LIKELIHOOD	'Possible' (10^{-3})	'Rare' (10^{-5})
CONSEQUENCES TO PROPERTY	'Minor' (5%)	'Minor' (5%)
RISK TO PROPERTY	'Moderate' (2×10^{-3})	'Very Low' (2×10^{-5})
RISK TO LIFE	6.4×10^{-5} /annum	8.3×10^{-7} /annum
COMMENTS	Following implementation of the recommendations outlined in Section 3.7, the above risk levels would reduce to 'Acceptable' levels within the site.	This level of risk to life and property is 'ACCEPTABLE' .

Photo 6: Rendered wall of the adjoining property to the north has built over undercut bedrock, on northern boundary in rear yard.
