Geotechnical Assessment

Project: Duplex
35 Moore Road, Freshwater NSW

Ref: AG 25207
22 May 2025

For **Proposed Duplex** at

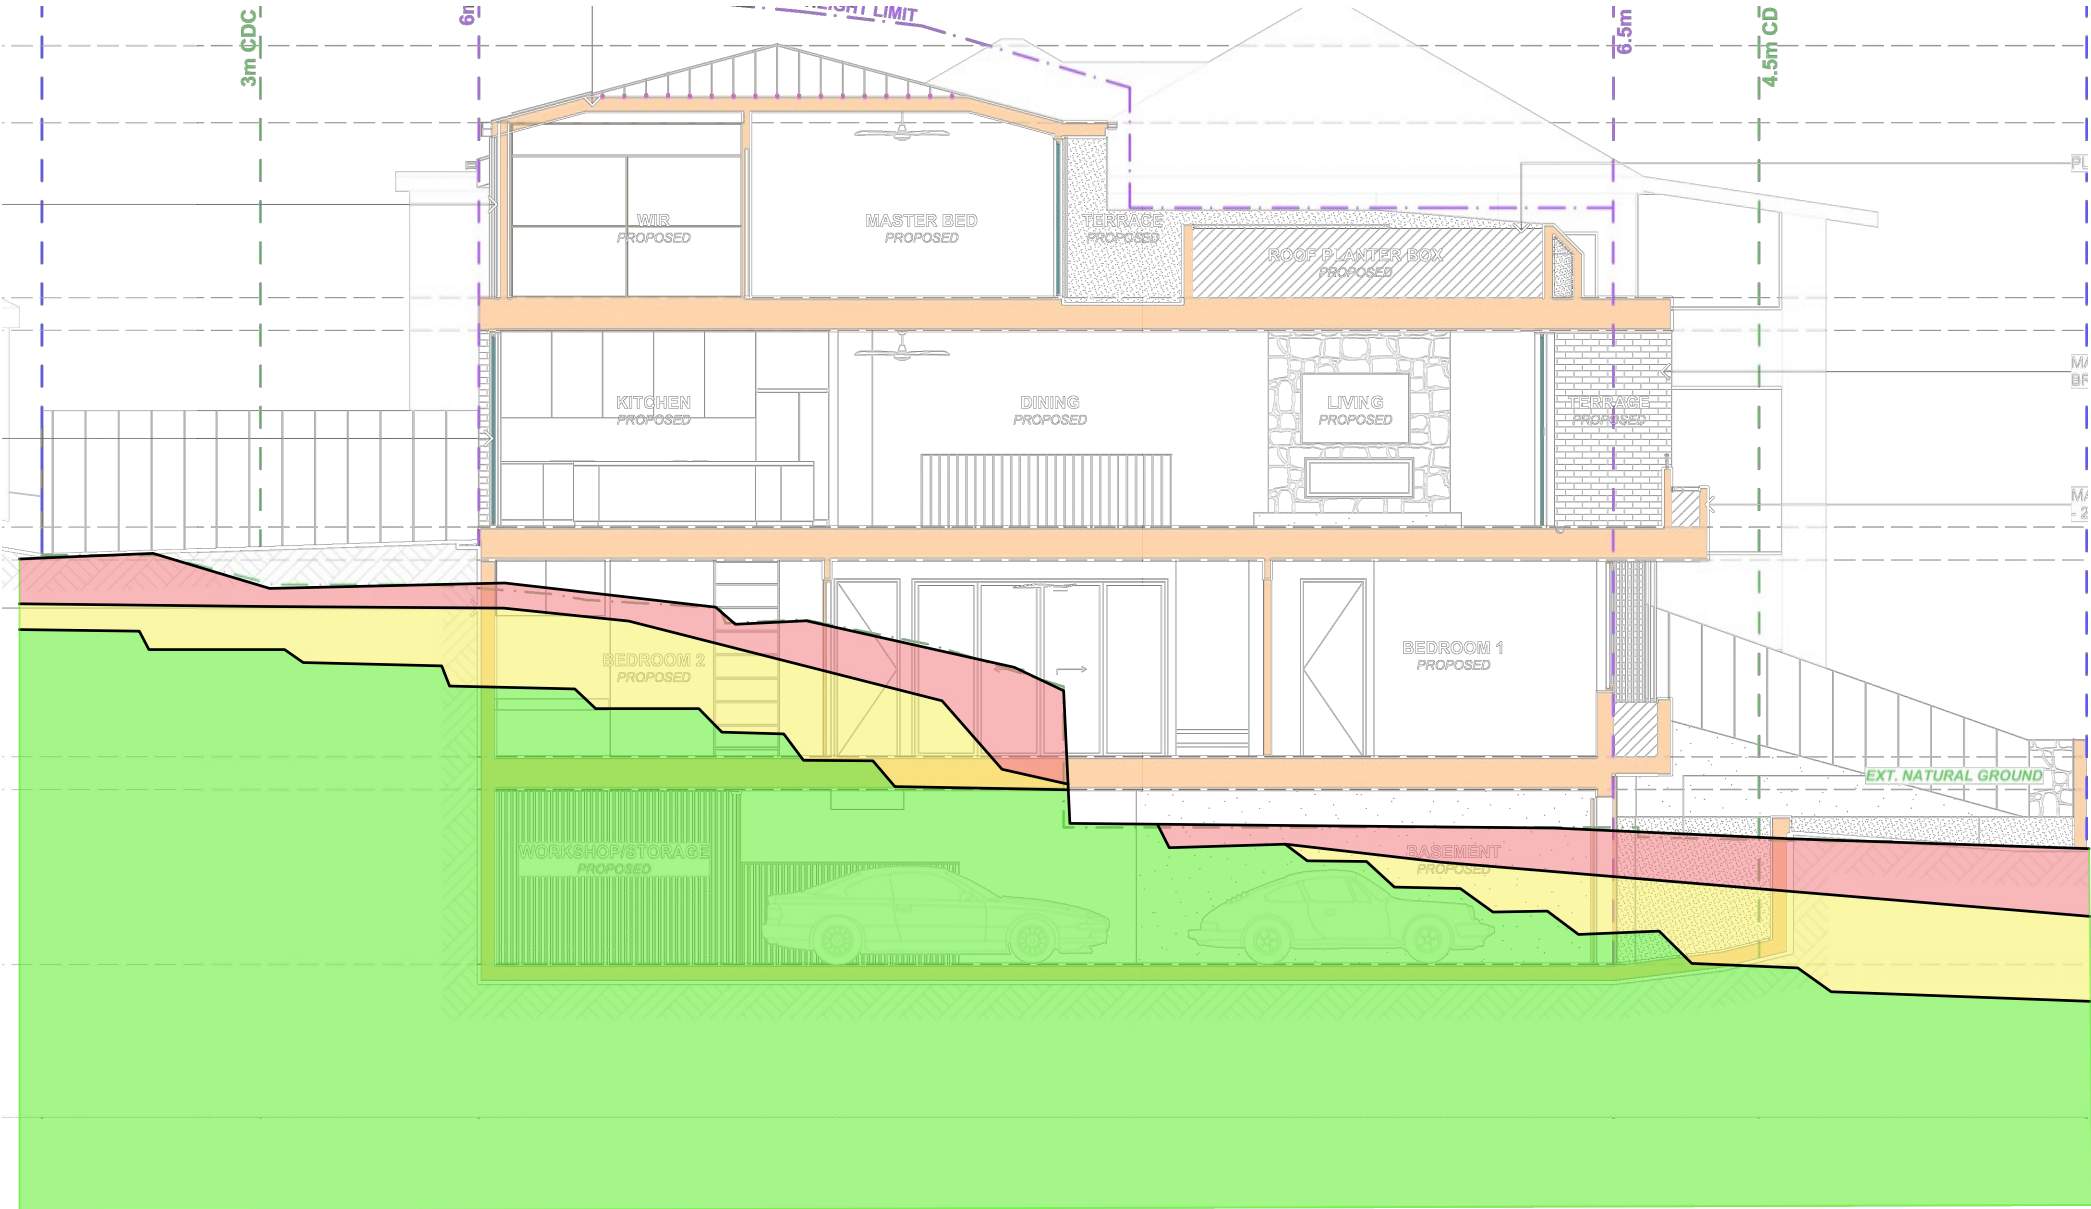
INFERRED GEOLOGICAL SECTION

Unit	Material Type	Material description
1	Topsoil/Fill	Paving and tiled areas. Stone paths. Silty Sand disturbed fill and topsoil.
2	Sand	Medium grained quartz sand. Generally loose.
3	Class V* Sandstone	Extremely weathered sandstone bedrock. Typically occurring near the uppermost metre (~) of bedrock.
4	Class IV* Sandstone	Mainly low strength sandstone bedrock with closely to moderately spaced defects resulting in blocky weathering. Typically encountered in the uppermost 2m (~) of bedrock profile.
5	Class III* Sandstone	Medium strength, massively bedded sandstone with isolated but persistent sub-vertical joints. Depth to this quality of rock is unconfirmed.

INTERPRETED SUBSURFACE SECTION ONLY.
ACTUAL GROUND CONDITIONS MAY VARY.

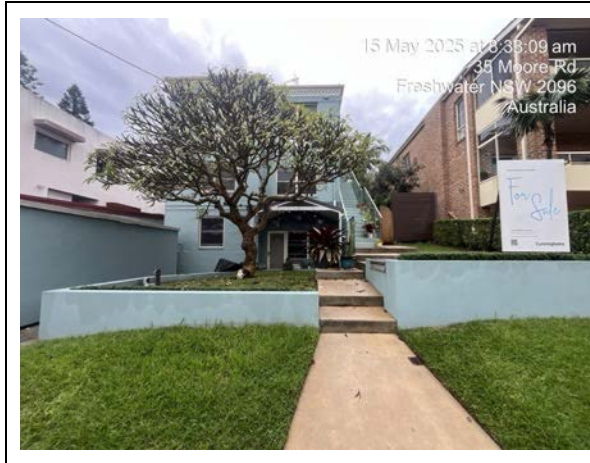
Photo 1: Facing SW. Residence frontage

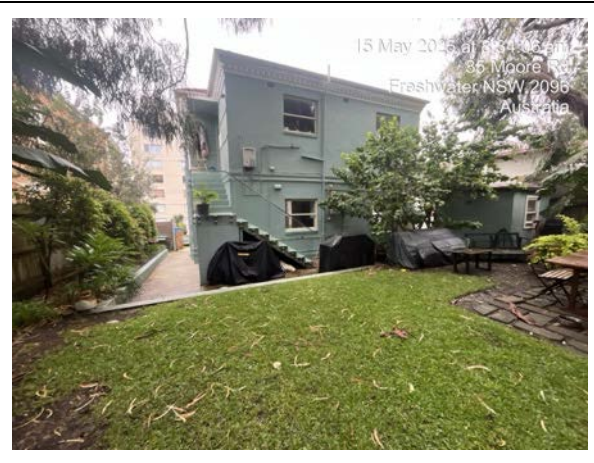
Photo 2: Facing SE. Residence rear

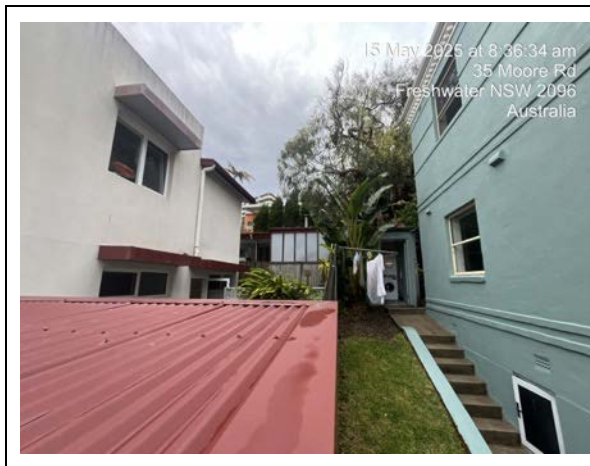
Photo 3: Facing SW along SE boundary

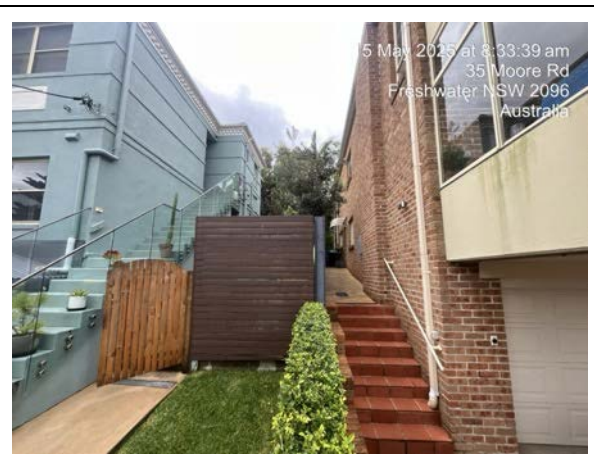
Photo 4: Facing SW along NW boundary
