ARBORICULTURAL IMPACT ASSESSMENT (AIA) REPORT

Site Address: 11 Ferguson Street Forestville

Inspection Dates: 19th February, 2020

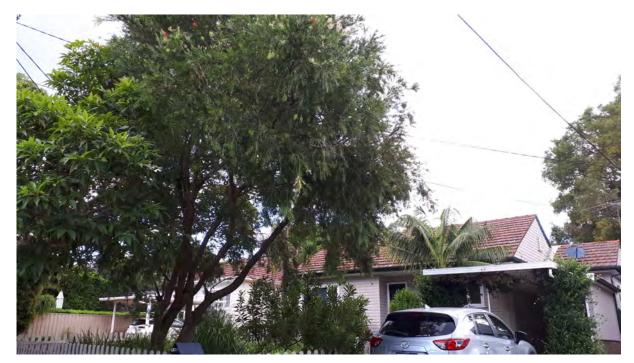
Photo 11: T1 Bottle brush

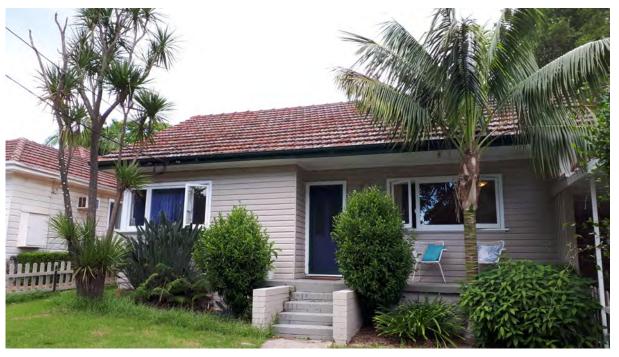
Photo 2: T2 Dracena sp at front of house.

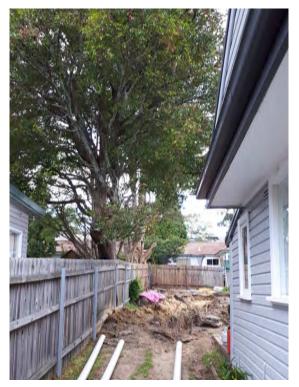
Photo 5: Trenching within No 15 and relative distance off base of trees within No 11 Ferguson. T3 in forgary and

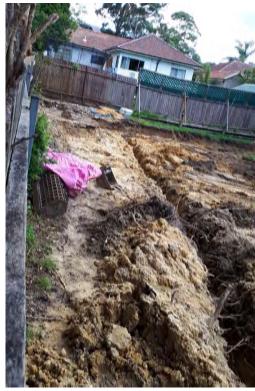
Photo 6: Trenching offset distance and extent.

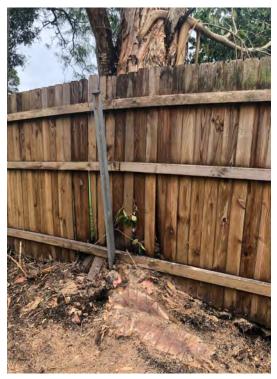
24.1	significant root volume due current	ml · · ·
	Melaleuca	construction works on neighbouring	This tree is
Т6	quinquenervia	property.	structurally
	Broad leaf		compromised
	paperbark	Under the proposal this tree is not	before works begin.
		retainable.	
		Irrespective of the design this tree should	
		be removed.	
		Environmental weed. Tree structurally	Retention value
		very poor.	Low
		very poor.	LOW
		Construction impact:. High	Remove
	Cinnamomum	construction impacts riigh	Remove
	camphor	Under the proposal this tree is not	
Т7	Camphor	retainable.	
	laurel		
		Irrespective of the design this tree should	
		be removed.	
		Mature tree in fair to good health.	Retention value
			Moderate
		Construction impact: "High" 50% of TPZ	
		inclusive of SRZ.	Remove
Т8	Melaleuca	Approximately 50% of TPZ falls beneath	
	bracteata	the proposed secondary dwelling.	
		Excavation is required for FFL	
		Tura is mak makaimalala

Photo 4:T6 showing extensive damage to base of trunk and first order roots. Photo supplied by

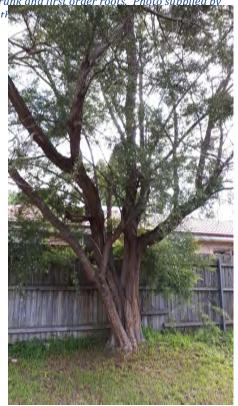
Photo 3: T8 Melaleuca
