## **GROUND TESTING:**

### **New Pool at 10 Kalinya Road, Newport**

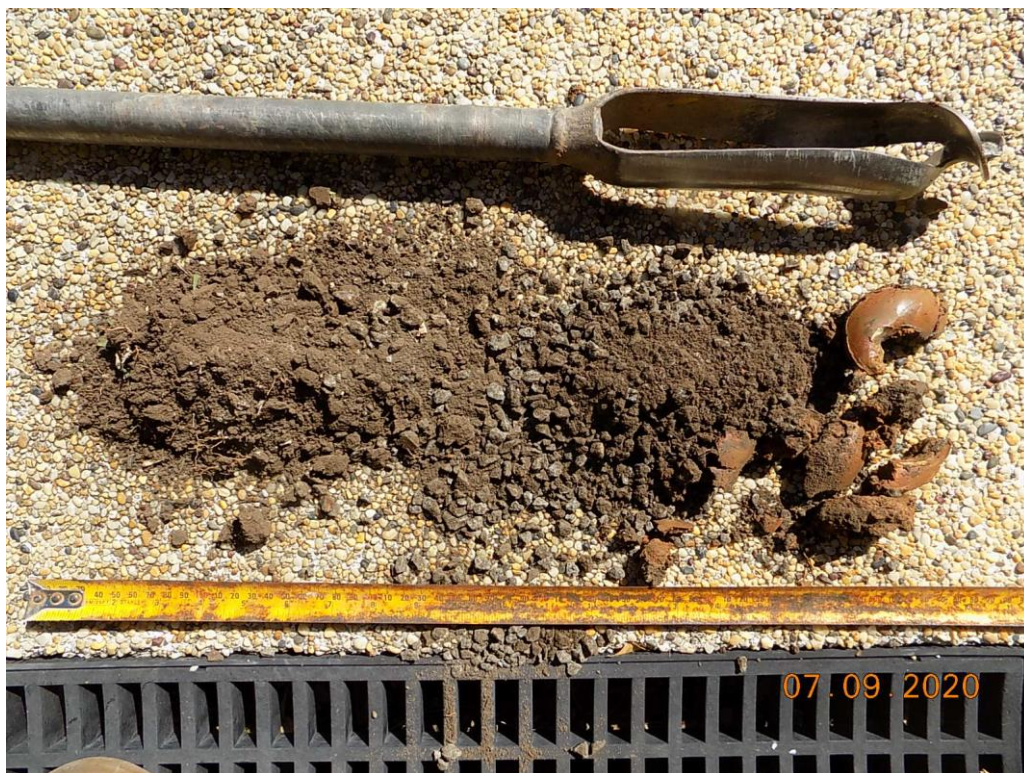
Photo 1: AH1 – Downhole is from left to right

## AUGER HOLE 1 – AH1 (Photo 1)

Depth (m)	Material Encountered
0.0 to 0.4	<b>FILL</b> , disturbed gravelly soil, dark brown and dark grey, dense, dry, medium to coarse grained with fine trace organic matter.
0.4 to 0.5	<b>CLAY</b> , weathered shale, maroon and mottled orange, very stiff, dry, fine grained.

End of test @ 0.5m in weathered shale. No watertable encountered.
