**RISK ANALYSIS & MANAGEMENT
FOR
PROPOSED SWIMMING POOL &
ALTERATIONS AND ADDITIONS
AT
37 TERAMA STREET, BILGOLA PLATEAU**

Job Number:
PX 00009
6th July, 2019
Page 11

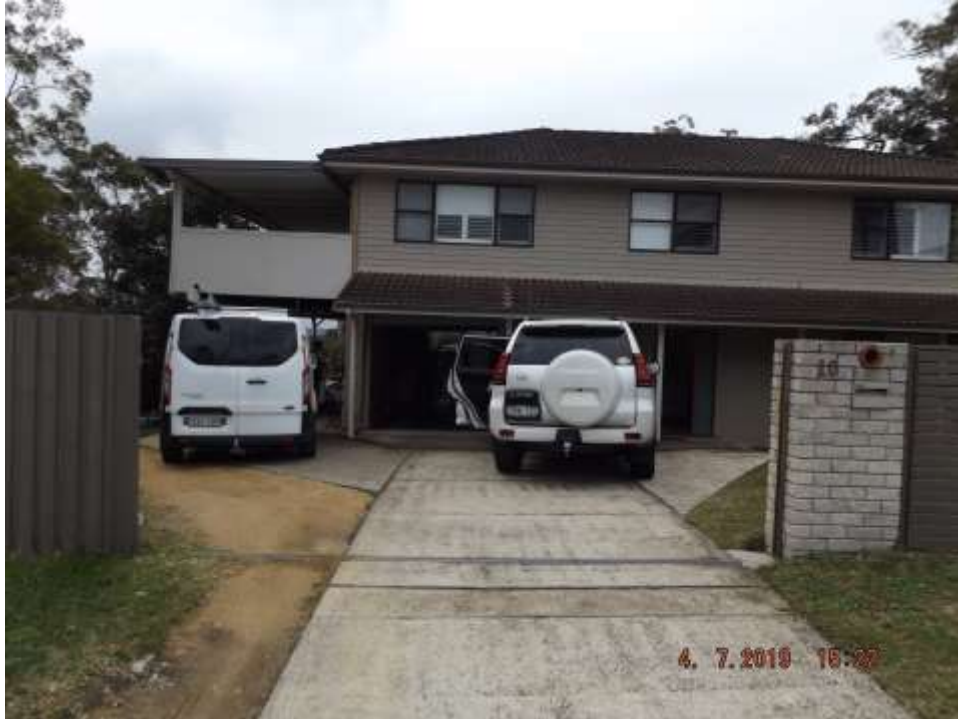
Photo 1

3.3 Access to the property is via the concrete driveway which starts from the edge of the Raymond Road adjacent north western corner of the property, Photo 1. Pedestrian access is also via the driveway where the main entry to the existing residence is on the ground floor level. The ground floor level garage is attached to the existing residence. A masonry retaining wall supports the fill material running along the western side of the existing residence, Photo 2. A lawn area slopes away to the north western corner of the property and is split into three separate levels by two concrete block retaining walls, Photos 3 & 4. A treated timber sleep retaining wall runs along the northern boundary, Photo 5. The above retaining walls were observed to be stable at the time of our inspection. The rear yard directly to the north of the existing residence is a level lawn and paved area that extends to the eastern side of the existing residence, Photo 6. The south eastern corner of the property is landscaped area, Photo 7.

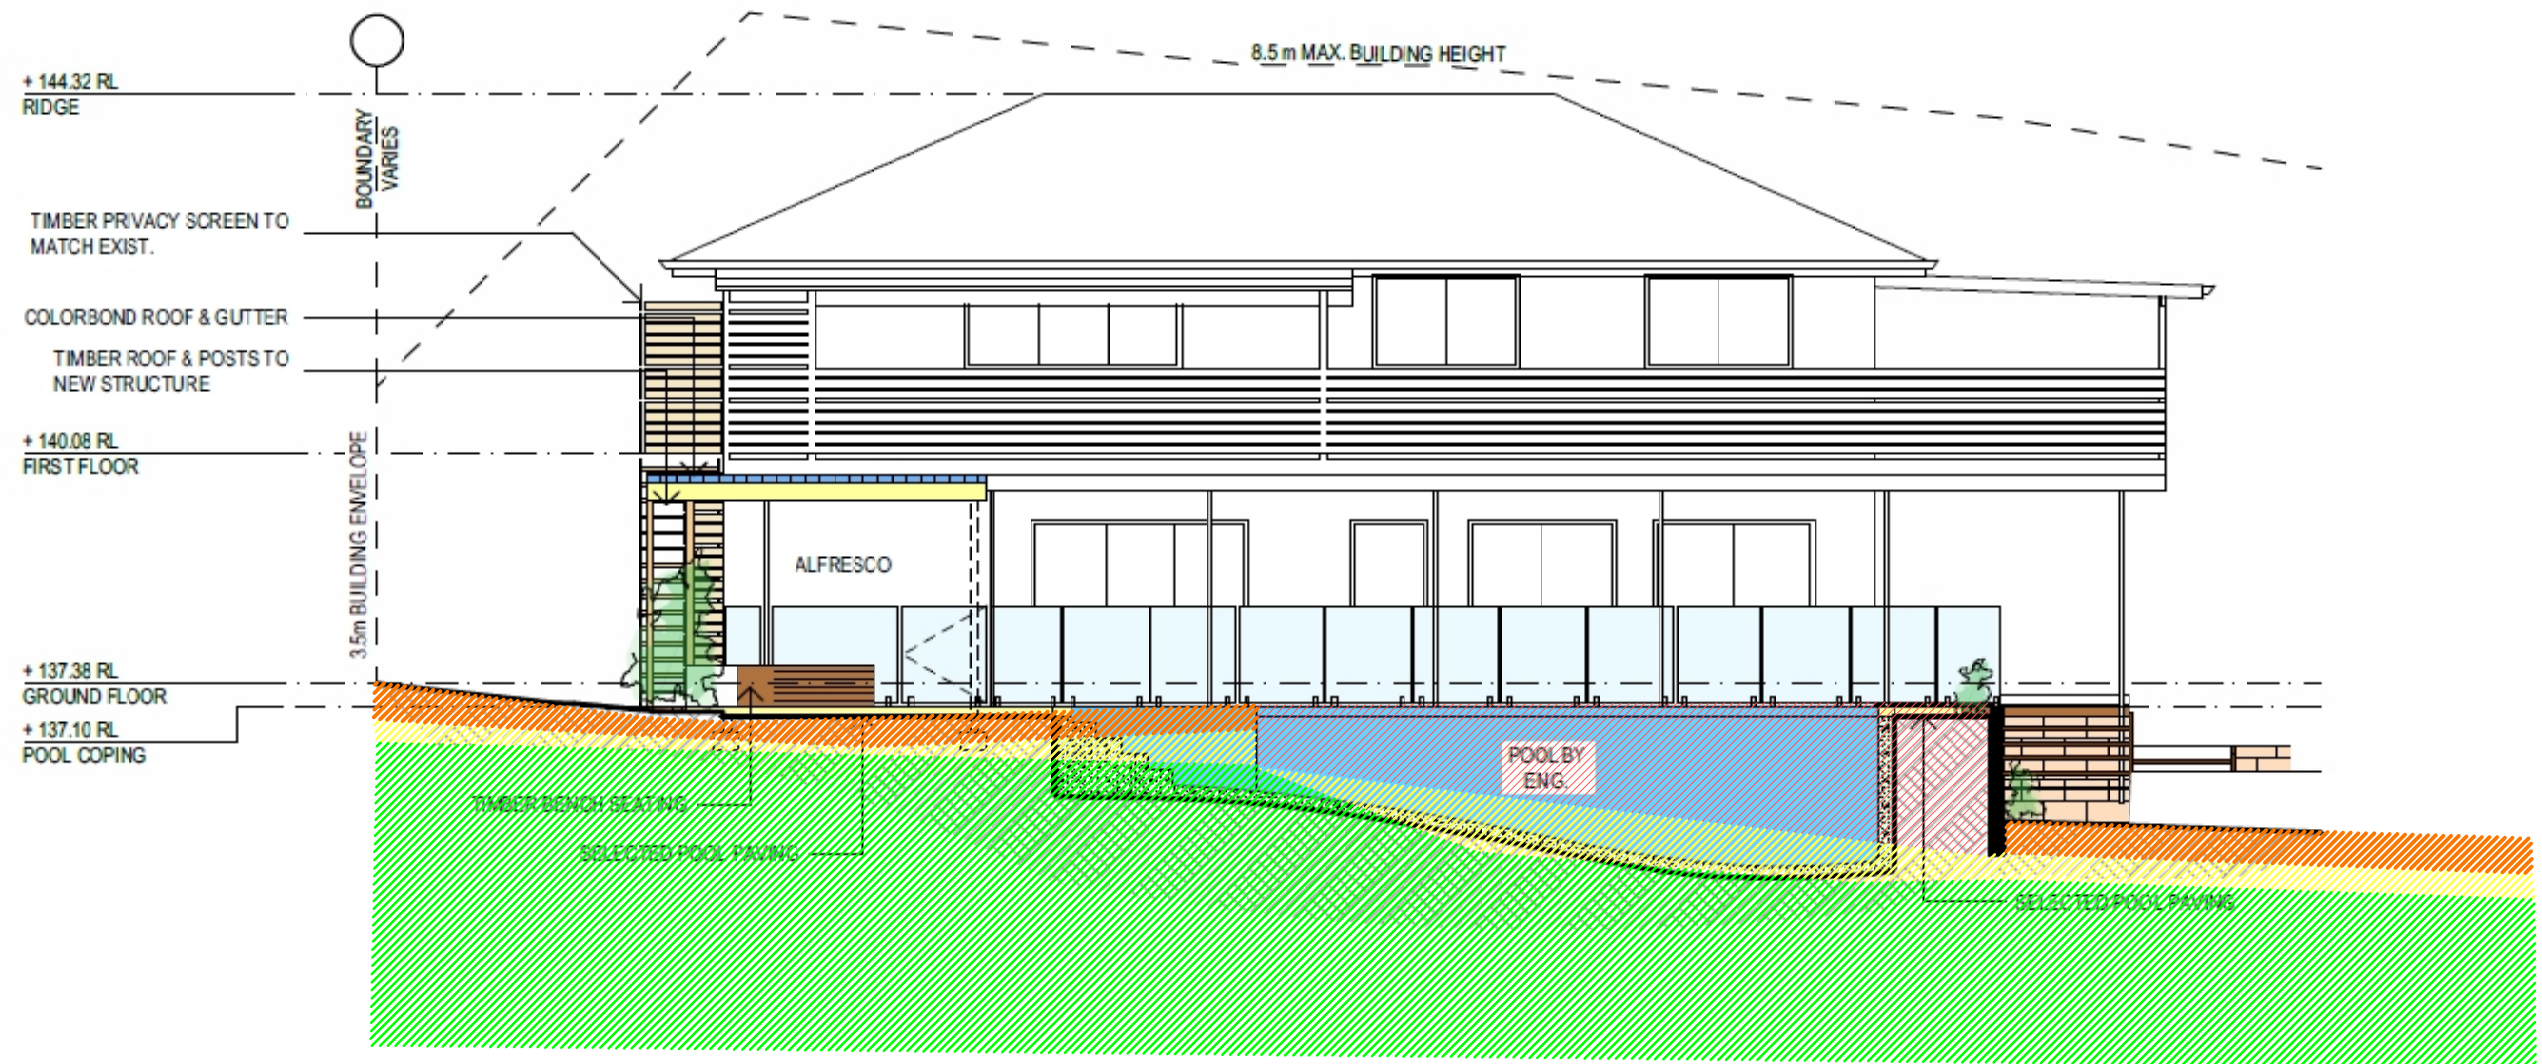
4.2 The slope materials are colluvial at the surface and residual at depth. They consist of sandy loams over sandy clays that merge into the weathered zone of the underlying rocks at depths expected to be in the range of 1.0 to 2.0 metres, or deeper where filling has been carried out.

NOTE
INTERPRETED SUB SURFACE SECTION ONLY.
ACTUAL GROUND CONDITIONS MAY VARY.
