ARBORICULTURAL ASSESSMENT REPORT AND TREE PROTECTION SPECIFICATION

3 Gondola Road
North Narrabeen
NSW 2101

Project No: 220323
Date: 22nd March 2022
Revision: A

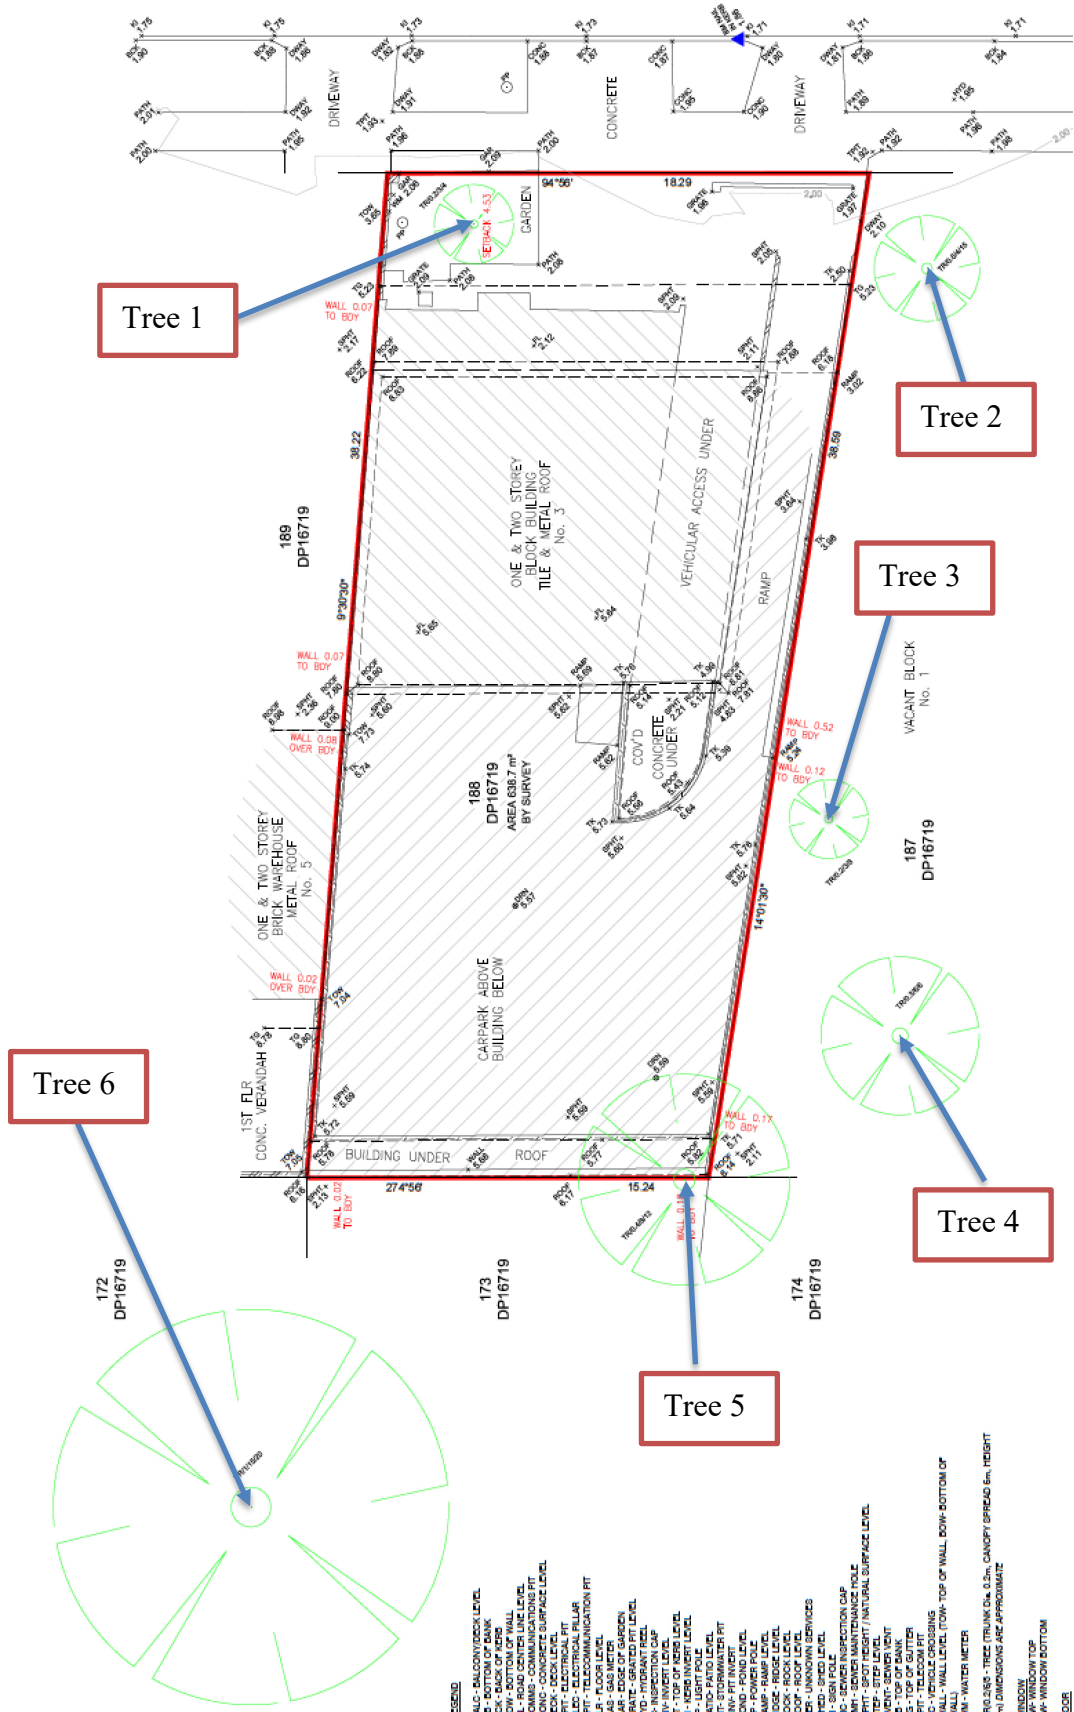
APPENDIX 1. SITE SURVEY PLAN AND TREE NUMBERS

4.8.4 **Tree 6** is a mature Eucalyptus spp in good health and condition. This tree is located in the rear adjoining property (6 Rickard Road North Narrabeen) and is approximately 12500mm to the south east of the southern boundary of the subject site.

4.8.4.1 The Tree Protection Zone for this tree is 12m radius based upon a 1 metre diameter at breast height. Therefore, the proposed work will occur outside the Tree Protection Zone and is acceptable for the long-term retention of the tree.

4.9.1 **Tree 5** is a mature *Eriobotrya japonica* (Loquat Tree) in good health and condition. This tree is located on the rear boundary of the neighbouring property of 2 Rickard Road North Narrabeen.

4.9.1.1 The southern wall of the proposed development will require this tree to be removed.

5.8.1 Trees 2, 3, 4, 5 and 6

5.8.1.1 These trees are to be protected according to AS4970-2009 (Protection of Trees on Development Sites) and as per Appendix 4 (Tree Protection Specification) during all stages of the construction process.

5.9.1 **Tree 1** whilst healthy and in good condition is situated in an unviable long term position. It may be removed with no detriment to the landscape intent of the property.
