Development Application for Luke Anglicas Name of Applicant
 Address of site 145 McCarrs Creek Road, Church Point

Report Title: RISK ANALYSIS & MANAGEMENT FOR PROPOSED NEW RESIDENCE AND GARAGE AT 143 McCARRS CREEK ROAD, CHURCH POINT – PX 00027

Job Number:
PX 00028
30th August, 2019
Page 1

**RISK MANAGEMENT
FOR
PROPOSED NEW RESIDENCE & GARAGE
AT
145 McCARRS CREEK ROAD, CHURCH POINT**

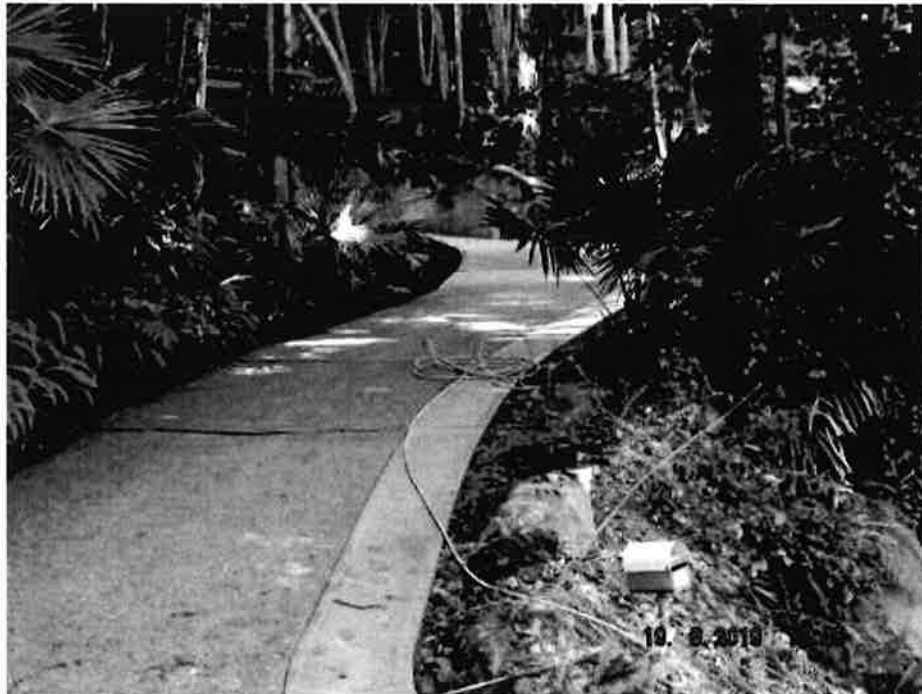
Photo 1

3.3 Access to the block is via the concrete driveway to the north of the property that provides access to 141 McCarrs Creek Road, Photo 1. From the McCarrs Creek road the steep road reserve cut batter rises to the front boundary. The cut batter is well vegetated and in some locations the exposed weathered shales of the Narrabeen Group of rocks is visible, Photo 2. There are numerous small to large trees spread over the block and medium dense undergrowth with displaced joint blocks (rock floaters) littered over the site, Photo 3. From the front boundary there is small level area where the slope rises consistently towards the rear boundary and to a rock ledge. The rock ledge has rock floaters on top and eroded overhangs in some locations and is approximately halfway up the property, Photos 4 & 5. The vegetated slope then continues to the rear boundary. A natural water course running adjacent along the southern side boundary is in the neighbouring reserve. Erosion of the road reserve batter by the watercourse was observed at the time of our inspection. This erosion should be motored and Council if informed of any changes especially after heavy rainfall events.

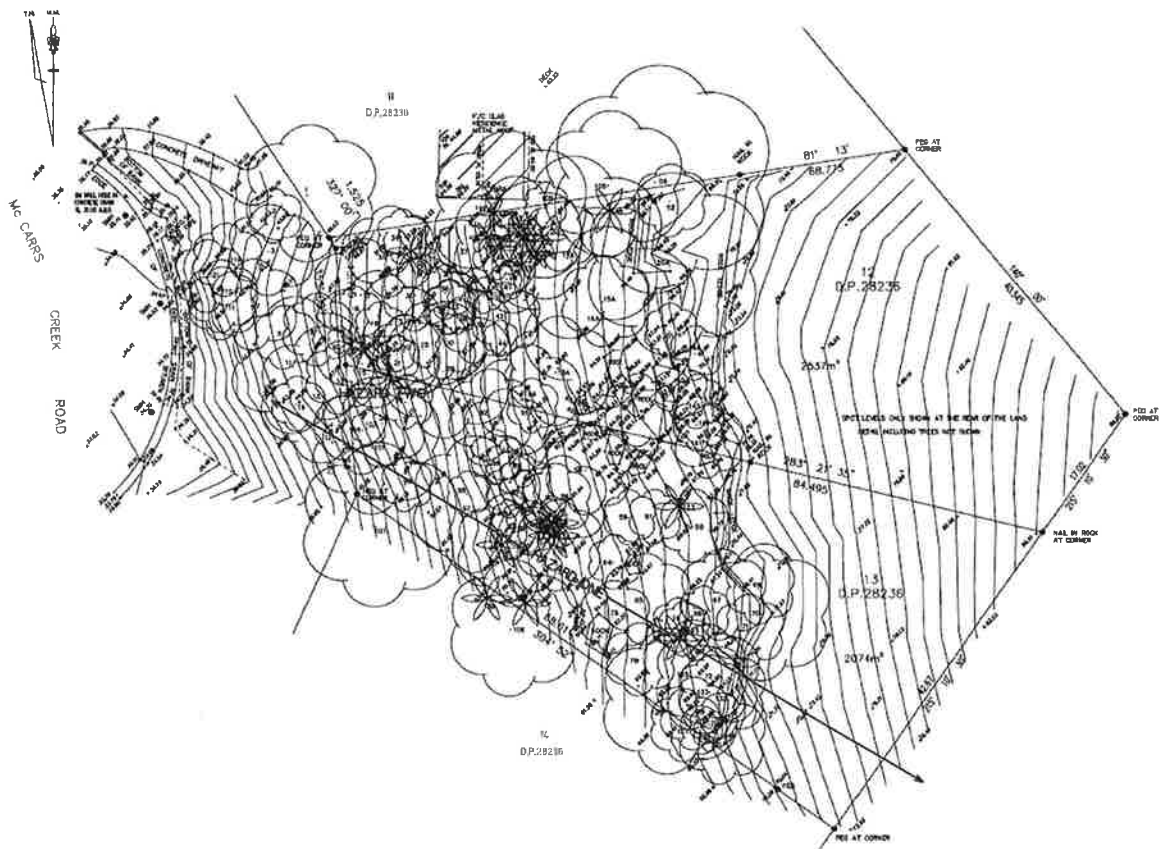
SITE PLAN - HAZARDOUS -

7.2.1 The site is classed slip affected under Council's Policy and a H1 Hazard. A failure of the slope across the property is considered to be a potential hazard (**HAZARD ONE**).

7.2.2 The excavations for the proposed garage are approximately 5.0m in depth. A possible failure of the cut batter during excavation is considered to be a potential hazard (**HAZARD TWO**).

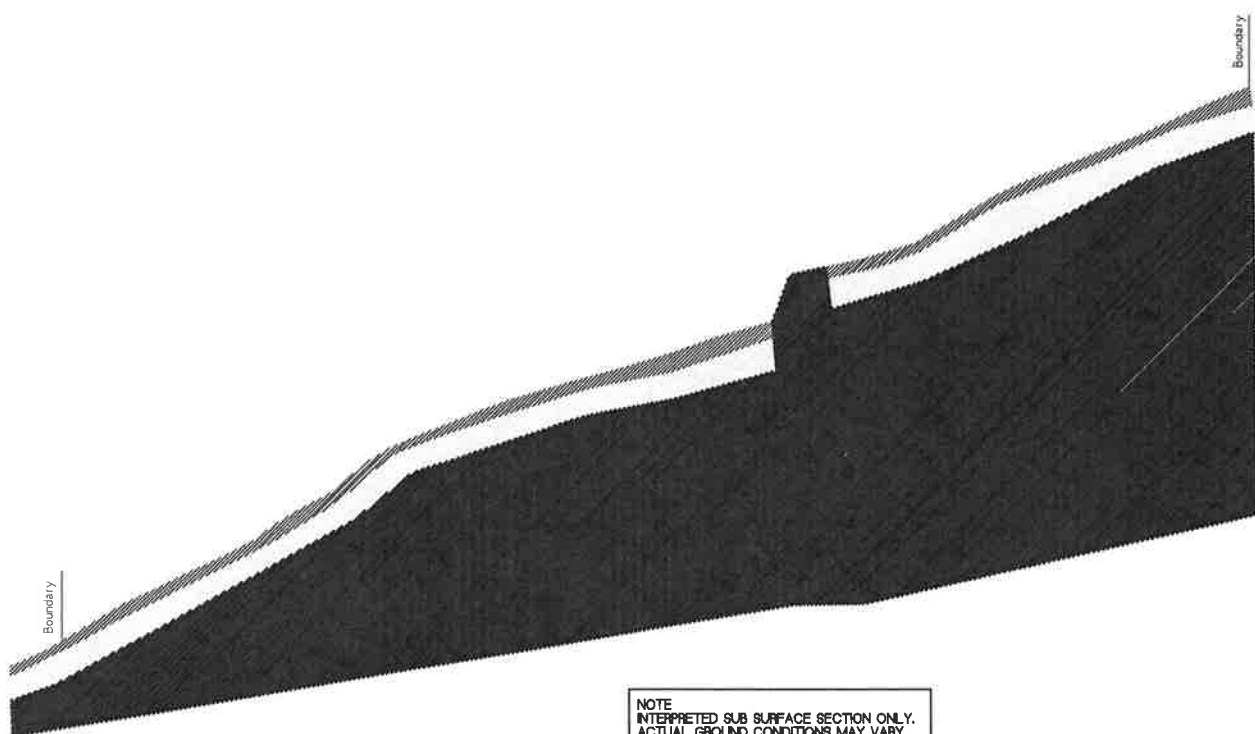
TYPE SECTION

4.2 The slope materials are colluvial in origin at the surface and became residual with depth. They consist of sandy loam topsoil over sandy clays and clays with rock fragments and some floaters through out the profile. The sandy clays and clays merge into the weathered zone of the under lying rocks at depths expected to be in the range 0.5 to 2.0 metres or deeper where filling has been carried out.
