# Geotechnical Assessment

**Project:** Waterfront Improvements  
158B & 158C McCarrs Creek Road, Church Point NSW

**Ref:** AG 24409  
2 October 2024

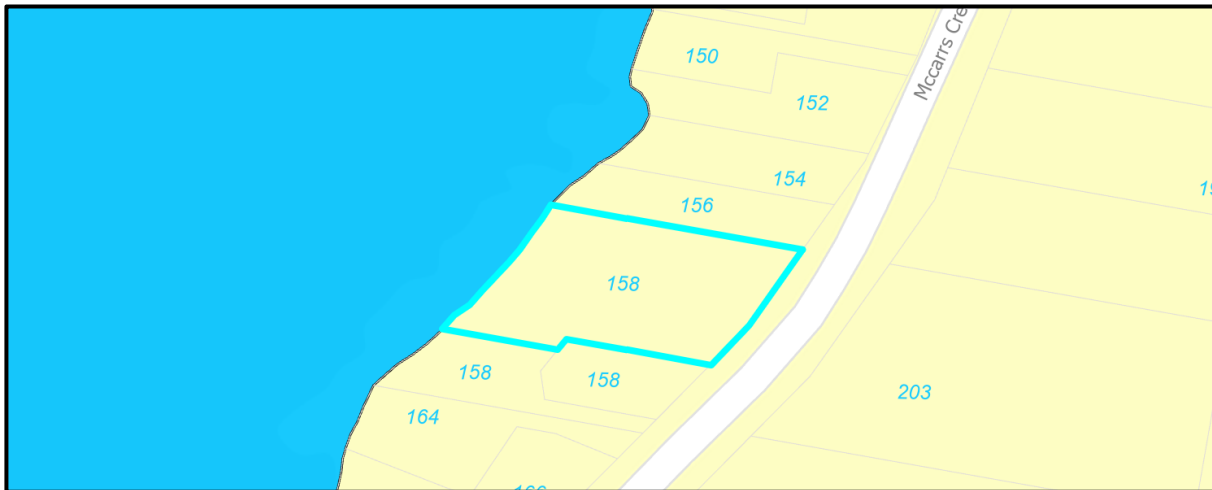
**Image 3.** Acid Sulfate Soils Map (NBC Maps): 158 McCarrs Creek Road, Church Point

With reference to the Northern Beaches Council (LEP) Acid Sulfate Soils Map, the Site is classified as “Class 5” with the proposed works extending into McCarrs Creek area classified as “Class 1” (Image 3).

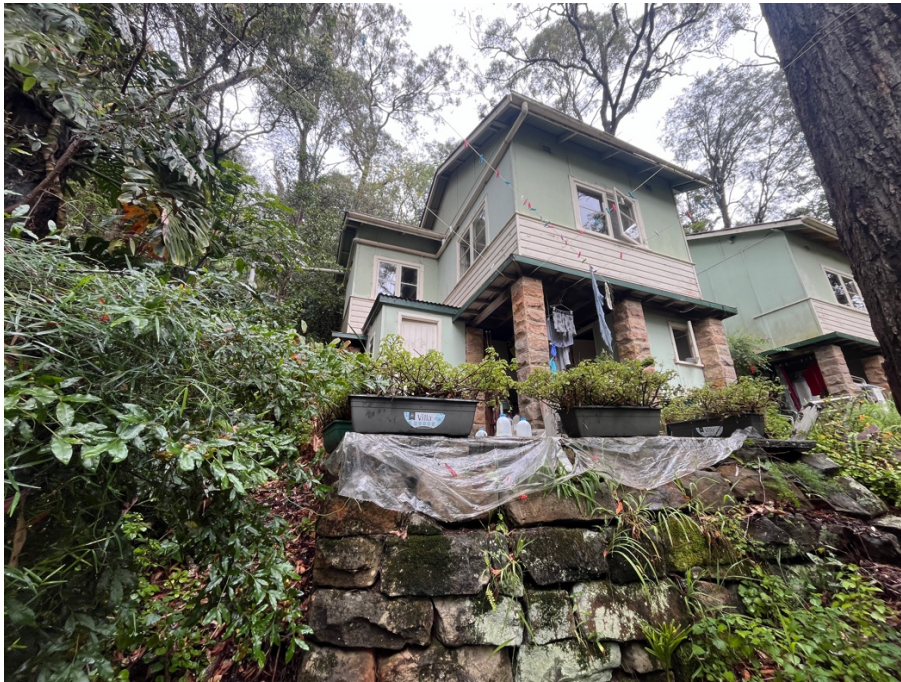
The existing structure on the site is a single storey clad cottage. This structure and various stack rock walls across the site are generally in good condition for their age.

**Photo 1:** Cottage dwelling

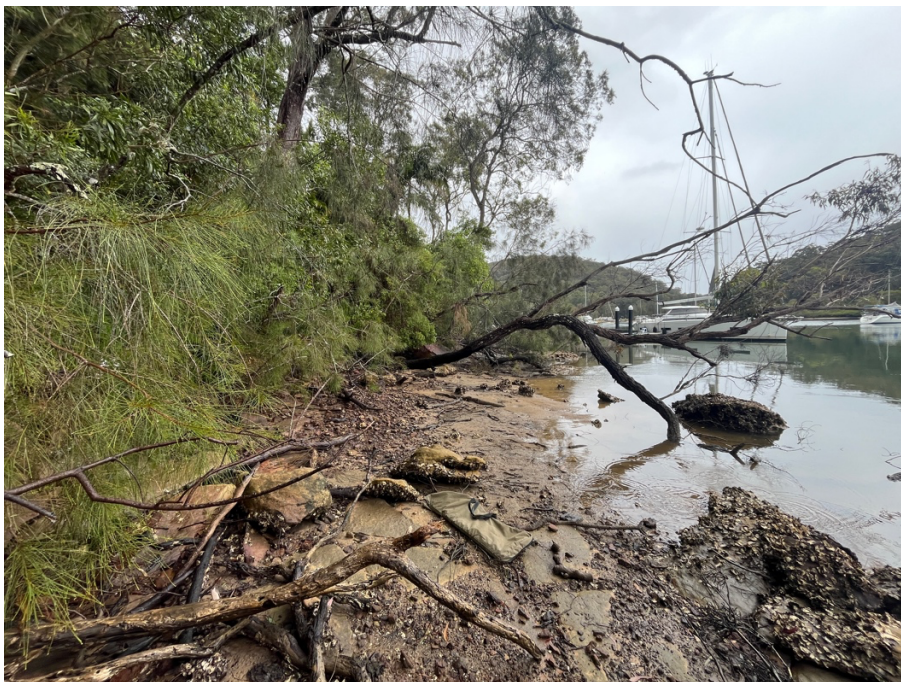
**Photo 2:** Waterfront area of the proposed works
