Pre-Demolition Hazardous Materials Inspection
Report and Register, Narrabeen R.S.L.

Asbestos, Lead, SMF and PCBs

Narrabeen North, N.S.W

10 January 2025

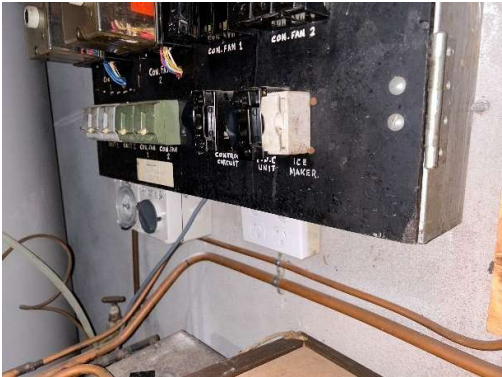
Building/Location	
<p>Photograph 7: Ground Floor, Room East of the Cool Room, Electrical Backing Board (8788/A7)</p>

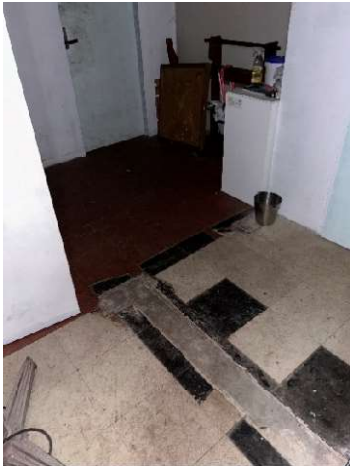
<p>Photograph 8: Ground Floor, Small space, White/Beige, Red Floor Tiles and Adhesive (8788/A9).</p>

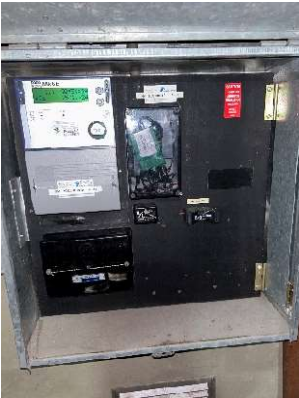
<p>Photograph 9: Air Conditioning Meter Room, Electrical Backing Board</p>

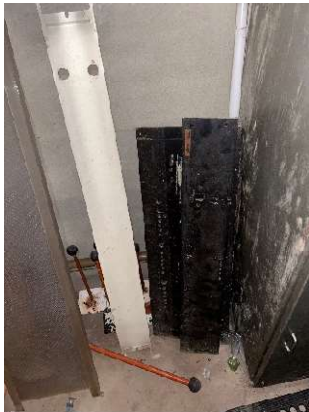
<p>Photograph 10: Air Conditioning Meter Room, Electrical Backing Board/s</p>

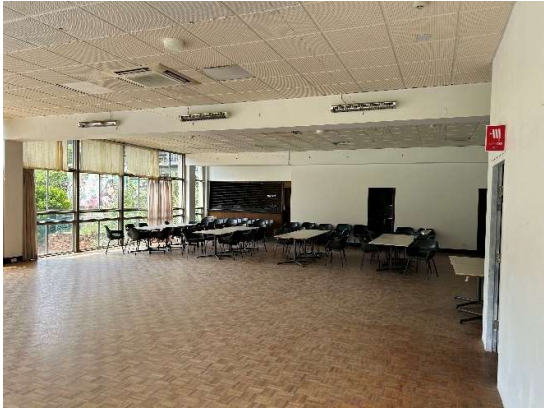
Building/Location	
<p>Photograph 13: Mezzanine, looking South towards Bar, with Ceiling Tiles (8788/A16).</p>

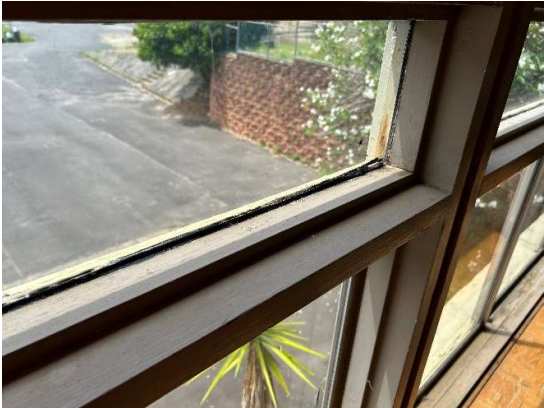
<p>Photograph 14: Mezzanine, Eastern Window, Putty and Brown Paint (8788/L4).</p>

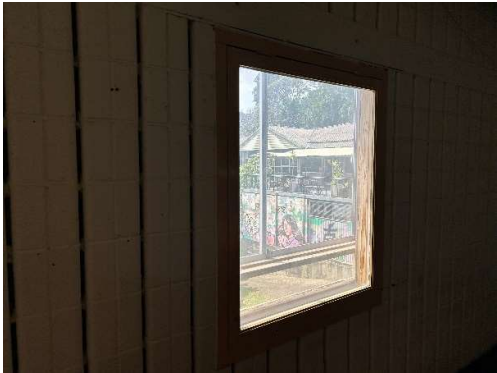
<p>Photograph 17: Auditorium, Eastern Windows, <i>Crème (8788/L7) and Orange Paint (8788/L8)</i></p>

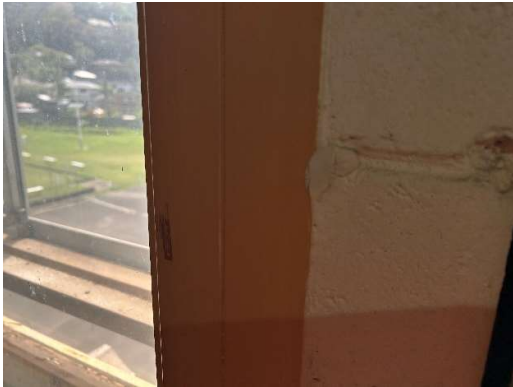
<p>Photograph 18: Auditorium, Eastern Windows, <i>Orange Paint and Putty.</i></p>

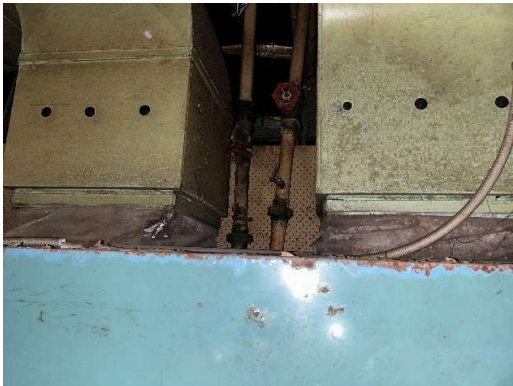
<p>Photograph 20: Plant within Cupboard. Not Accessed.</p>

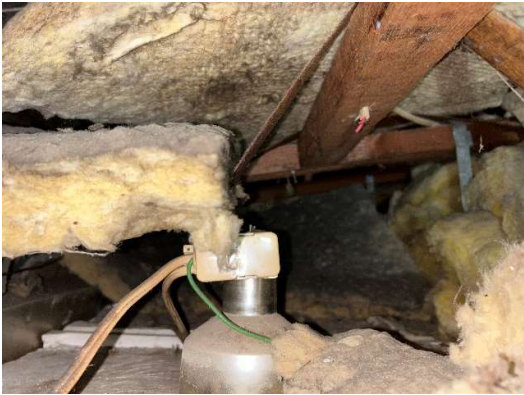
Building/Location	
<p>Photograph 21: Auditorium, Southern side above Restaurant space, Insulation Above Ceiling, Mineral Fibre</p>

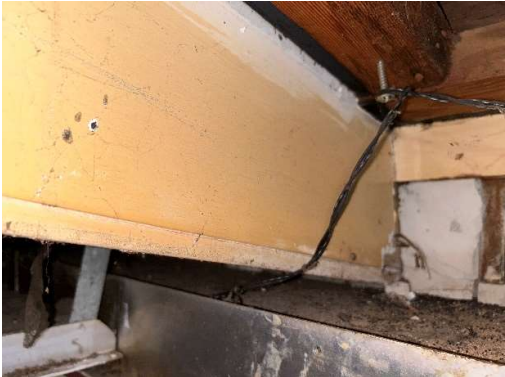
<p>Photograph 22: Auditorium, Southern end above Kitchen Seating, above ceiling tiles, length of W-E Beam, Cement sheeting affixed to side of Beam. Beige (8788/A44).</p>

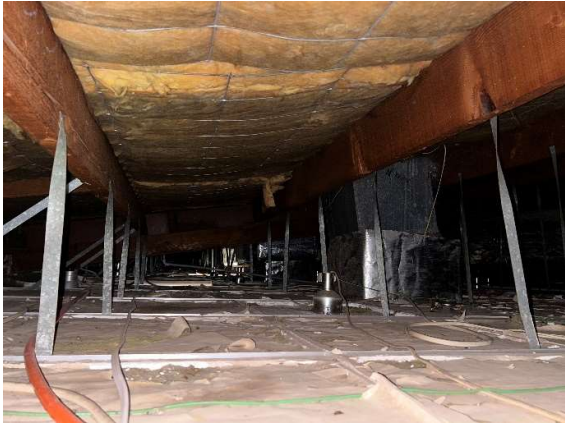
<p>Photograph 23: Auditorium, Northern end of Auditorium. Mineral Fibre. No other Beams with sheeting affixed, observed.</p>

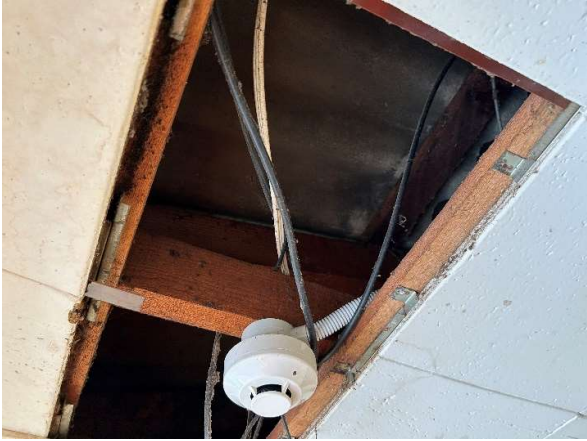
Building/Location	
<p>Photograph 24: No Entry Room. Super Six Roofing visible above Ceiling Tiles (8788/A29)</p>

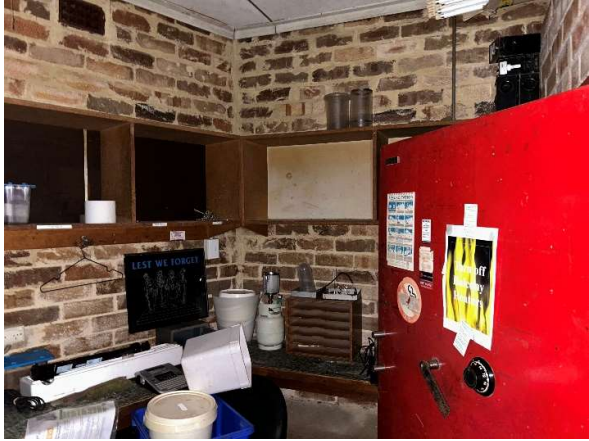
<p>Photograph 25: Main Foyer, Office to Strong Room, Ceiling Lining and Cornice (8788/A31 and A32)</p>

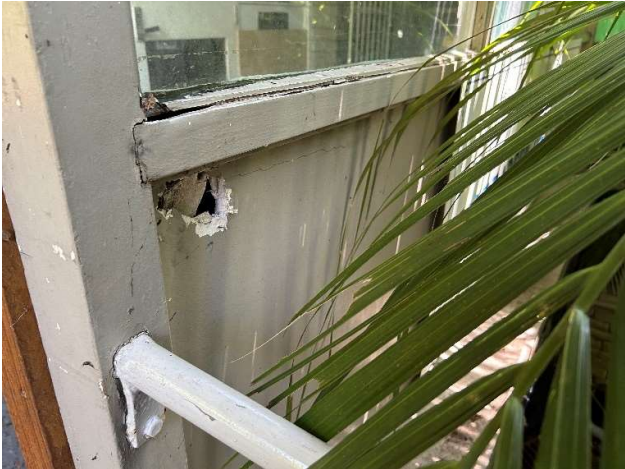
<p>Photograph 26: Main Entrance, Exterior, Eastern side of entry, Infill Panel (8788/A43)</p>

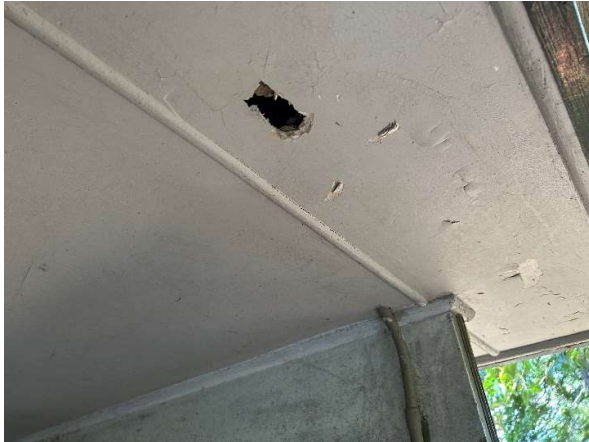
<p>Photograph 27: Main Entrance, Exterior, Eaves, White (8788/A34)</p>

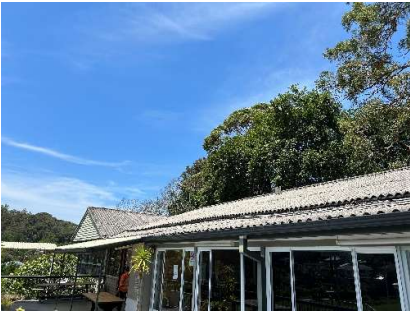
Building/Location	
<p>Photograph 32: Main Foyer to Poker Machine Room, Super-Six Roofing (8788/A29)</p>

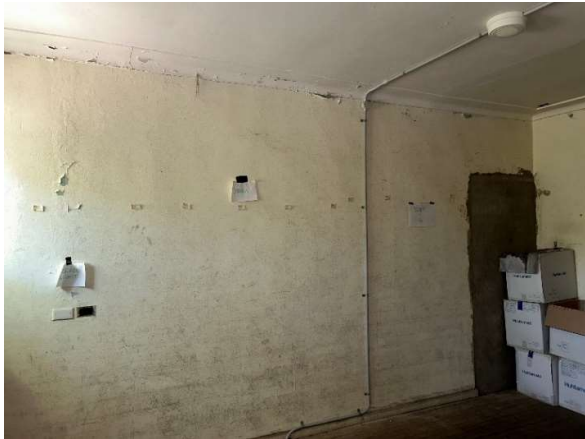
Building/Location	
<p>Photograph 37: Storage beneath Poker Machines, Store 2 East, Wine Room, Paint, Crème (8788/L19)</p>

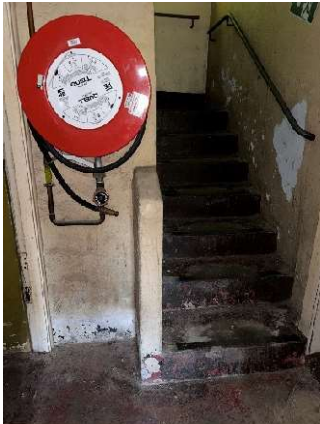
<p>Photograph 38: Storage beneath Poker Machines, Stairs to Telephone Room and Poker Machines, Paint, Green (8788/L20) and Red (8788/L21)</p>

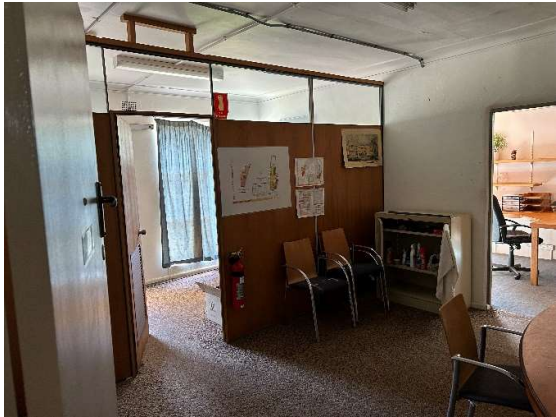
Building/Location	
<p>Photograph 39: Office beneath Poker Machines Northern Room, Walls, Paint, White (8788/L27)</p>

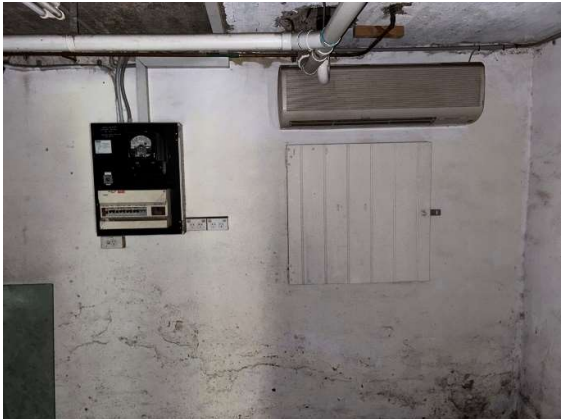
<p>Photograph 40: “Whipper Snipper Garage”, Southern Room, Garage, Western Wall, Sub-Floor (Access Hatch) (8788/A41) and EBB.</p>

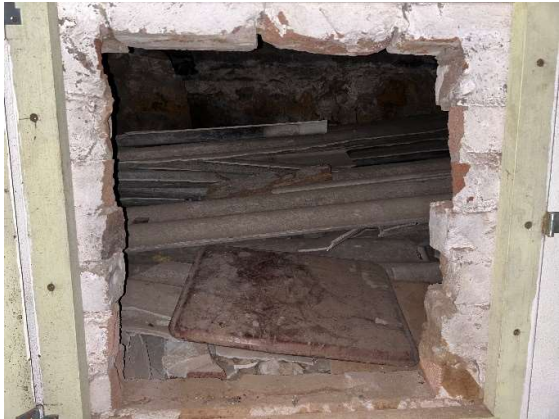
<p>Photograph 41: “Whipper Snipper Garage”, Southern Room, Garage, Western Wall, Sub-Floor (Access Hatch) (8788/A41)</p>

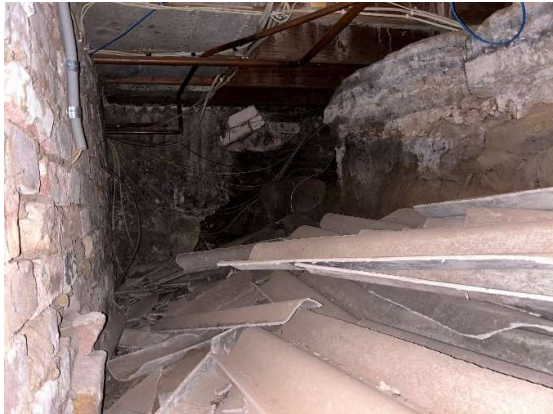
<p>Photograph 42: “Whipper Snipper Garage”, Southern Room, Garage, Western Wall, Sub-Floor (Access Hatch) (8788/A41)</p>

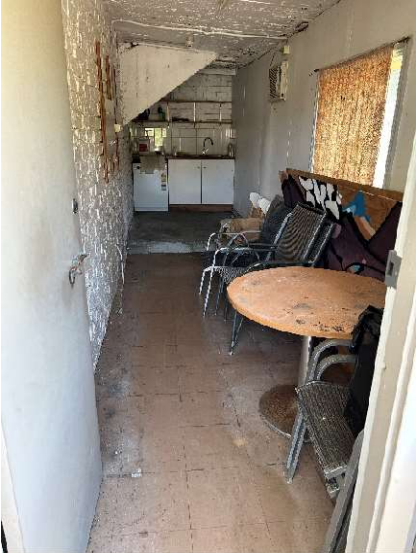
Building/Location	
<p>Photograph 43: Kitchen, Southern Wall, Paint, White (8788/L23)</p>
