GEOTECHNICAL ASSESSMENT

PROPOSED RESIDENTIAL DEVELOPMENT

13 LODGES LANE
(STRATA PLAN 30051)
FRESHWATER NSW 2096

OUR REPORT REFERENCE: GF1692-A

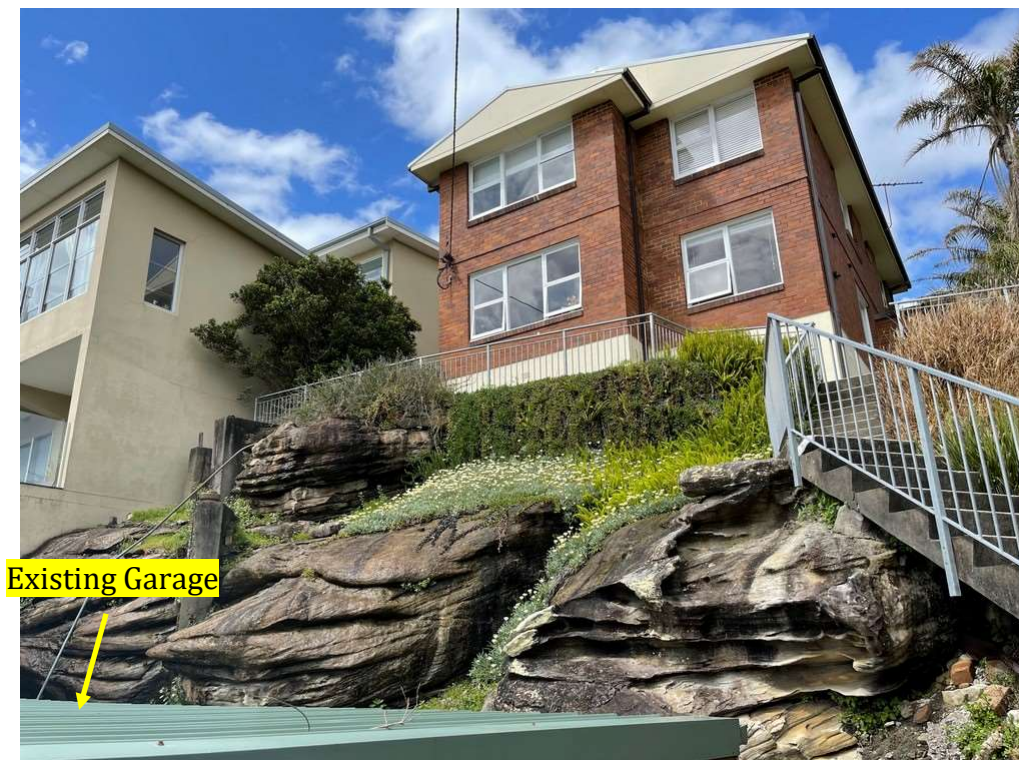
At the time of the fieldwork, a two-storey building was occupied in the middle section of the site (the upper part of the site). A garage was located in front of Coastview Place (the bottom part of the site). A rock cliff was exposed near the middle portion of the site, in front of the existing building. The rock cliff was estimated to be approximately 8m high. No obvious sign of slope instability (e.g. rock toppling) was observed during our walkover assessment.

Photo 2:Rock cliff face in front of the existing building

Based on our walkover assessment, high-strength sandstone rock was exposed at the surface and the cliff face. Hence, the site is classified as Class A in accordance with AS2870-2011. A qualified geotechnical engineer must confirm this prior to pouring concrete.

- If Class III or better quality sandstone is exposed during the excavation, it may be cut vertically and left unsupported in the long-term, subject to a professional geotechnical engineer's confirmation at the appropriate time. Therefore, a qualified geotechnical engineer must be engaged to assess the exposed cut face at 1.5m intervals to confirm the rock quality and defect spacing.

- Written permission by the geotechnical engineer should be obtained before continuing the excavation.
- Allowance should be made for rock anchors and another retention system, such as shotcrete, if adverse defects are identified by the engineer during the inspection.

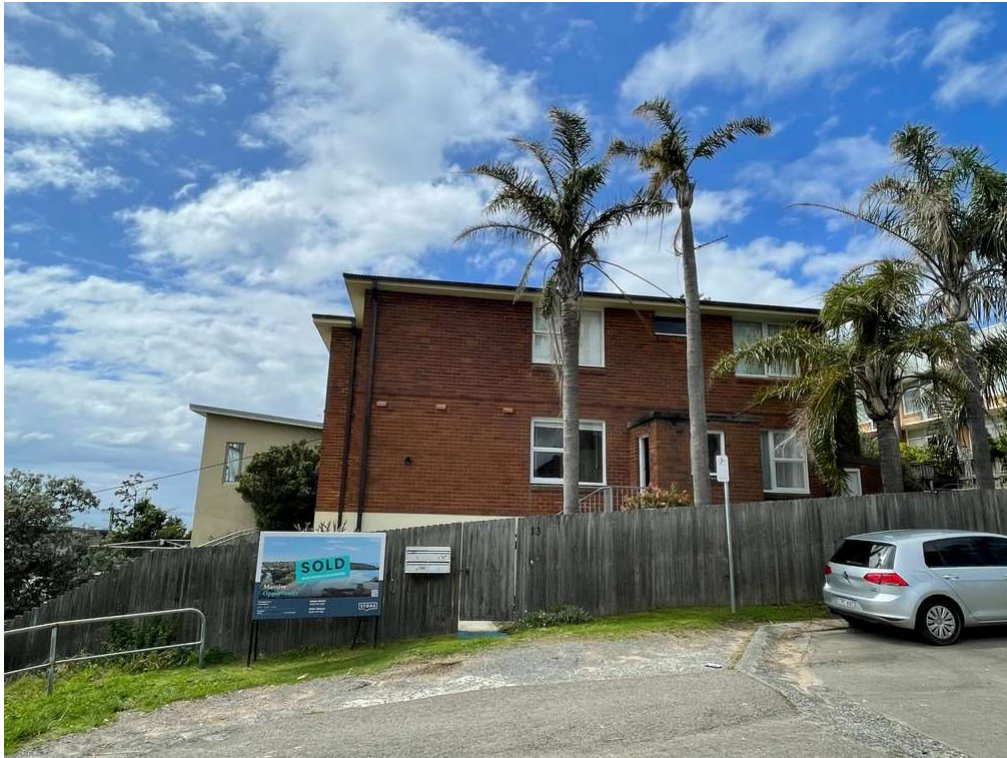
Photo 3: Looking to the site from Lodge Lane

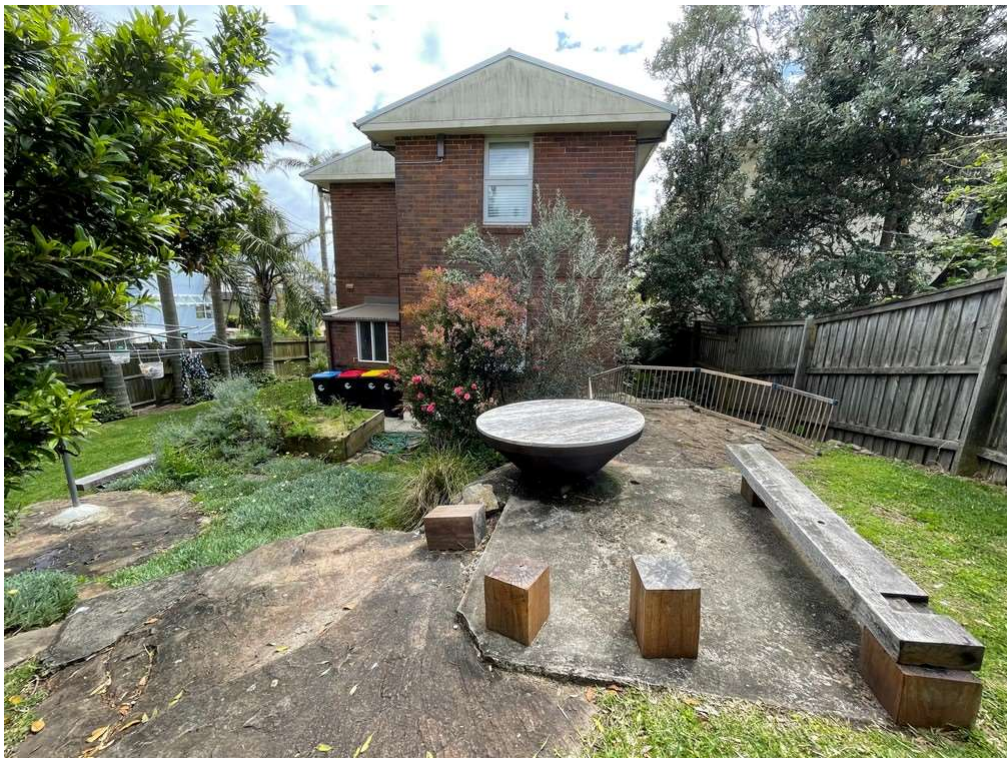
Sandstone outcrops were also observed on the backyard surface.

Photo 4: Existing backyard condition exposing Sandstone outcrops
