| <b>Address of site</b> | <b>105 Prince Alfred Parade, Newport</b> |

**RISK ANALYSIS & MANAGEMENT  
FOR  
PROPOSED SWIMMING POOL &  
ALTERATIONS AND ADDITIONS  
AT  
105 PRINCE ALFRED PARADE, NEWPORT**

**Job Number:**  
**PX 00013**  
6<sup>th</sup> July, 2019  
Page 11

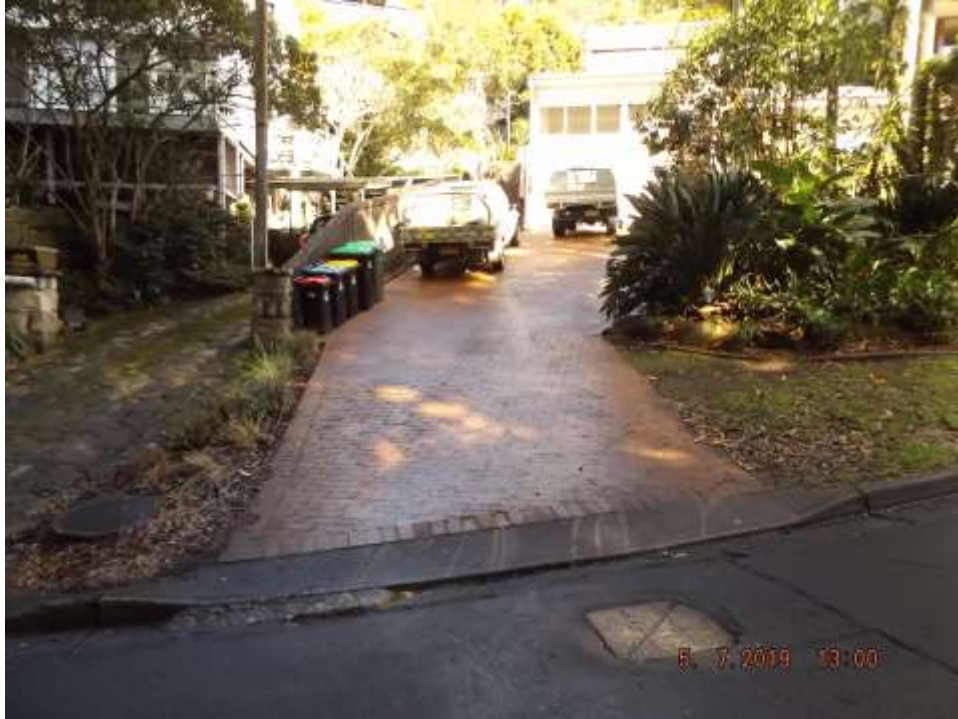
**Photo 1**

**3.3** Access to the property is via the paved driveway which starts from the edge of the Prince Alfred adjacent north eastern corner of the property, Photo 1. The attached double garage is under the north eastern corner of the existing residence. Pedestrian access is also via the driveway and set of stairs that lead to the main entry to the existing residence, Photo 2. From the road side a landscaped earth batter rises up to the lawn area at the front of the existing residence. A small sandstone rock retaining wall runs along the western side of the driveway, Photo 3. Access to the rear of the property is via series of timber, stone and paved stairs and paths, Photo 4. Small timber and stone retaining walls support the fill and cut material in the various terraces as the access rises to the rear of the existing residence, Photo 5. At the rear of the existing residence a number of segmental block and stone retaining walls terrace the rear yard, Photo 6. These retaining walls were observed to be stable at the time of our inspection. A set of timber stairs provide access to Elvina Avenue. At the top of western side of the existing residence is a vegetated slope leading to a covered battered slope, Photos 7 & 8. Access to the western side of the existing residence is via pathway and timber stairs with a concrete block retaining wall running along the western side boundary, Photo 9. The footing at a step in the concrete block retaining wall was observed to be undermined and in need of remedial work as soon as possible, Photo 10. At the only access point at the time of our inspection to the subfloor of the existing residence we observed a stable earth batter, Photo 11.

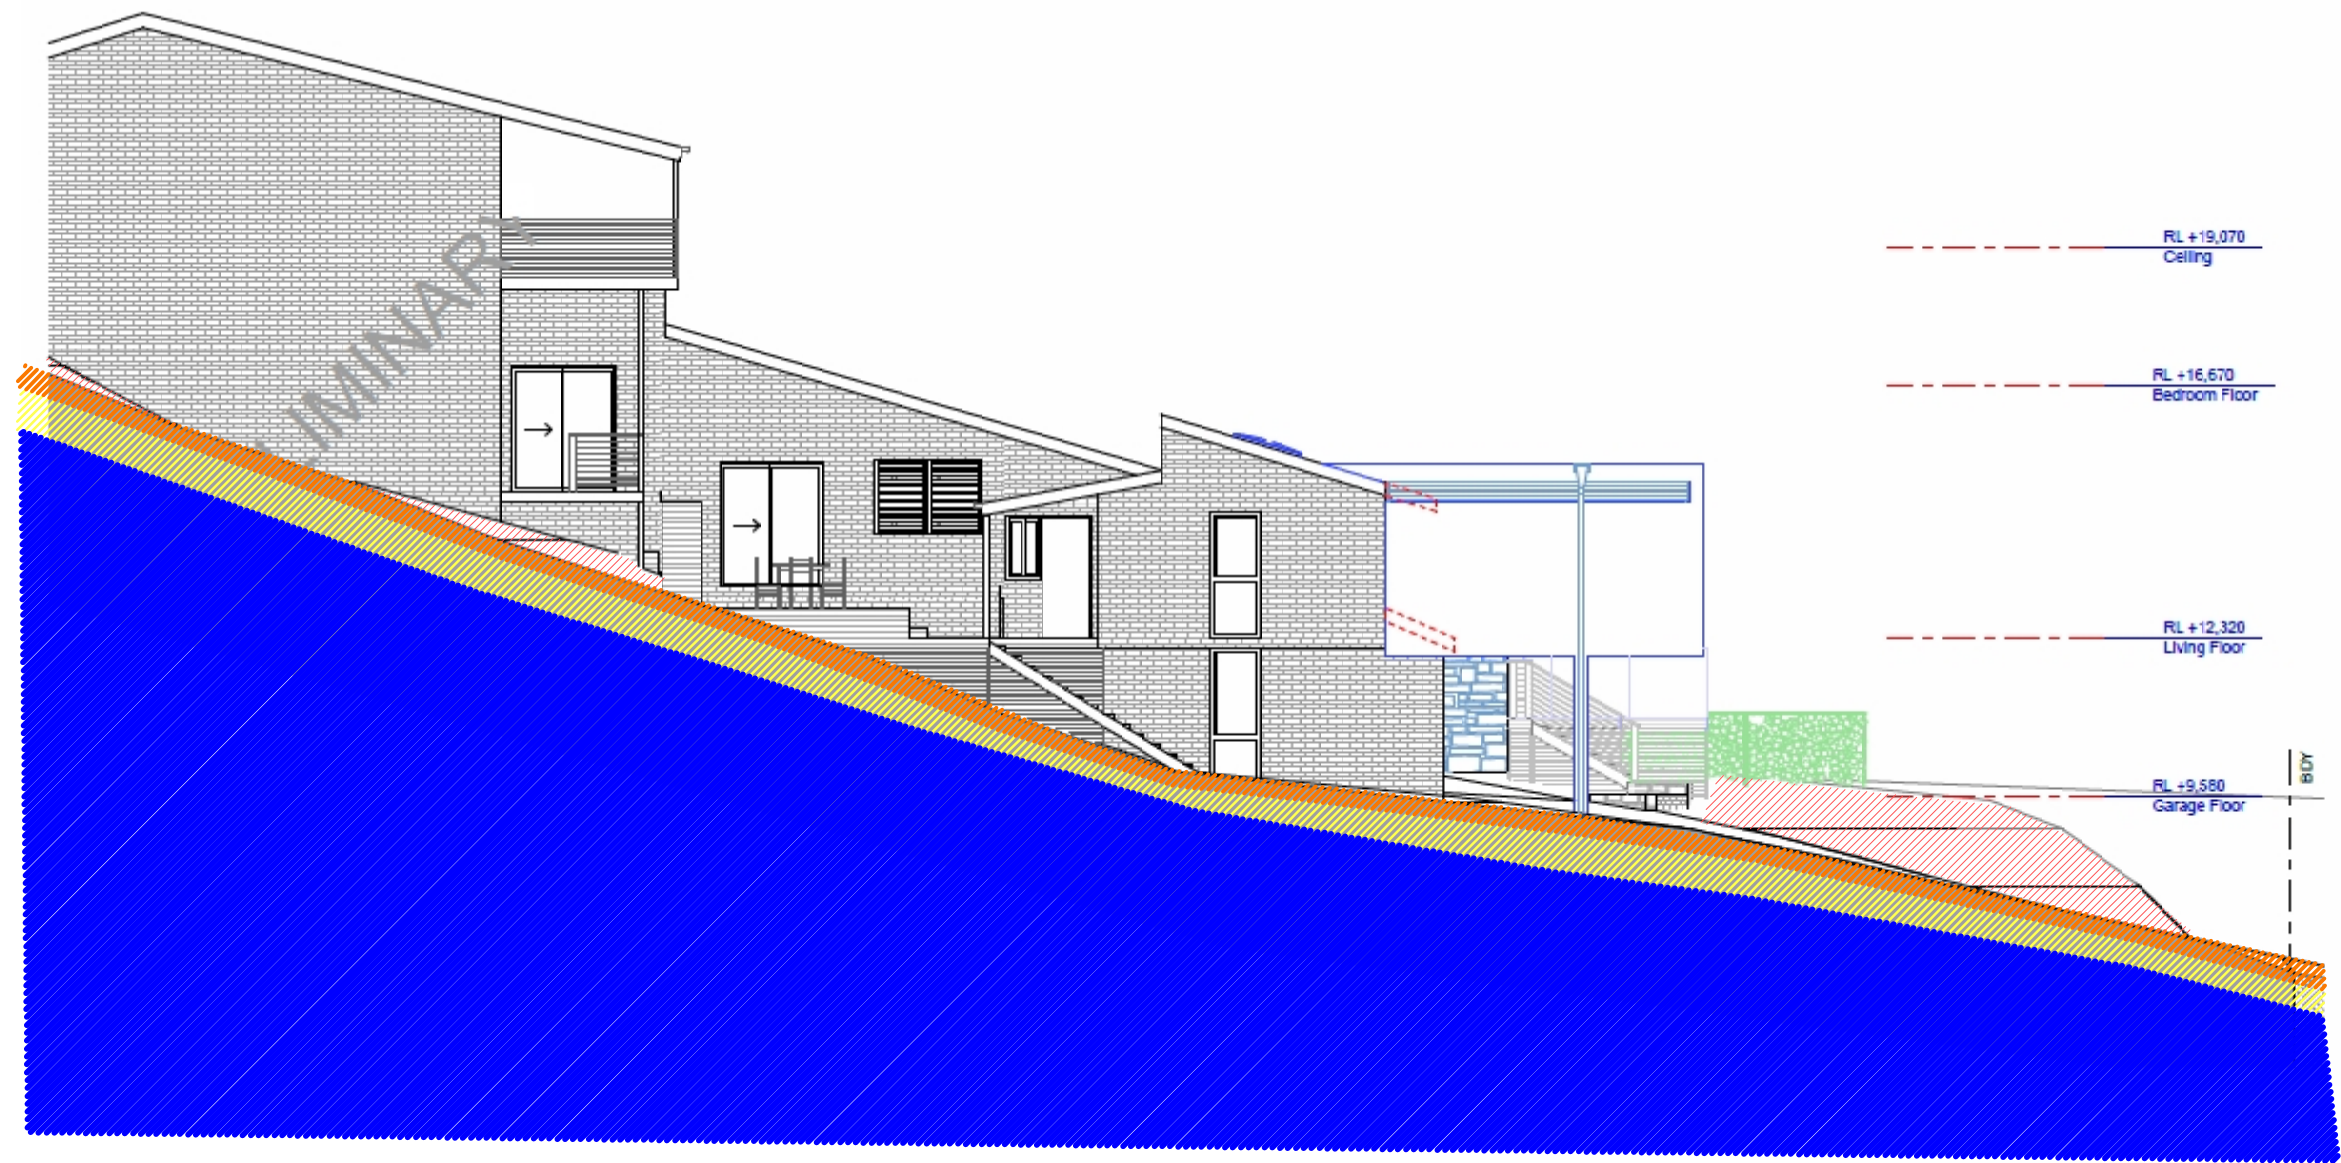
TYPE SECTION

**4.2** The slope materials are colluvial in origin at the surface and become residual with depth. They consist of topsoil over sandy clays and clays that merge into the weathered rock at depths varying from 0.5 to 3.0 metres or deeper where filling has been carried out.

**NOTE**  
INTERPRETED SUB SURFACE SECTION ONLY.  
ACTUAL GROUND CONDITIONS MAY VARY.
