18 May 2020
E24685.G02

Preliminary Landslip Risk Assessment Report 532 Pittwater Road, North Manly, NSW

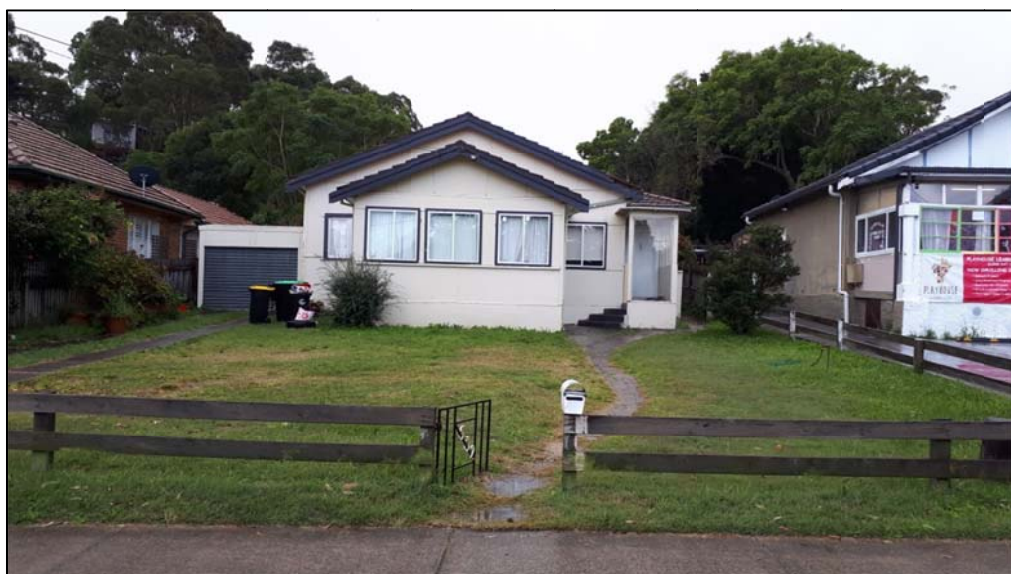
Plate 2: Front view of the site house, looking north

- The front of the site consists of a near level grassy lawn with a concrete strip driveway along the western site boundary that provides access to a single lock up garage located adjacent to the western side of the existing site house. A narrow concrete pathway through the front lawn provides access to the front entrance while a slightly uneven concrete pathway along the eastern site boundary leads to the rear of the property. A front view of the existing site house is shown below in **Plate 2**.

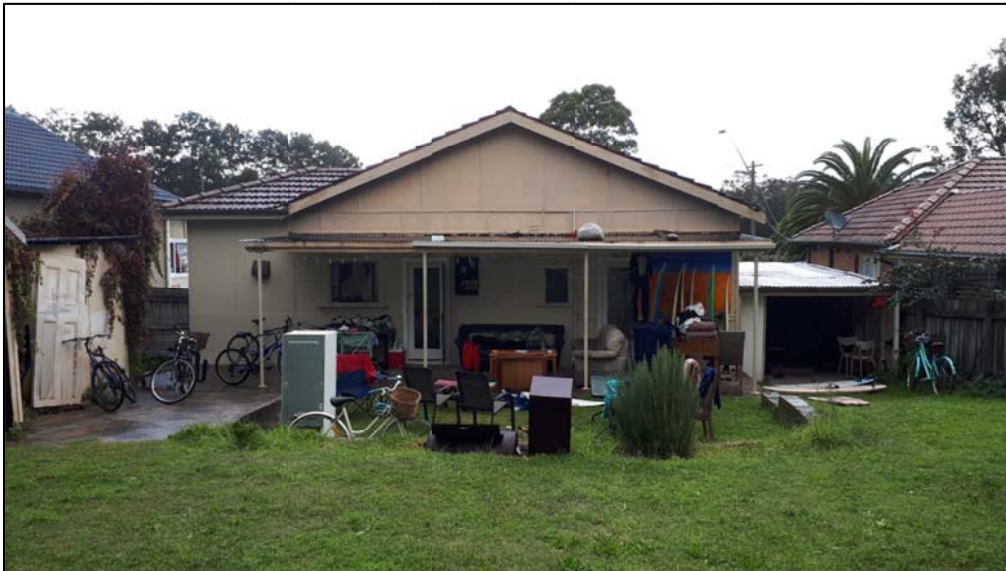
Plate 3: Rear view of the site house, looking south

- The existing house is a single storey fibro residence with tiled roof located approximately on the centre of the block. It is raised approximately 0.50m above the ground surface level at the front south side of the house via brick column footings. The house appears at grade or slightly excavated into the slope at the rear northern end of the house with a small retained garden adjacent to a covered pergola on the northern side of the house. The house structure appears of significant age (>80 years) and is in a reasonable condition. However there were no indications of movement within the column footings supporting the house structure. A rear view of the existing site house is shown below in **Plate 3**.

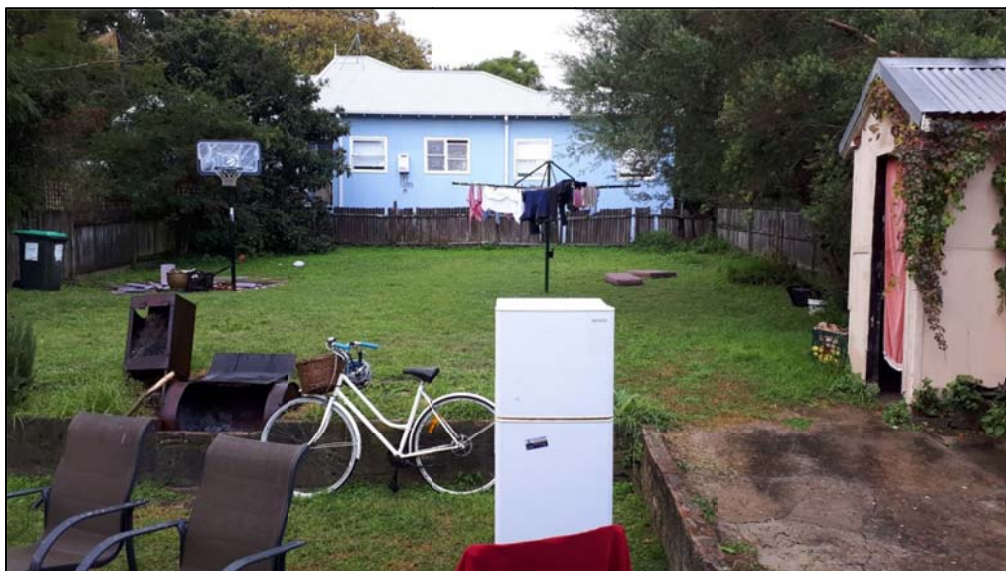
Plate 4: A view of the back yard, looking north

- The back yard at the rear north of the site is gently south dipping and formed with lawns and gardens along with a small timber secondary dwelling formed at grade adjacent to the northern side boundary. A general view of the backyard is shown below in **Plate 4**.
