Date: 19th April 2021

Project No.: 2021-061

Preliminary Landslip Assessment for Proposed New Boundary Wall,
14 Ellen Street, Freshwater, NSW.

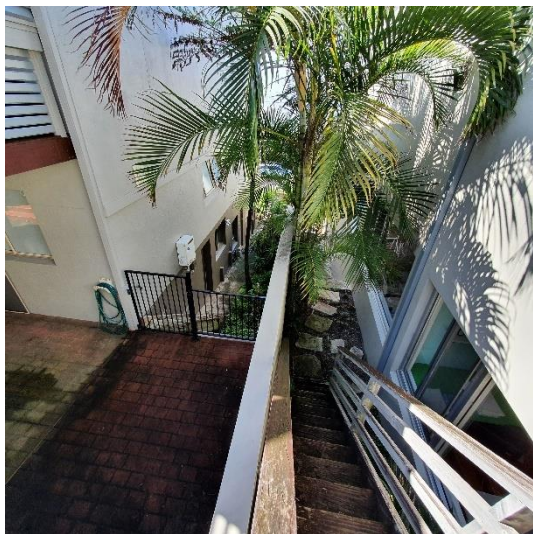
The site-dwelling comprises a two to three storey rendered brick residence which broadly occupies the eastern portion of the block and extends north and south to approximately 1.0m off the northern and southern boundaries. Along the northern side of the dwelling is a series of paved pathways and stairs and a timber staircase (Photograph-1) which allows access to a raised grass lawn. Along the southern side of the

dwelling is a series of concrete pathways and stairs that lead to the rear of the dwelling. Signs of deformation, cracking or underlying geotechnical issues were not observed within the dwelling's external walls or adjacent structures and all appeared in good condition.

Photograph-1: Existing site's northern boundary. View looking down east.

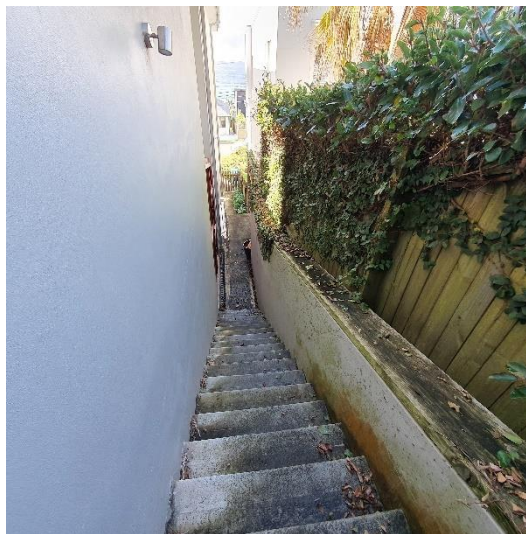
Photograph-2: Existing site's southern boundary. View looking down east.

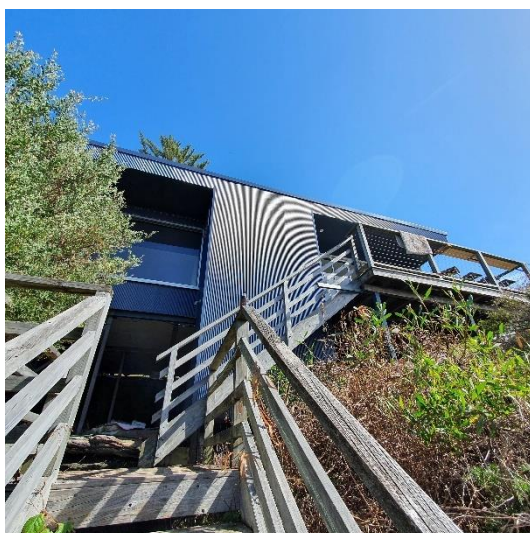
Access to the western higher portion of the block (above the cliff face) is available via a series of timber staircase located to the south-west of the site-dwelling. Numerous bedrock outcrop along with dense vegetation is present around the timber staircase. The timber staircase leads to a secondary dwelling which is located at the higher western end of the block, comprising a timber framed, metal clad studio (Photograph-3) supported by steel columns (Photograph-4). The secondary dwelling structure and timber staircase appeared in good condition, signs of instability or underlying geotechnical issues were not identified within these structures or the cliff face.

Photograph-3: Secondary dwelling. View looking high west.

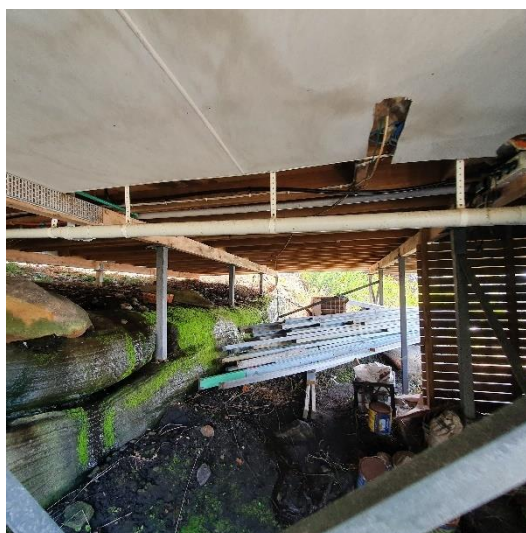
Photograph-4: Secondary dwelling supported by steel columns. View looking north.
