Geotechnical Assessment

Project: Alterations and Additions
174 Woorarra Avenue, Elanora Heights NSW.

Prepared for:
Sean Tapp
174 Woorarra Avenue
Elanora Heights, NSW 2101

REF: AG 20243
29 September, 2020

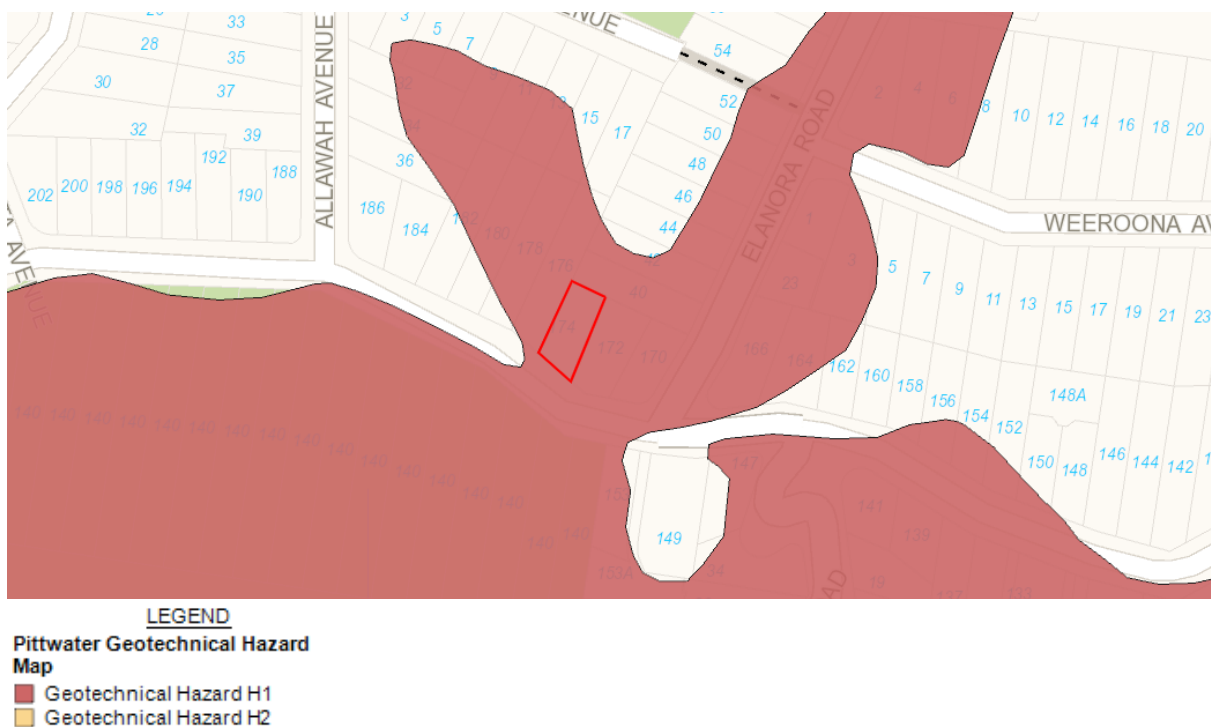
Image 2. PLEP Geotechnical Hazard Map – 174 Woorarra Avenue, Elanora Heights NSW (NBC Maps)

- No evidence of significant soil creep, tension cracks or landslip instability were identified across the site or on adjacent properties, as viewed from the subject site, at the time of our inspection.
- The property is classified as **Geotechnical Hazard H1** with reference to Northern Beaches Council PLEP Landslip Risk Map Sheet (PLEP Geotechnical Hazard Map **Image 2** below).

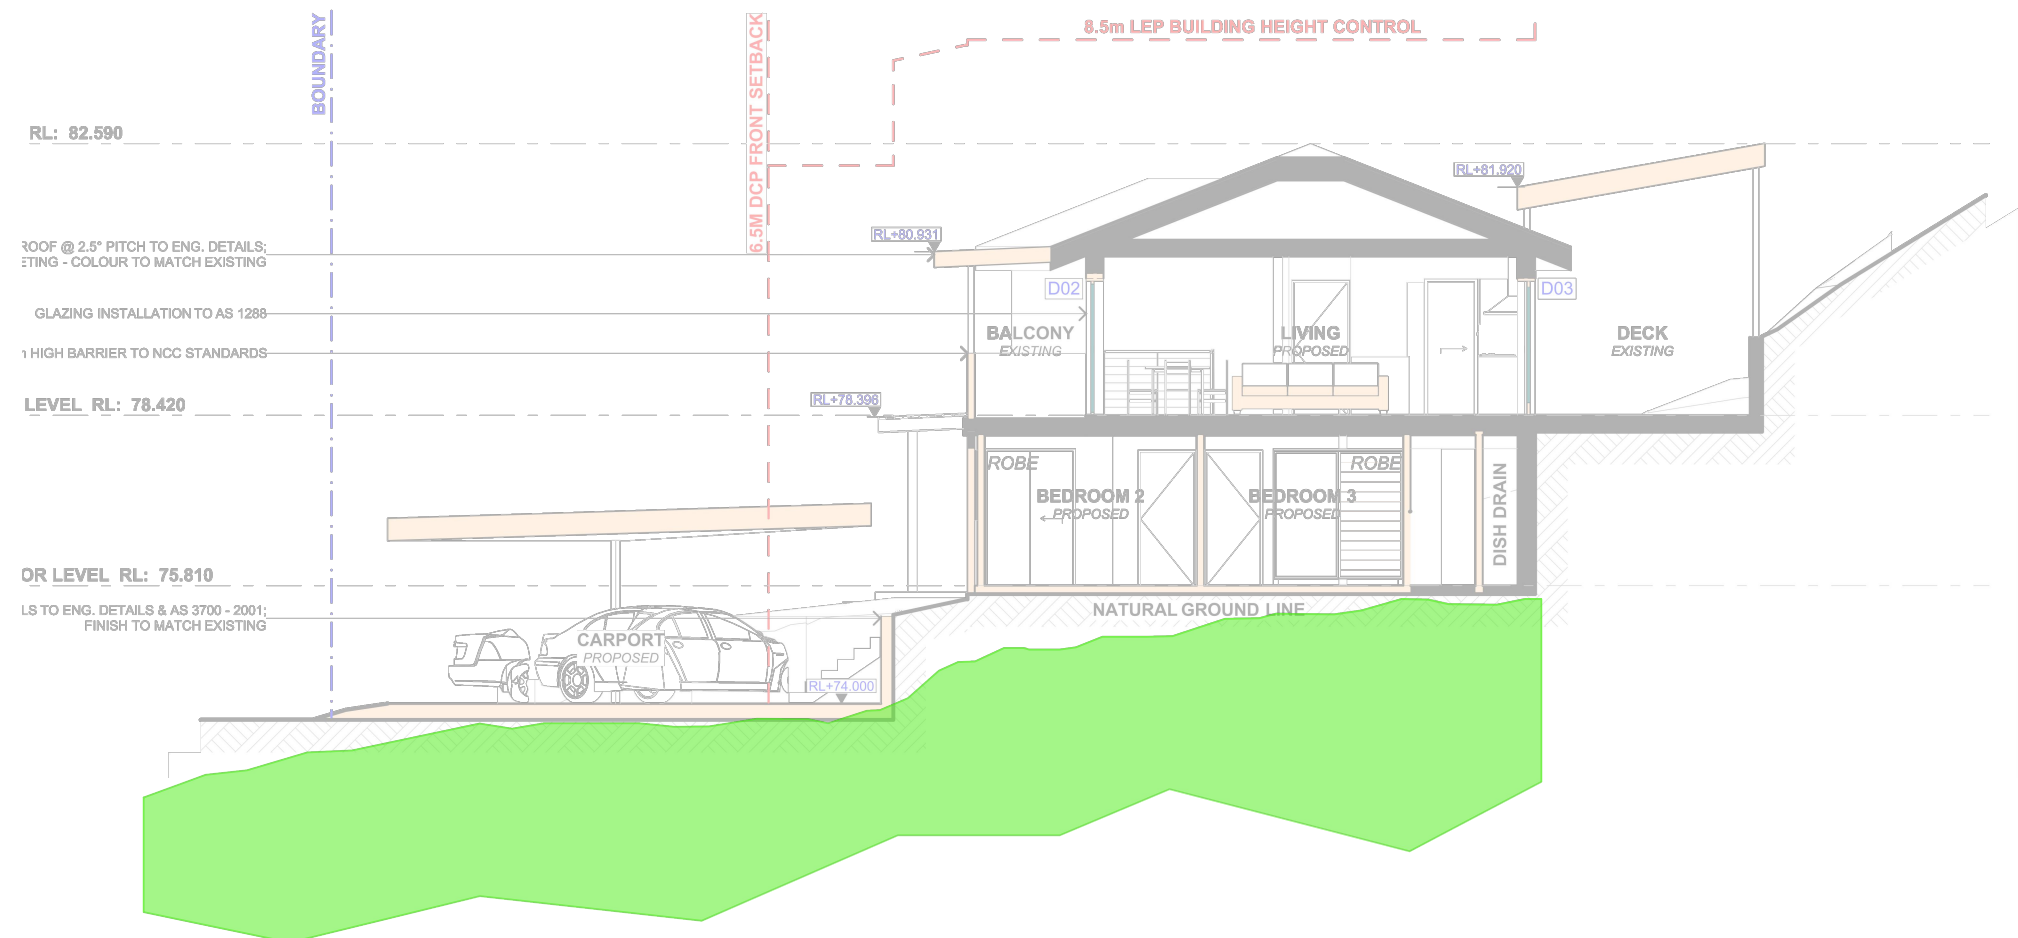
ESTIMATED ROCK PROFILE SECTION

The soil profile consists of shallow uncontrolled fill and silty sand top soils (O & A Horizons), clayey sand (B Horizon), and weathered sandstone bedrock (C Horizon). Based on our observations and the results of testing onsite, we would expect competent weathered bedrock, to be found within 500–1600mm from current surface levels across the site.
