STANDFAST TREE SERVICES
ESTABLISHED 1979

Arboricultural Impact Assessment (AIA)

Location: 17 Playfair Road, North Curl Curl NSW 2099

Report date: 26.3.2018

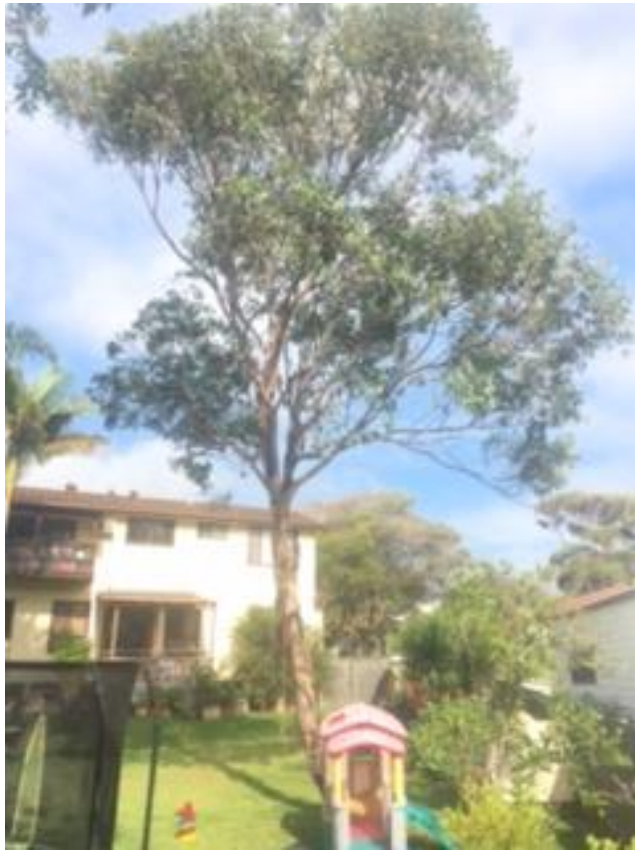
- 1.1 This AIA has been commissioned to assess the trees on the subject site for a DA application to subdivide the land. One tree is impacted - the *Eucalyptus punctata* or grey gum close to the northern boundary at the rear of 17 Play Road, North Curl Curl (refer Figure 1).

#	DBH	TPZ radius	DAB	SRZ radius	Comments
Grey gum	0.35	4.2	0.5	2.47	The trench excavated to install the stormwater will be 1m away from the base of the grey gum and will be within the SRZ

- 3.1 The circular area of the *E. punctata*'s SRZ (radius approximately 2.47m), an area set aside to protect tree stability,² will be breached by excavation to install the stormwater pipe in a trench approximately 1m away from the base of the tree
- 3.2 Minor encroachments into the TPZ can be allowed but regarding the SRZ, AS 4970-2009 says '*The woody root growth and soil cohesion in this area are necessary to hold the tree upright.*'
- 3.3 Cutting the trench approximately 1m away from the grey gum will cut through roots that stabilise the tree as well as its absorbing roots. '*Roots of most plants, including large trees, grow primarily in the top meter (3ft) of soil.*' (Richard W. Harris, 2004).

Figure 1: *Eucalyptus punctata* or grey gum

- 4.1 The root system close to the base of the grey gum would be exposed and cut during excavation work for the proposed stormwater pipe resulting in destabilisation and loss of absorbing roots.
- 4.2 As the tree has deteriorated further since July 2016, is under attack from canker fungi and is in poor condition it should be removed.

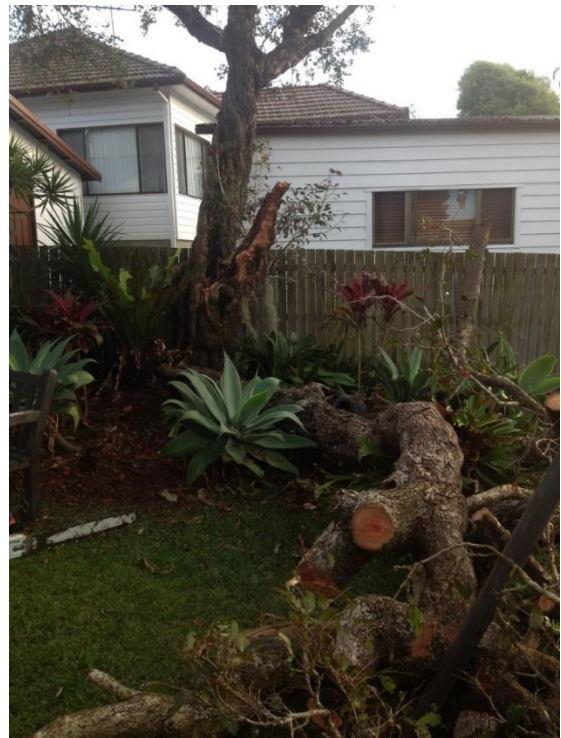
- 1.5 Since the initial Survey Plan (11.1.16) was issued, Standfast Tree Services have provided arborist advice and carried out removals, commencing in July 2016 when a *Glochidion ferdinandi* or Sydney cheese tree was removed. It had failed, revealing a large area of decay in its base – the home of too many Christmas beetle larvae (refer Figures 2 and 3).

Figure2: Failed cheese tree July 2016

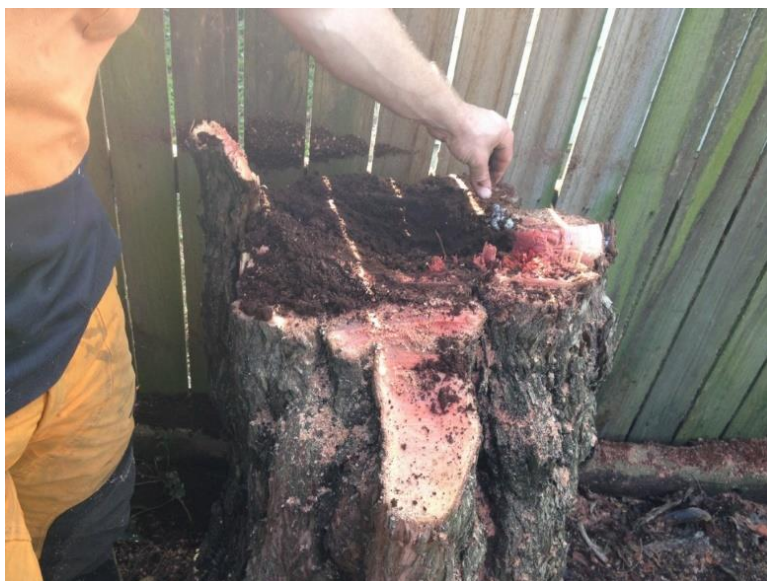
Figure 3: Decay in base of cheese tree, home to Christmas beetle larvae

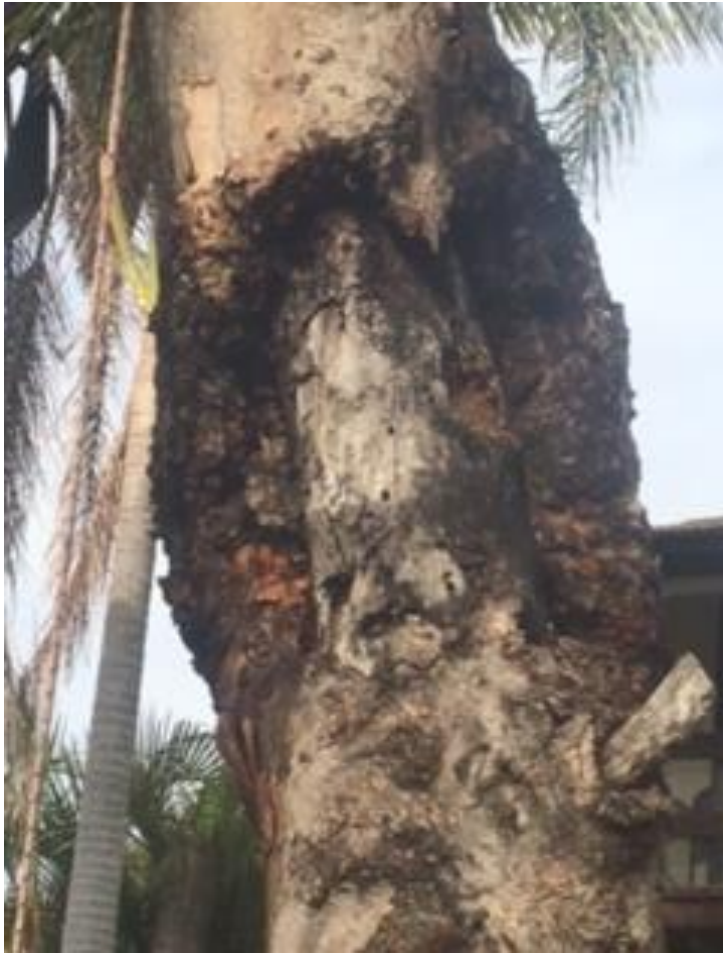
- 2.4 There is a large canker¹ on the main stem, approximately 3m above ground level (refer Figure 4). Exposed wood occupies approximately half the trunk diameter.
- 2.5 There are other small cankers visible on the tree's branches throughout the canopy
- 2.6 The site of a recent branch failure (approximately 80mm diameter), some 4m above the ground shows the failure point occurring at a canker sited near the base of the branch (refer Figure 5).
- 2.7 Two old pruning sites near the base of the grey gum do not have new cambium and bark cover to the exposed wood - most likely caused by fungi that have invaded the sites. Decay has begun to take hold (refer Figure 6).

Figure 4: Canker on main stem,
about 3m above ground

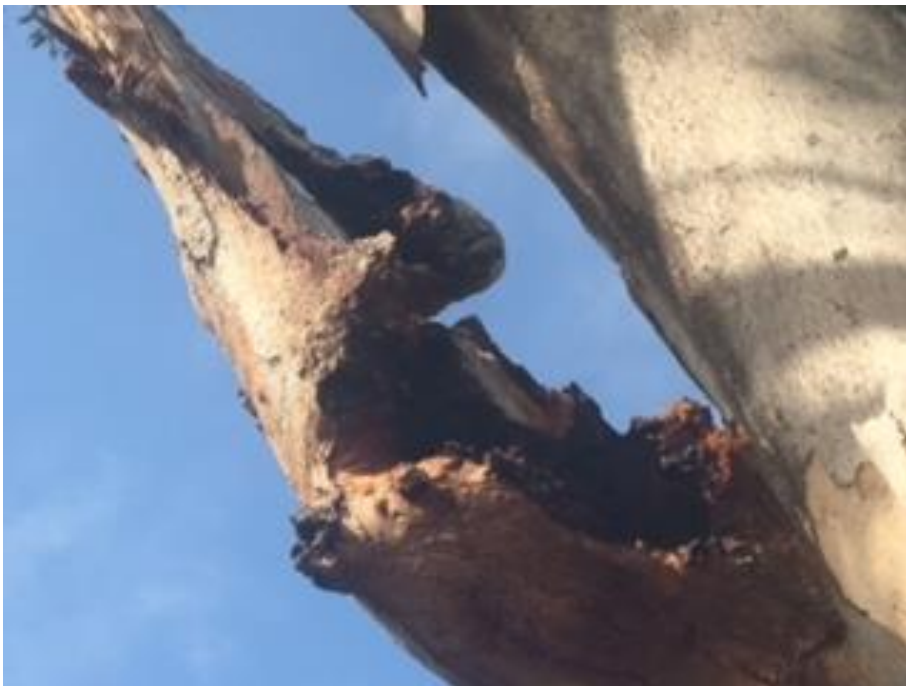
Figure 5: A canker was the point of failure for a branch which recently fell

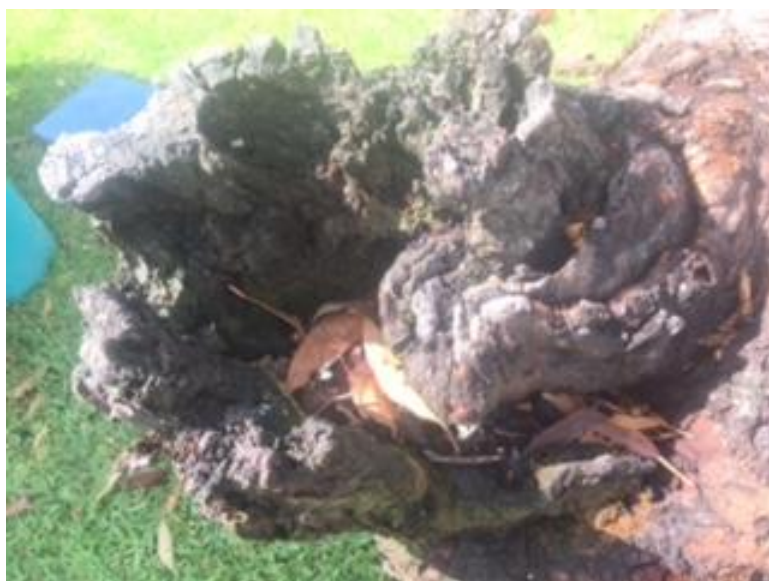
Figure 6: Old pruning scar now site of canker and decay
